1. Report No. FHWA/TX-01/1458-3	2. Government Accession No.	3. Recipient's Catalog No.	
4. Title and Subtitle TESTING AND EVALUATION OF RECYCLED MATERIALS IN ROADSIDE SAFETY DEVICES		5. Report Date October 2000 Resubmitted: April 2001

# **TESTING AND EVALUATION OF RECYCLED MATERIALS IN ROADSIDE SAFETY DEVICES**

Report 1458-3  
Project Number 0-1458  
Research Project Title: Recycled Materials in Roadside Safety Devices

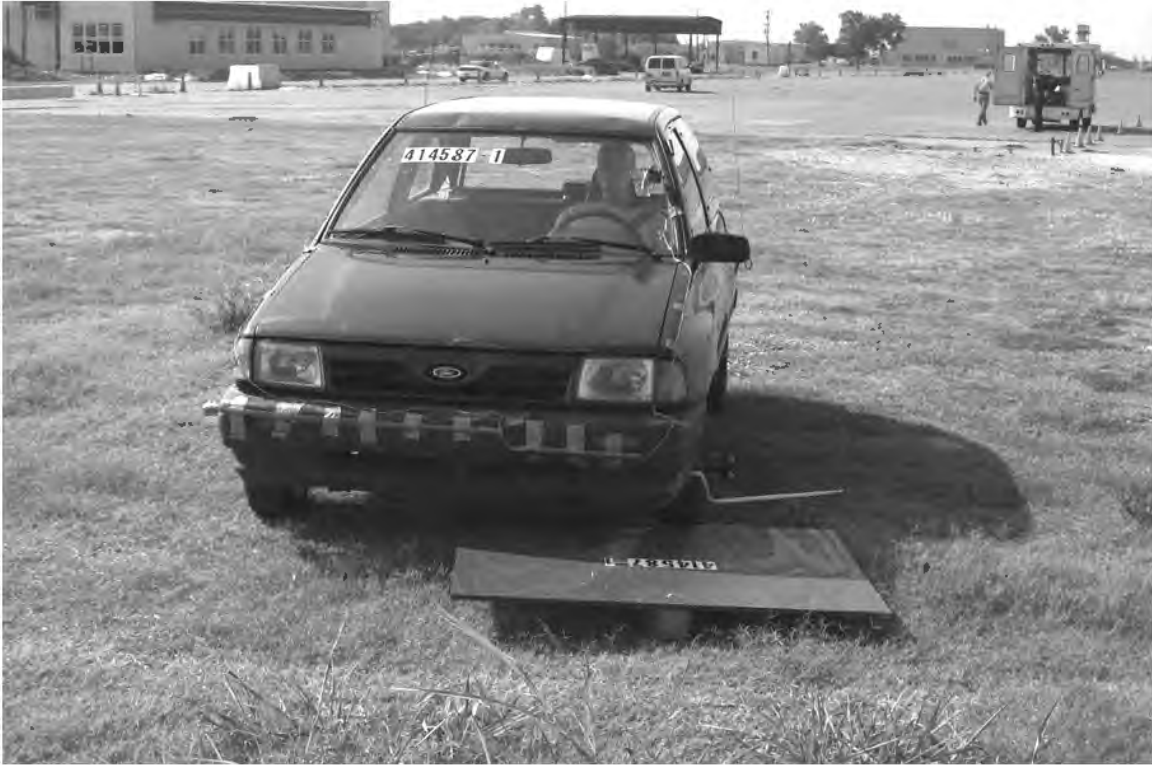
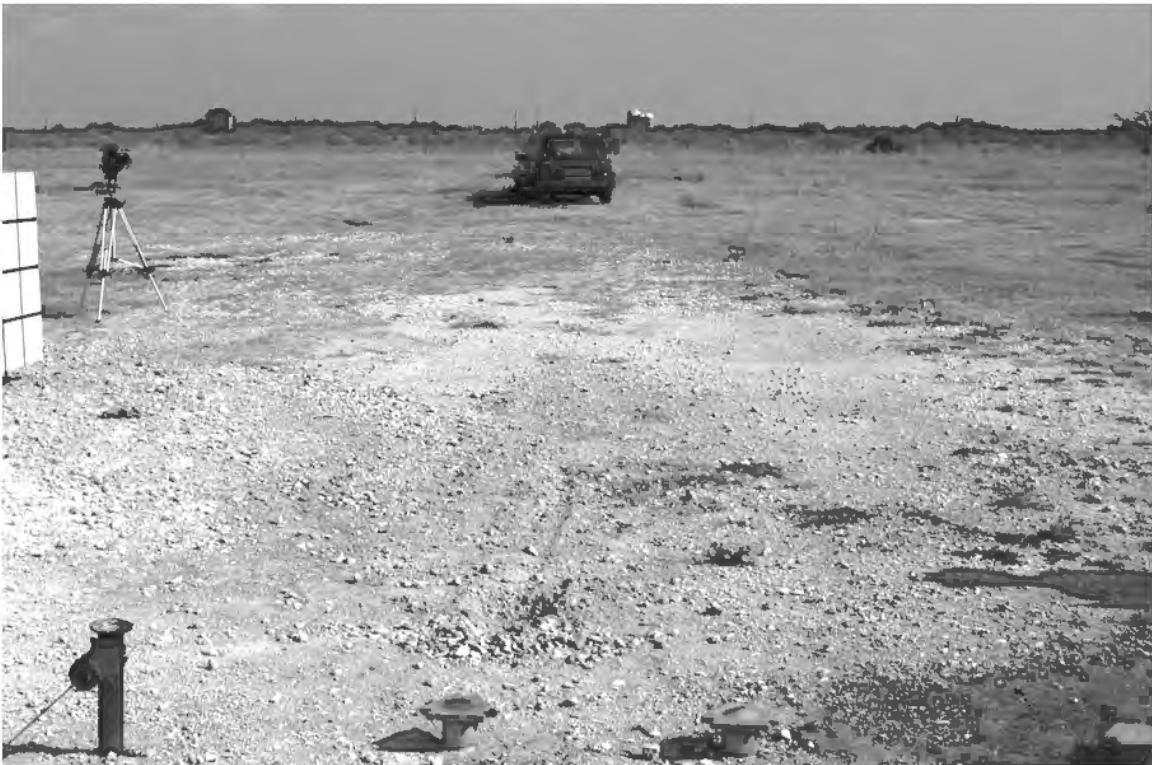
**Figure 7. After Impact Trajectory for Test 414587-1.**

The sign support fractured 203 mm below ground level. The support and sign were dragged under the vehicle until the vehicle came to a stop. The sign support was not reusable. Damage to the sign installation is shown in [figures 7 and 8](#).

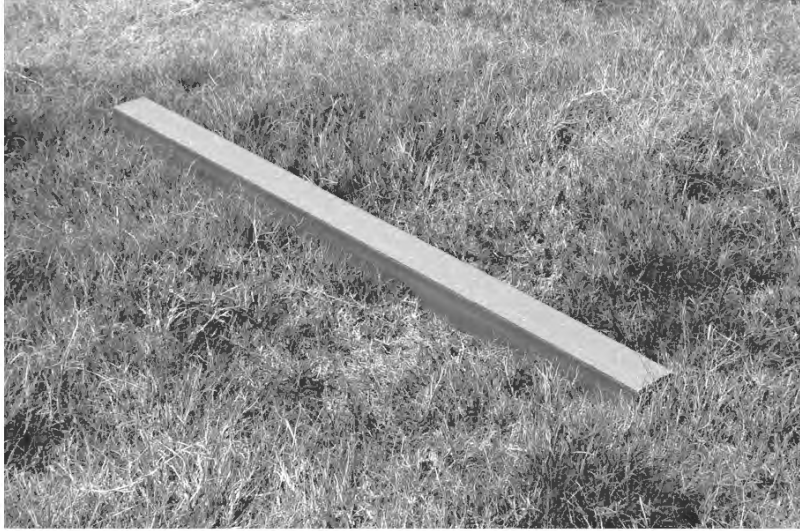
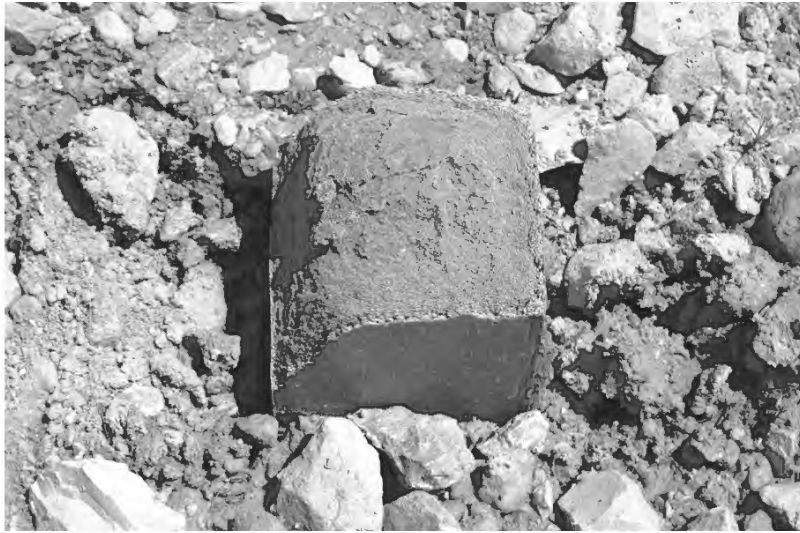
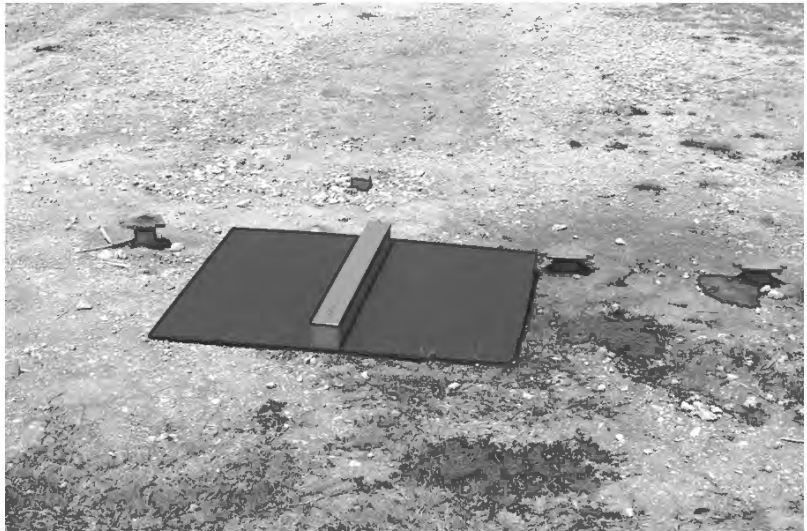
**Figure 15. Support After Test 414587-2.**

The sign support fractured near ground level, as shown in figures 14 and 15, and then into three sections. The base of the support fractured at 10 mm (impact side) and 45 mm (rear side) above ground level. The sign panel and a piece of the support separated during initial impact and came to rest near the impact point. One section of the support was 0.3 to 0.6 m long, and the other was 1.8 m long. The soil around the support was only disturbed. The support was not reusable.

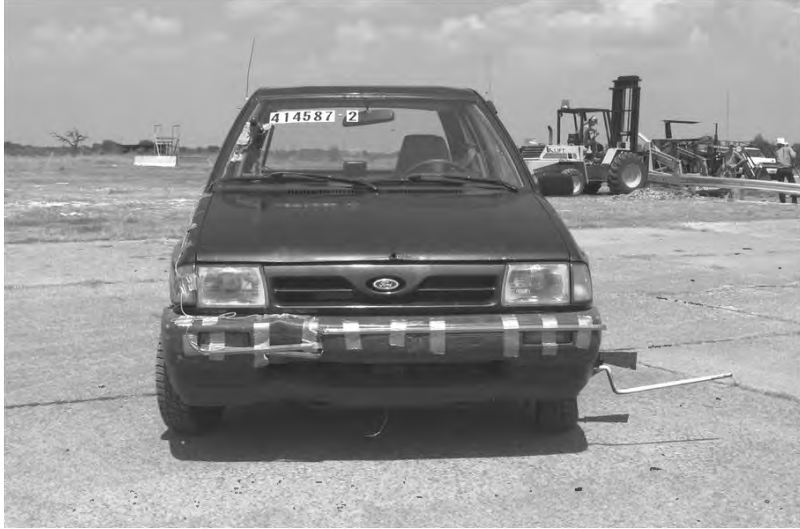
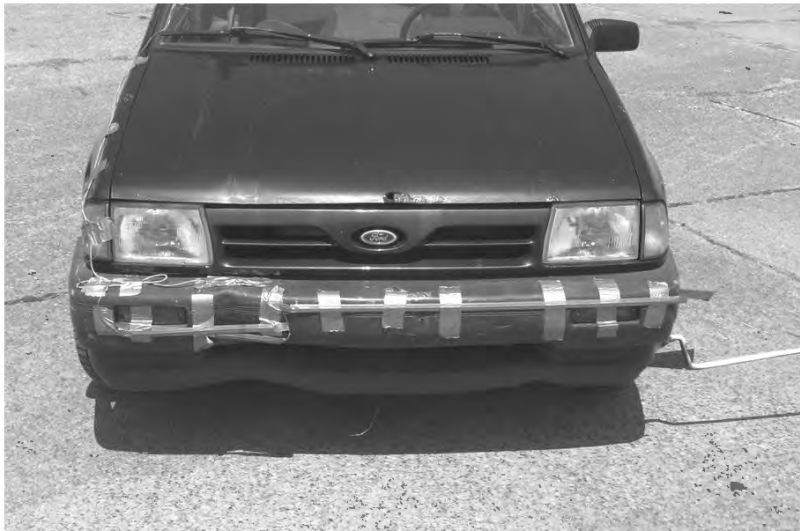
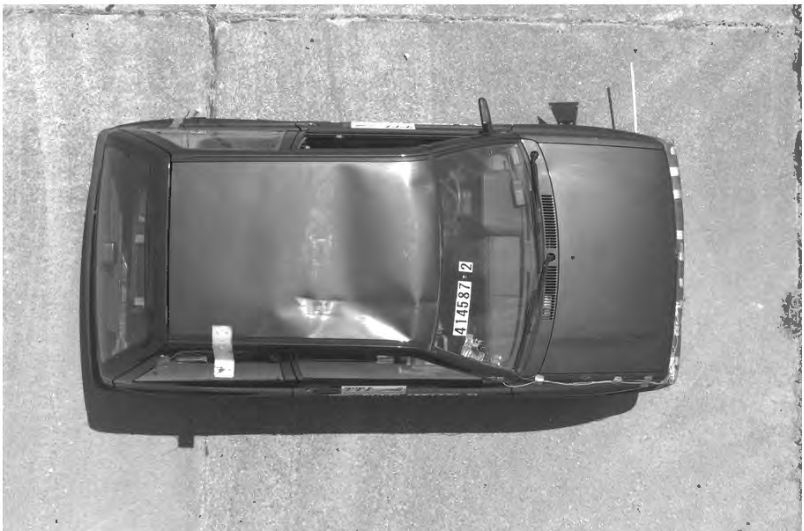
**Figure 16. Vehicle After Test 414587-2.**

Minor damage was done to the vehicle, as shown in figure 16. The right front bumper was dented in 15 mm. The roof was dented 25 mm deep in an area 700 mm in length by 900 mm wide. A scuff mark from contact with the panel was noted within the roof indentation. Maximum occupant compartment deformation was 7 mm in the rear occupant roof area.

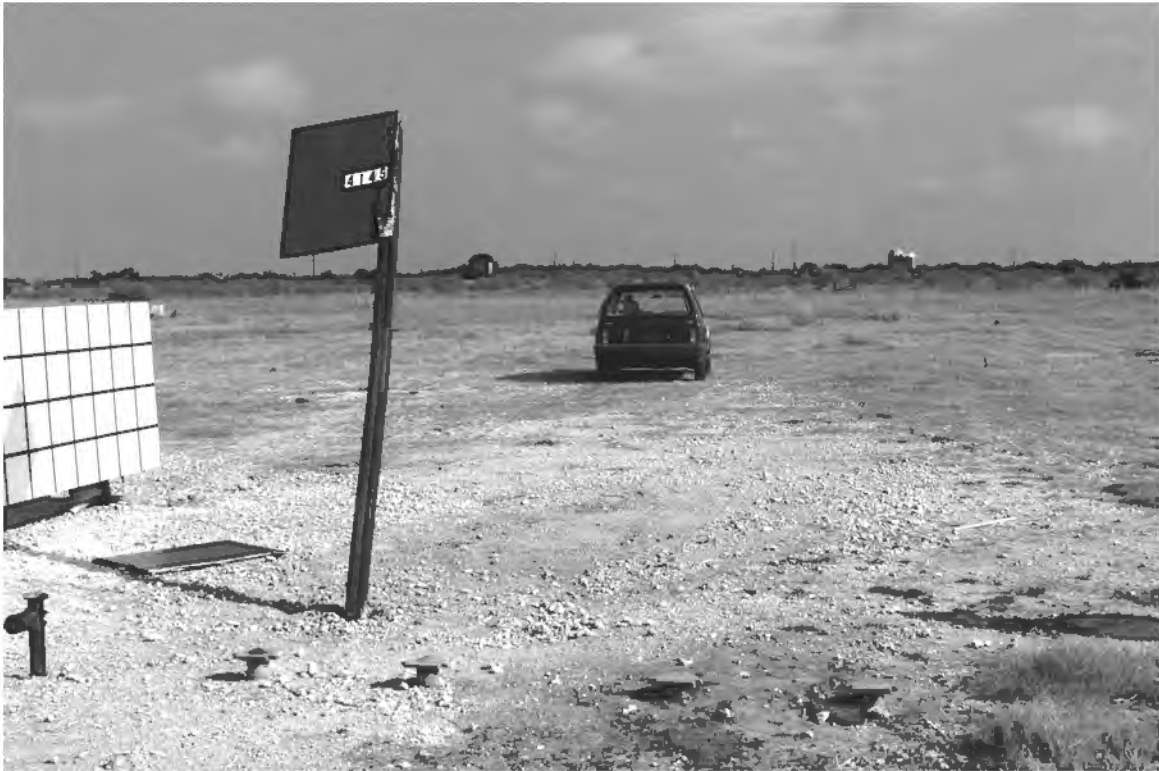
**Figure 21. After Impact Trajectory for Test 414587-3.**

Damage to the sign support is shown in figures 21 and 22. The support had been pushed back 185 mm during the test (measured at ground level) and had a permanent displacement of

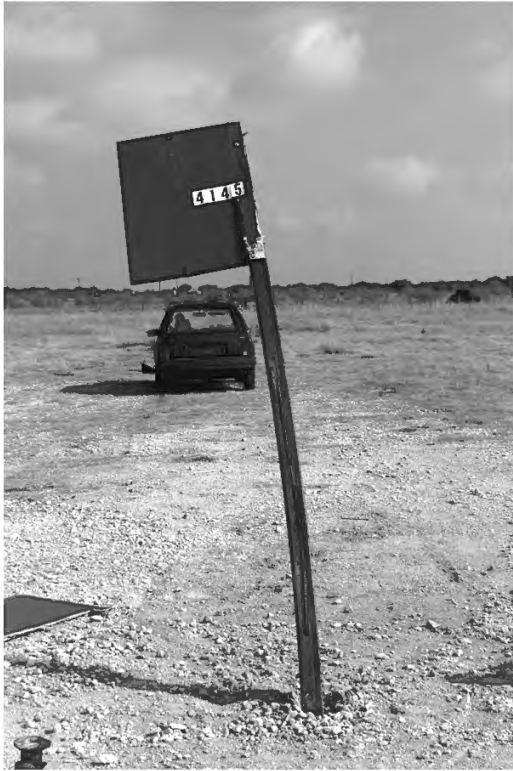
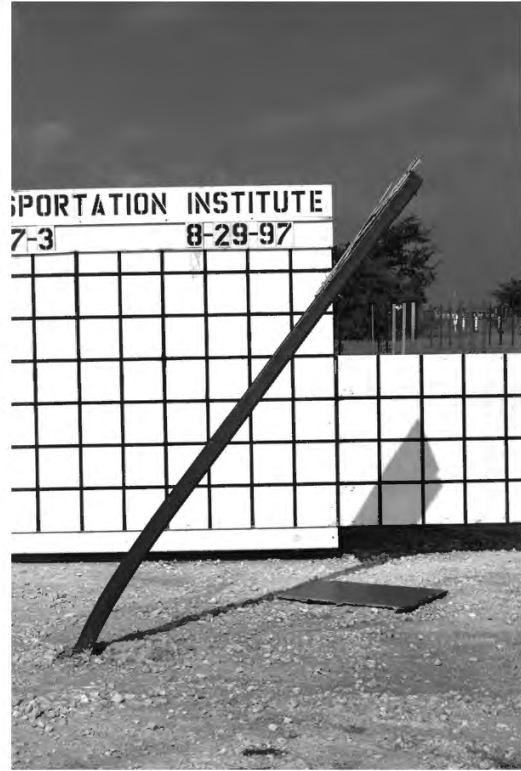
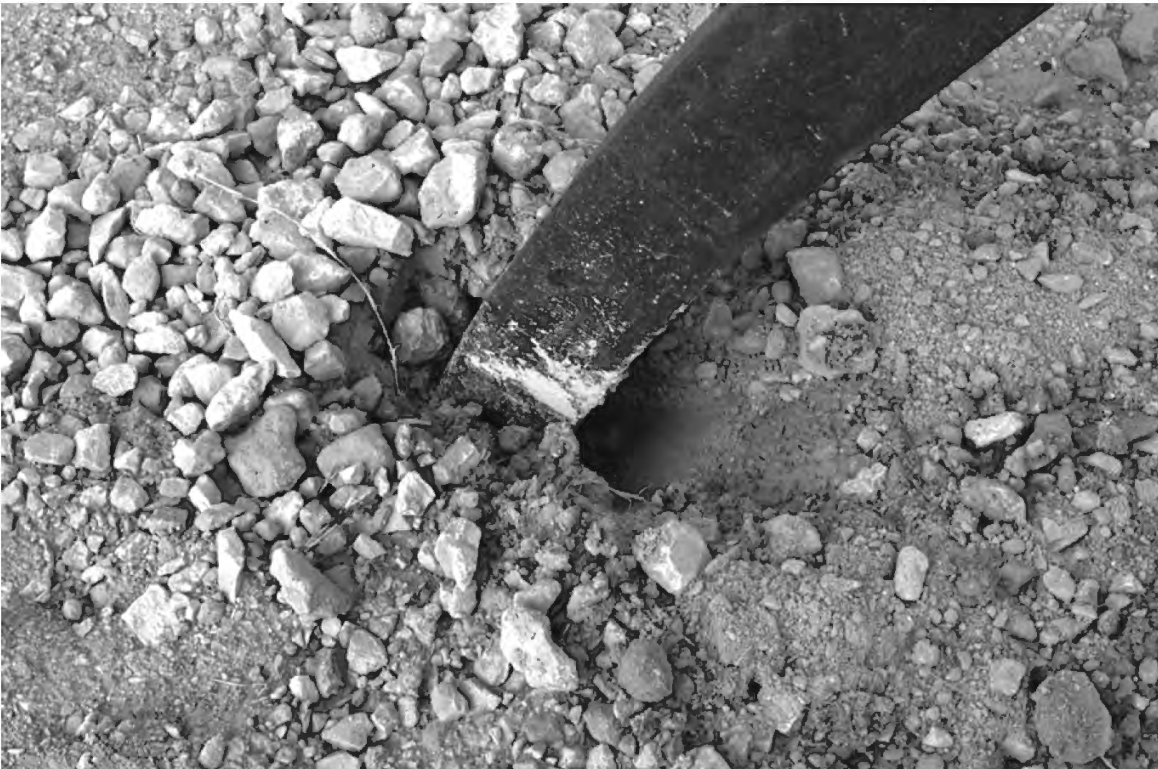
**Figure 22. Support After Test 414587-3.**

75 mm after the test (measured at ground level). The support did not rotate in the soil, but was leaning back at about a 60 degree angle. The plywood sign panel was split with one half remaining attached to the support and the other half coming to rest near the impact point.

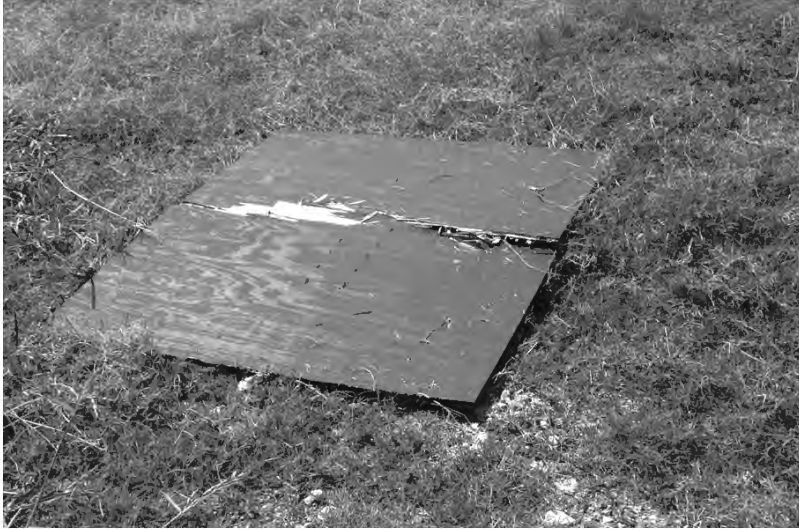
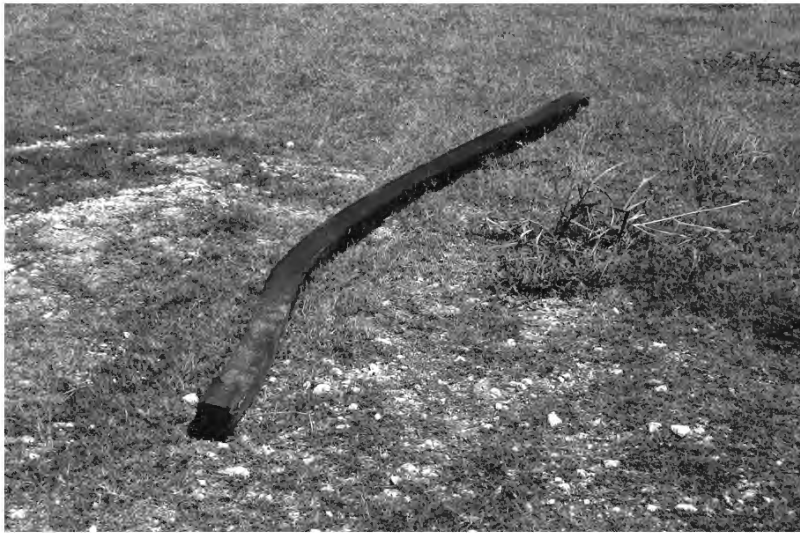
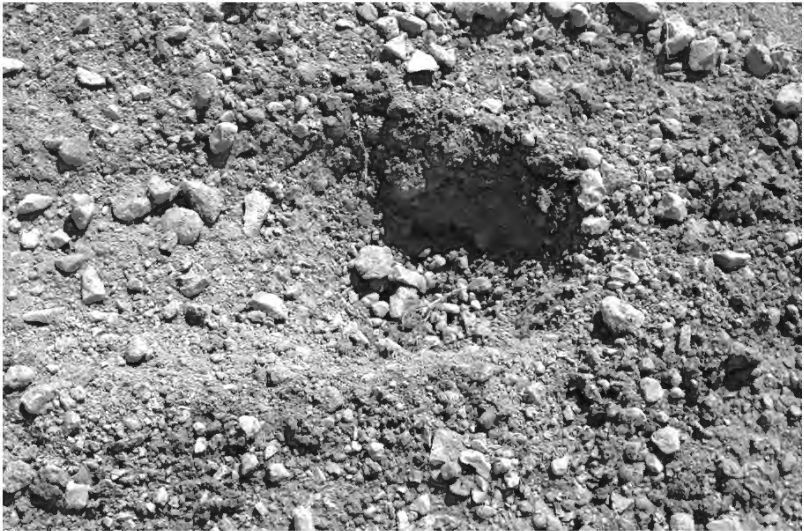
**Figure 29. Support After Test 414587-4.**

As can be seen in figures 28 and 29, the support pulled out of the ground without fracturing. The support was deformed from ground level to just above bumper height. The sign panel was split and separated from the support.

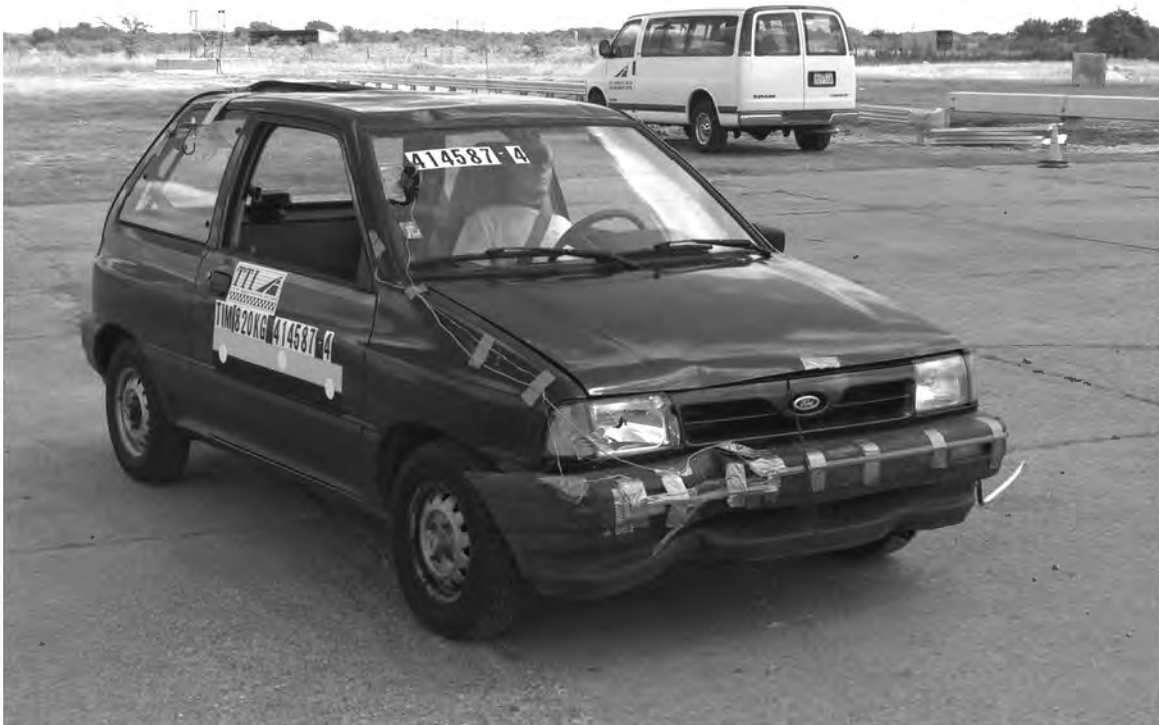
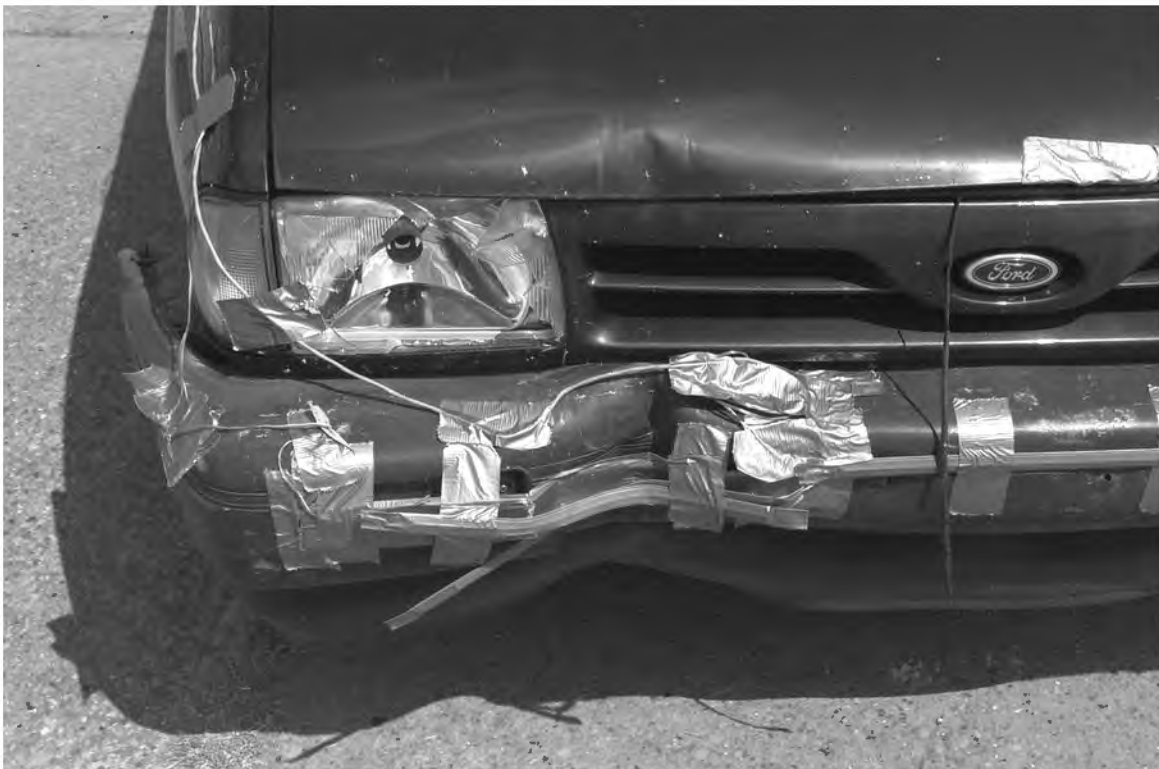
**Figure 30. Vehicle After Test 414587-4.**

Figure 30 shows the moderate damage sustained by the vehicle. The right front bumper was dented 30 mm, and the right front headlight was broken. The hood was slightly dented. A dent in the roof measuring 960 mm long by 960 mm wide by 17 mm deep was noted. The rear hatch was damaged on the right side with a gap between the body and the hatch of 120 mm. Maximum exterior crush to the right side of the vehicle was 30 mm at the bumper. Maximum occupant compartment deformation was 37 mm in the roof toward the rear of the occupant compartment. Exterior crush and occupant compartment measurements are shown in appendix B, tables 11 and 12.

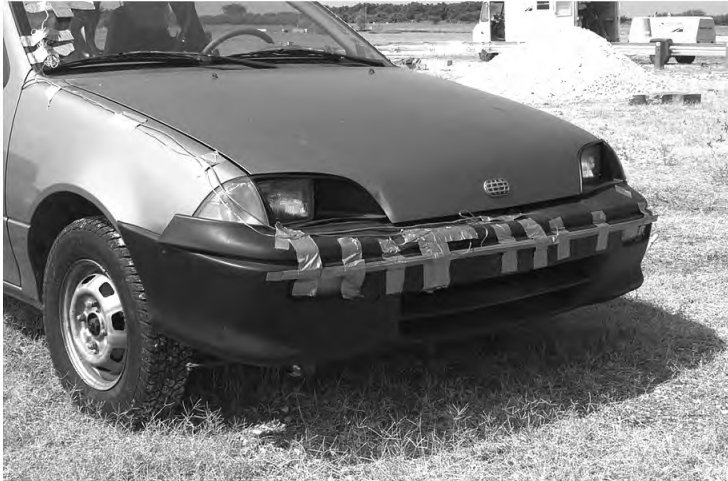
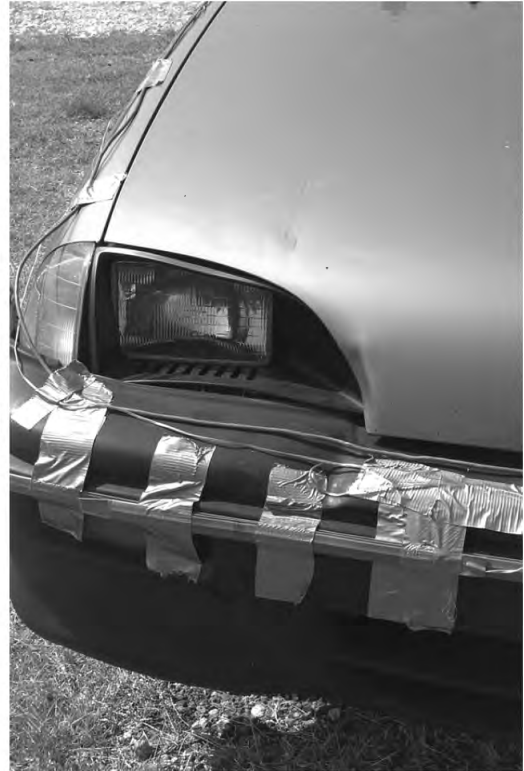
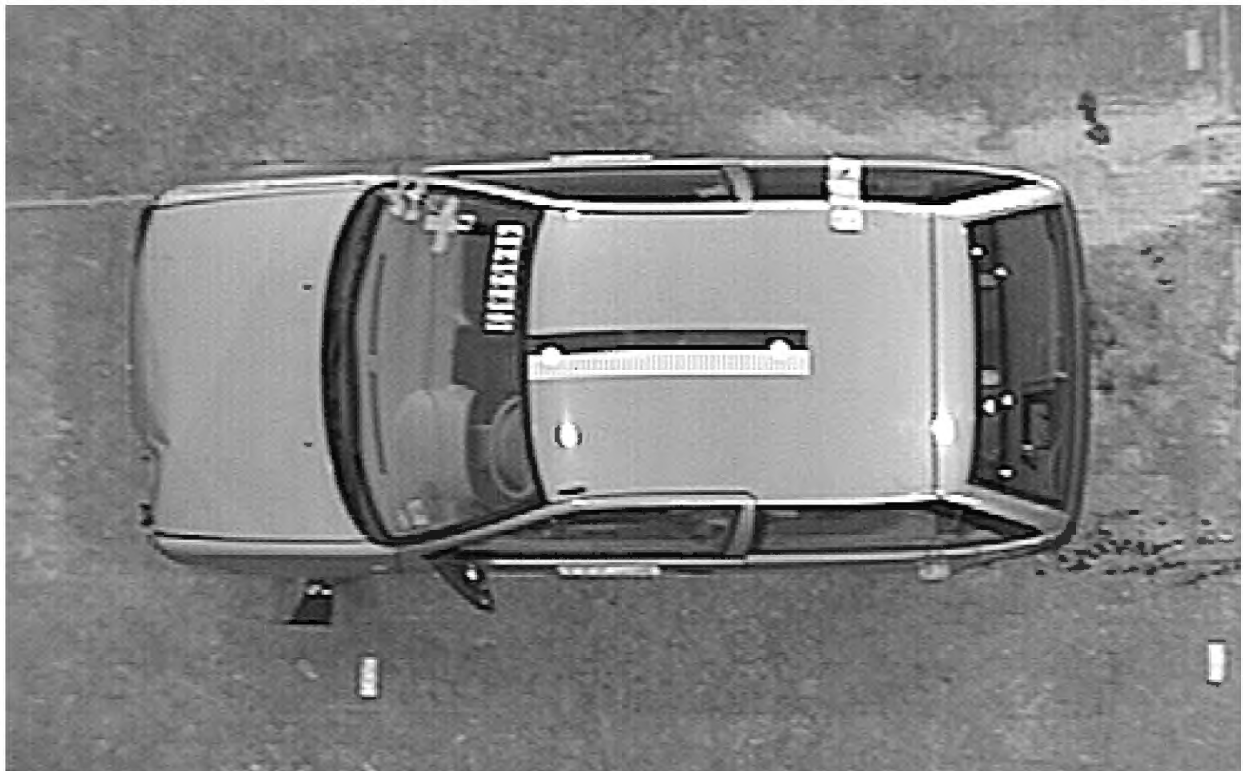
**Figure 37. Vehicle After Test 414588-2.**

As can be seen in figure 37, minimal damage was received by the vehicle. There was a small indentation in the bumper, and the hood, windshield, and passenger door were scuffed. No measurable crush occurred to the exterior of the vehicle, and no deformation of the occupant compartment occurred. Occupant compartment measurements are shown in appendix B, table 13.

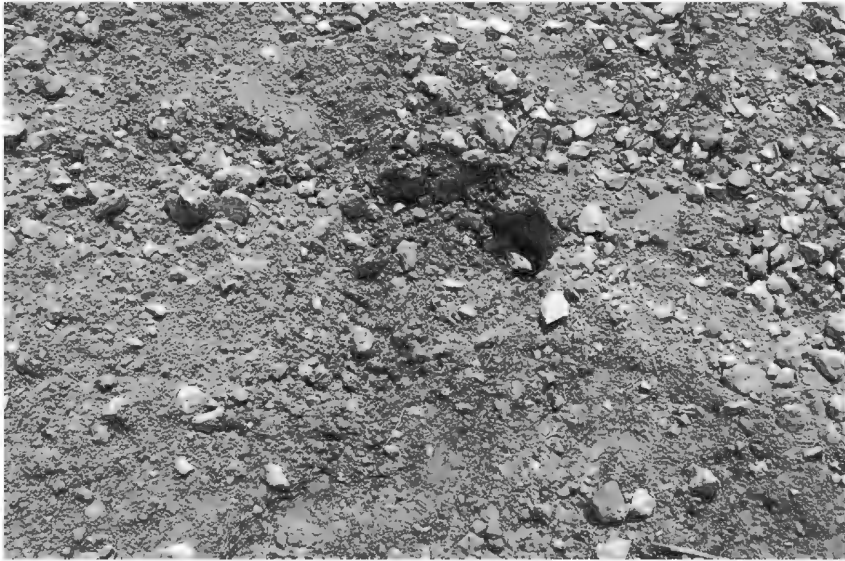
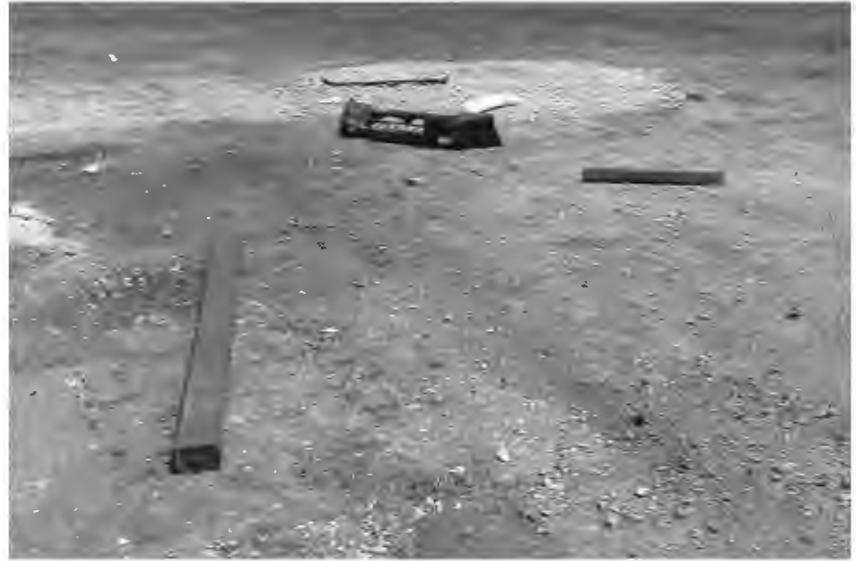
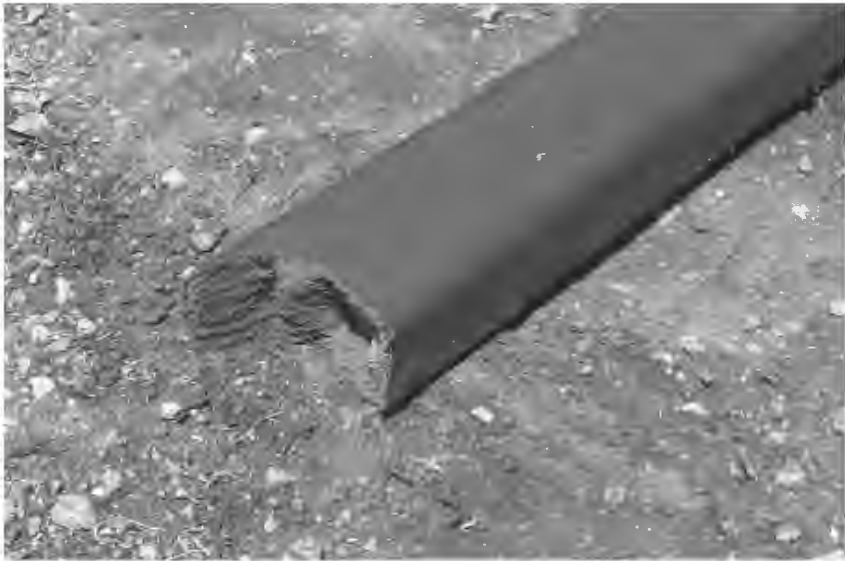
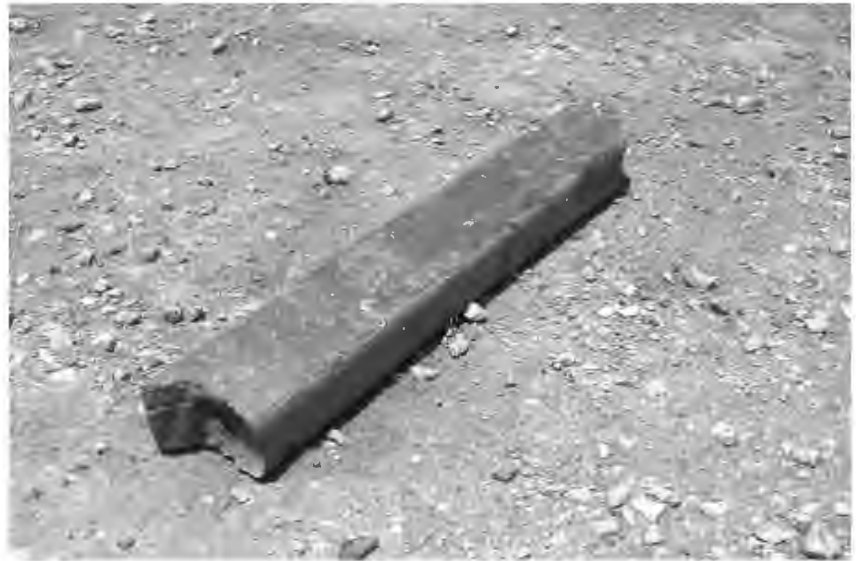
Figure 43. Support After Test 414588-3.

As can be seen in figures 42 and 43, the support fractured into three pieces. A piece 680 mm long remained below ground. The other fragments were 920 mm long and 2920 mm long. The sign panel was separated from the support.

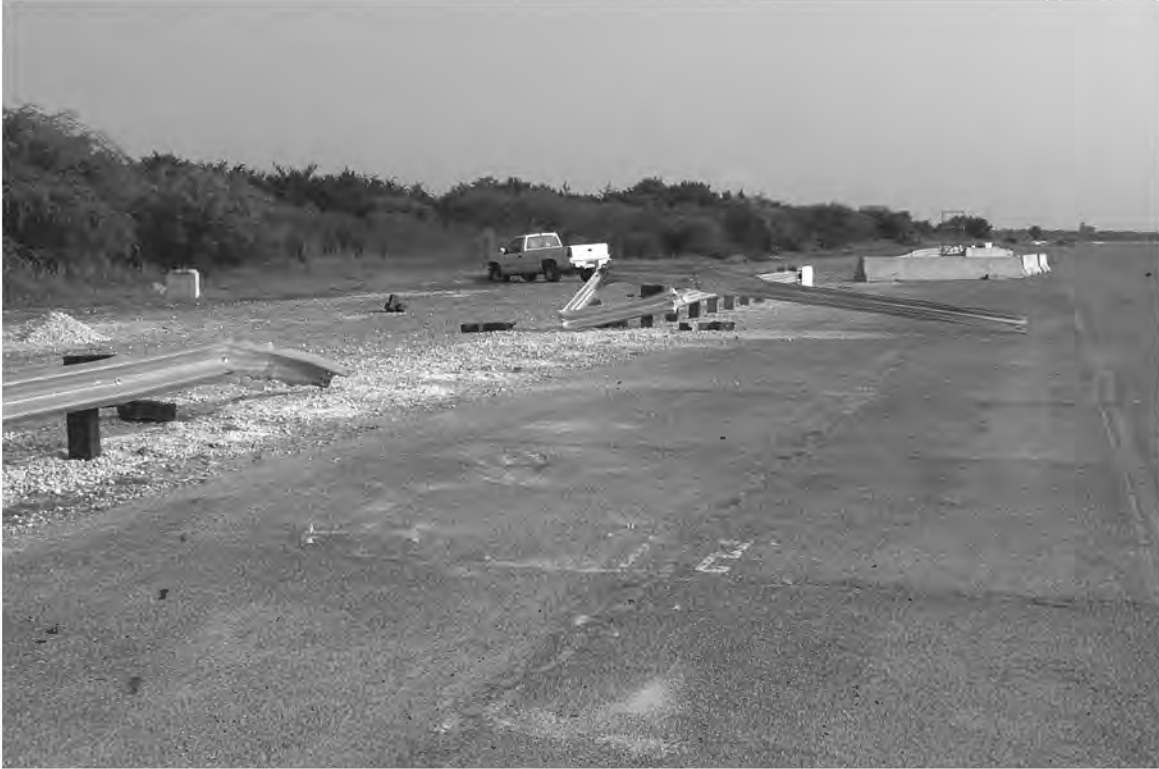
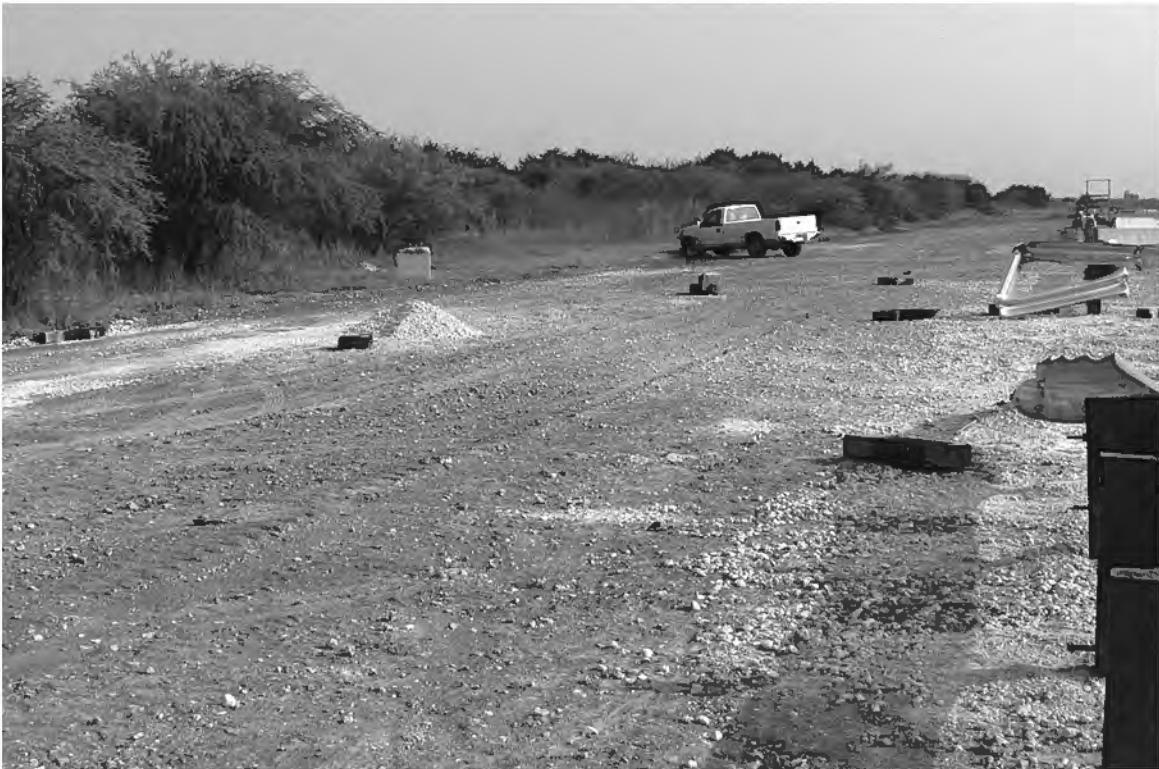
**Figure 51. After Impact Trajectory for Test 414588-1.**

The vehicle, traveling at 100.6 km/h, impacted the guardrail at 26.5 degrees. Initial contact was 330 mm upstream of post 13. Upon impact the rail element moved as posts 12 and 13 began to deflect. At 0.020 s the front of the vehicle contacted and fractured post 13. The vehicle began to redirect at 0.047 s. At 0.079 s post 14 fractured in advance of the vehicle. Post 15 and post 16 both fractured in advance of the vehicle at 0.114 s and 0.143 s, respectively. Post 17 fractured at 0.177 s. At 0.206 s the rail ruptured at a splice at the location of post 15. Post 18 fractured 940 mm from the top about its strong axis but remained upright, supported by the rail. At 0.288 s an elbow formed as the ruptured rail bent around post 18. At 0.539 s the ruptured rail and the vehicle contacted post 19 and fractured the post about its weak axis. The vehicle contacted post 20 at 0.692 s, causing the post to fracture about its weak axis. At 0.866 s the separated rail section swung over the posts. The vehicle continued traveling through the guardrail system behind the test installation. Brakes on the impacting vehicle were applied at 5.4 s. The vehicle remained upright and subsequently came to rest 45.7 m down from impact and 13.7 m behind the installation. Sequential photographs of the test period are shown in appendix C, figures 65 and 66.

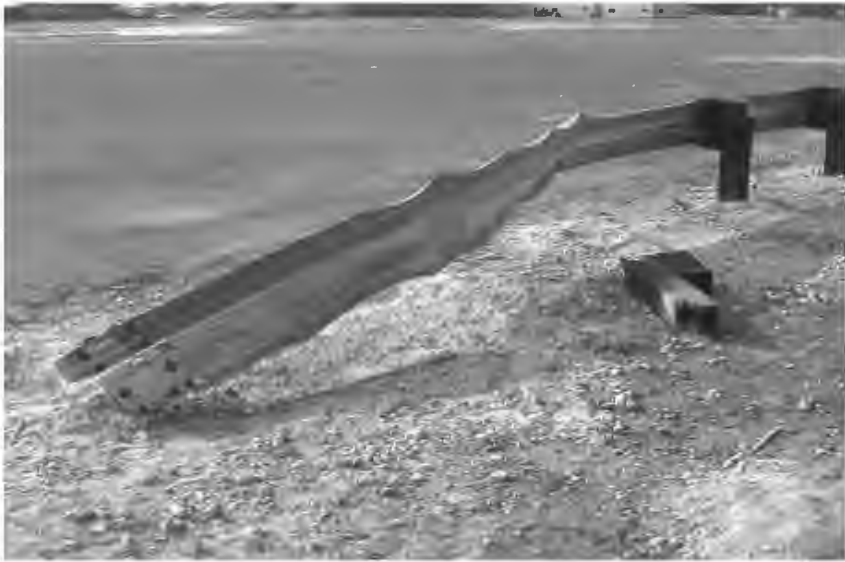
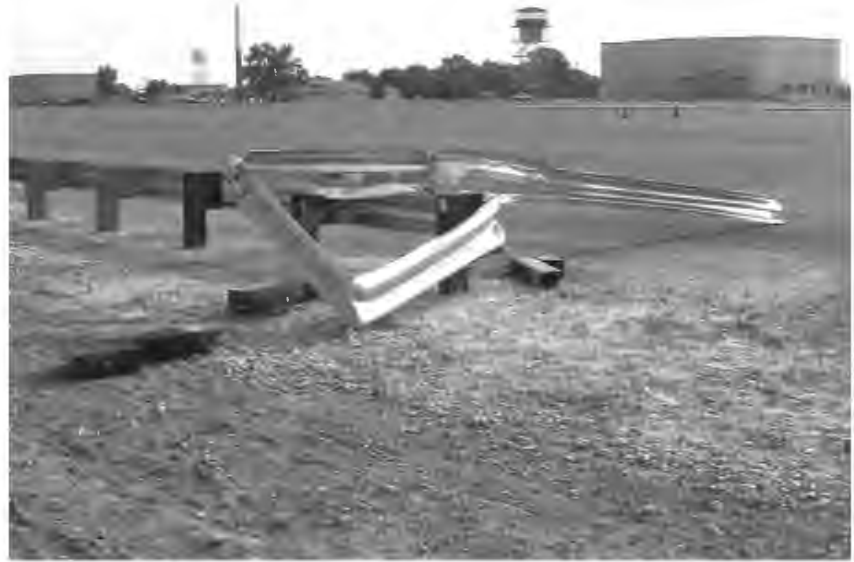
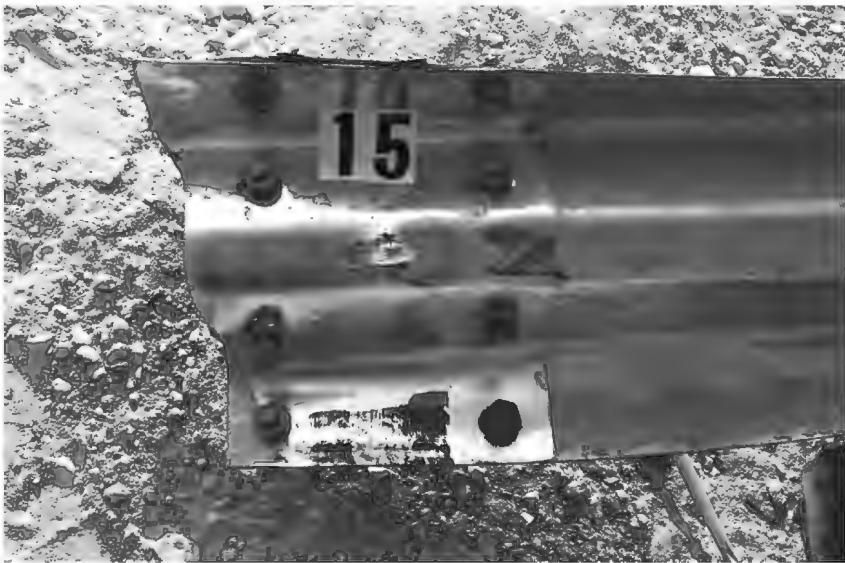
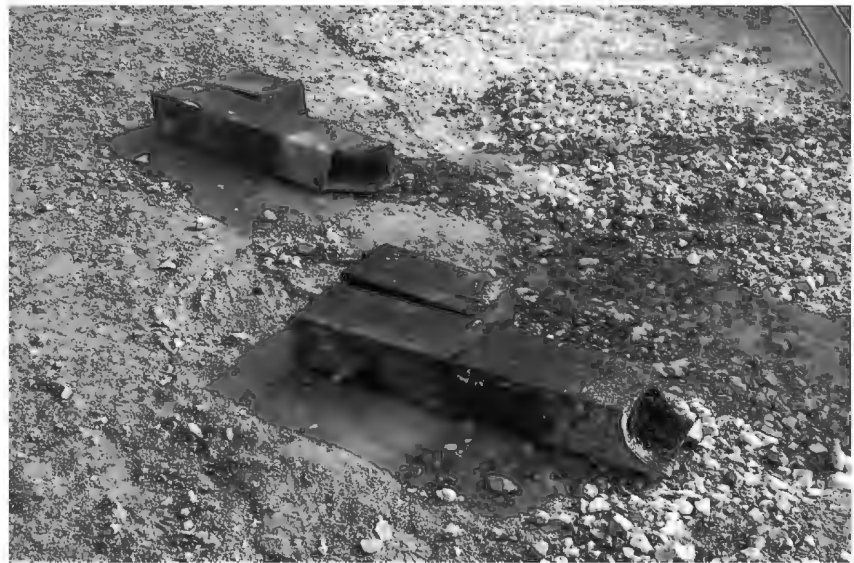
**Figure 52. Installation After Test 414588-1.**

The W-beam guardrail with plastic posts and blockouts sustained substantial damage as shown in figures 51 and 52. The W-beam rail element ruptured at the lower bolt holes of the connection splice at post 15. Posts 1 through 6 were disturbed, post 7 was pulled laterally 5 mm, and posts 8 through 10 were disturbed. Post 11 was displaced 10 mm in both the lateral and longitudinal directions and post 12 was displaced 20 mm longitudinally. Posts 13 through 20 were fractured. Post 21 was pulled laterally 20 mm, post 22 was pulled back 15 mm, and the blockout was rotated. The post to rail connection bolt was pulled from the rail at posts 21 and 22. Posts 23 through 29 were disturbed, and the end anchors were each pulled inward 5 mm.

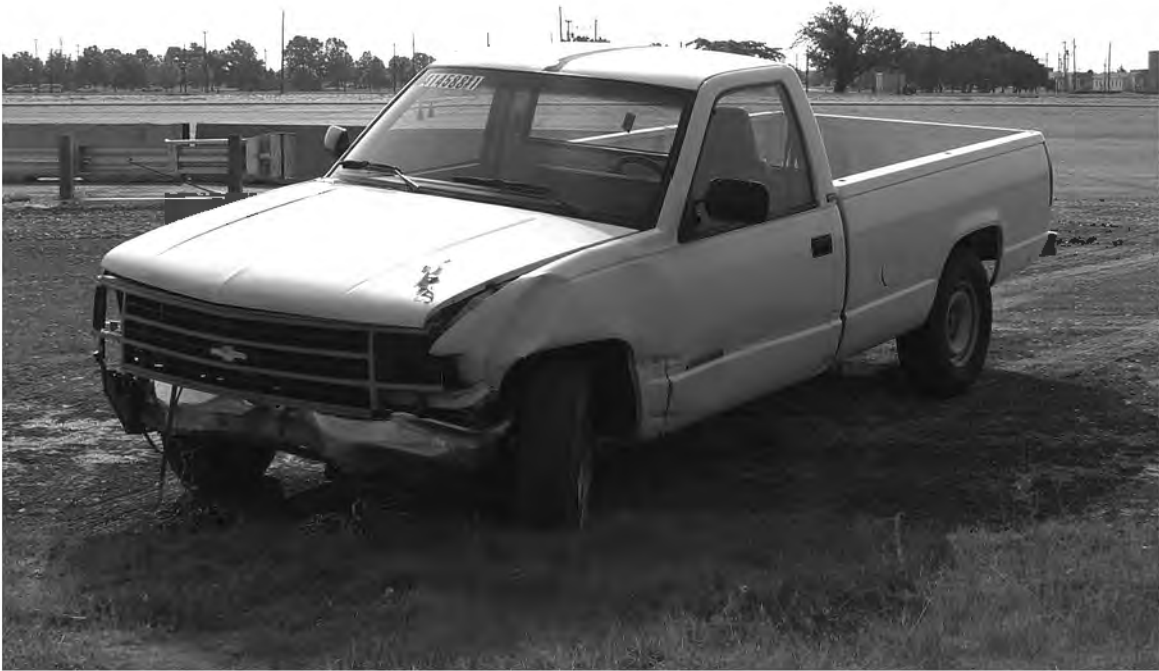
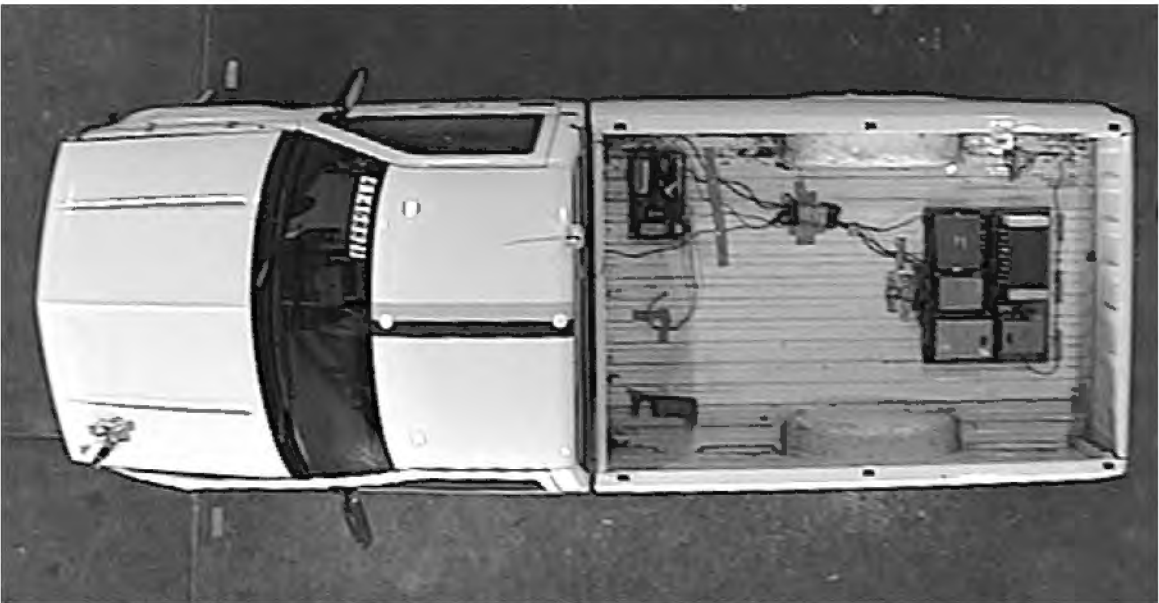
**Figure 53. Vehicle After Test 414588-1.**

The vehicle sustained moderate damage as shown in figure 53. Structural damage included the left outer tie rod and left lower A-arm. The left front tire was flat and the rim bent. The left and right front quarter panels, grill, and bumper were damaged. A dent was noted in the left corner of the cab. Scuff marks and dents were found on the left door. Maximum crush to the vehicle was 360 mm at the left front corner of the front bumper. No intrusion into the occupant compartment occurred, as shown in figure 54. Details of the vehicle damage are given in tables 16 and 17 of appendix B.

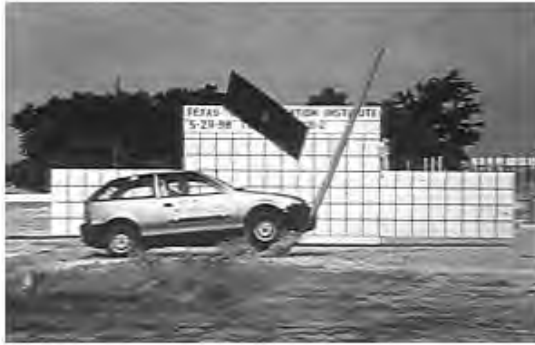
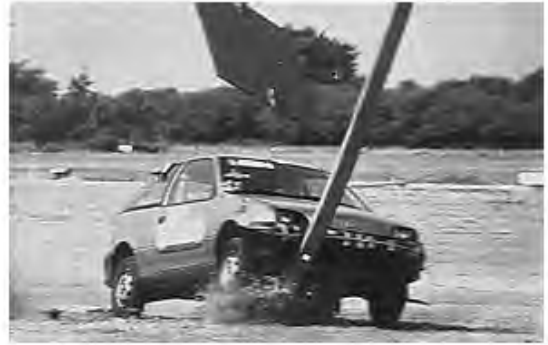
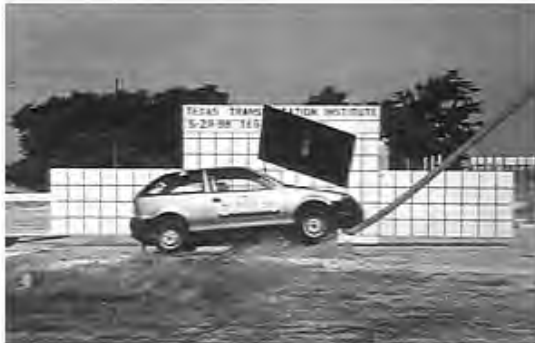
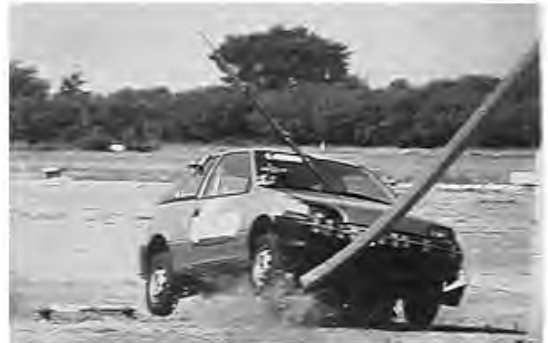
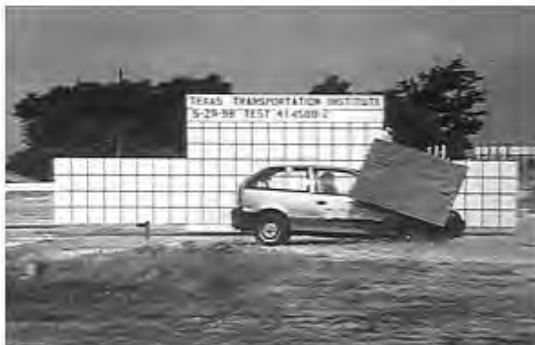
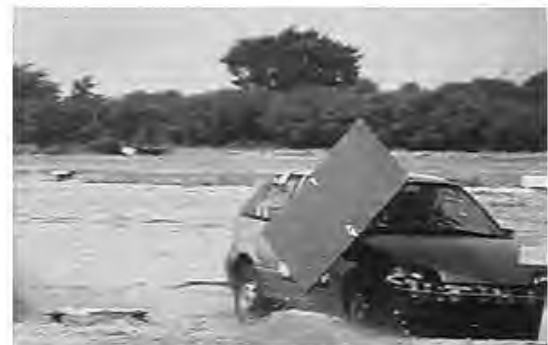
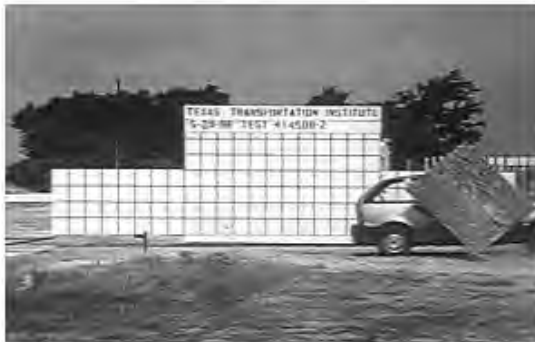
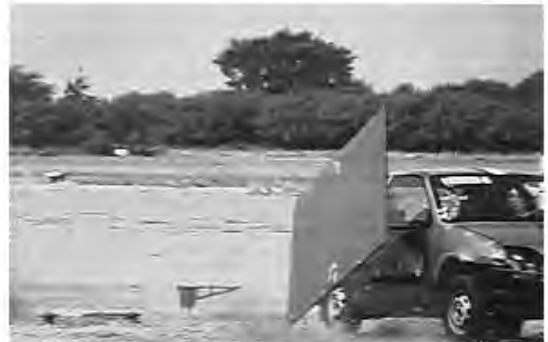
**Figure 63. Sequential Photographs for Test 414588-2  
(Perpendicular and Oblique Views).**

The vehicle, traveling at 34.7 km/h, impacted the recycled plastic support with the right quarter point at zero degree. At 0.041 s the support fractured just below ground level and began to rotate toward the vehicle. The top and bottom brackets on the sign panel sheared at 0.080 s and 0.082 s, respectively, releasing the sign panel from the support. At 0.156 s the vehicle began to ride up the support, and the left front wheel momentarily left the ground followed by the right. The vehicle lost contact with the support at 0.329 s while traveling at a speed of 22.9 km/h. As the vehicle continued forward, the corner of the plywood sign panel contacted the hood at 0.388 s and then the windshield at 0.393 s. The sign panel bounced off the vehicle at 0.440 s. At 0.536 s the left front wheel returned to the ground. At 0.704 s the sign panel lightly grazed the vehicle on the passenger door as it fell to the ground 3.6 m down from and 2.6 m to the right of the point of impact. The support traveled along with the vehicle and came to rest in front of the vehicle 30.0 m down from the point of impact. Brakes on the vehicle were not applied. The vehicle came to a safe and controlled stop on its own 26.0 m down from the point of impact. Sequential photographs of the test period are shown in appendix C, [figure 63](#).
