1. Report No. FHWA/TX-01/1458-3	2. Government Accession No.	3. Recipient's Catalog No.	
4. Title and Subtitle TESTING AND EVALUATION OF RECYCLED MATERIALS IN ROADSIDE SAFETY DEVICES		5. Report Date October 2000 Resubmitted: April 2001

# **TESTING AND EVALUATION OF RECYCLED MATERIALS IN ROADSIDE SAFETY DEVICES**

Report 1458-3  
Project Number 0-1458  
Research Project Title: Recycled Materials in Roadside Safety Devices

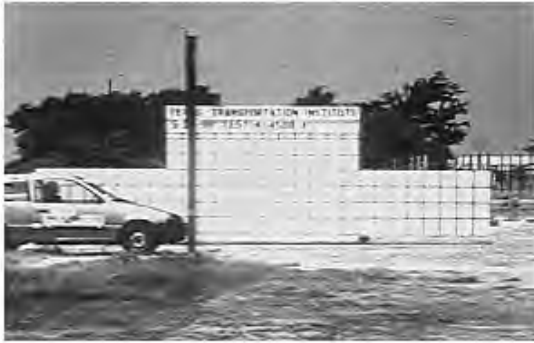
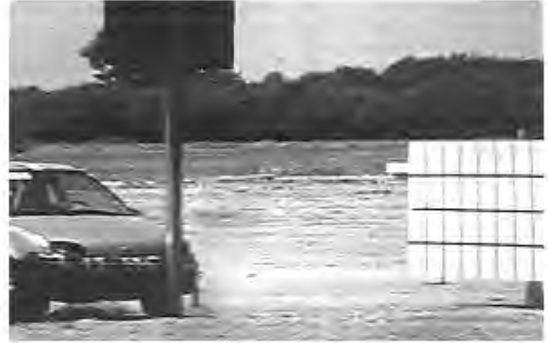
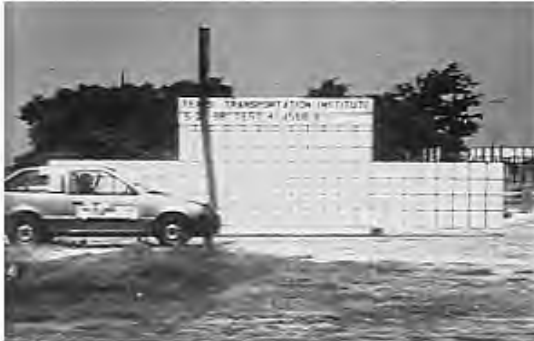
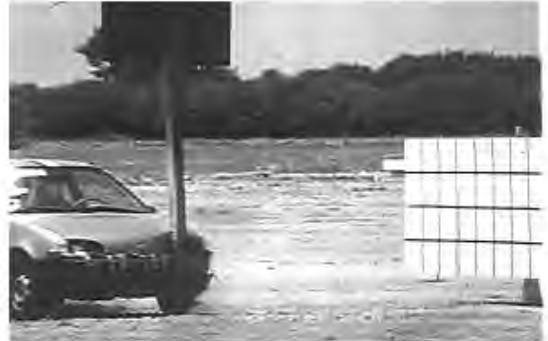
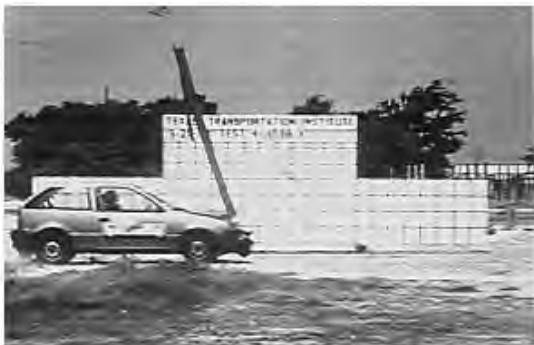
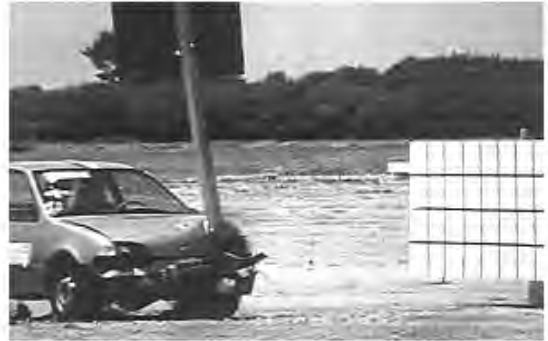
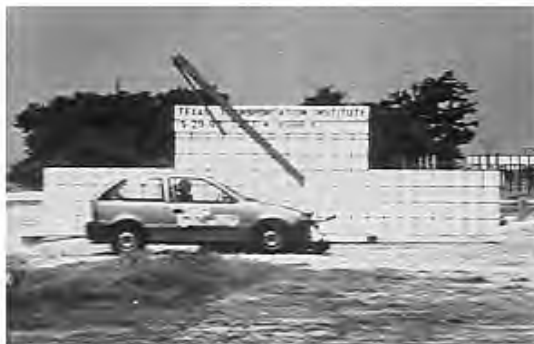
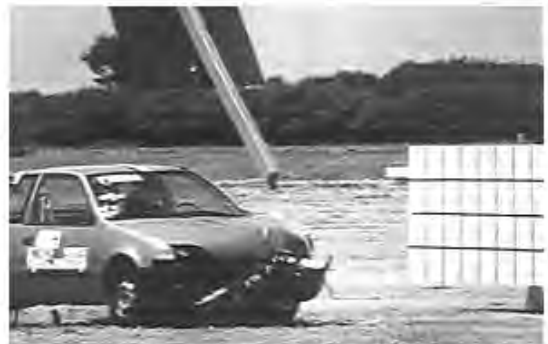
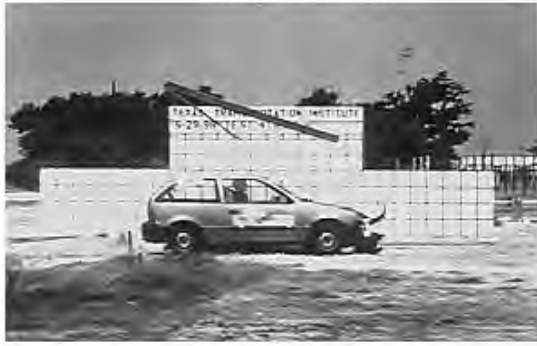
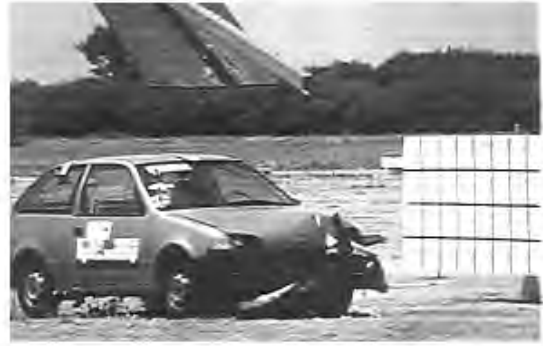
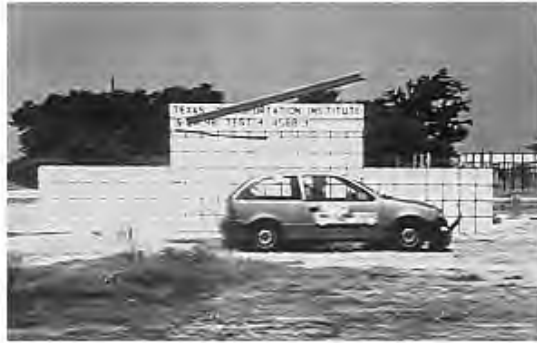
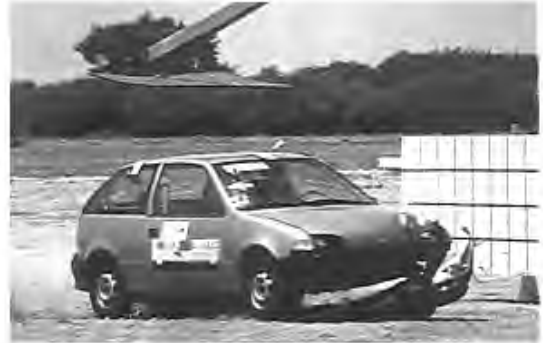
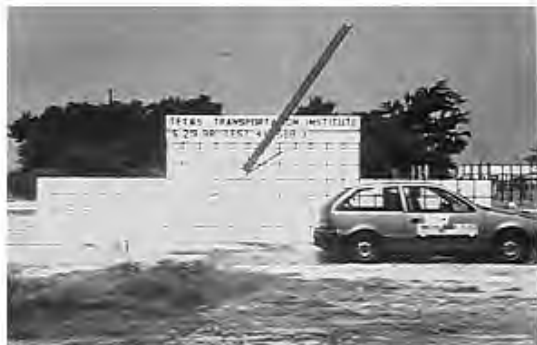
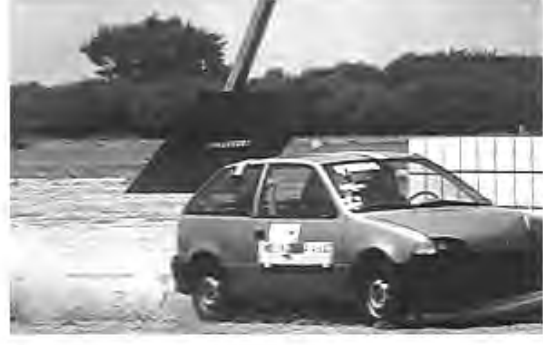
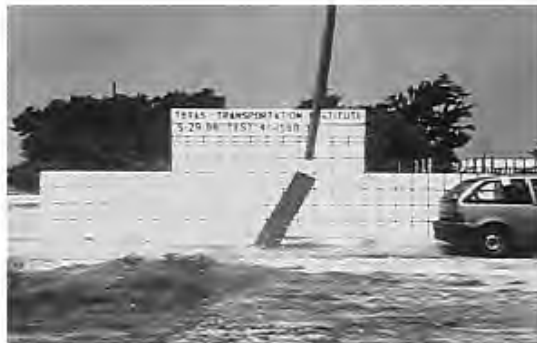
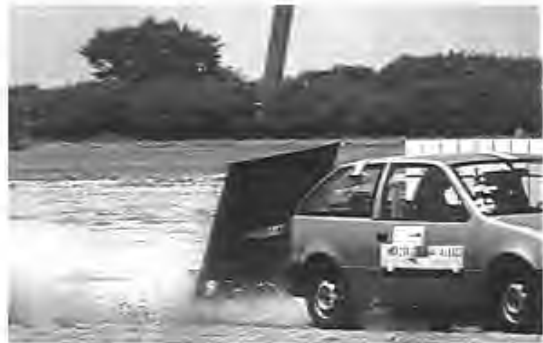
**Figure 64. Sequential Photographs for Test 414588-3  
(Perpendicular and Oblique Views).**

The vehicle, traveling at 102.3 km/h, impacted the recycled plastic support with the left quarter point at zero degree. Immediately upon impact the support moved, and by 0.019 s the support had pushed through the soil at ground level. At 0.024 s the support fractured near hood height of the vehicle, and the lower bracket attaching the sign panel to the support failed. The support fractured at a second location below ground level at 0.032 s. At 0.046 s the lower segment of the fractured post, which was 920 mm long, contacted the ground and bounced in front of the vehicle. The vehicle lost contact with the support while traveling at a speed of 95.5 km/h. At 0.112 s the upper bracket of the sign panel failed, causing the plywood panel to separate from the support. The upper fragment of the support was parallel over the roof of the vehicle at 0.136 s. This fragment was 2920 mm long and eventually came to rest 10.5 m down from and 2.2 m to the left of the point of impact. The smaller fragment traveled along with the vehicle and came to rest 13.0 m down from and 1.7 m to the right of the point of impact. Brakes on the vehicle were applied at 1.75 s after impact as the vehicle exited the test site. The vehicle subsequently came to a safe, controlled stop 86.5 m down from and 7.0 m to the left of the point of impact. Sequential photographs of the test period are shown in appendix C, figure 64.

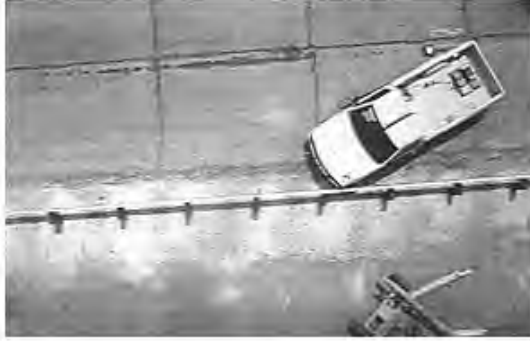
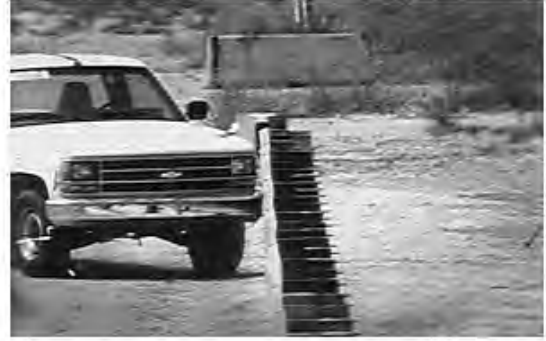
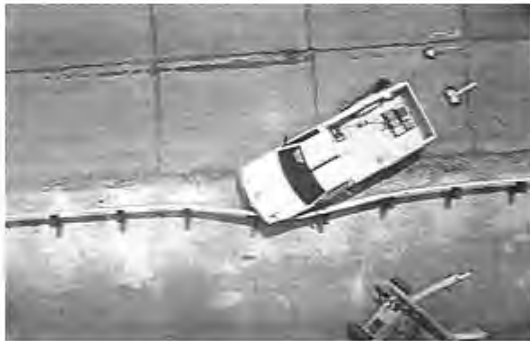
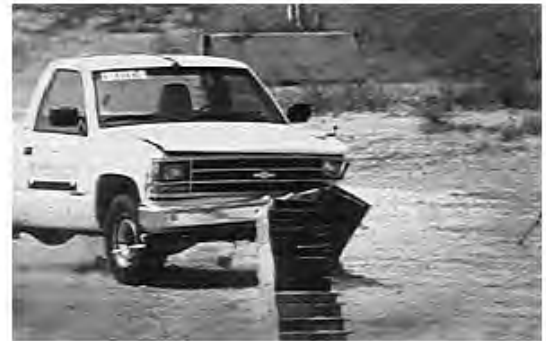
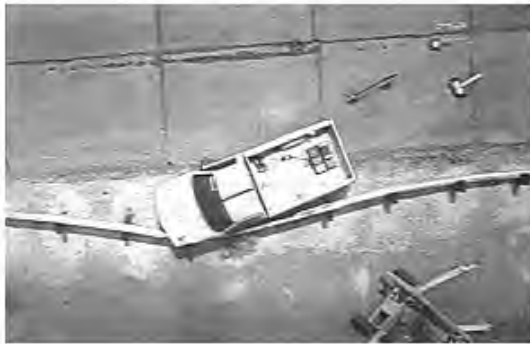
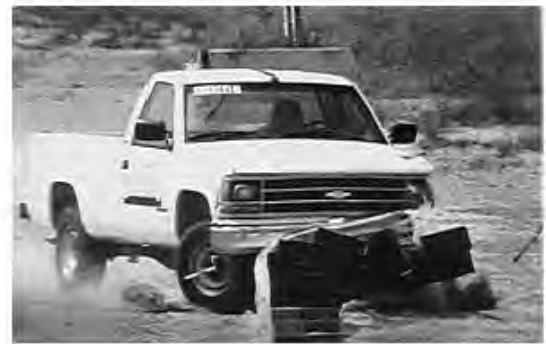
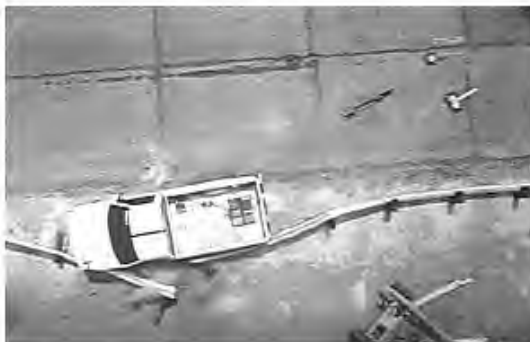
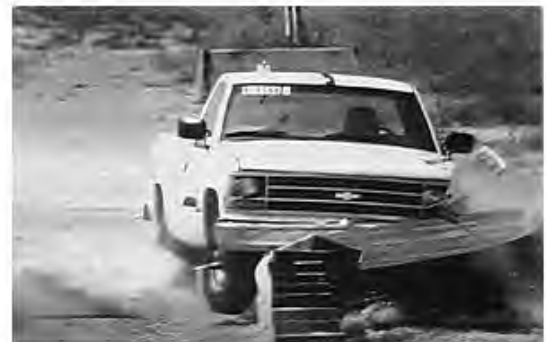
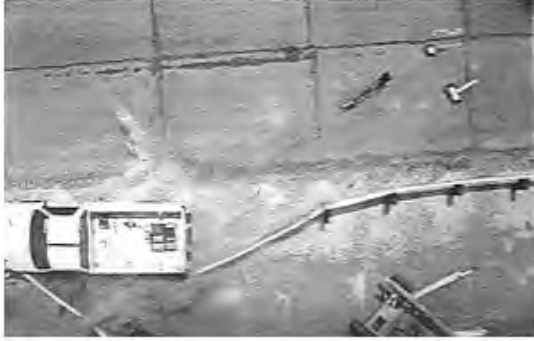
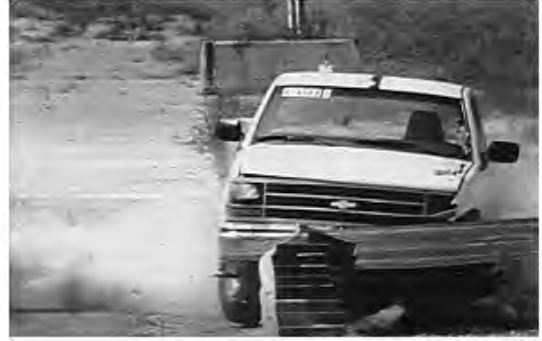
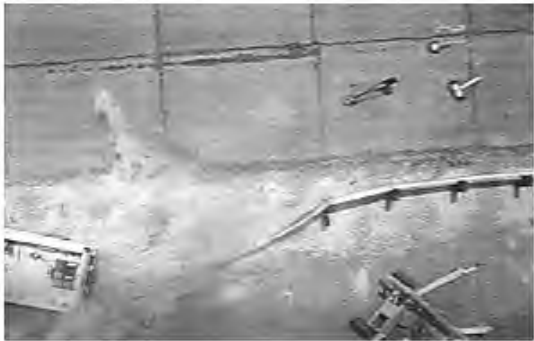
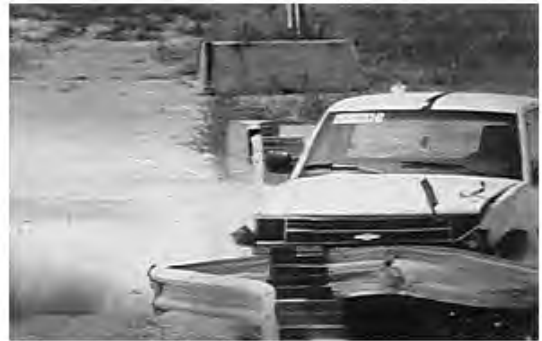
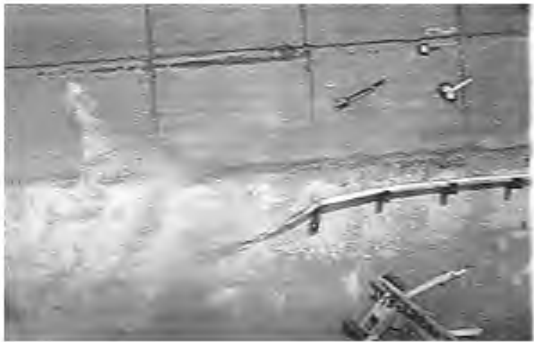
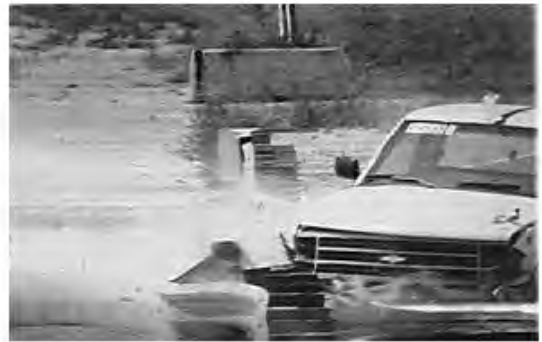
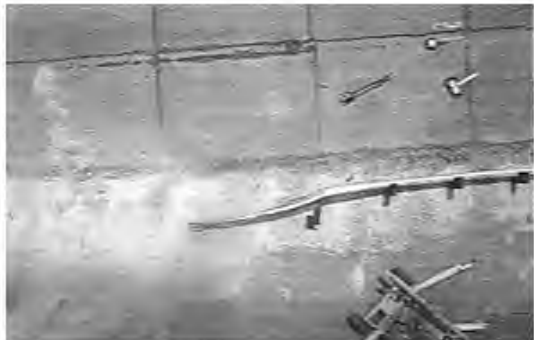
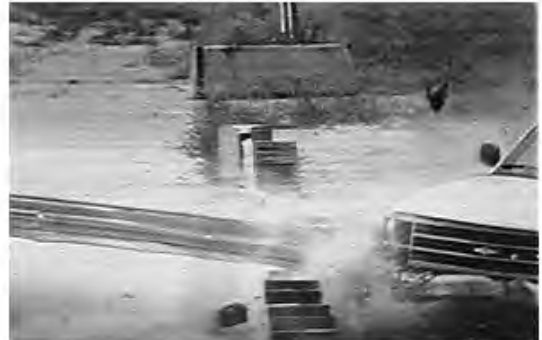
**Figure 65. Sequential Photographs for Test 414588-1 (Overhead and Frontal Views).**

The vehicle, traveling at 100.6 km/h, impacted the guardrail at 26.5 degrees. Initial contact was 330 mm upstream of post 13. Upon impact the rail element moved as posts 12 and 13 began to deflect. At 0.020 s the front of the vehicle contacted and fractured post 13. The vehicle began to redirect at 0.047 s. At 0.079 s post 14 fractured in advance of the vehicle. Post 15 and post 16 both fractured in advance of the vehicle at 0.114 s and 0.143 s, respectively. Post 17 fractured at 0.177 s. At 0.206 s the rail ruptured at a splice at the location of post 15. Post 18 fractured 940 mm from the top about its strong axis but remained upright, supported by the rail. At 0.288 s an elbow formed as the ruptured rail bent around post 18. At 0.539 s the ruptured rail and the vehicle contacted post 19 and fractured the post about its weak axis. The vehicle contacted post 20 at 0.692 s, causing the post to fracture about its weak axis. At 0.866 s the separated rail section swung over the posts. The vehicle continued traveling through the guardrail system behind the test installation. Brakes on the impacting vehicle were applied at 5.4 s. The vehicle remained upright and subsequently came to rest 45.7 m down from impact and 13.7 m behind the installation. Sequential photographs of the test period are shown in appendix C, figures 65 and 66.
