1. Report No. FHWA/TX-01/1792-6	2. Government Accession No.	3. Recipient's Catalog No.	
4. Title and Subtitle TESTING AND EVALUATION OF MOLDED PLASTIC MAILBOXES		5. Report Date September 2001

TESTING AND EVALUATION OF MOLDED PLASTIC MAILBOXES

Report 1792-6
Project Number 0-1792
Research Project Title: Roadside Safety Hardware
for Traffic Control Devices

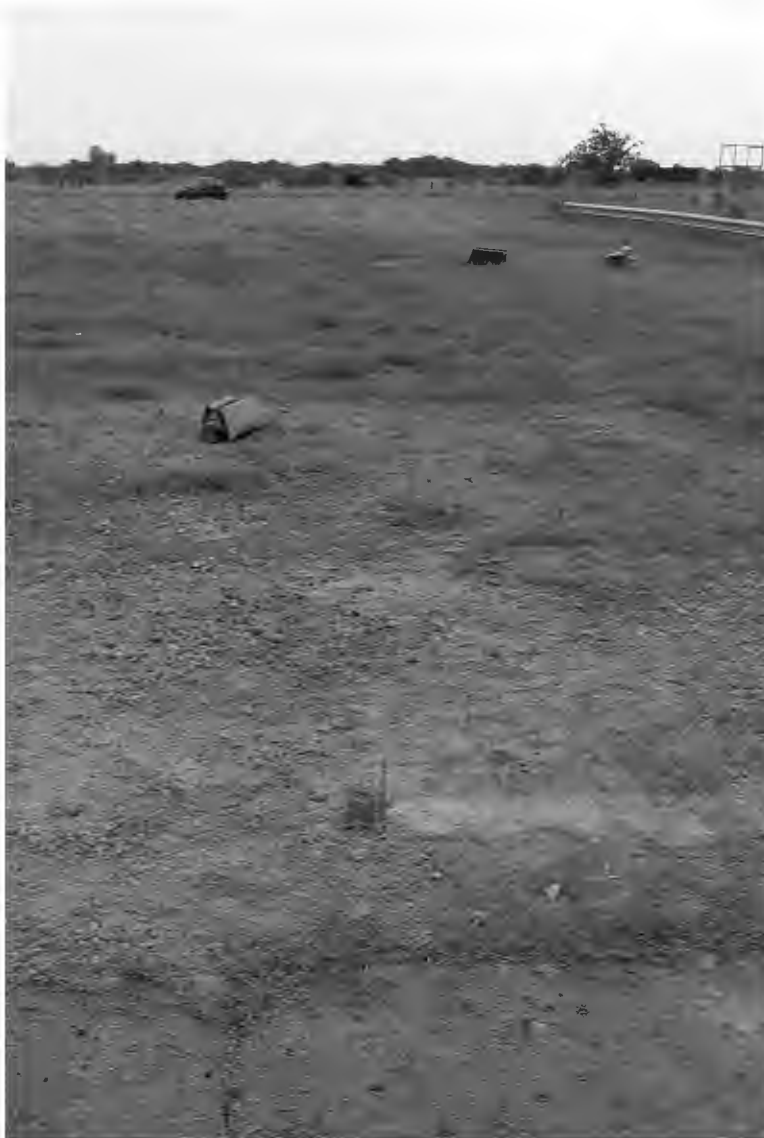
Figure 9. After Impact Trajectory for Test 417921-2.

Figures 9 and 10 show damage to the test installation. The 4×4 timber support pulled out of the ground 3.5 in. before fracturing flush with ground level. The mailbox separated into several pieces, the heaviest of which weighed 12 lb-2 oz. The debris pattern extended 77.5 ft downstream, 20.0 ft to the left, and 25 ft to the right of the point of impact.

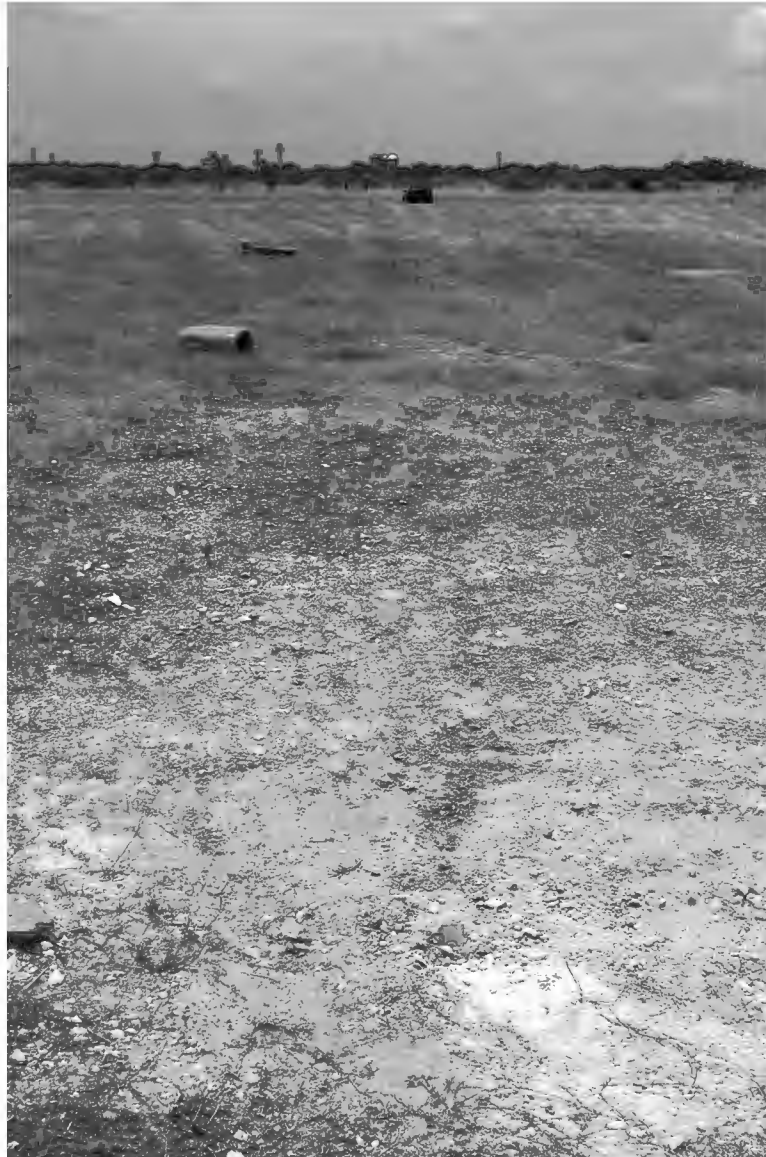
Figure 16. After Impact Trajectory for Test 417921-3.

Damage to the test installation is shown in Figures [16](#) and [17](#). The impact caused the upper portion of the mailbox unit to separate from the lower base portion. The steel U-channel fractured at ground level with the lower molded plastic base portion still attached. The ground stub remaining from the U-channel projected 1.75 in. above ground level. The molded plastic mailbox separated into several pieces, the heaviest of which weighed 13 lb-8 oz. The debris pattern extended 80.0 ft downstream and 15.0 ft to the left of the point of impact.

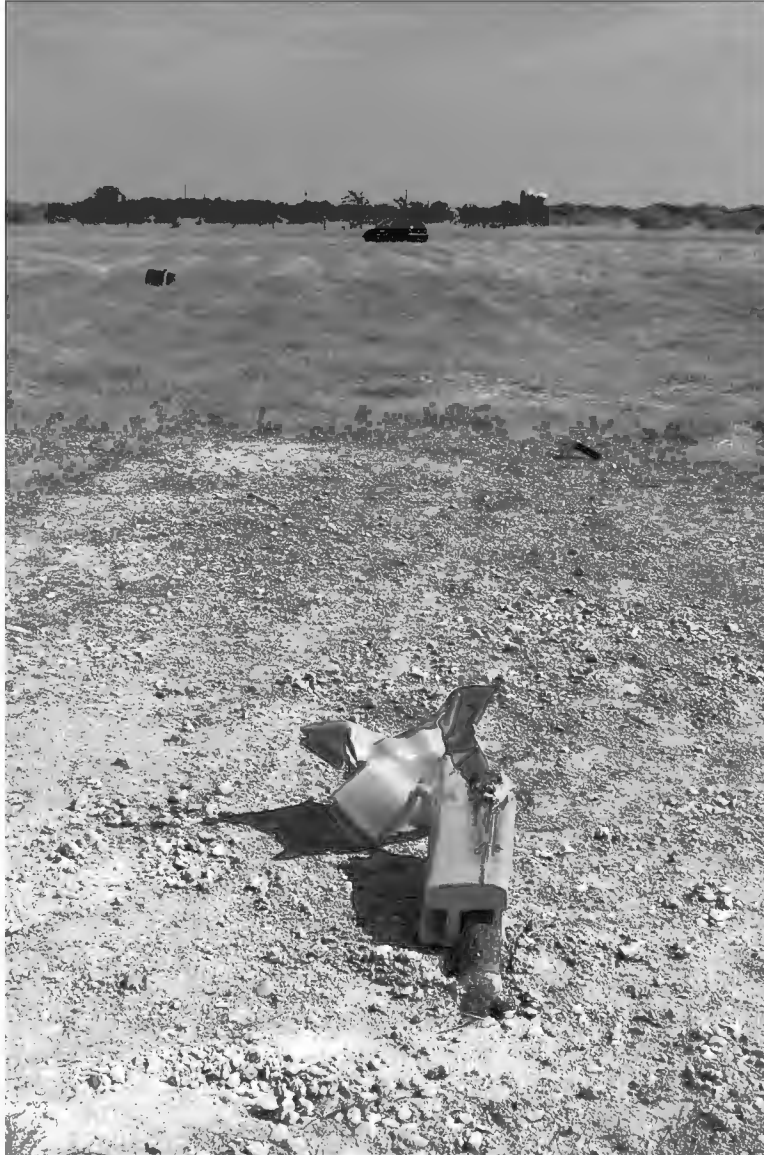
Figure 23. After Impact Trajectory for Test 417921-4.

Damage to the test installation is shown in [Figures 23 and 24](#). The steel pipe support yielded and bent near ground level. As the vehicle rode over the pipe support, most of the lower molded plastic base section of the mailbox was pulled off the support post. The upper portion of the deformed steel pipe had a maximum height of 5.1 in. above ground level. The mailbox separated into several pieces, none of which was considered heavy enough to cause physical threat. The debris pattern extended 45.0 ft downstream, 18 ft left, and 10 ft right of the point of impact.

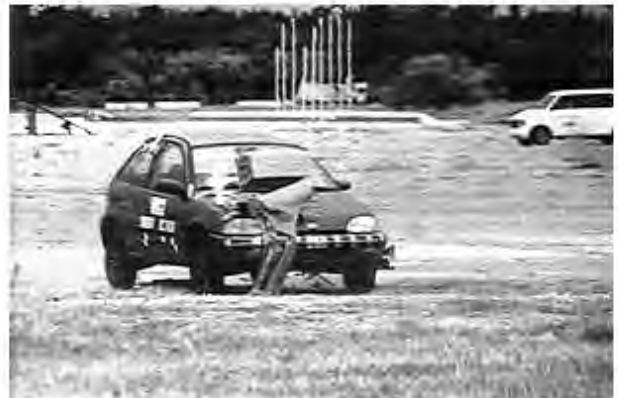
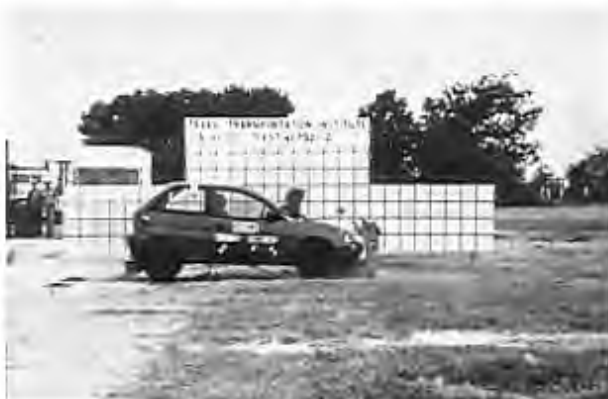
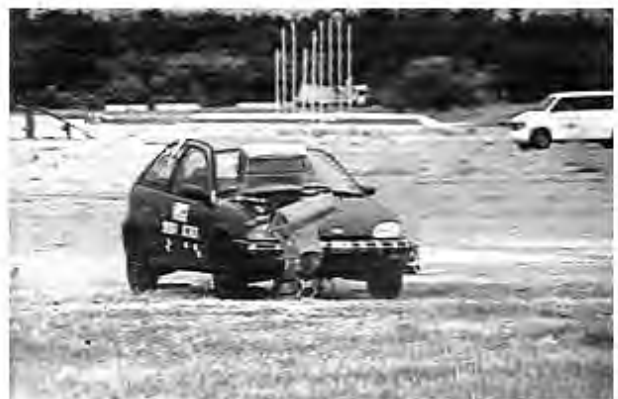
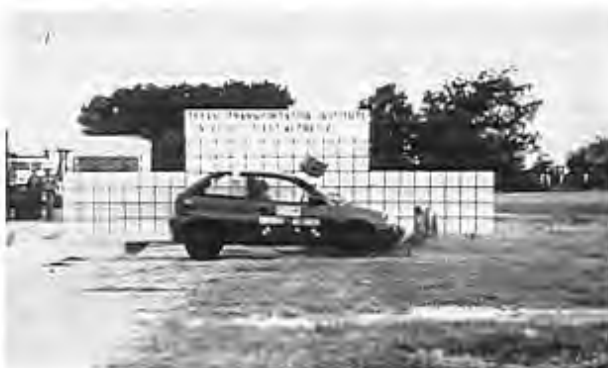
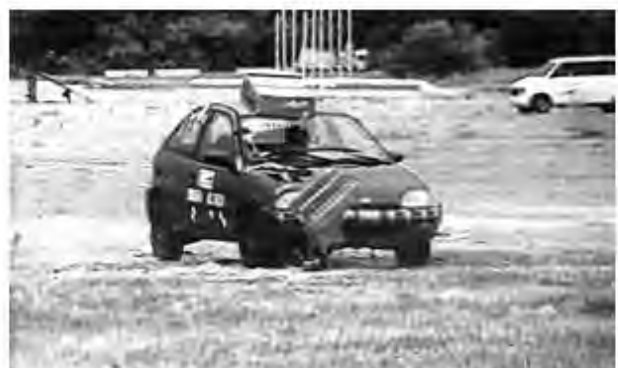
**Figure 30. Sequential Photographs for Test 417921-2
(Perpendicular and Oblique Views).**

mailbox began to separate from the lower base portion. At 0.010 s, the timber support post began to fracture at ground level. At 0.015 s, the upper end of the lower base portion of the mailbox contacted the hood of the vehicle. The upper molded portion containing the mailbox was completely separated from the lower base portion of the unit by 0.020 s. This upper section subsequently contacted the rear of the hood and lower part of the windshield at 0.032 s. The lower base portion and wood support post lost contact with the vehicle bumper at 0.052 s, and the upper section lost contact with the windshield at 0.077 s. Speed of the vehicle at loss of contact was 59.5 mi/h. The vehicle traveled forward in a straight path, and brakes were remotely applied at 1.3 s. The vehicle subsequently came to rest 263 ft downstream of impact. Sequential photographs of the test period are shown in [Appendix C, Figure 30](#).

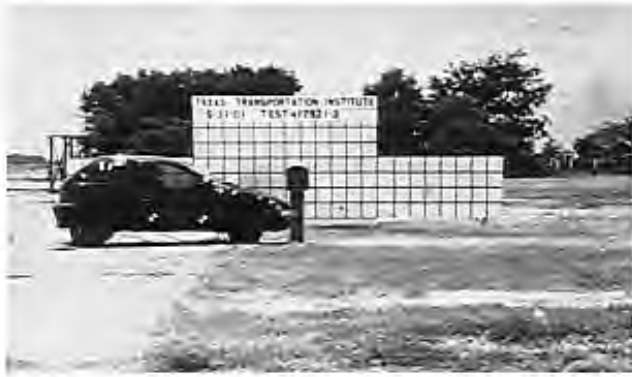
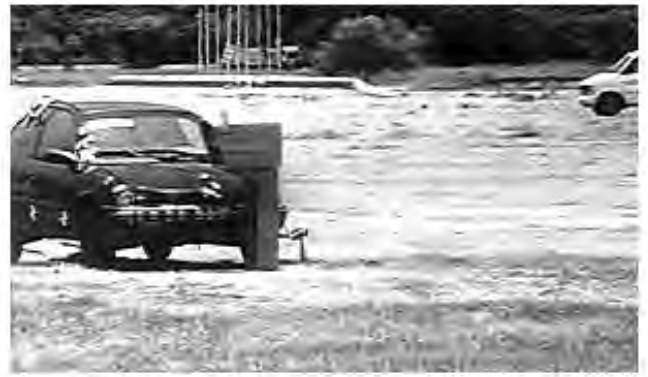
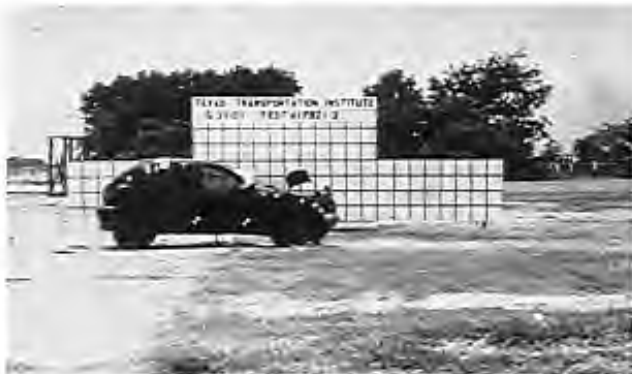
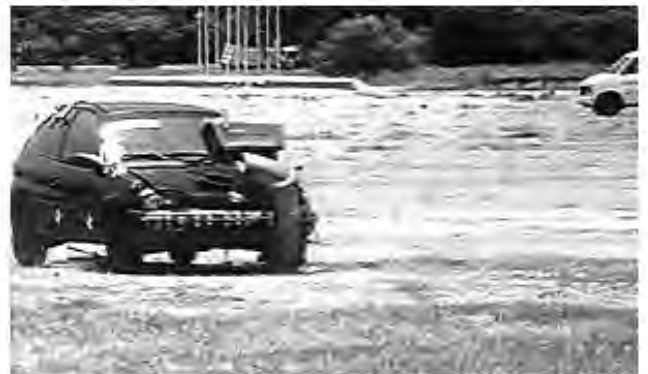
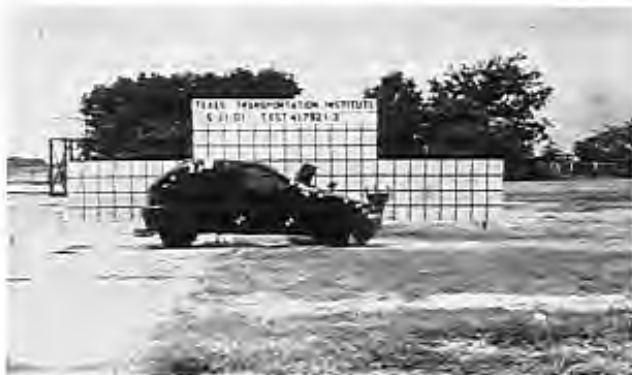
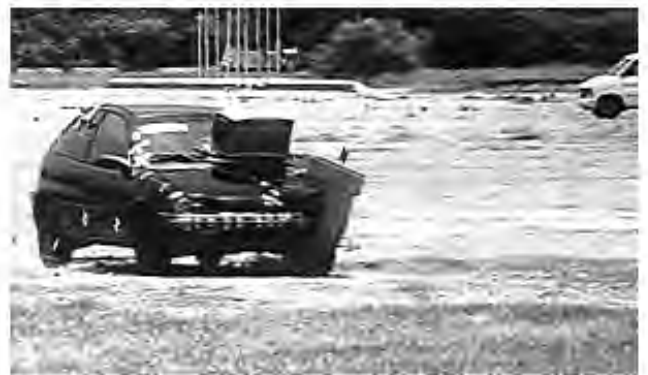
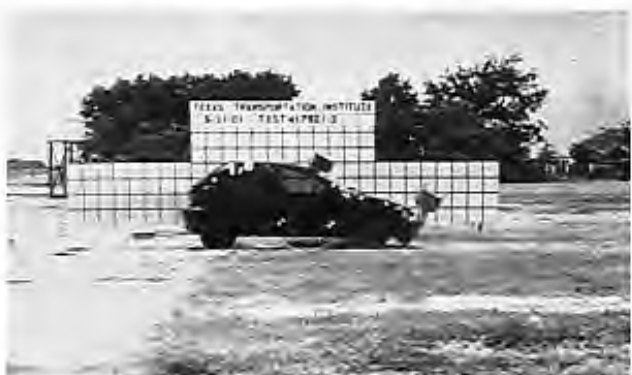
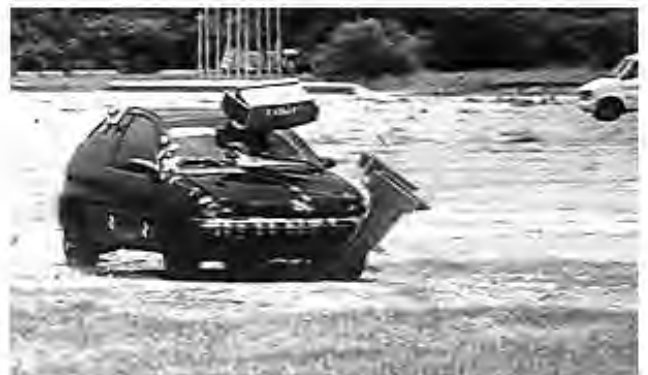
**Figure 31. Sequential Photographs for Test 417921-3
(Perpendicular and Oblique Views).**

The vehicle, traveling at 60.7 mi/h, impacted the MailMaster Deluxe mailbox on a 2 lb-ft U-channel support post at 0 degree with the vehicle left quarter point aligned with the centerline of the mailbox support. Shortly after impact, the mailbox began to deflect, and at 0.017 s the upper section of the mailbox separated from the lower base section. The U-channel fractured at ground level at 0.025 s with the lower molded plastic base section attached. The upper section of the mailbox contacted the hood at 0.030 s and then contacted the windshield at 0.040 s. At 0.089 s the vehicle lost contact with the upper section of the mailbox, and at 0.149 s the vehicle lost contact with the U-channel support post. Speed of the vehicle at loss of contact was 59.0 mi/h. Brakes on the vehicle were remotely applied 1.8 s after impact. The vehicle traveled on a straight path through the test site and subsequently came to rest 272.5 ft downstream of the point of impact. Sequential photographs of the test period are shown in [Appendix C, Figure 31](#).

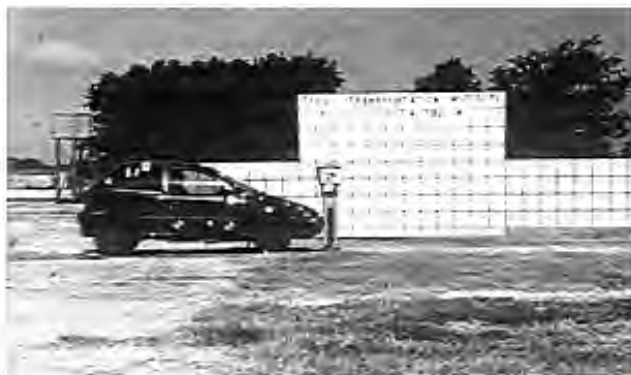
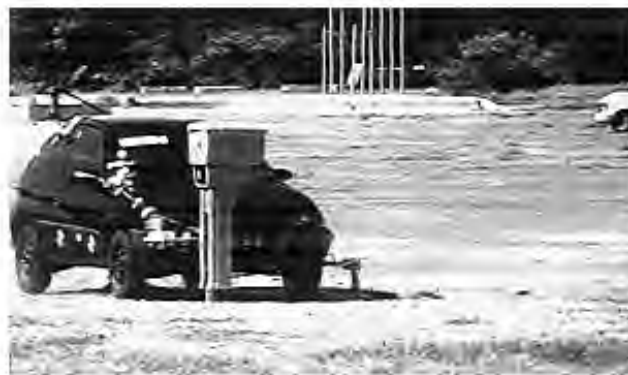
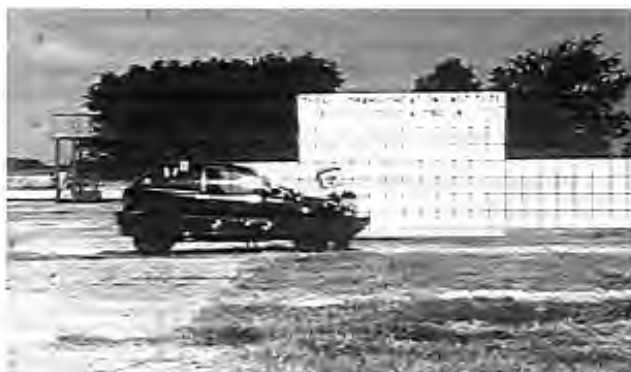
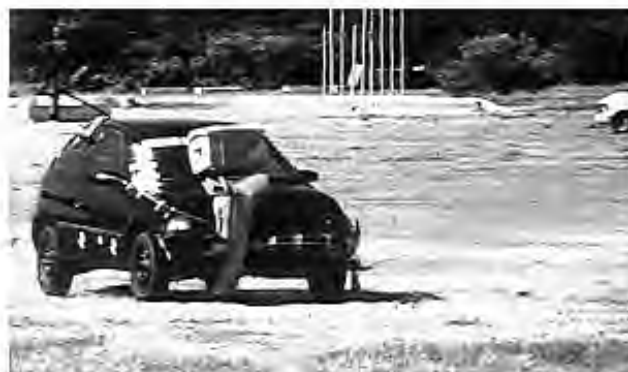
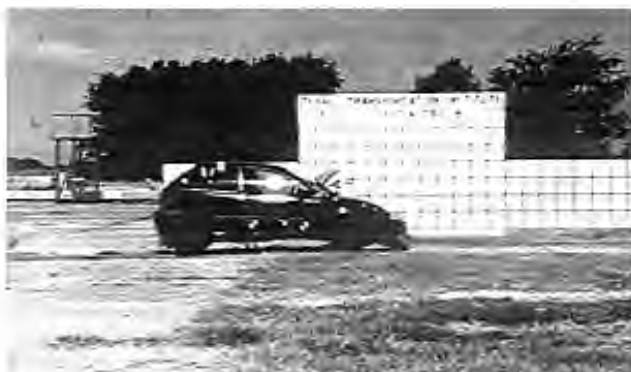
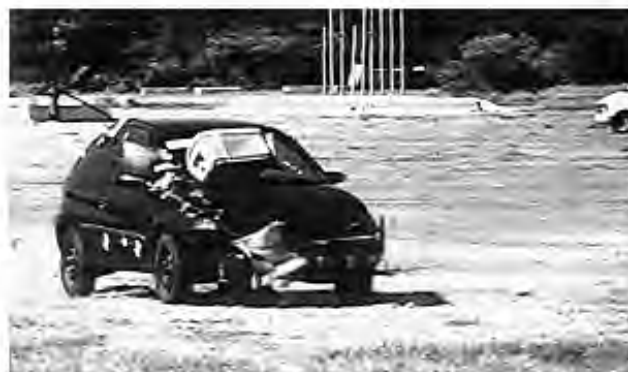
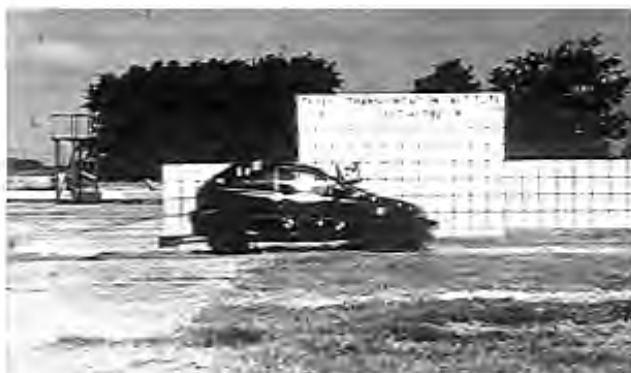
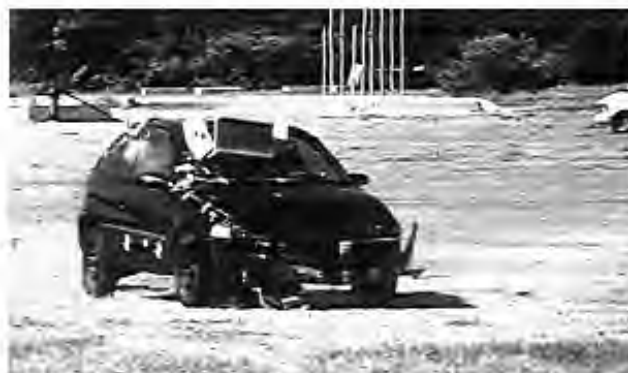
**Figure 32. Sequential Photographs for Test 417921-4
(Perpendicular and Oblique Views).**

downstream and 25.0 ft left of the point of impact. Sequential photographs of the test period are shown in [Appendix C, Figure 32](#).
