Testing of State Roadside Safety Systems Volume I: Technical Report

PUBLICATION NO. FHWA-RD-98-036

APRIL 1999

6. Performing Organization Code	
7. Author(s) King K. Mak, Roger P. Bligh, and Wanda L. Menges				8. Performing Organization Report No. Research Foundation 471470-Vol. I

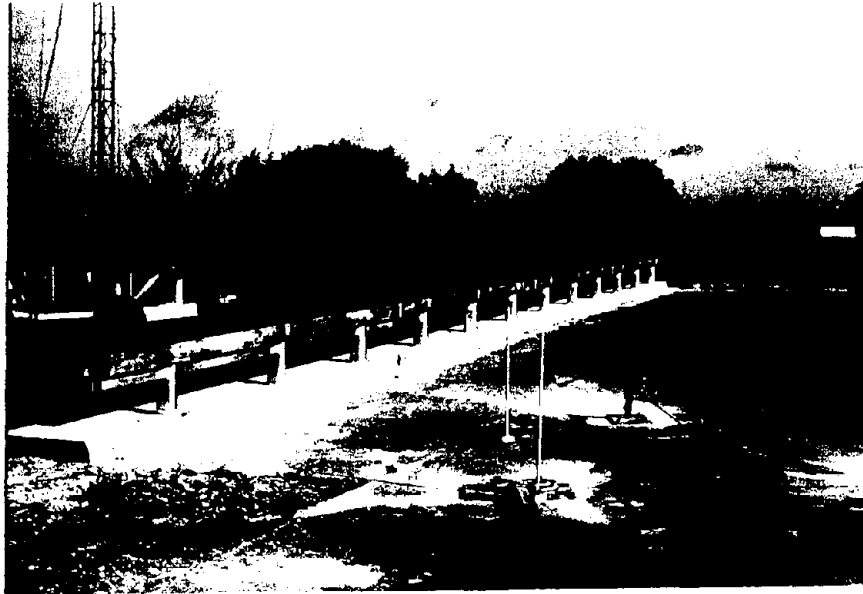
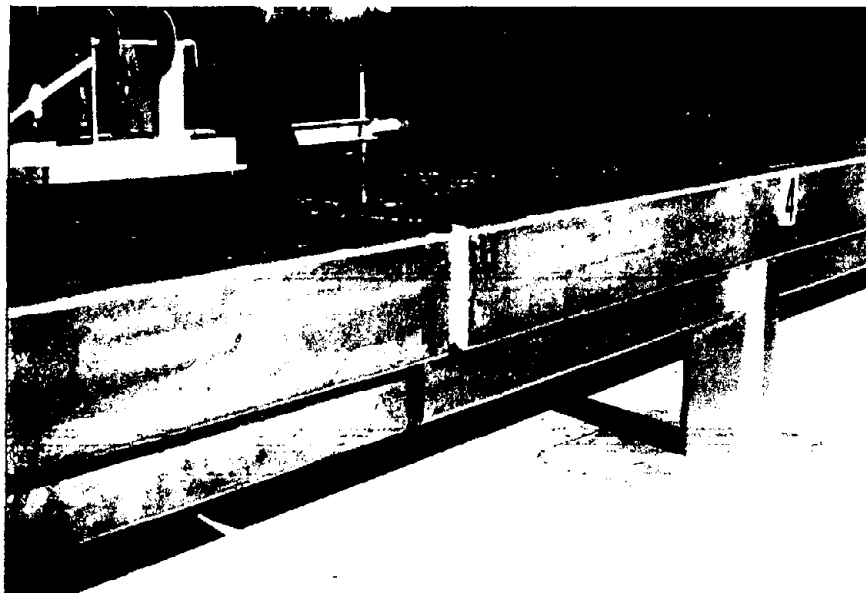
Figure 22. Photographs of test installation 471470-6.

The vehicle impacted the bridge railing midspan between posts 3 and 4, or approximately 5.72 m (18 ft, 9 in) downstream from the upstream end of the bridge railing. As the vehicle bumper contacted the bridge rail, the left front tire contacted the curb at the same time and appeared to partially air out. The vehicle bumper hit post 4 and the vehicle began to redirect. The left front tire of the vehicle mounted the curb and contacted post 4 when the roof of the vehicle began to buckle. Tire marks indicated that the left front tire

folded and went underneath the box beam and overlapped post 4 by a distance of 254 mm (10 in). The tires began to pull to the left and the front bumper began to come apart, extending behind the rail. There was sudden left steer input again, and the front bumper of the vehicle contacted post 5. The vehicle was traveling parallel to the bridge rail system at a speed of 62.9 km/h (39.1 mi/h). The left front tire impacted post 5, again pulling the front tires to the left. The vehicle exited the bridge rail traveling at a speed of 55.5 km/h (34.5 mi/h) with an exit angle of 1.5 degrees. After the vehicle exited from the bridge rail, the bumper struck post 6, cleared the rail and the left front tire dropped off the curb. Due to the damage sustained by the left front tire and the orientation of the front tires, the vehicle turned back toward the bridge rail after exiting from the initial impact and impacted it again near post 8. The vehicle then rode along and off the end of the bridge rail. The brakes were applied after the vehicle cleared the test installation and the vehicle came to rest 32.0 m (105 ft) downstream from and 7.6 m (25 ft) behind the point of initial impact. A summary of pertinent data from the electronic instrumentation, high-speed film, and field measurements is given in figure 24.

There was no permanent deformation of the bridge railing. The total length of contact for the initial impact was 4.0 m (13.0 ft). Tire marks extended 254 mm (10.0 in) under the rail element at post 4. The vehicle's sway bar, left strut, and inner C.V. joint were damaged. The windshield was broken, and the roof, floor pan, and instrument panel were bent. There was damage to the front bumper, hood, grill, radiator, left front quarter panel, left rear door and glass, left rear quarter panel, and the rear bumper. The firewall and floor pan were pushed into the steering column and clutch pedal for a maximum intrusion into the occupant compartment of 356 mm (14.0 in). The wheelbase on the right side was shortened from 2.1 m (84.0 in) to 1.7 m (66.5 in). The left front tire and rim were damaged from contact with the posts and the rear tire and rim were damaged in later contact with the curb. Maximum crush to the vehicle was 254 mm (10.0 in) at the left front corner at bumper height.

Review of the results of the first test suggested that the unsatisfactory performance of the original bridge rail design was caused by the bumper underriding the beam element of the bridge rail, resulting in the bumper impacting the posts head-on and the left front tire of the vehicle snagging severely on the posts. It was therefore recommended that the bottom TS 102-mm \times 76.2-mm \times 6.4-mm (4-in \times 3-in \times 1/4-in) box-beam sections be replaced with wider TS 152-mm \times 50.8-mm \times 6.4-mm (6-in \times 2-in \times 1/4-in) box-beam sections and the box-beam sections be moved forward to be flush with the face of the posts on the traffic side. This would reduce the potential for the bumper and the front wheel of the vehicle to underride the beam element of the bridge rail and impact the posts directly.

As mentioned previously, the original design of the Washington, DC, bridge rail did not perform satisfactorily in the first crash test (test no. 471470-6) with an 820-kg passenger car. The bridge rail design was then modified by replacing the bottom TS 102-mm × 76.2-mm × 6.4-mm (4-in × 3-in × 1/4-in) box-beam sections with wider TS 152-mm × 50.8-mm × 6.4-mm (6-in × 2-in × 1/4-in) box-beam sections and moving the box-beam sections forward to be flush with the face of the posts on the traffic side. These box-beam sections were welded to the bottom of the top box-beam rail element and to the sides of the posts. The modified bridge rail design was then crash tested in the next two crash tests (test nos. 471470-8 and 471470-9). Photographs of the modified test installation are shown in figure 23.

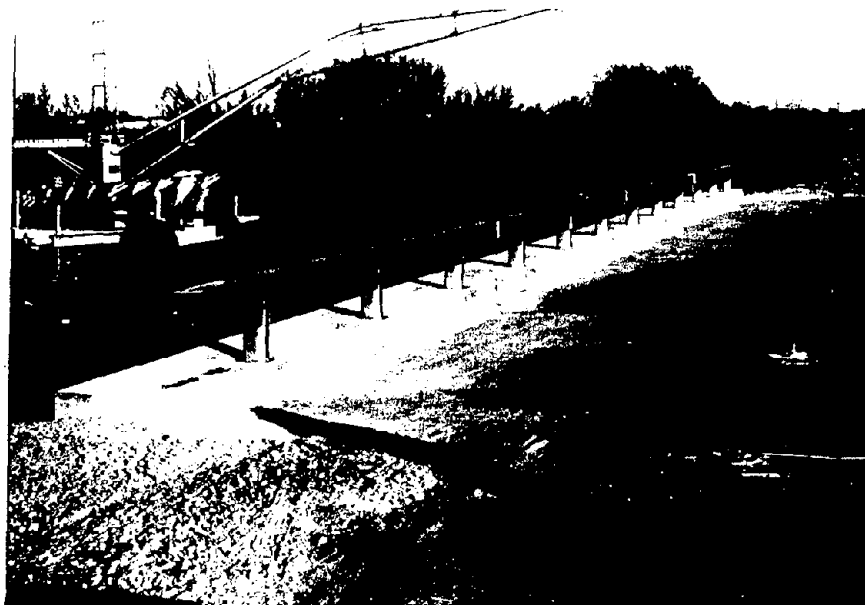
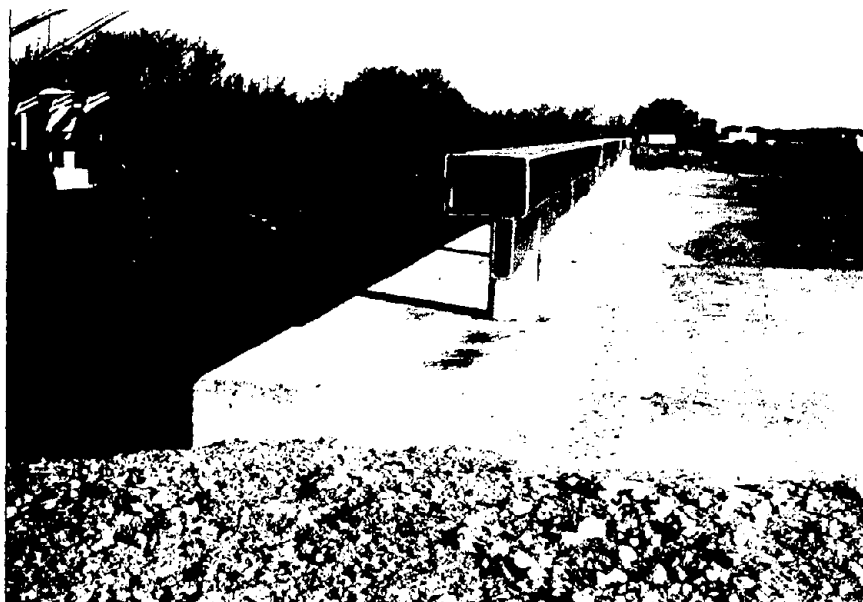
Figure 23. Photographs of modified test installation.

The modified Washington, DC, historic bridge rail was then crash tested with successful results. The second test (test no. 471470-8) was a repeat of the first test with a small passenger car on the modified bridge rail design. Summaries of the performance evaluation according to evaluation criteria set forth in the 1989 *AASHTO Guide Specifications for Bridge Railings* are presented in table 15. The vehicle was redirected smoothly and did not penetrate or go over the bridge railing. The bridge railing received only minimal damage and there were no detached elements or debris to show potential for penetration of the occupant compartment or to present undue hazard to other traffic. The vehicle remained upright and stable during the impact with the bridge railing and after exiting the test installation. The vehicle sustained moderate damage with essentially no deformation or intrusion into the passenger compartment. The occupant impact velocities and ridedown accelerations were well within the acceptable limits.

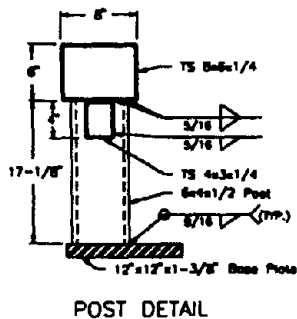
Figure 24. Summary of results for test 471470-6.

Test No.	7147-6	Impact Speed	82.4 km/h (51.2 mi/h)
Date	09/17/91	Impact Angle	20.1 deg
Test Installation	Washington, DC, Historic Bridge Rail	Speed at Parallel	62.9 km/h (39.1 mi/h)
Installation Length	23 m (75 ft)	Exit Speed	55.5 km/h (34.5 mi/h)
Max. Dynamic Deflection	nil	Exit Trajectory	1.5 deg
Max. Perm. Deformation	none	Vehicle Accelerations (Max. 0.050-s avg)	
Test Vehicle	1987 Yugo GV	Longitudinal	-8.5 g's
Vehicle Weight		Lateral	-9.4 g's
Test Inertia	817 kg (1800 lb)	Occupant Impact Velocity at true c.g.	
Gross Static	894 kg (1970 lb)	Longitudinal	7.5 m/s (24.7 ft/s)
Vehicle Damage Classification		Lateral	5.1 m/s (16.6 ft/s)
TAD	11FL6 & 11LD7	Occupant Ridedown Accelerations	
CDC	11FLEK4 & 11LDEW4	Longitudinal	-6.5 g's
Maximum Vehicle Crush	254 mm (10.0 in)	Lateral	-9.9 g's

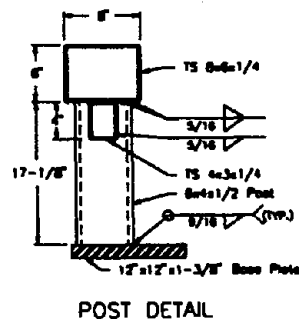
Figure 25. Summary of results for test 471470-8.

There was no permanent deformation of the bridge railing. The total length of contact with the rail was 2.5 m (8.3 ft). Tire marks extended 64 mm (2.5 in) under the rail element just before post 4. The vehicle's left strut and C.V. joint were damaged. The driver's window was broken and there was damage to the front bumper, hood, grill, radiator, left front quarter panel, left door, left rear quarter panel, and the rear bumper. The wheelbase on the left side was shortened from 2.3 m (90.25 in) to 2.2 m (87.0 in). The left front tire and rim were damaged from contact with the curb and post 4. Maximum crush to the vehicle was 216 mm (8.5 in) at the left front corner at bumper height.

Test No.	7147-8	Impact Speed	80.0 km/h (49.7 mi/h)
Date	12/10/91	Impact Angle	21.5 deg
Test Installation	Washington, DC, Historic Bridge Rail	Speed at Parallel	65.3 km/h (40.6 mi/h)
Installation Length	23 m (75 ft)	Exit Speed	64.5 km/h (40.1 mi/h)
Max. Dynamic Deflection	nil	Exit Trajectory	3.5 deg
Max. Perm. Deformation	none	Vehicle Accelerations (Max. 0.050-s avg)	
Test Vehicle	1988 Ford Festiva	Longitudinal	-6.0 g's
Vehicle Weight		Lateral	-10.2 g's
Test Inertia	817 kg (1800 lb)	Occupant Impact Velocity at true c.g.	
Gross Static	892 kg (1965 lb)	Longitudinal	4.3 m/s (14.2 ft/s)
Vehicle Damage Classification		Lateral	5.7 m/s (18.7 ft/s)
TAD	11FL2 & 11LD3	Occupant Ridedown Accelerations	
CDC	11FLEK1 & 11LDEW3	Longitudinal	-1.4 g's
Maximum Vehicle Crush	216 mm (8.5 in)	Lateral	-6.9 g's

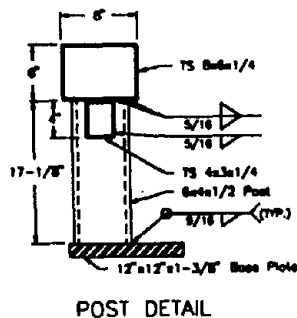
There was no permanent deformation of the bridge railing. The total length of contact with the rail was 3.9 m (12.9 ft). Tire marks indicated that the tire did not go under the rail element. The vehicle's driver-side window was broken and there was damage to the front bumper, hood, grill, left front quarter panel, left door, left rear quarter panel, and the rear bumper. The left front and rear rims were damaged from contact with the curb and rail element. Maximum crush to the vehicle was 254 mm (10.0 in) at the left front corner at bumper height.

Test No.	7147-9
Date	12/16/91
Test Installation	Washington, DC, Historic Bridge Rail
Installation Length	23 m (75 ft)
Max. Dynamic Deflection	nil
Max. Perm. Deformation	none
Test Vehicle	1986 Chevrolet Pickup
Vehicle Weight	
Test Inertia	2352 kg (5400 lb)
Gross Static	2527 kg (5565 lb)
Vehicle Damage Classification	
TAD	11FL2 & 11LD3
CDC	11FLEK2 & 11LDEW2
Maximum Vehicle Crush	254 mm (10.0 in)

Impact Speed	76.7 km/h (47.7mi/h)
Impact Angle	20.6 deg
Speed at Parallel	71.4 km/h (44.4 mi/h)
Exit Speed	70.3 km/h (43.7 mi/h)
Exit Trajectory	5.4 deg
Vehicle Accelerations (Max. 0.050-s avg)	
Longitudinal	-3.6 g's
Lateral	-8.7 g's
Occupant Impact Velocity at true c.g.	
Longitudinal	2.7 m/s (8.9 ft/s)
Lateral	4.8 m/s (15.6 ft/s)
Occupant Ridedown Accelerations	
Longitudinal	-2.2 g's
Lateral	-14.1 g's

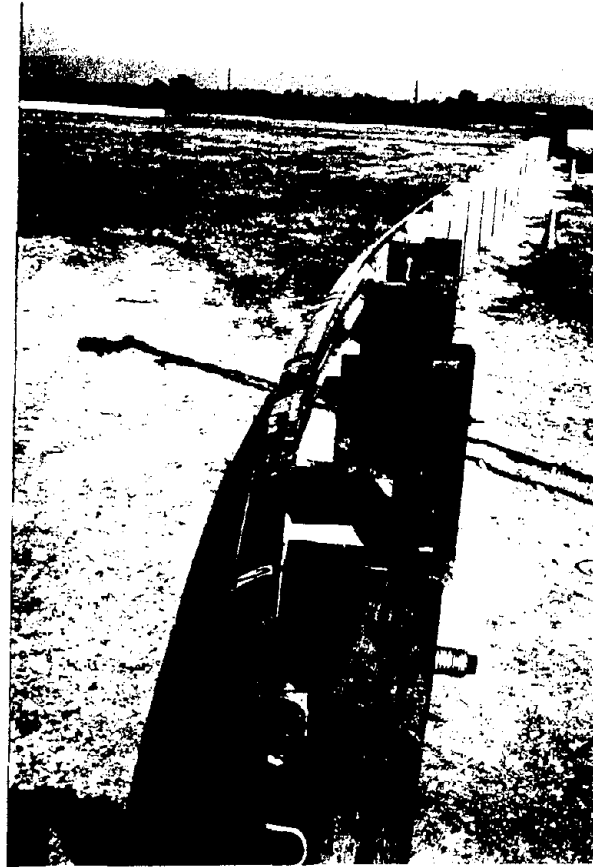
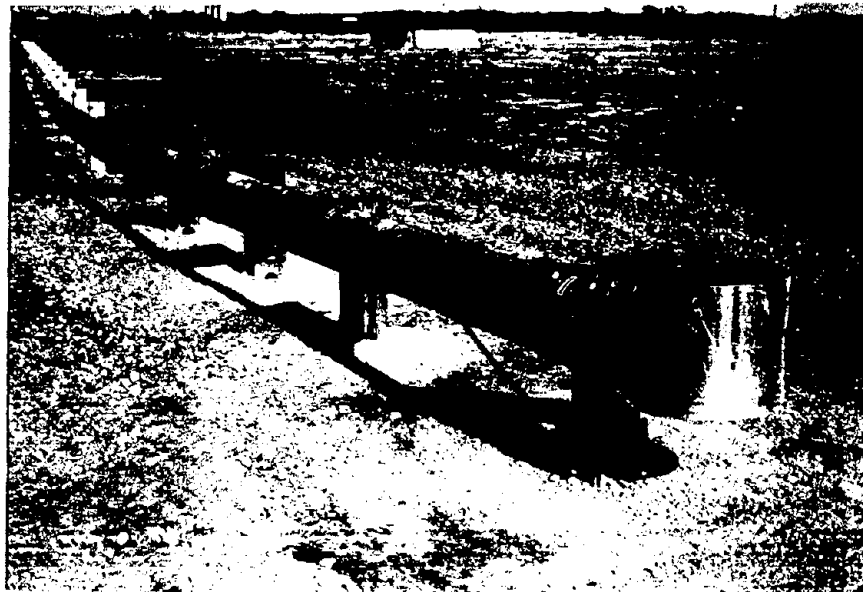
Figure 29. Photographs of test installation 471470-7.

It should be noted that posts 3 through 5 were replaced prior to pulling out the rail element at post 2. Thus, the rail element was not directly against posts 3 through 5 (i.e., there were gaps between the rail element and the faces of posts 3 through 5). The widths of the gaps at posts 3, 4, and 5 were 89 mm (3.5 in), 76 mm (3.0 in), and 67 mm (2.6 in), respectively. However, it is believed that the gaps between the rail element and the faces of posts 3 through 5 would have little effect on the impact performance of the terminal for an end-on impact.

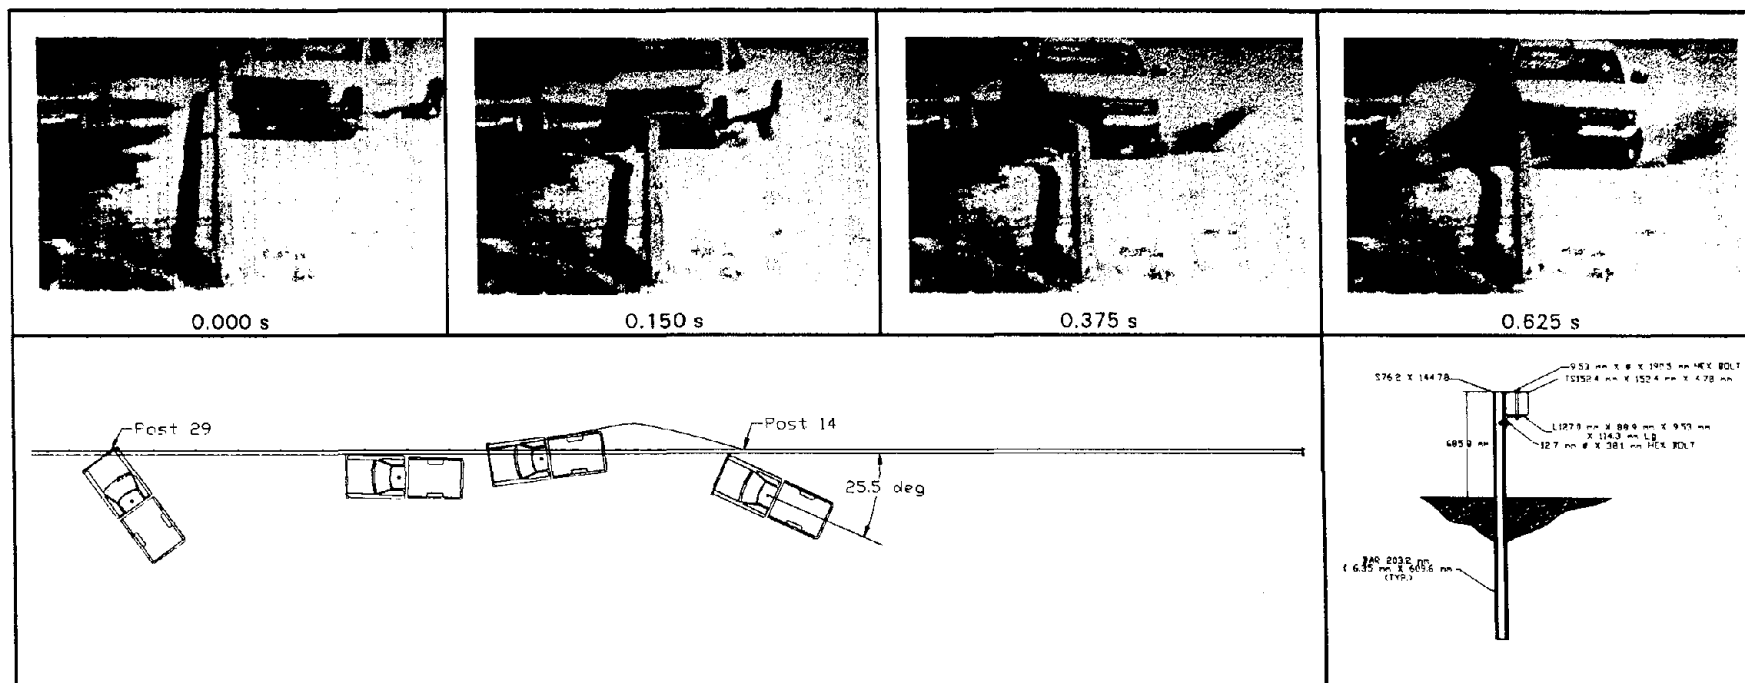
Figure 81. Summary of results for test 471470-22.

front of the vehicle impacted post 6. Maximum dynamic deflection of the guardrail was 1.4 m (4.5 ft). The vehicle was traveling parallel to the installation at 38.0 km/h (23.6 mi/h). The front of the vehicle impacted post 7. As the vehicle continued to be redirected, the vehicle began to turn counterclockwise toward the rail because of the orientation of the front tires. The vehicle separated from the guardrail traveling at an estimated exit speed and angle of 25.7 km/h (16.0 mi/h) and 9.5 degrees. The vehicle came to rest 17.3 m (56.7 ft) downstream from the initial point of impact adjacent to the face of the rail element. A summary of pertinent data from the electronic instrumentation, high-speed film, and field measurements is given in figure 81.

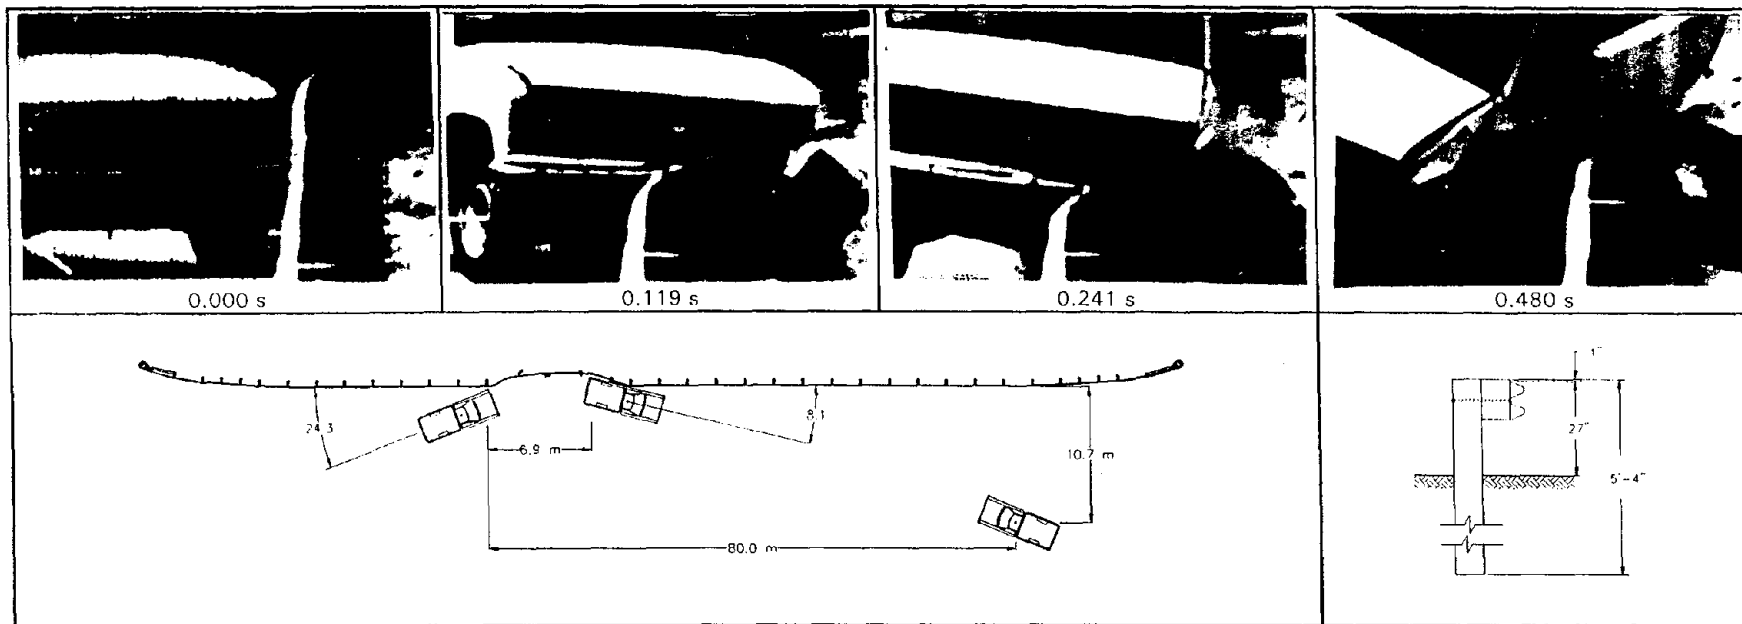
The test installation consisted of a 45.7-m- (150-ft-) long section of the standard G4(2W) guardrail with a MELT at the upstream end and a standard breakaway cable terminal (BCT) at the downstream end, for a total installation length of 68.6 m (225 ft). The vehicle impacted the length-of-need section 0.61 m (2 ft) upstream of post 14, or 4.5 m (14.5 ft) upstream of the splice at post 16. As the vehicle impacted the guardrail, the W-beam rail element began to deform and post 14 began to displace laterally. The vehicle impacted post 14 shortly afterwards, and redirection of the vehicle began. The front of the vehicle contacted post 15 and then the tire contacted the post. The vehicle contacted post 16 and the tire contacted post 16. Shortly after that, the left front wheel assembly separated from the vehicle and the blockout on post 16 split. The rear of the vehicle made contact with the guardrail. The vehicle contacted post 17 and the vehicle was parallel with the installation traveling at 74.3 km/h (46.3 mi/h). Maximum deflection of the W-beam rail of 0.82 m (2.7 ft) occurred near post 16. The vehicle lost contact with the installation traveling at a speed of 70.8 km/h (44.0 mi/h) and at an exit angle of 8.1 degrees. As the vehicle exited the rail, it had rolled 25 degrees counterclockwise and was yawing clockwise. Maximum roll angle attained was 39 deg. As the damaged front end of the vehicle contacted the ground, the vehicle righted itself and began to yaw counterclockwise, subsequently coming to rest 80 m (263 ft) downstream and 10.7 m (35 ft) forward of the point of impact. The vehicle had yawed approximately 150 degrees. A summary of pertinent data from the electronic instrumentation, high-speed film, and field measurements is given in figure 83.

The bolts were pulled out of the W-beam rail element at posts 15 and 16, and the blockout on post 16 was split. None of the posts broke off, but some posts were pushed back. The W-beam rail element was deformed from posts 13 through 18 and there was evidence of tire contact with posts 14 through 17. Maximum dynamic deflection of the

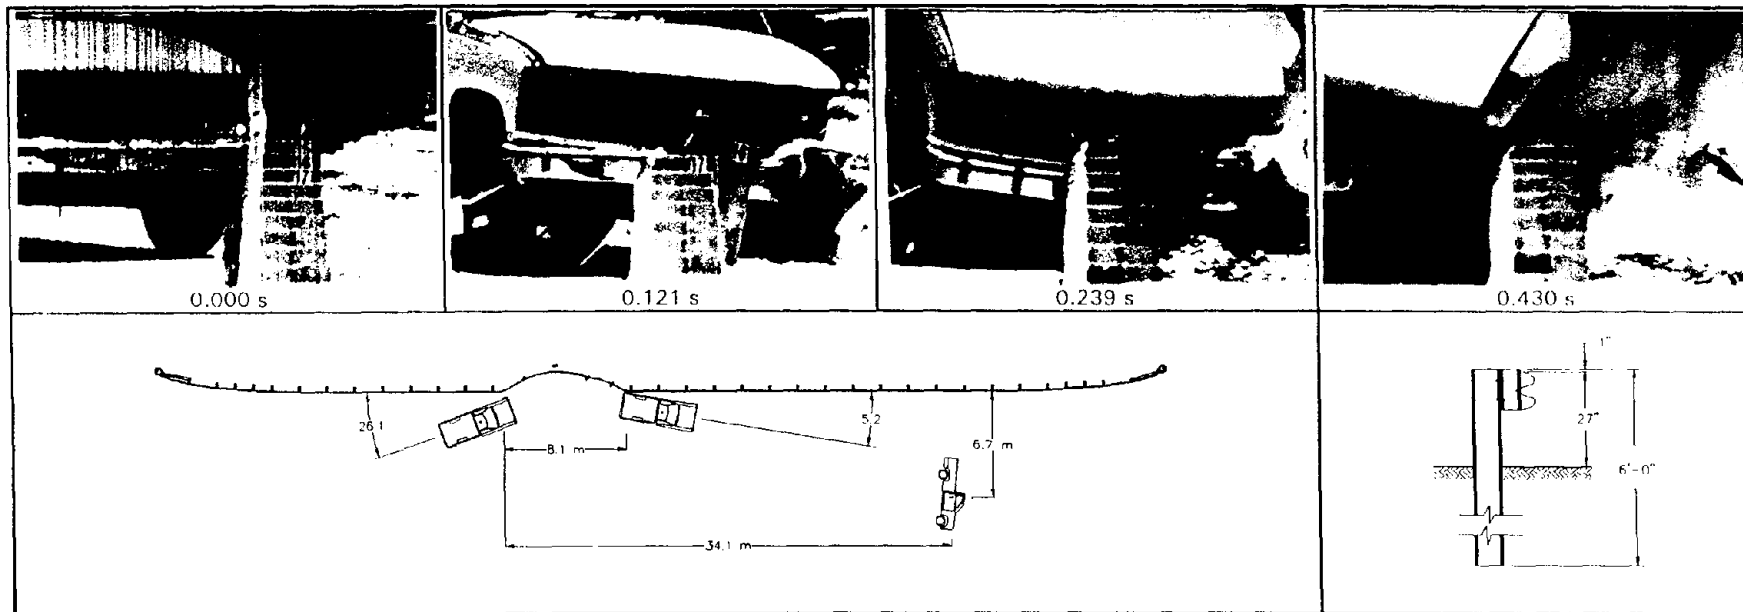
The test installation consisted of a 45.7-m- (150-ft-) long section of the standard G4(1S) guardrail with a MELT at the upstream end and a standard BCT at the downstream end, for a total installation length of 68.6 m (225 ft). The vehicle impacted the length-of-need section 0.61 m (2 ft) upstream of post 14, or 4.5 m (14.5 ft) upstream of the splice at post 16. As the vehicle impacted the guardrail, the W-beam rail element began to deform, and posts 13 and 14 began to displace laterally. The front of the vehicle impacted post 14 shortly thereafter, the left front tire of the vehicle contacted post 15, and, as the vehicle continued forward, the tire aired out and began to fold under. Redirection of the vehicle began as the body of the vehicle began to bow upward in the center (between the cab and bed). The left front tire snagged on post 16 and the body of the vehicle began to bow substantially. The rear of the vehicle made contact with the W-beam rail and then the vehicle was parallel with the installation traveling at 66.0 km/h (41.0 mi/h). As the vehicle traveled past post 17, the left front tire made slight contact with the post. Maximum deflection of the W-beam rail was 1.01 m (3.3 ft). The vehicle lost contact with the installation traveling at a speed of 58.7 km/h (36.5 mi/h) and at an exit trajectory of 5.2 degrees. As the vehicle exited the rail, it had rolled 28 degrees counterclockwise and was yawing clockwise. As the damaged front end of the vehicle contacted the ground, the vehicle continued to roll onto its left side and subsequently slid to rest on its left side 34 m (112 ft) downstream and 6.7 m (22 ft) forward of the point of impact. A summary of pertinent data from the electronic instrumentation, high-speed film, and field measurements is given in figure 84.

The MELT anchor on the upstream end had pulled up slightly and moved laterally 44.5 mm (1.75 in). The buffered end nose was pulled off the end post (post 1). The bolts were pulled out of the W-beam rail element at posts 15, 16, and 17, and the posts and blockouts were bent. All the steel posts upstream of impact were disturbed with measurable displacements. The W-beam rail element was deformed between posts 14 through 18 and there was evidence of tire contact with posts 15 through 17. Maximum dynamic deflection

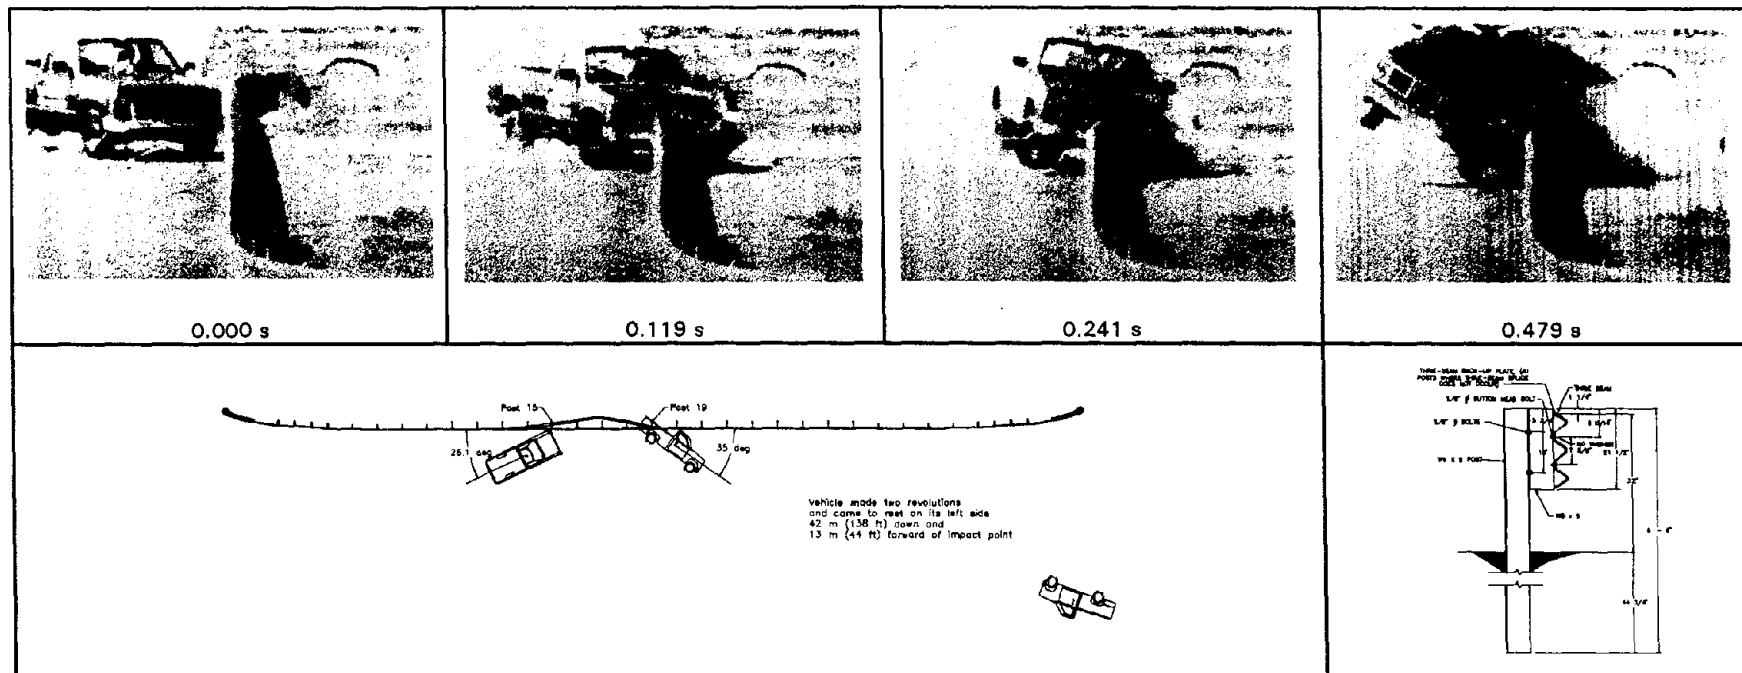
The test installation consisted of a 30.5-m- (100-ft-) long length-of-need section of the standard thrie-beam (G9) guardrail with a 1.9-m- (6-ft, 3-in-) long transition section from the thrie-beam to the W-beam rail element, a 3.8-m- (12-ft, 6-in-) long section of standard steel-post, W-beam G4(1S) guardrail and a 11.4-m- (37-ft, 6-in-) long MELT at each end, for a total installation length of 64.8 m (212 ft, 6 in). The vehicle impacted the length-of-need section 102 mm (4.0 in) upstream of post 15. As the vehicle impacted the installation, the thrie-beam rail element began to deflect and redirection of the vehicle began. The left front wheel began to steer sharply toward the guardrail, and posts 16 and 17 began to rotate about their vertical axes. The left front tire caught the flanges of post 16 and post 17. Maximum dynamic deflection of the thrie-beam rail element of 1.07 m (3.5 ft) occurred between posts 17 and 18. The vehicle became parallel with the installation traveling at 67.5 km/h (41.9 mi/h). The rear of the vehicle contacted the thrie-beam rail element. The vehicle lost contact with the installation traveling at a speed of 54.5 km/h (33.9 mi/h), an exit angle of approximately 35 degrees, and a roll angle of roughly -45 degrees. As the vehicle exited the installation, it continued to roll counterclockwise and yaw clockwise. The vehicle rolled two and a quarter revolutions and came to rest on its left side 42 m (138 ft) down and 13 m (44 ft) forward of the initial point of impact, with the front of the vehicle facing the direction of impact. A summary of pertinent data from the electronic instrumentation, high-speed film, and field measurements is given in figure 85.

There were tire marks on the face of the thrie-beam rail element from posts 15 through 19, and on the face of posts 16 and 17. The thrie-beam rail element was separated from post 16 and the flanges on post 17 showed evidence of wheel contact. Posts 15 through 19 were twisted severely. The lateral deflections occurred at posts 13 through 20. Maximum dynamic deflection of the thrie-beam rail element was 1.07 m (3.5 ft). Maximum permanent

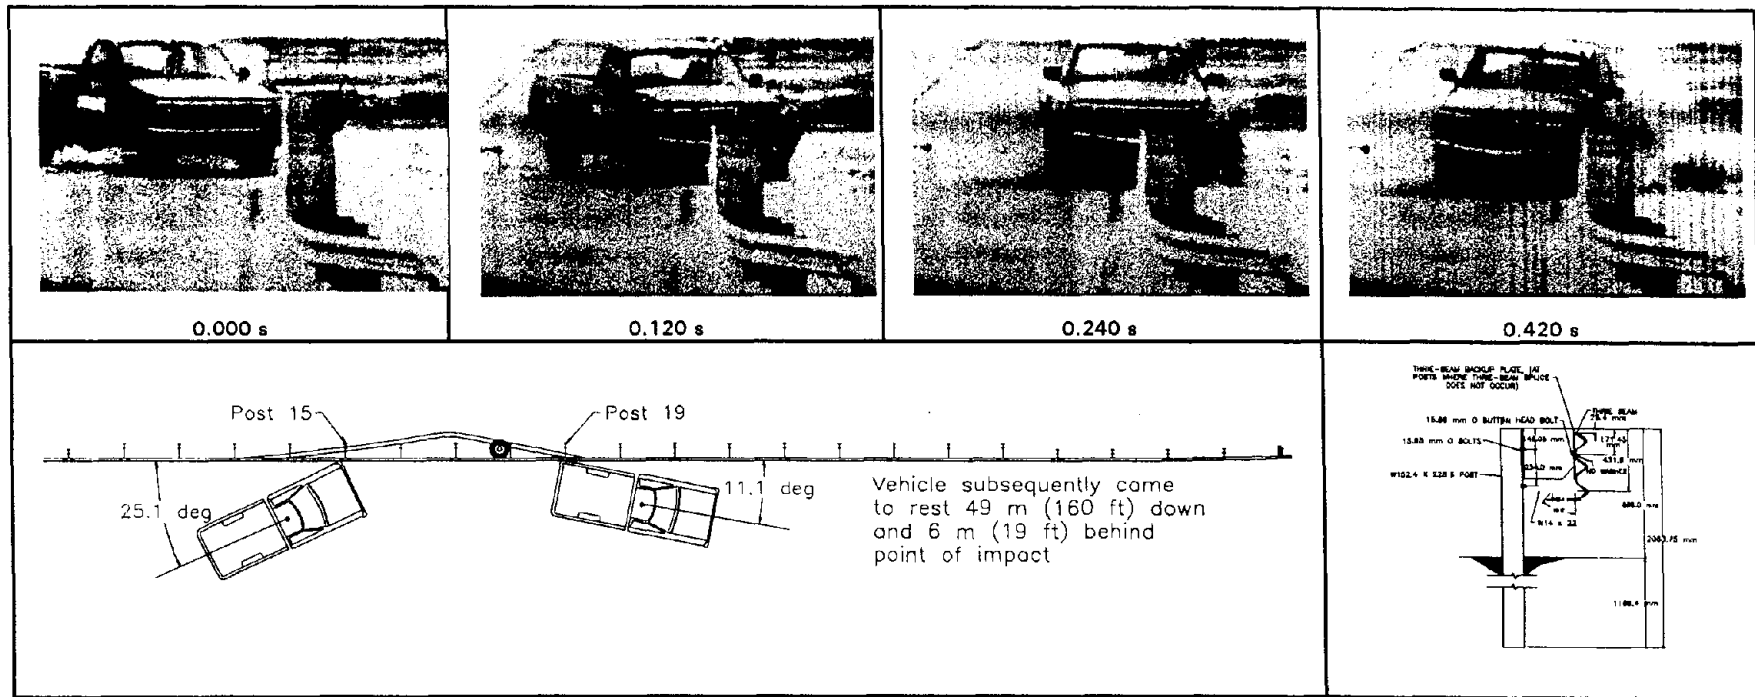
The test installation consisted of a 30.5-m- (100-ft-) long length-of-need section of the modified thrie-beam guardrail with a 1.9-m- (6-ft, 3-in-) long transition section from the thrie-beam to the W-beam rail element, a 3.8-m- (12-ft, 6-in-) long section of standard steel-post, W-beam G4(1S) guardrail and a 11.4-m- (37-ft, 6-in-) long MELT at each end for a total installation length of 64.8 m (212 ft, 6 in). The vehicle impacted the length-of-need section at post 15. As the vehicle impacted the installation, the thrie-beam guardrail began to deflect and redirection of the vehicle began. The left front tire made contact with the flange and face of post 16, which caused the wheel to turn outward (or counterclockwise). The vehicle continued forward as posts 17 and 18 began to rotate about their vertical axes. The left front wheel assembly caught the flange at post 17 and the entire wheel assembly was torn from the axle. The front of the vehicle reached post 18 and the rear of the vehicle made contact with the thrie-beam rail element. The vehicle became parallel with the installation traveling at 74.3 km/h (46.2 mi/h). The vehicle lost contact with the installation traveling at a speed of 67.4 km/h (41.9 mi/h) and an exit angle of approximately 11.1 degrees. The vehicle brakes were applied as the vehicle exited the test area, and subsequently came to rest 49 m (160 ft) down and 6 m (19 ft) behind the initial point of impact. A summary of pertinent data from the electronic instrumentation, high-speed film, and field measurements is given in figure 86.

There were tire marks on the face of the thrie-beam rail element from posts 15 through 19, and on the face of post 16 and the back side of post 17. The thrie-beam rail element was separated from post 17 and the flanges on post 17 showed evidence of wheel contact. Posts 16, 17, and 18 were twisted severely. Lateral deflections occurred at posts 14 through 20. Maximum dynamic deflection of the thrie-beam rail element was 1.02 m (3.4 ft). Maximum permanent deformation of the installation was 0.61 m (2.0 ft) just upstream of post 17. Total length of contact of the vehicle with the installation was 8.0 m (26.1 ft).

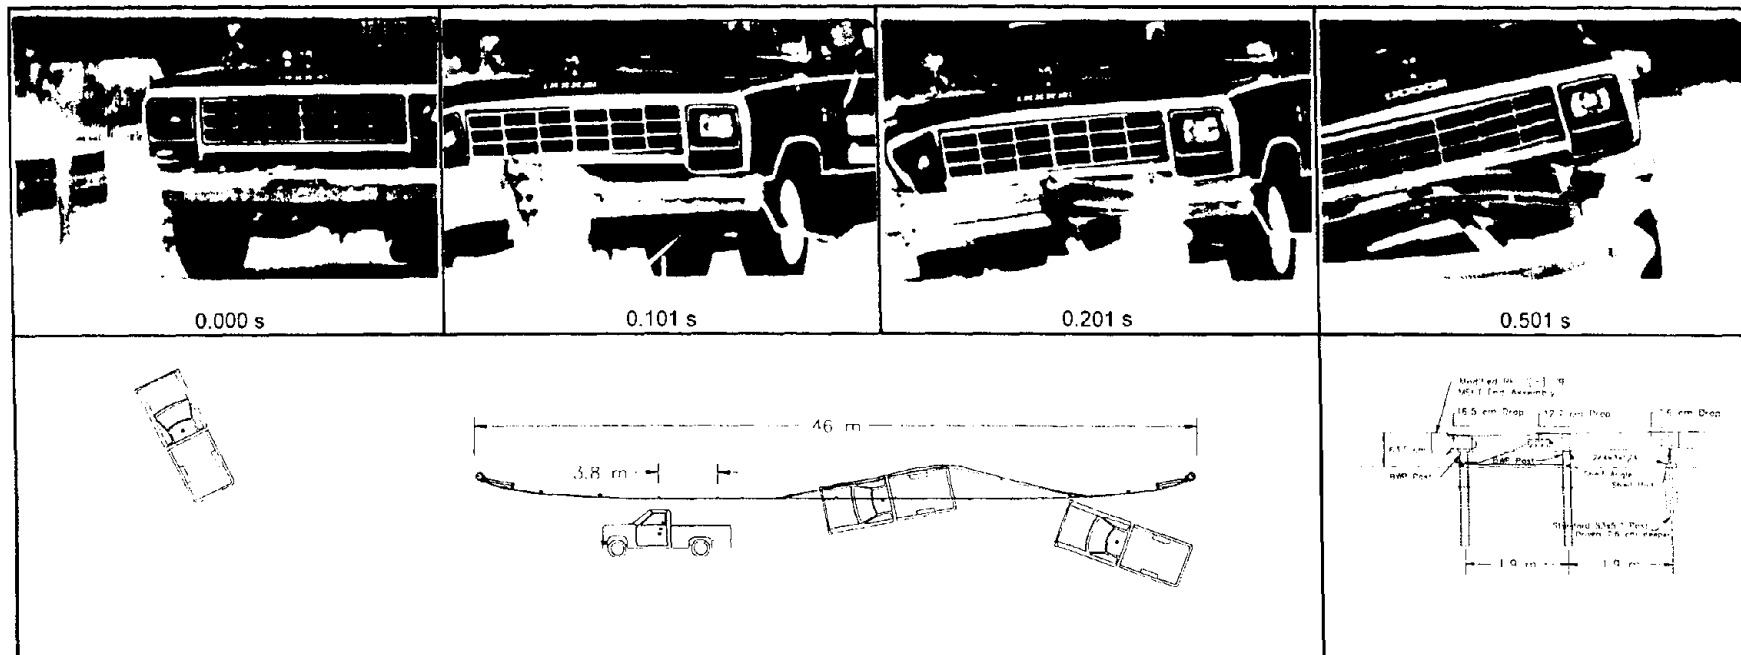
The vehicle impacted the terminal at post 4 (the beginning of the length of need) or 7.62 m (25 ft) downstream from the end post. As the vehicle impacted the terminal, the

W-beam rail element began to deform, and the vehicle began to redirect. As the vehicle continued forward, the W-beam rail element rode over the top of the posts as the W-beam deformed along the path of the vehicle. The right front tire rode over post 5, causing the post to fracture just above the soil plate. The rear of the vehicle contacted the guardrail and the vehicle was traveling parallel to the installation at 78.4 km/h (48.7 mi/h). Maximum dynamic deflection of the guardrail was 2.0 m (6.7 ft). As the vehicle was being redirected, the W-beam rail element dropped and began to dig into the ground. The vehicle began to roll clockwise and the rear of the vehicle began to rise significantly. The vehicle was airborne and continued to roll clockwise as it lost contact with the installation. Shortly after that, the vehicle landed on its right side, bounced, and righted itself. The vehicle came to rest upright 90 m (296 ft) downstream and 9 m (31 ft) behind the point of impact. A summary of pertinent data from the electronic instrumentation, high-speed film, and field measurements is given in figure 67.

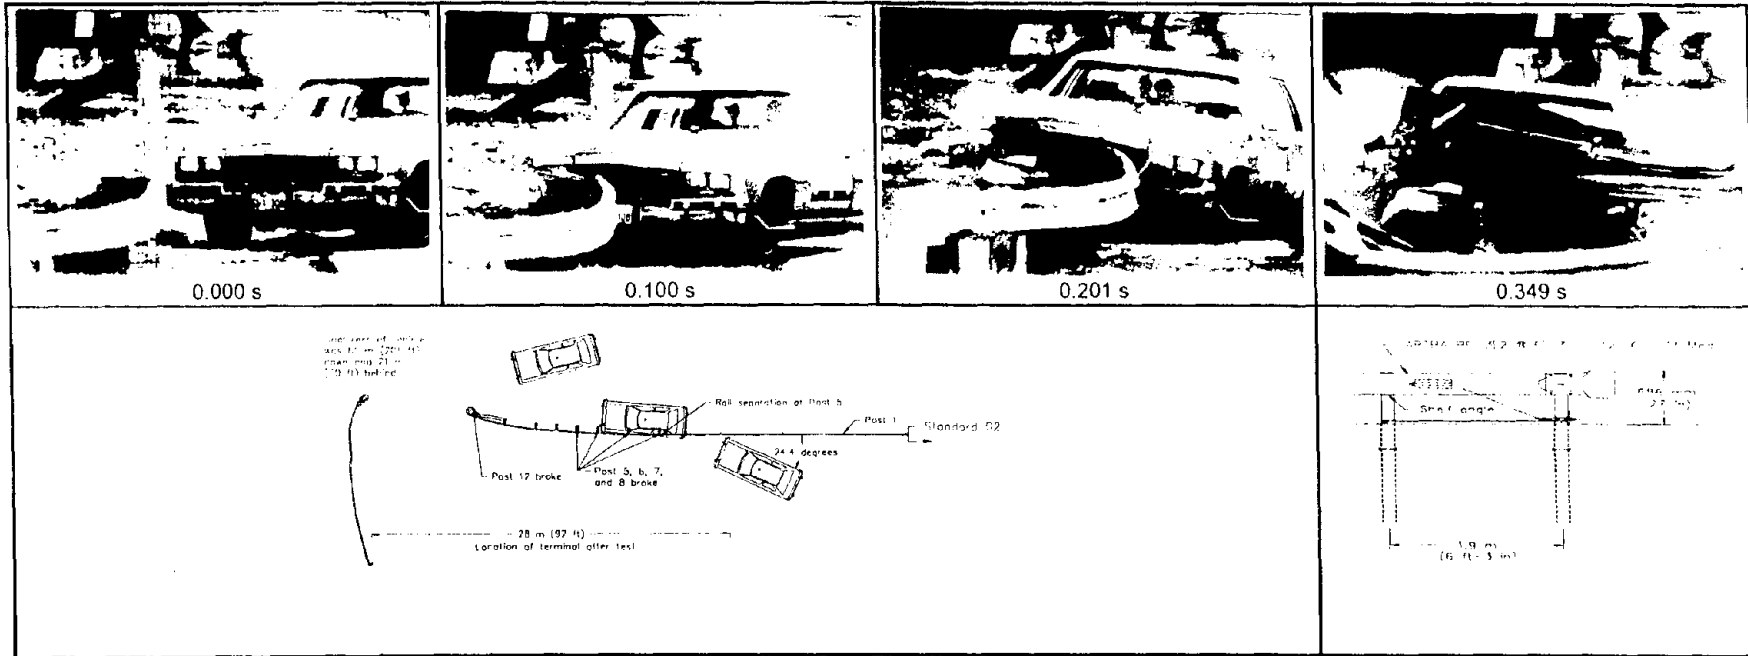
Figure 68. Summary of results for test 471470-23.

The vehicle impacted the guardrail in the reverse direction (i.e., opposite to normal direction of travel) 4.6 m (15 ft) upstream of the last wooden post of the terminal (post 5), or 0.76 m (2 ft, 6 in) upstream of post 3. Note that the numbering system of the posts for this crash test was different from that of the other crash tests (i.e., the end post was numbered post 12, the second post numbered post 11, etc.). As the vehicle impacted the guardrail, the W-beam rail element began to deform and post 3 began to displace laterally. The front tire of the vehicle impacted post 3 and then post 4. The W-beam rail element ruptured at the splice at post 5 (last wood post of the terminal section). Just before the rupture, the rail element had deflected 0.3 m (1.09 ft), but post 5 did not deflect laterally. The vehicle impacted the end of the ruptured rail and post 5 while the vehicle was traveling at 85.3 km/h (53.0 mi/h). The W-beam rail was loaded axially, the bolt in post 6 pulled out, and subsequently the rail element buckled at the post 6 location. The axial loading and longitudinal movement of the W-beam rail element caused the end post (post 12) to fracture just above ground level. The vehicle continued forward through the opening in the rail, making contact with and fracturing

posts 6 and 7 just below ground level. The vehicle lost contact with the separated terminal end section and was traveling at a speed of 70.8 km/h (44.0 mi/h). As the vehicle continued behind the installation, it began to slide sideways as it yawed counterclockwise. The vehicle came to rest 61 m (201 ft) downstream and 21 m (70 ft) behind the point of impact. A summary of pertinent data from the electronic instrumentation, high-speed film, and field measurements is given in figure 68.

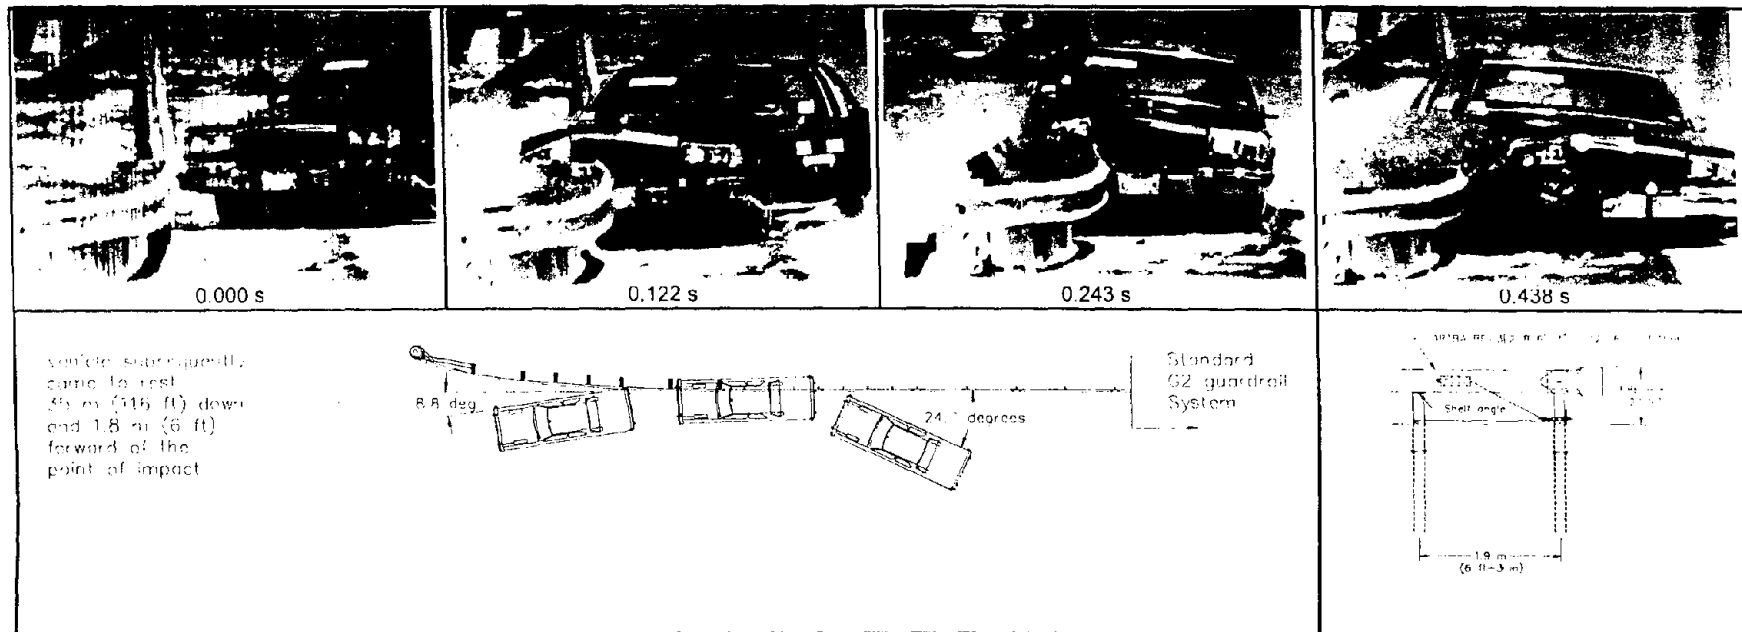
The vehicle impacted the transition area in the reverse direction (i.e., opposite to normal direction of travel) just upstream of post 13 (i.e., 4.6 m (15 ft) upstream of the last wooden post (post 8) of the Mini-MELT). As the vehicle impacted the terminal, the W-beam rail element began to deform and posts 12 and 13 began to displace laterally. The front tire of the vehicle impacted post 13 shortly afterwards, and movement began at posts 11, 14, and 10, respectively. The vehicle contacted post 12, and the right front tire aired out as it rode over post 12. Contact was made with post 11 and post 10 and the rear of the vehicle made contact with the rail near post 14. The vehicle then made contact with post 9 and post 8. The vehicle became parallel with the installation traveling at 73.2 km/h (45.5 mi/h). Maximum deflection of 0.96 m (3.15 ft) occurred near the post 10 location. The vehicle lost contact with the installation traveling at a speed of 58.4 km/h (36.3 mi/h) and at an exit angle of 8.8 degrees. As the vehicle exited the rail, it began to yaw clockwise, and subsequently came to rest 35 m (116 ft) downstream and 1.8 m (6 ft) forward of the point of impact. A summary of pertinent data from the electronic instrumentation, high-speed film, and field measurements is given in figure 69.

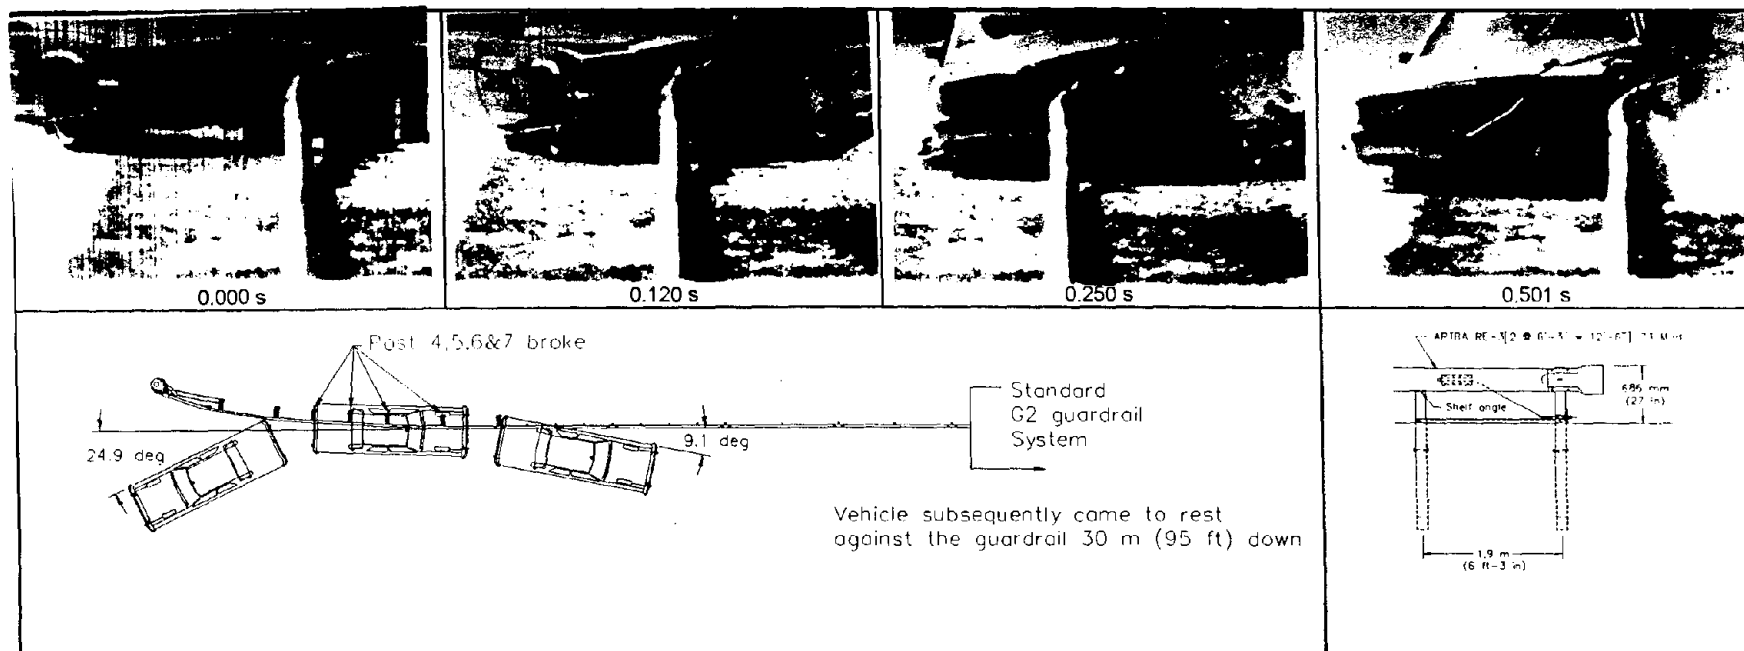
The vehicle impacted the terminal just upstream of post 3 (i.e., at the beginning of length of need) or 3.8 m (12 ft, 6 in) downstream of the end post. As the vehicle impacted the terminal, the W-beam rail element began to deform and post 4 began to displace laterally. The front tire of the vehicle impacted post 3 and the W-beam element began to displace forward at post 5. The vehicle began to redirect and made contact with post 4. The W-beam began to pull back to post 5, and then to bend near post 6. Post 4 fractured at ground level, post 5 fractured and the vehicle rode over it. Post 6 fractured, the vehicle impacted the post, and the rear of the vehicle made contact with the W-beam element. The front of the vehicle contacted post 7, fracturing the post, and at the same time, the vehicle became parallel with the installation traveling at 75.3 km/h (46.8 mi/h). Maximum dynamic deflection of 1.2 m (3.8 ft) occurred between the post 6 and 7 locations. The front tire contacted post 9 and the tire aired out. The vehicle lost contact with the installation traveling at 52.3 km/h (32.5 mi/h) and at an exit angle of 9.1 degrees. As the vehicle exited the rail, it began to yaw counterclockwise, subsequently impacting the guardrail 27 m (89 ft) downstream of the point of initial impact. The vehicle rode along the guardrail for 1.9 m (6.3 ft) and stopped against the guardrail. A summary of pertinent data from the electronic instrumentation, high-speed film, and field measurements is given in figure 70.

Posts 4 through 7 broke off near ground level, and the blockout on post 8 was splintered. A number of other posts were pushed back. For posts 4 through 7 that broke off, the post displacement measurements indicate maximum post movement just prior to breaking of the posts. The W-beam rail element was buckled and torn (but not ruptured) at the lower splice bolts on the outer edge of the splice located at post 8. The tearing propagated over half the width of the W-beam rail element, indicating that the tensile capacity of the W-beam rail
