Testing of State Roadside Safety Systems Volume I: Technical Report

PUBLICATION NO. FHWA-RD-98-036

APRIL 1999

6. Performing Organization Code	
7. Author(s) King K. Mak, Roger P. Bligh, and Wanda L. Menges				8. Performing Organization Report No. Research Foundation 471470-Vol. I

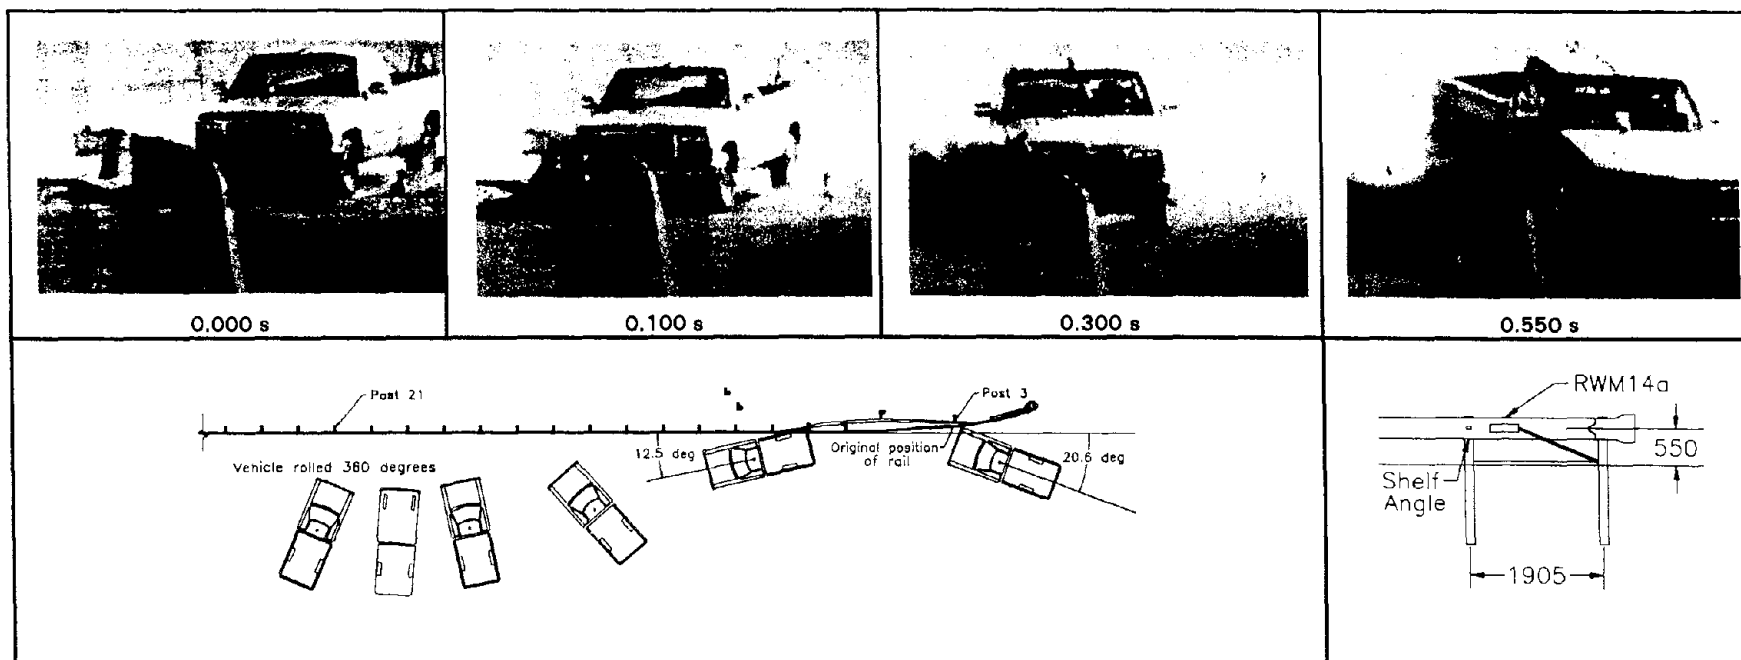
Figure 93. Summary of results for test 471470-32.

downstream and 3.3 m (11 ft) forward of the initial point of impact. A summary of pertinent data from the electronic instrumentation, high-speed film, and field measurements is given in figure 93.

The W-beam rail element was deformed between posts 3 and 9. The foundation tube for post 1 (end post) was displaced 44 mm (1.75 in) toward the point of impact. Posts 4, 5, and 6 fractured at ground level and were thrown behind the installation. Lateral deflection occurred at posts 2 through 9. The post bolt tore through the W-beam rail element at post 7 and the post and blockout were twisted. Maximum dynamic deflection of the W-beam rail element during the test was 1.2 m (4.0 ft) near post 7. Maximum permanent deformation of the W-beam rail element was 0.7 m (2.3 ft), also at post 7. The vehicle was in contact with the terminal section for a length of 7.5 m (24.8 ft).

The vehicle's right side A-arm, tie rods, spindle, shocks, and frame were damaged. The right front tire was cut, the right rear tire was partially aired out, and both rims were bent. There was buckling in the floor pan area and in the frame between the cab and bed. The front bumper, grill, hood, left and right front quarter panels, right door, right rear quarter panel, and rear bumper were also damaged. Maximum exterior crush at the right front corner of the vehicle was 430 mm (16.9 in) at bumper height. Maximum crush in the right side floor pan area was 51 mm (2.0 in). Damage to the vehicle because of rollover included the roof, windshield, and left side of the vehicle. Maximum occupant compartment deformation was 171 mm (6.7 in) on the right side of the roof.

In the length-of-need strength test (test no. 471470-32), the MELT successfully contained and redirected the vehicle. However, the right front wheel assembly of the vehicle snagged on post 7 (the first standard line post), causing the vehicle to yaw and pitch significantly and subsequently to roll 360 degrees. The test installation sustained moderate damage. The vehicle sustained moderate damage from impact with the terminal. The subsequent rollover resulted in additional damage to the vehicle with some intrusion into the roof area of the occupant compartment. The exit trajectory of the vehicle was judged to

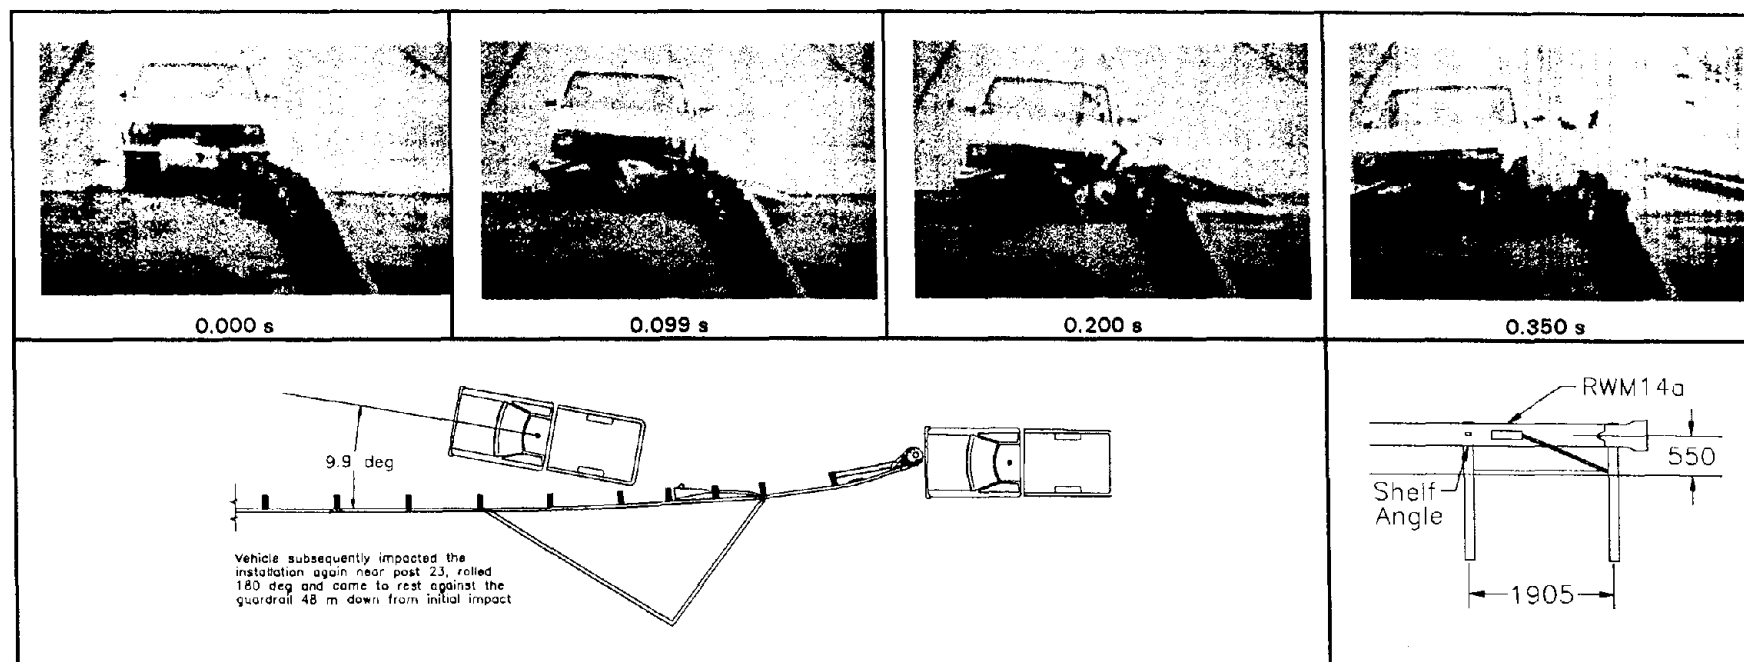
After the vehicle exited the installation, the damage sustained by the left corner of the front bumper restricted the rotation of the left front tire and caused the front wheels to turn sharply to the left. Consequently, the vehicle turned abruptly to the left toward the backside of the guardrail installation and began to yaw rapidly in a counterclockwise direction. The vehicle was skidding sideways when it subsequently impacted the backside of the guardrail installation near post 23 or approximately 40 m (131 ft) downstream from the nose of the terminal. Upon impact with the guardrail installation, the vehicle began to roll to its right and subsequently rolled 180 degrees, impacting posts 23 and 24 in the process. The vehicle came to rest on its roof on top of the guardrail approximately 48 m (158 ft) downstream of the initial point of impact. Note that the brakes were not applied until after the secondary impact. A summary of pertinent data from the electronic instrumentation, high-speed film, and field measurements is given in figure 94.

The W-beam rail element was deformed from posts 1 through 8 and extended 3.2 m (10.5 ft) toward traffic. The foundation tube for post 2 was displaced 32 mm (1.25 in). Posts 1 through 4 fractured at ground level and came to rest just behind the installation (maximum distance of 1.2 m (4.0 ft)). There were marks on the rear of posts 5 and 6 where the end terminal was pushed into them as the vehicle passed behind the installation. The test installation sustained minor damage from the secondary impact. Post 23 was fractured near ground level and posts 24 and 25 were displaced. The W-beam rail element was deformed in the vicinity of these posts. Note that the W-beam rail was lying on the ground since post 24 was the first standard strength post for the downstream MELT and the W-beam rail element was not connected to posts 25 through 29.

The vehicle sustained moderate damage from the initial impact prior to the rollover from the secondary impact. The frame, steering box, and pitman arm were damaged. The front bumper was pushed rearward into the tires and wheel assembly. There was slight buckling in the floor pan area on the left side. The front bumper, grill, hood, left and right front quarter panels, left door, left rear quarter panel, and rear bumper also were damaged. Maximum exterior crush at the center front of the vehicle was 440 mm (17.3 in) at bumper height. Maximum crush in the left side floor pan area was 9 mm (0.4 in). All other damage to the vehicle occurred after the vehicle rolled. Damage to the vehicle because of rollover included the roof, windshield, and right side of the vehicle. Maximum occupant compartment deformation was 400 mm (15.7 in) downward from the roof on the driver's side.

In the end-on test (test no. 471470-34), the MELT gated as designed, allowing the vehicle to penetrate behind the guardrail installation in a controlled manner. There were no detached elements or debris from the test article that penetrated or showed the potential for penetrating the occupant compartment, or presented undue hazard to adjacent traffic. Posts 1 through 4 fractured at ground level, but remained near the installation. There was minimal deformation or intrusion into the occupant compartment. The left side of the floor pan area was deformed 9 mm (0.4 in), which was not considered of any serious consequence. The vehicle remained upright and stable during the collision and upon loss of contact for the initial impact. However, after the vehicle penetrated behind the test installation and exited from the initial impact with the terminal, it turned back toward the back side of the test installation because of interactions between the damaged front bumper and the left front wheel assembly. The vehicle subsequently impacted the backside of the test installation in a secondary collision, resulting in the vehicle rolling 180 degrees to its right and coming to rest on its roof. The rollover resulted in extensive damage to the vehicle with significant intrusion into the roof area of the occupant compartment.

The performance of the MELT for the initial impact was judged to be satisfactory, but the post-impact trajectory of the vehicle was not considered acceptable because of rollover after the secondary impact. It could be argued that the interactions between the damaged front bumper and the left front wheel assembly might be a rare occurrence. Another argument is that the terrain behind the guardrail in a typical field installation is usually not flat and level as with the test installation, and there would be a slope or embankment behind the guardrail that would have reduced the probability of the vehicle turning back toward and impacting the backside of the installation. On the other hand, the front bumper will likely be damaged in any end-on impact with the terminal, and the interaction between the damaged bumper and the front wheel assemblies is highly unpredictable. Also, there are installations where the terrain behind the guardrail is relatively level and flat, such as those shielding bridge piers and other fixed hazards.

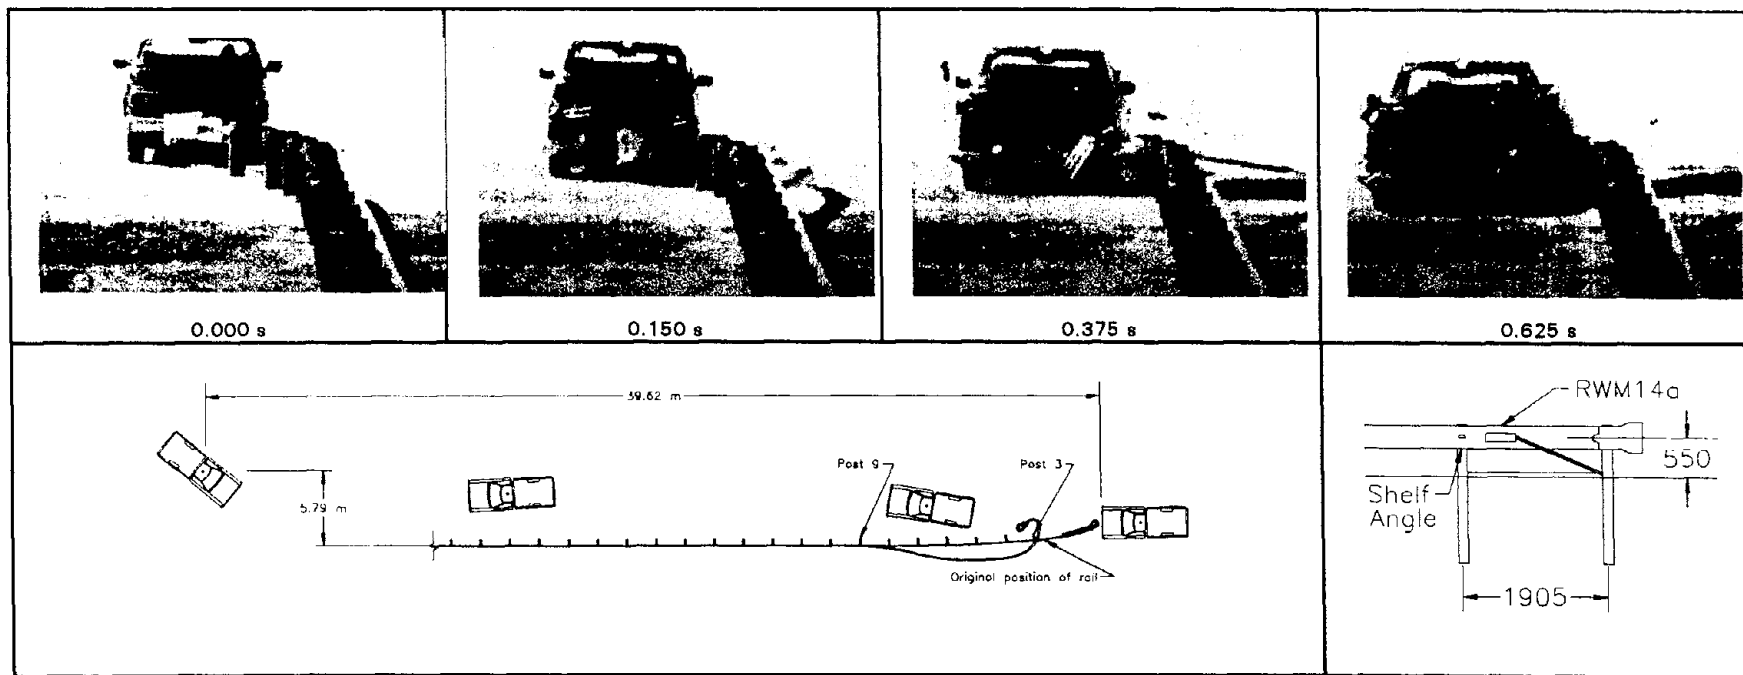
Figure 101. Summary of results for test 471470-35.

The nose then contacted post 3. The W-beam rail element began to buckle at post 4, and the nose contacted the post. Maximum dynamic deflection of the rail of 2.03 m (6.7 ft) toward the traffic side occurred at the buckle formed at post 4. The vehicle lost contact with the installation traveling at a speed of 87.7 km/h (54.5 mi/h) and at an exit angle of 4.1 degrees behind the installation. After exiting from the test installation, the vehicle continued forward and subsequently impacted a concrete barrier protecting a camera stand at the downstream end of the test installation. The vehicle came to rest upright approximately 85 m (280 ft) downstream of the initial point of impact and 6 m (19 ft) behind the installation. Note that the brakes were not applied until after the secondary impact with the concrete barrier. A summary of pertinent data from the electronic instrumentation, high-speed film, and field measurements is given in figure 101.

The W-beam rail element was deformed between posts 1 through 9. The foundation tubes were displaced 35 mm (1.4 in) at post 1 and 50 mm (2.0 in) at post 2. Posts 1 and 2 fractured at ground level and came to rest just behind the installation. There were marks on the rear of posts 3 and 4 where the nose of the terminal was pushed into them as the vehicle passed behind the installation. Maximum permanent deformation of the rail was 1.66 m (5.4 ft) toward the traffic side at post 4.

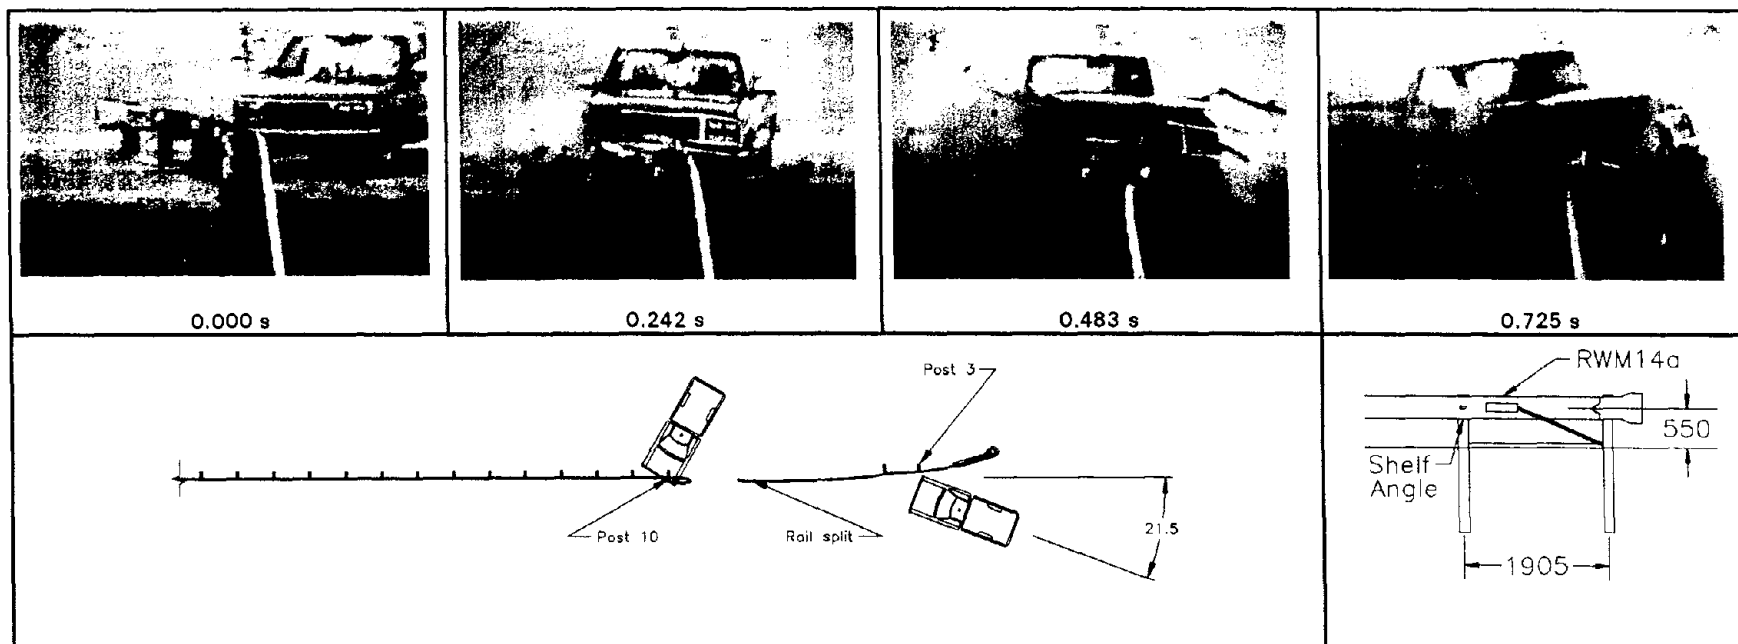
The vehicle impacted the terminal 152 mm (6.0 in) upstream of post 3. Upon impact, post 3 began to move laterally and the W-beam rail element began to flex and move away from post 6. The right front tire made contact with post 4 and the W-beam rail element was moving away from post 7. As the vehicle continued forward, the W-beam rail element began moving back toward posts 6 and 7. The vehicle contacted post 5, fracturing the post. Post 6 fractured and the front of the vehicle made contact with post 6. The right front tire contacted post 6, and then post 7, causing the post to fracture just below ground level. The lower edge of the W-beam rail element began to tear at post 7, and the front of the vehicle made contact with post 8 at an angle of 2.2 degrees. The W-beam rail element then ruptured completely. The vehicle made contact with post 9 and was traveling parallel with the length-of-need section at a speed of 53.6 km/h (33.3 mi/h). The vehicle made contact with post 10, rotated counterclockwise, and came to rest with the right front wheel near post 10. A summary of pertinent data from the electronic instrumentation, high-speed film, and field measurements is given in figure 102.

In summary, the modified MELT was judged to have performed satisfactorily in the end-on test, but failed in the redirection test in accordance with evaluation criteria set forth in NCHRP Report 350, as shown in tables 43 and 44, respectively.
