**Federal Railroad
Administration**

A Study of Environmental and Track Factors that Contribute to Abrasion Damage of Concrete Ties

9. SPONSORING/MONITORING AGENCY NAME(S) AND ADDRESS(ES) U.S. Department of Transportation Federal Railroad Administration Office of Railroad Policy and Development Office of Research, Development and Technology Washington, DC 20590			10. SPONSORING/MONITORING AGENCY REPORT NUMBER DOT/FRA/ORD-19/38

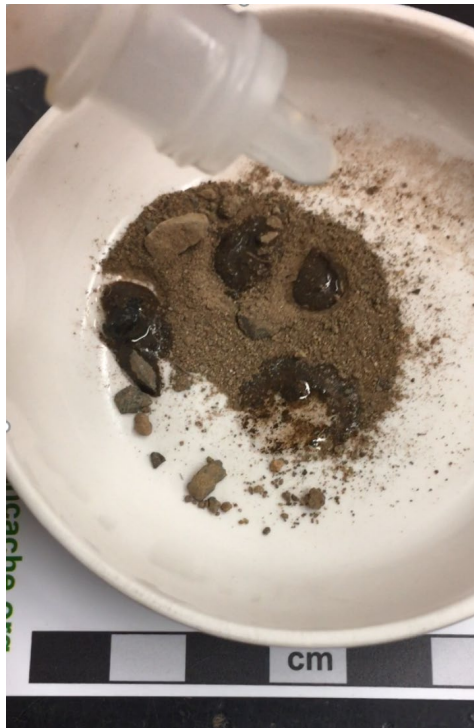
Figure 2-2: Ballast fines sample that was not carbonaceous and did not react with the addition of hydrochloric acid

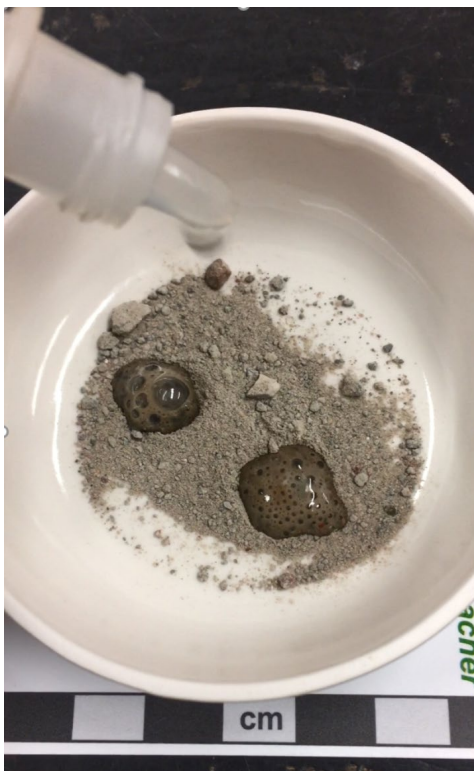
Figure 2-3: Ballast fines sample that was carbonaceous and reacted with the addition of hydrochloric acid

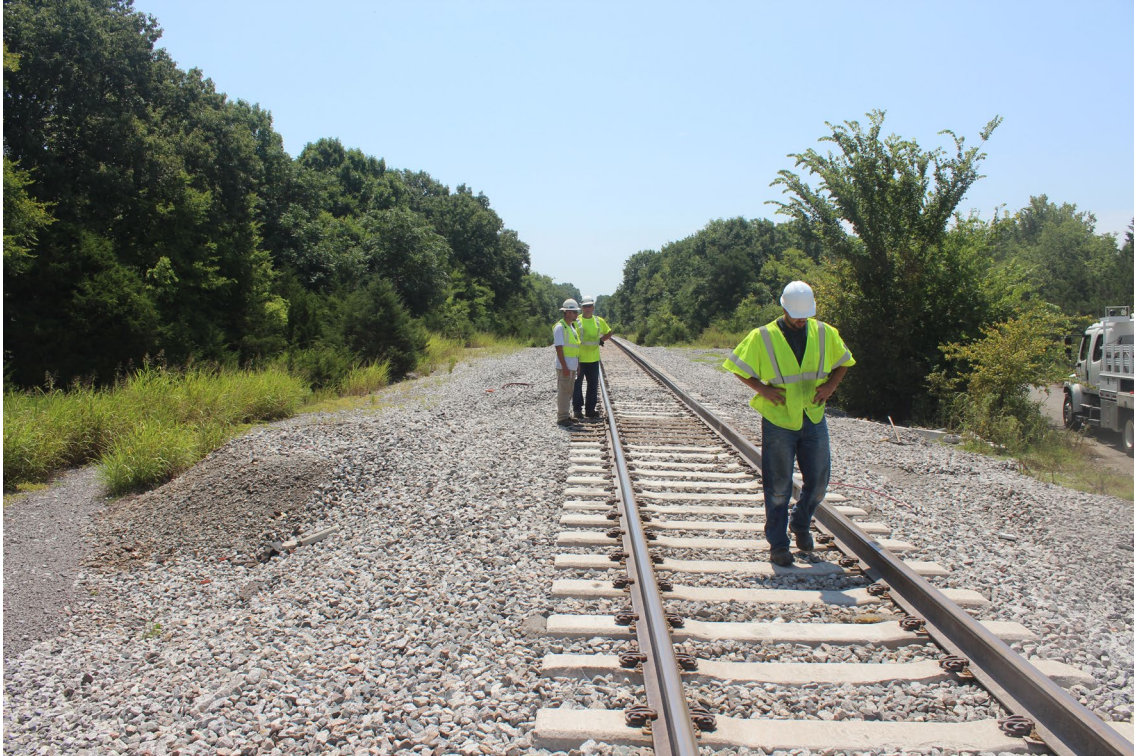
The presence of water or poor drainage was an issue at sites with significant abrasion damage. Poor drainage was seen in 95 percent of the sites that had tie abrasion damage greater than 0.5 inches. The cause of the poor drainage was in many cases inadequate grading. [Figure 3-1](#) shows an example of a location with drainage issues at a signal (Signal #2, [Appendix B, Section B.3](#)). In other cases, poor drainage could have been caused by ballast breakdown. Sites with center-binding tie cracking but without significant abrasion were in locations with excellent drainage and often in arid climates. In a tunnel location, water was seen in the ditches on both sides of the road, as shown in [Figure 3-2](#). After the water in the ditch traveled a few dozen yards from the tunnel entrance, it turned and went through the track structure to empty out into the ditch on the other side of the track. Concrete ties near the location where the water went under the track were recently replaced in part because of abrasion damage.

Figure 3-1: Location with concrete tie abrasion damage had grading issues at signal controls

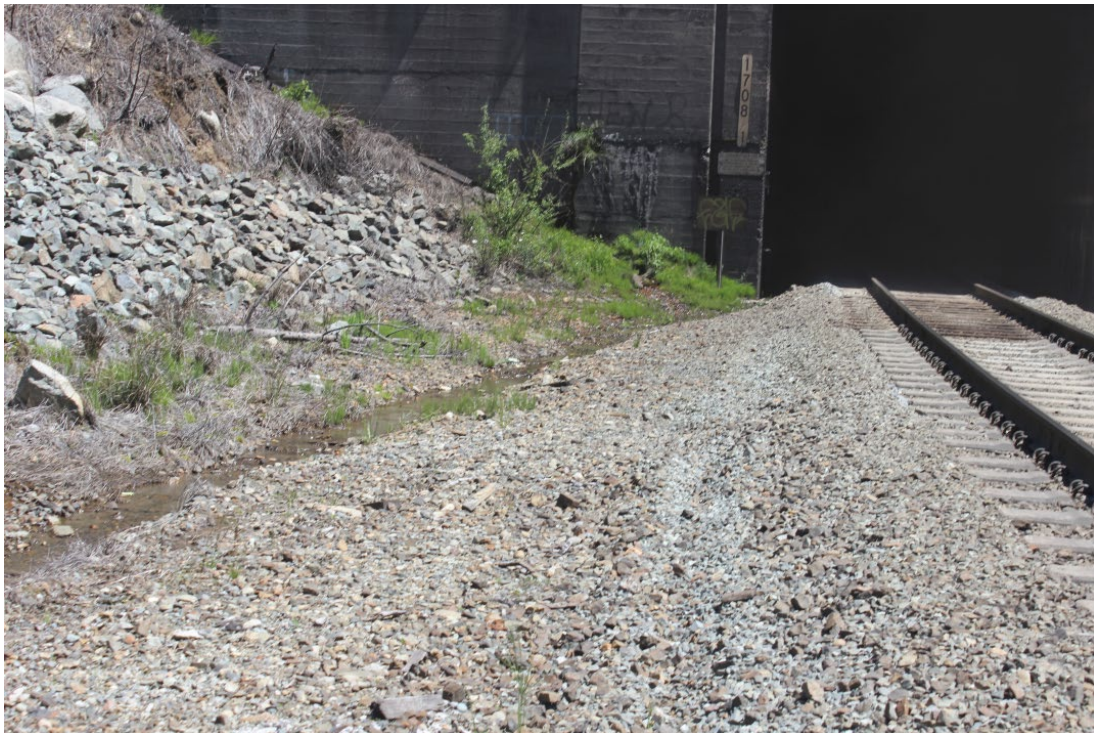
Figure 3-2: Water emanating from tunnel portal

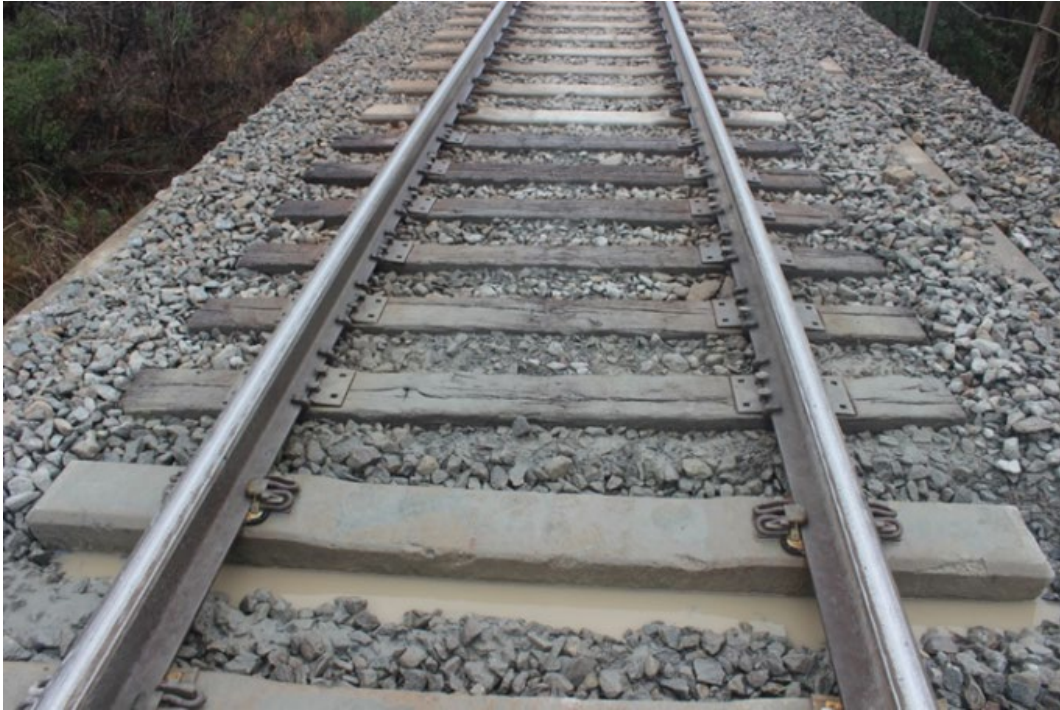
Bridge decks were especially vulnerable to drainage issues. Bridges have built-in weep holes, drainage pipes, and other drainage features, however these can quickly become clogged by ground-up ballast, coal, dust, or concrete fines. [Figure 3-3](#) shows Bridge #3 with standing water in track (Bridge #3, [Appendix A, Section A.3](#)). In this case, concrete ties with significant abrasion were removed from track and replaced with wooden ties. [Figure 3-4](#) shows one of those ties after removal from track. Since the ballast was not cleaned and replaced, the concrete fines remained in track to block drainage. All three bridges with abrasion damage had drainage issues.

Figure 3-3: Bridge #3 section repaired with wooden ties

The track visual inspection showed that six ties were removed from track and replaced with wooden ties, (Figure 3-3). The concrete ties that were removed from track were found on the side of the track, as shown in Figure 3-4 and Figure A-14. These were rounded on the bottom and had significant abrasion loss, exposing prestressing steel. The section of track where the concrete ties were removed had drainage problems. Figure A-15 shows a picture of the clogging seen on the bridge ends. Figure A-16 shows a diagram of the bridge drainage system in the bridge. Ties in this track section showed significant pumping, a likely contributing factor to the abrasion damage. Moderate center binding cracking was seen on some the ties as shown in Figure A-17. Figure A-18 shows ties at the approach with center-binding cracking.

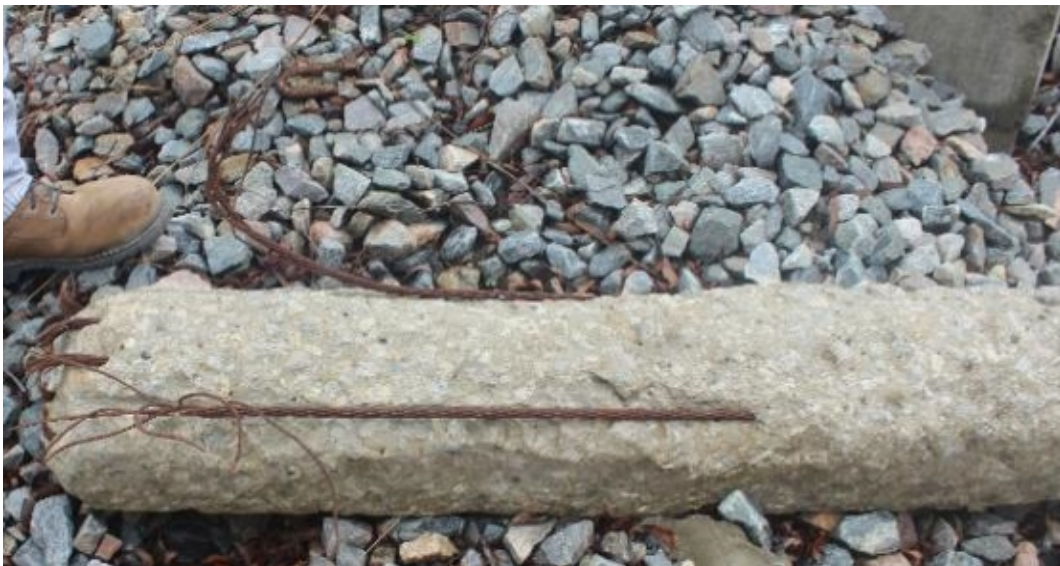
Figure 3-4: Tie from Bridge #3 after removal from track

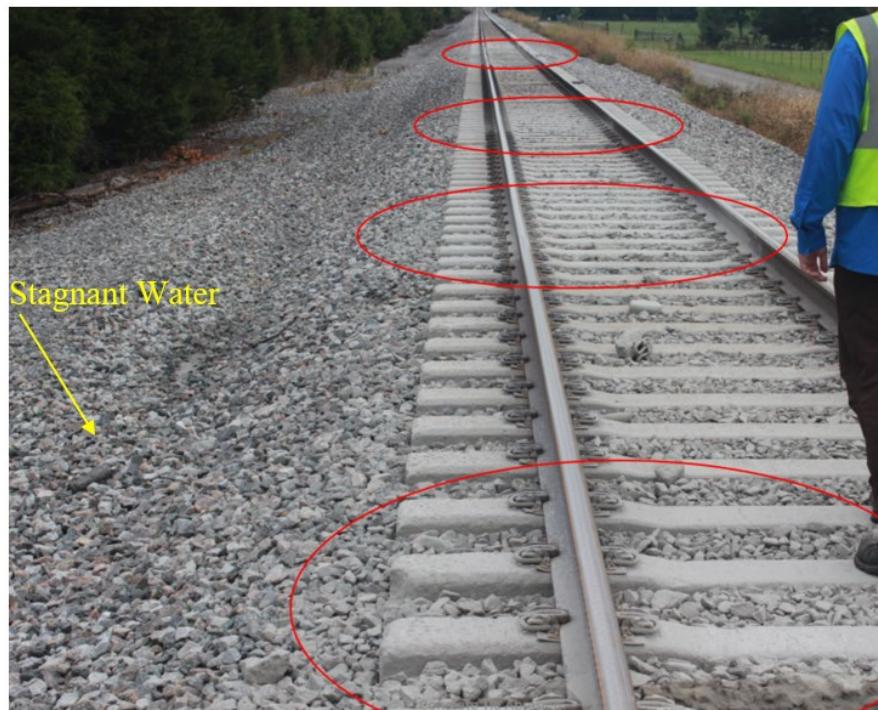
Figure 3-7: Adjacent mud spots seen near Crossing #3 ([Appendix C, Section C.3](#))

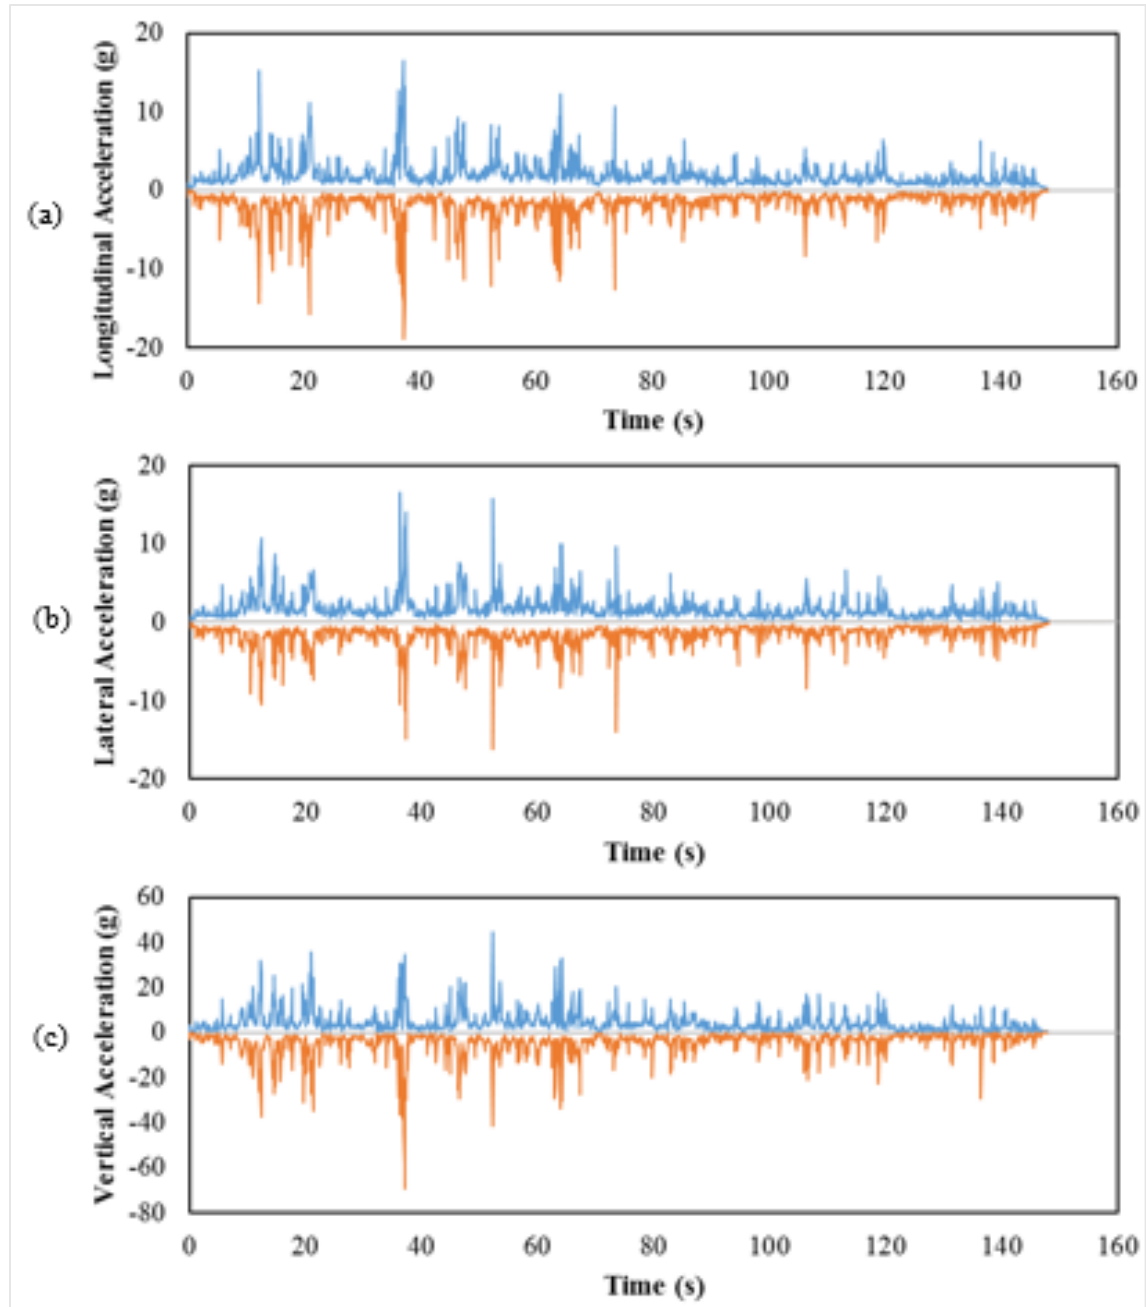
Where permitted, a three-dimensional accelerometer was fixed to the top surface of the concrete tie to measure the tie movement during a train pass. Tie movement is necessary to cause frictional rubbing and grinding according to classical abrasion mechanisms (ACI 201.2, 2008). Significant tie acceleration under train loading was measured in the vertical, rail, and tie directions in locations with abrasion damage. [Figure 3-8](#) shows the acceleration measured for a tie located at signal #2, and described in [Appendix B, Section B.2](#), in the longitudinal, lateral, and vertical directions. Over 10 g of acceleration was measured in the lateral direction, and over 40 g in the vertical direction during a train pass. In this case, the pumping created a gap under the tie, giving low amounts of lateral tie restraint. This resulted in some track misalignment after a single train pass, as seen in the before and after pictures in [Figure 3-9](#) and [Figure 3-10](#). Analysis of high-definition video of the track taken during the train pass confirms the vertical acceleration measurements recorded, as shown in [Figure 3-11](#). [Figure 3-12](#) and [Figure 3-13](#) show screen shots of the video used to obtain [Figure 3-11](#). Maintenance crews replaced ties from this location the next day. Tie bottom wear measurements after removal are shown in [Figure 3-14](#).

Figure 3-8: Acceleration measured with accelerometer in three dimensions: (a) vertical acceleration, (b) lateral acceleration (direction of tie), and (c) longitudinal acceleration (direction of rail).

The longitudinal and lateral forces that ties can experience, [Figure 3-8](#), can create large contact stresses between the side of the tie and ballast. In the case of the ties shown in [Figure 3-21](#) and [Figure 3-22](#), these high stresses cause significant mass loss. Other locations with fines and insufficient ballast underneath ties showed mud pumping, but only minor amounts of abrasion damage. Track with fouled ballast is known to have varying stiffness depending on the track moisture content. During dry conditions, the fines greatly increase the track stiffness, while during wet conditions they greatly decrease the track stiffness.

Researchers measured tie accelerations in three directions in fouled ballast area. Acceleration readings were taken at 20 kHz. Figure B-19 shows the attached sensor to the tie for acceleration measurement. [Figure 3-8](#) shows the acceleration in three dimensions. The lateral acceleration was more than 18 g, resulting in lateral tie movement. Analysis of the recorded video showed that the tie moved vertically 1.2 in., as shown in [Figure 3-11](#).

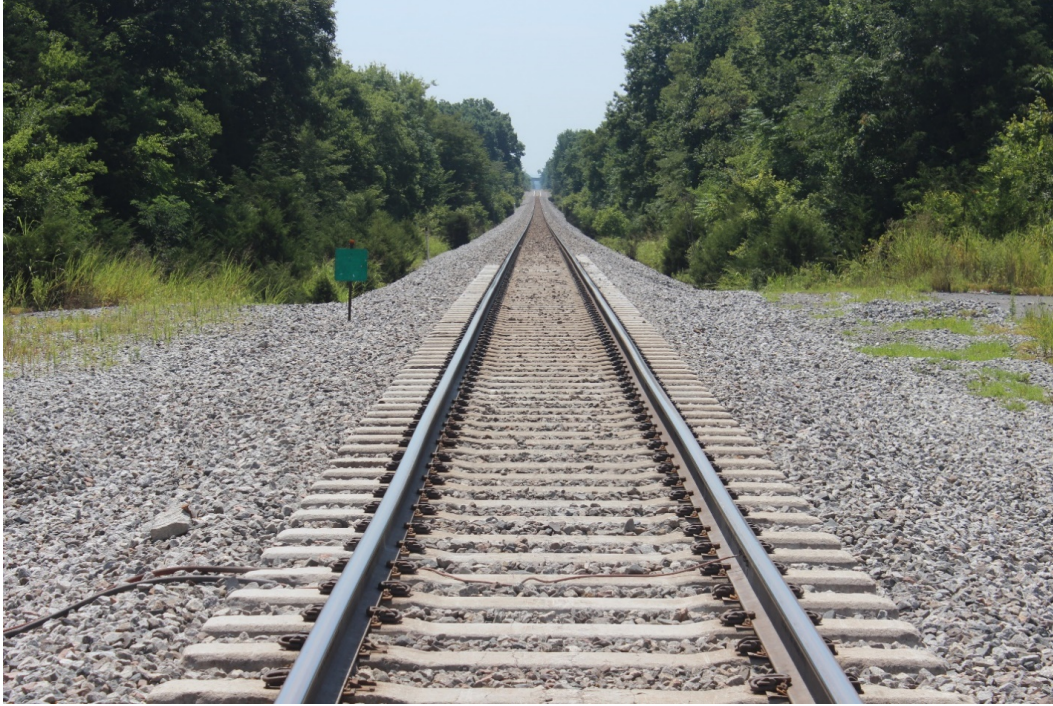
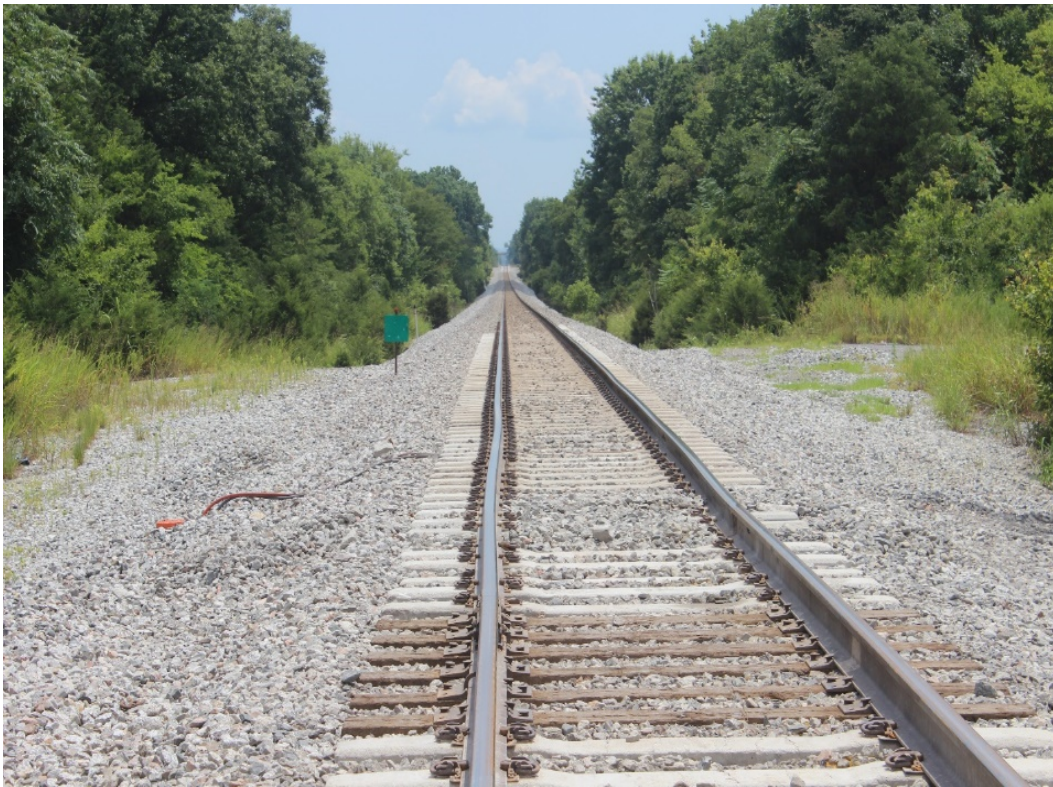
Figure 3-9: Picture of track before the train pass

Figure 3-10: Picture of track after the train pass

Visually, the track displayed alignment and vertical profile deviations. A train passed over the site during the team's visit. Pictures taken before and after the train pass show the effect of this single train pass on the track, see [Figure 3-9](#) and [Figure 3-10](#). The track displaced laterally by approximately 1 inch.

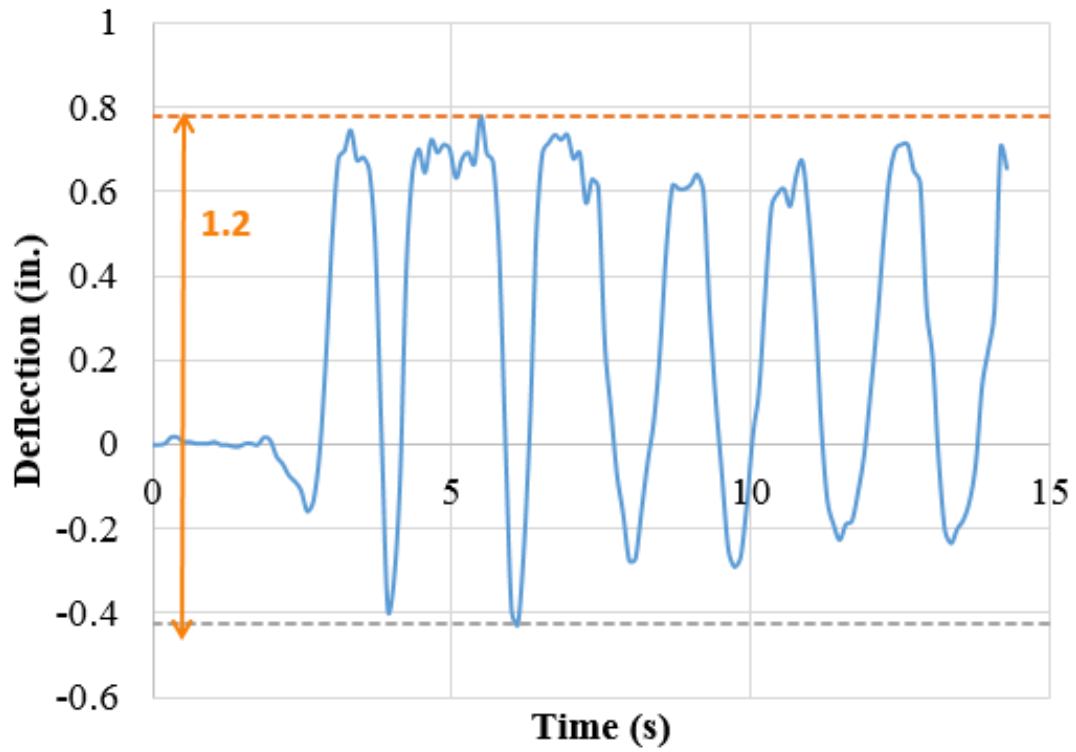
Figure 3-11: Tie deflection measured from video during train pass

Investigators measured large amounts of tie deflection at Signal #2 as shown in [Figure 3-11](#), and for Crossing #5 and Tangent Track #6. A large rail surface profile variation was seen at a mud spot location with abraded ties, [Figure 3-17](#). High levels of rail and tie deflections during loading can fatigue the rail and contribute to rail breaks. Rail welds were commonly found at locations with abrasion damage.

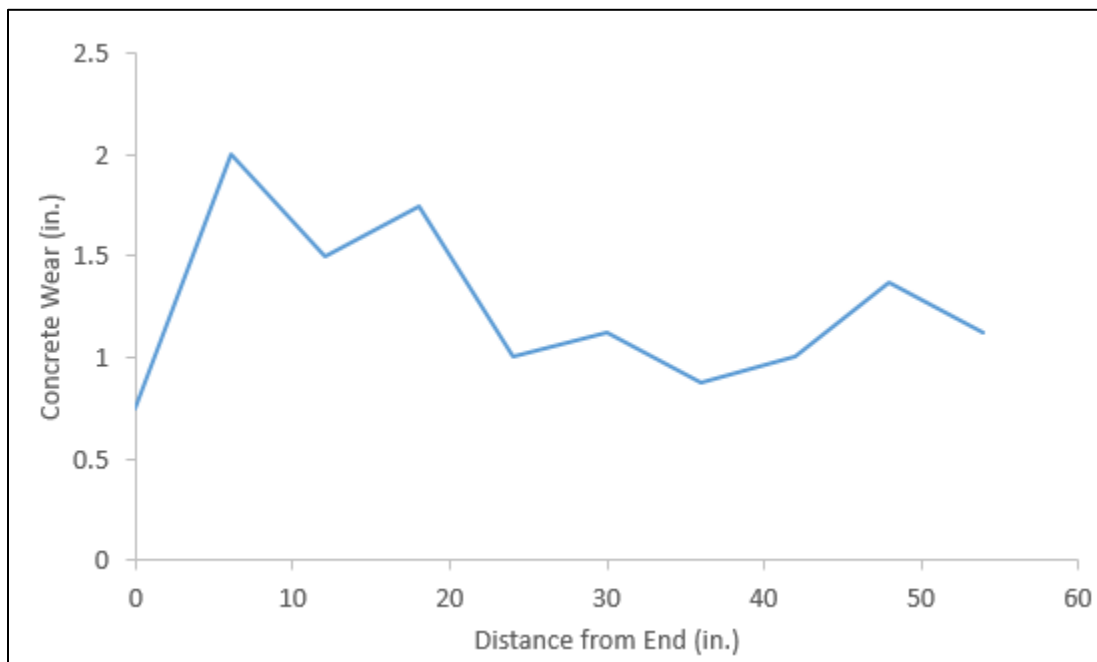
Figure 3-14: Concrete wear of tie removed from track

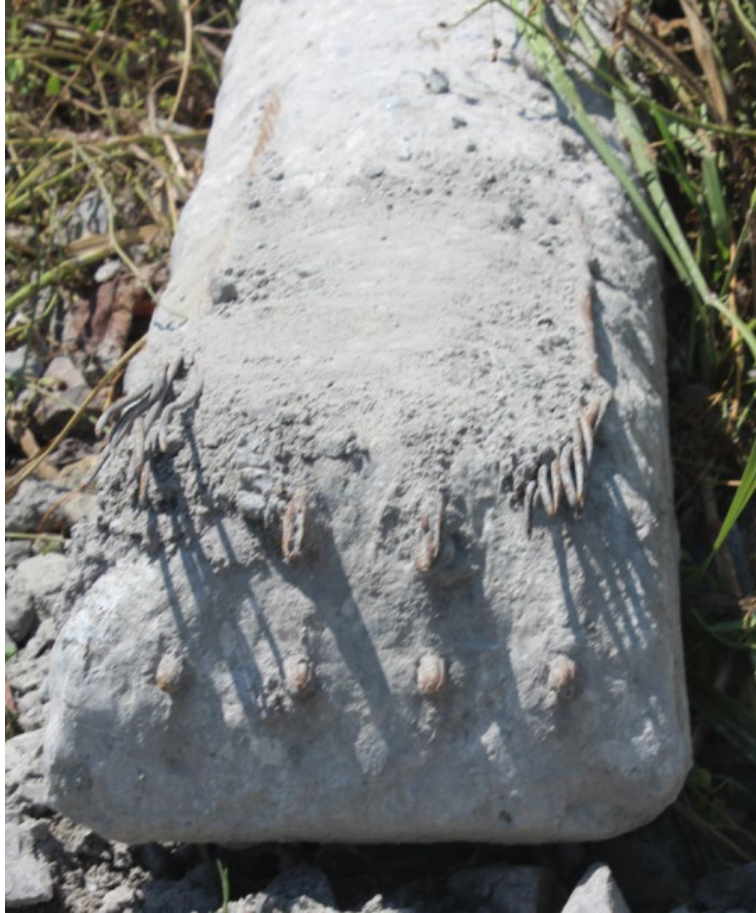
Siliceous gravel and limestone aggregates are known to be harder than limestone aggregates. Limestone and dolomitic limestones typically have a Mohs hardness under 4. Gravel and granite aggregates have a Mohs hardness above 6. Softer aggregates are known to abrade at faster rates than harder aggregates. Aggregate hardness was measured with Schmidt hammer readings. The average Schmidt hammer readings of ties made with limestone aggregates was 4.8 lower than that of the ties made with siliceous gravel or granite. Ties made with limestone aggregates showed more even wear across the tie bottom and sides, with tie bottom corner rounding more pronounced as shown in [Figure 3-15](#) and [Figure 3-16](#). Compared to siliceous gravel, the hardness of limestone aggregates is more similar to that of cement paste, giving a more even wear. Abrasion on concrete ties with siliceous aggregates showed to be much more varied, with the cement paste wearing at a much faster rate than the aggregates. These ties have a jagged wear pattern. The more even wear seen on ties with limestone aggregates is indicative of faster abrasion rate.

Figure 3-15: Bottom of a tie made with limestone coarse aggregates found with abrasion damage on the side of the road

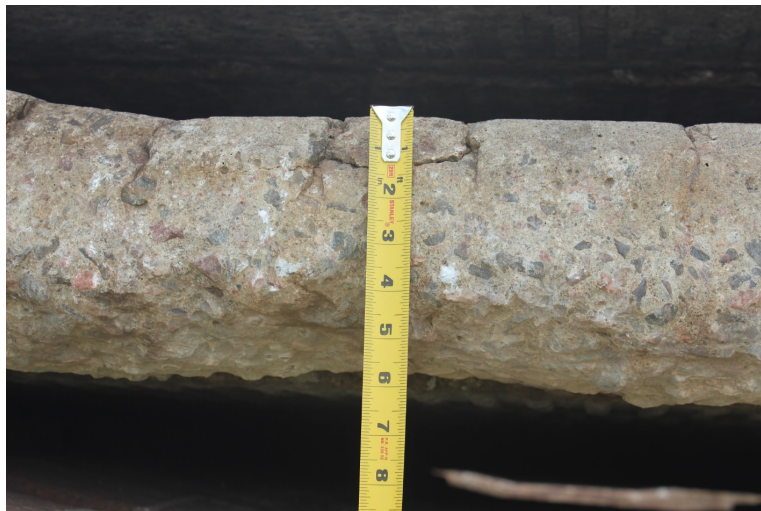
Figure 3-16: Tie made from hard siliceous aggregates in boneyard with significant abrasion damage

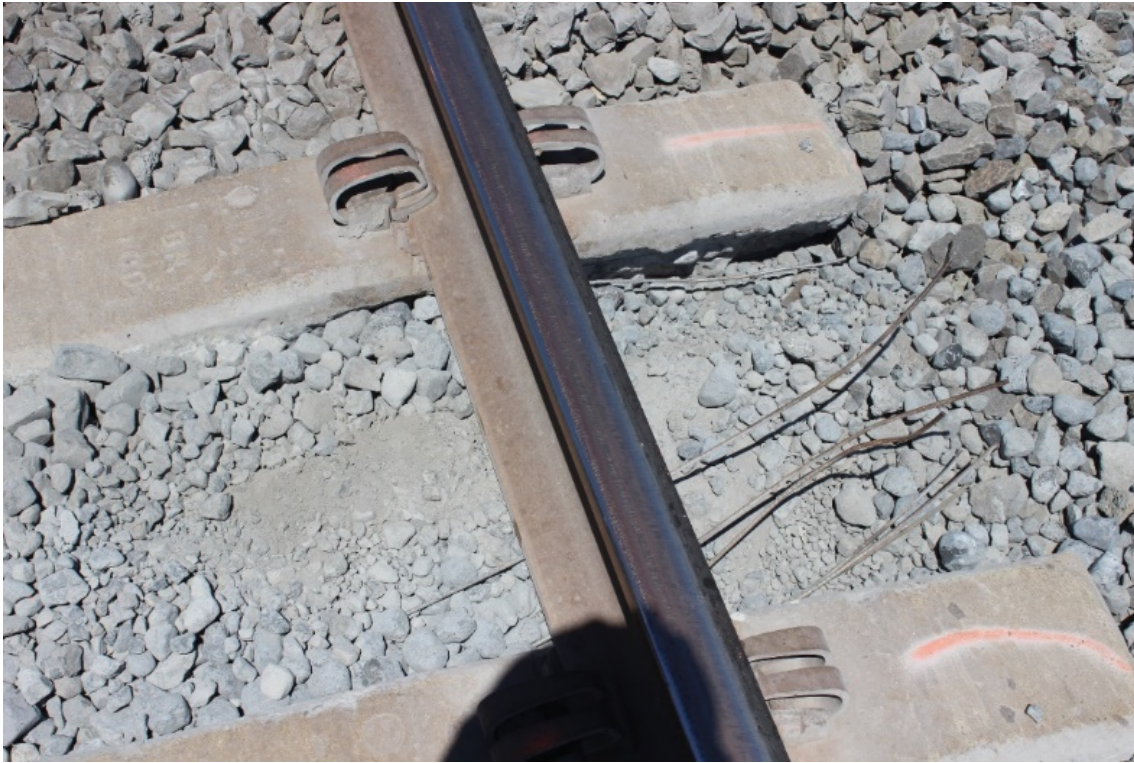
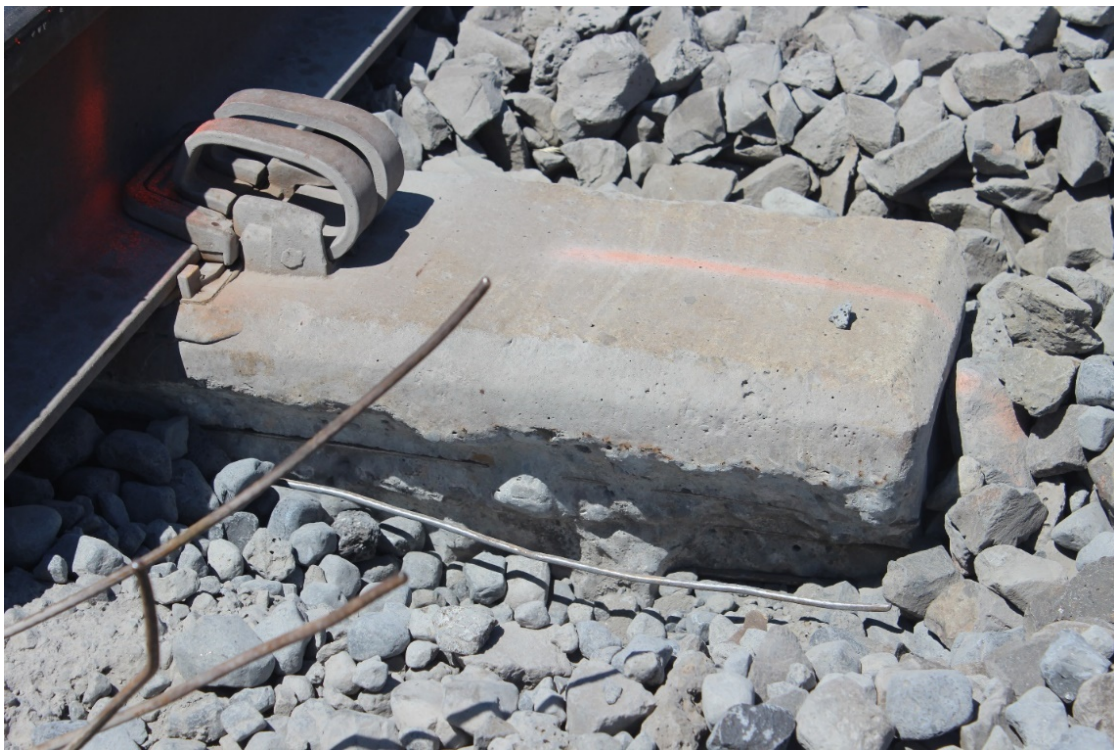
Another location that was especially illustrative of the effects of increased track stiffness was Curve #3 ([Appendix D, Section D.3](#)). Two ties were found with severe abrasion on the sides facing towards each other. Part of an old tie was left between the two ties with severe side abrasion damage, as shown in [Figure 3-21](#). This situation creates a very stiff track condition between the ties, leading to fouled ballast and retained water.

Figure 3-21: Abrasion found on sides of ties with an old tie in between, Curve #3

Figure 3-22: Close-up view of tie with side abrasion, Curve #3

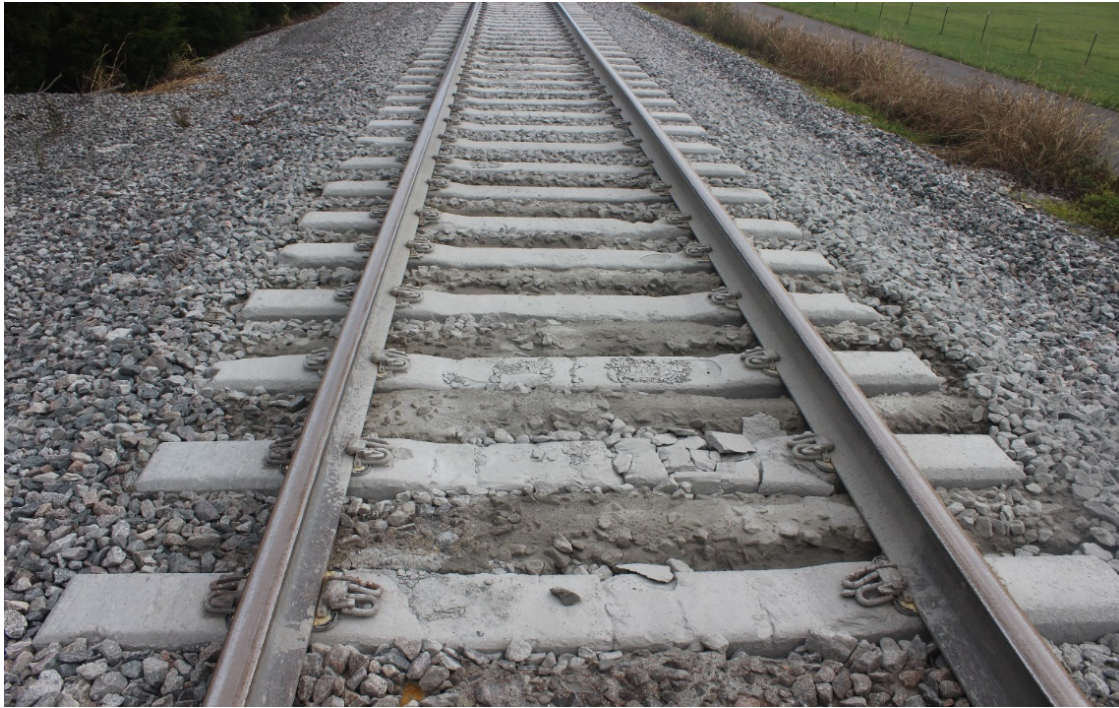
Center-binding cracks were regularly found at track locations with mud pumping and abrasion damage, as shown in [Figure 3-23](#) for Crossing #3 ([Appendix C, Section C.3](#)). The presence of center-binding cracks did not directly correlate with abrasion damage. However, sections of track with center-binding cracking without fouling or drainage issues, but with low ballast support on the shoulders did show problems with abrasion damage. [Figure 3-24](#) shows Tangent Track #1 ([Appendix E, Section E.1](#)) as an example of track with severe center-binding cracks, sometimes with shattered tie tops but without significant abrasion damage. In this case, the center-binding cracking was a recent phenomenon. Inadequate tamping after shoulder cleaning that had occurred the year prior to the research team visits appeared to reduce support at the rail-seat area. This led to center-bound ties and cracking within a month, without any evidence of abrasion damage.

Figure 3-23: Shattered ties at mud pumping location

2 inches. Figure C-12 shows a satellite view of the site investigated. [Figure 3-23](#) shows a view of a portion of the track visited.

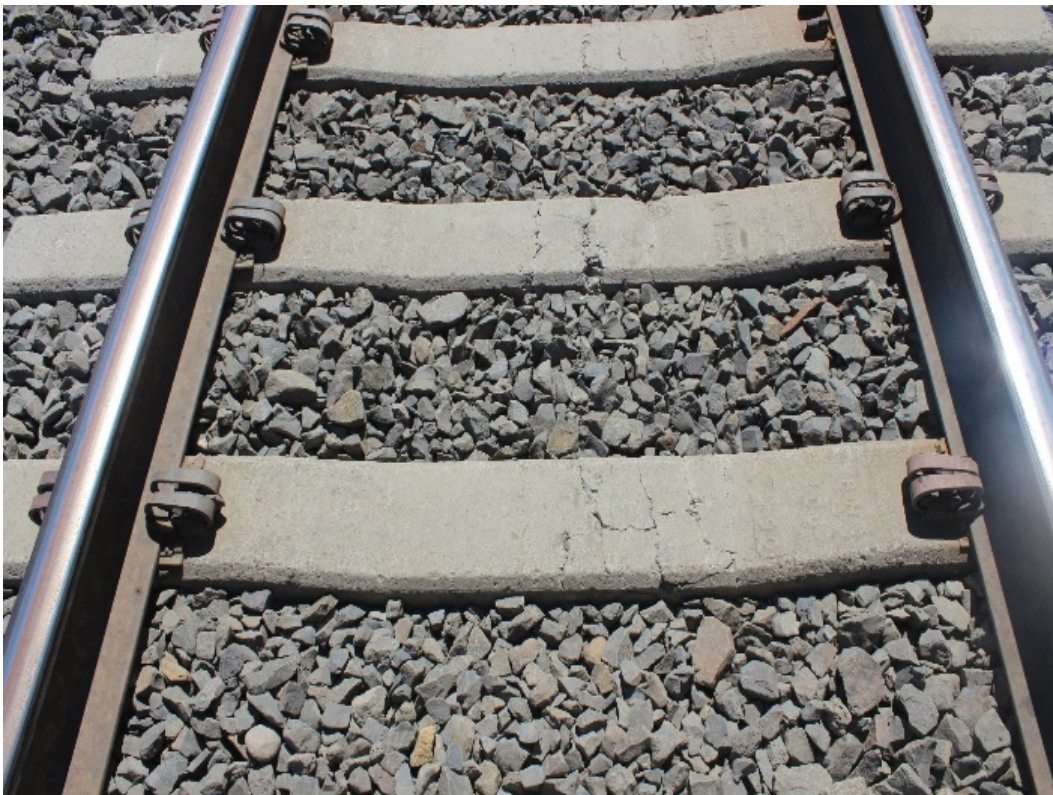
Figure 3-24: Ties with center-binding cracks in an area with good drainage, maintenance, and support conditions and very low measured bottom wear

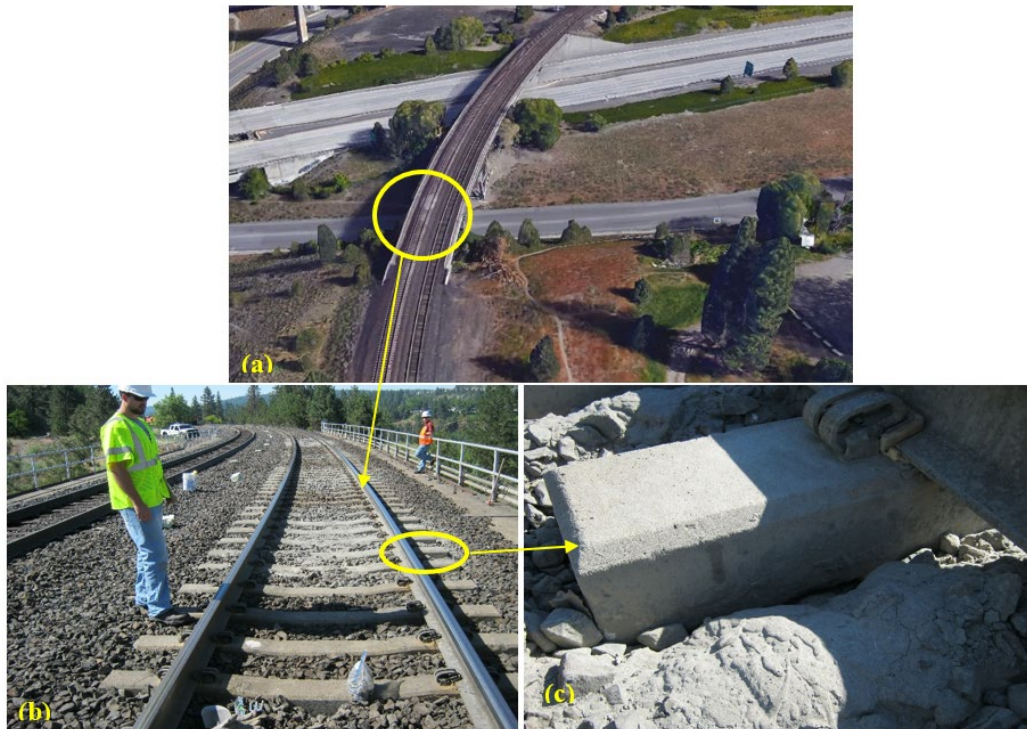
Figure A-1: Gray mud in track is visible in a) satellite image from Google Earth, b) track-level view, and c) up-close view of a concrete tie, Bridge #1

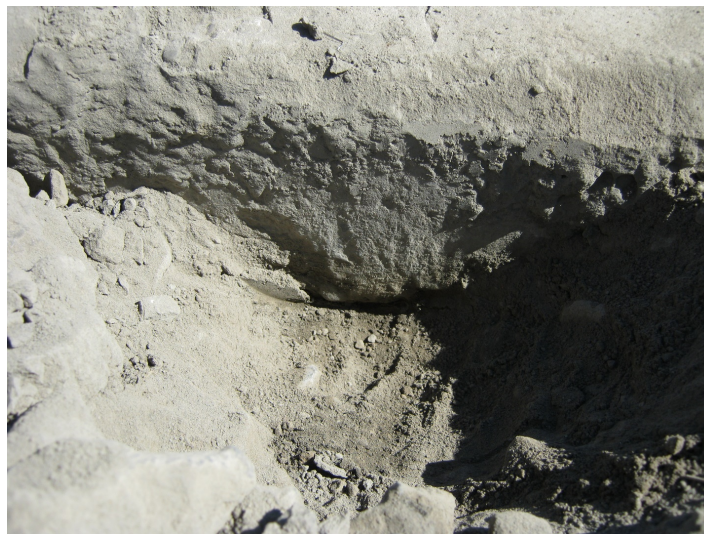
The road master reported that the railroad began replacing the ballast on the bridge 10 years prior, but was forced to stop half-way through the project by local authorities. Half of the bridge showed large amounts of gray mud and pumping, while the other half that had been undercut did not have gray mud at the surface. Figure A-3 shows fines present at the bottom of ties. Gray mud spots were seen in periodic intervals on the bridge, with heavier fouling seen in ballast sections directly over the bridge piers. Bridge piers prevent vertical movement of the bridge deck and create localized increases in track stiffness. The higher local track stiffness likely caused high ballast stresses, particle breakdown, and concrete wear. Center-binding cracking was seen at fouled ballast locations, as shown in Figure A-4.

Figure A-3: Fine particles available due to tie abrasion, Bridge #1

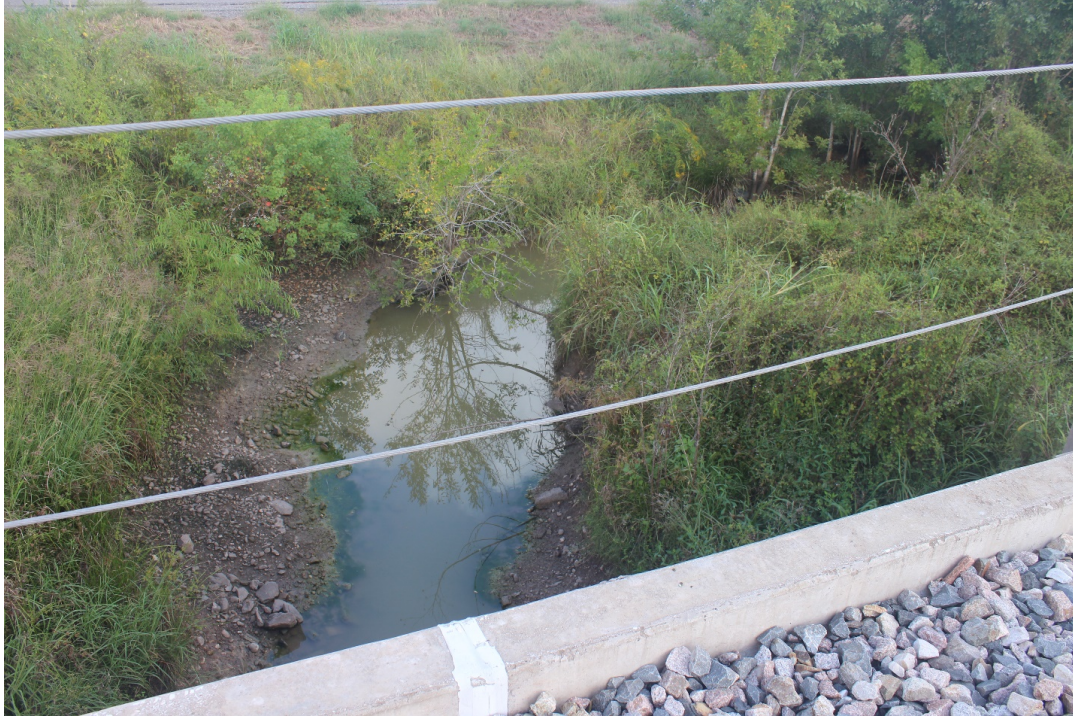
Figure A-5: Stagnant water under Bridge #2

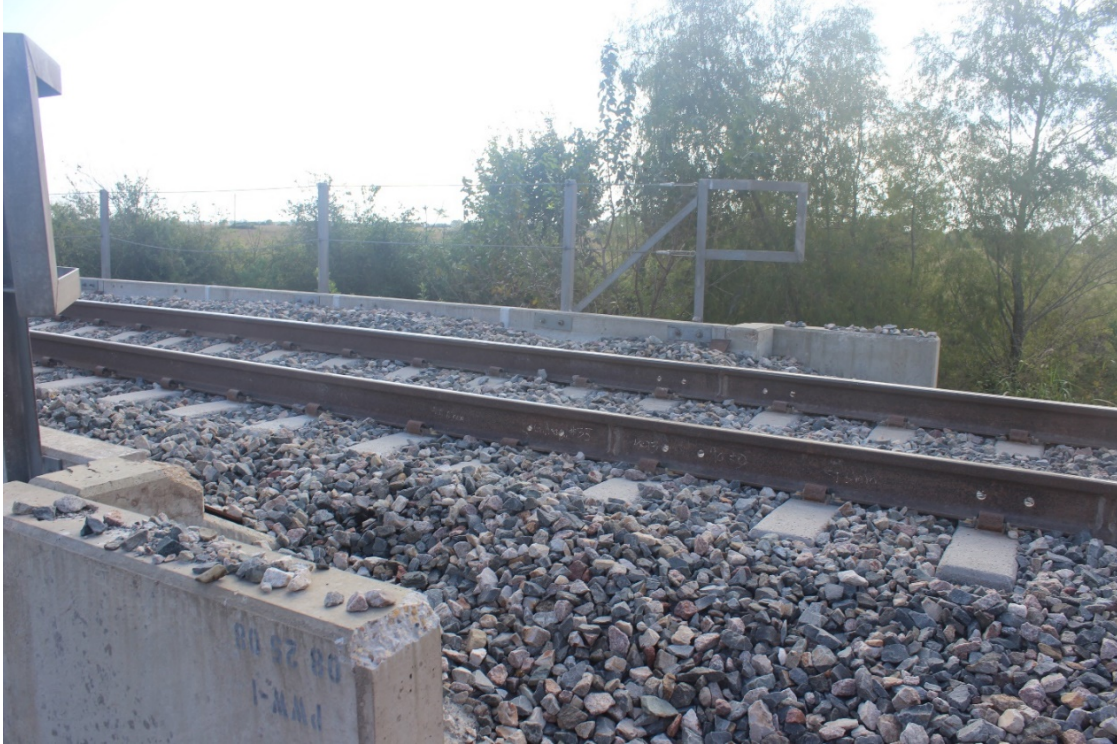
A section of the ballast near the bridge abutment was cribbed out to remove fouled ballast about 8 months before the research team visited the site (Figure A-8). A water ditch, Figure A-9, was created at the same time the ballast was replaced to improve drainage. Drainage holes at the location of the ballast fouling were plugged, whereas at the other locations on the bridge they were not clogged. Eight ties at the location where the ballast maintenance was performed showed moderate-to-severe center-binding cracking, as shown in Figure A-10.

Figure A-8: Bridge #2 abutment where ballast was replaced 8 months prior to the site visit by the research team

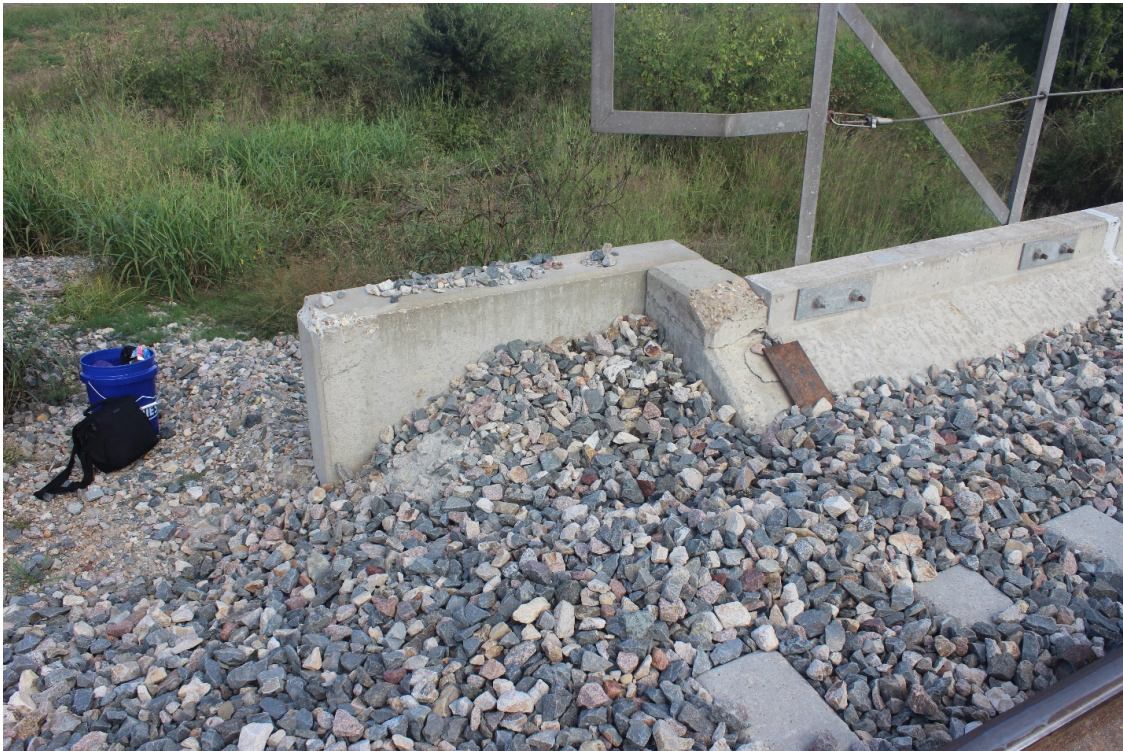
Figure A-9: Ditch in ballast to improve drainage on Bridge #2

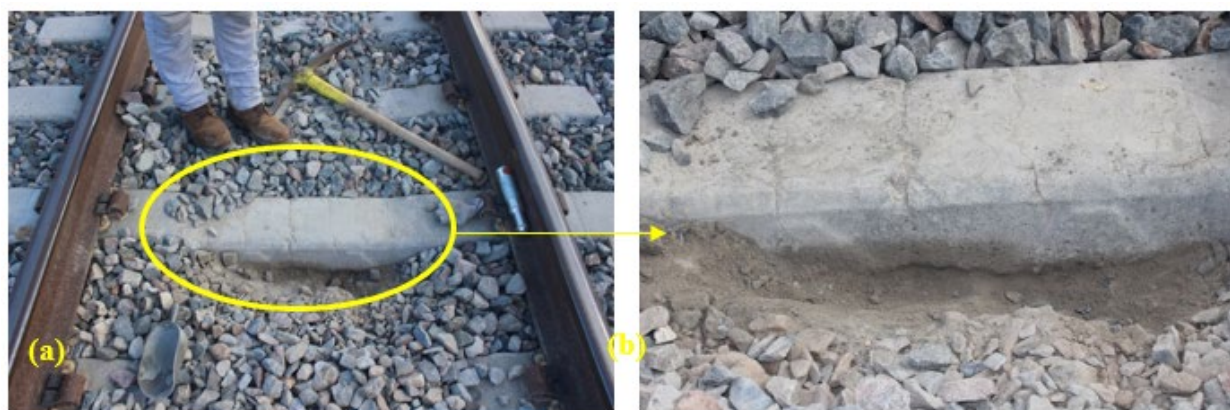
Figure A-10: Ties with moderate-to-severe center-binding cracking, Bridge #2

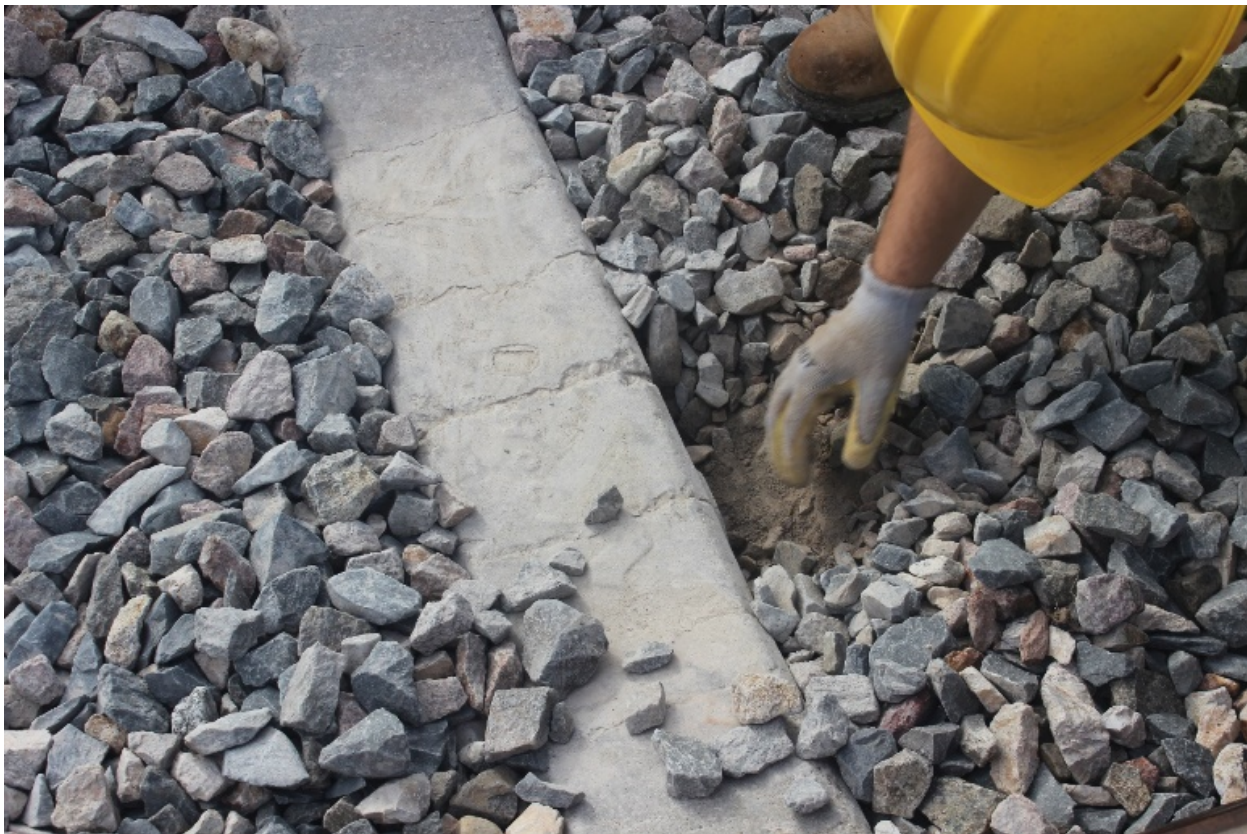
A ballast sample was taken at the depth of bottom of the concrete railroad tie from the location shown in Figure A-11. The ballast analysis is shown in Table A-4. Concrete fines were present in

significant amounts, confirming that the ties lost a significant amount of material thickness. The analysis also showed that the ballast was comprised of granite and gneiss aggregates that are known for being hard and durable.

Figure A-11: Ballast sample collection location, Bridge #2

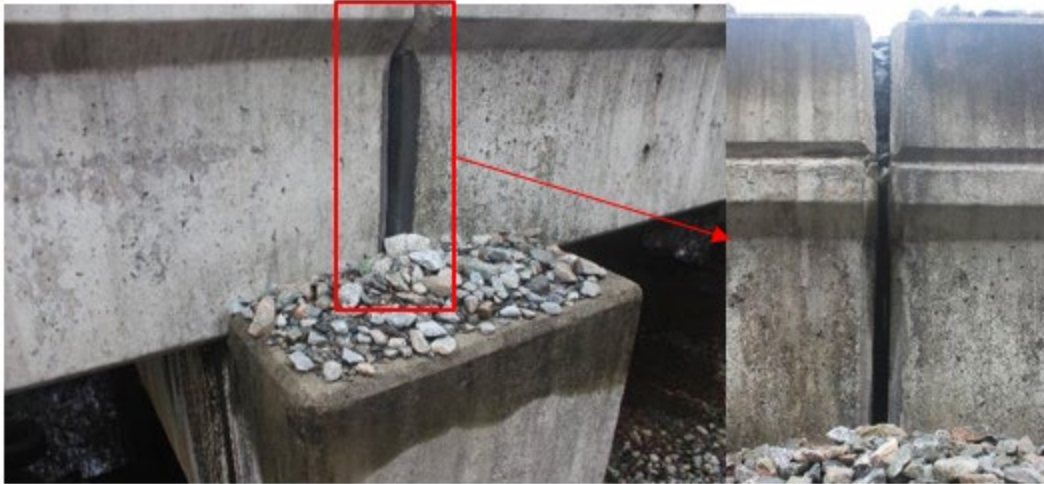
Figure A-15: Drainage issues on Bridge #3
