**Federal Railroad
Administration**

A Study of Environmental and Track Factors that Contribute to Abrasion Damage of Concrete Ties

9. SPONSORING/MONITORING AGENCY NAME(S) AND ADDRESS(ES) U.S. Department of Transportation Federal Railroad Administration Office of Railroad Policy and Development Office of Research, Development and Technology Washington, DC 20590			10. SPONSORING/MONITORING AGENCY REPORT NUMBER DOT/FRA/ORD-19/38

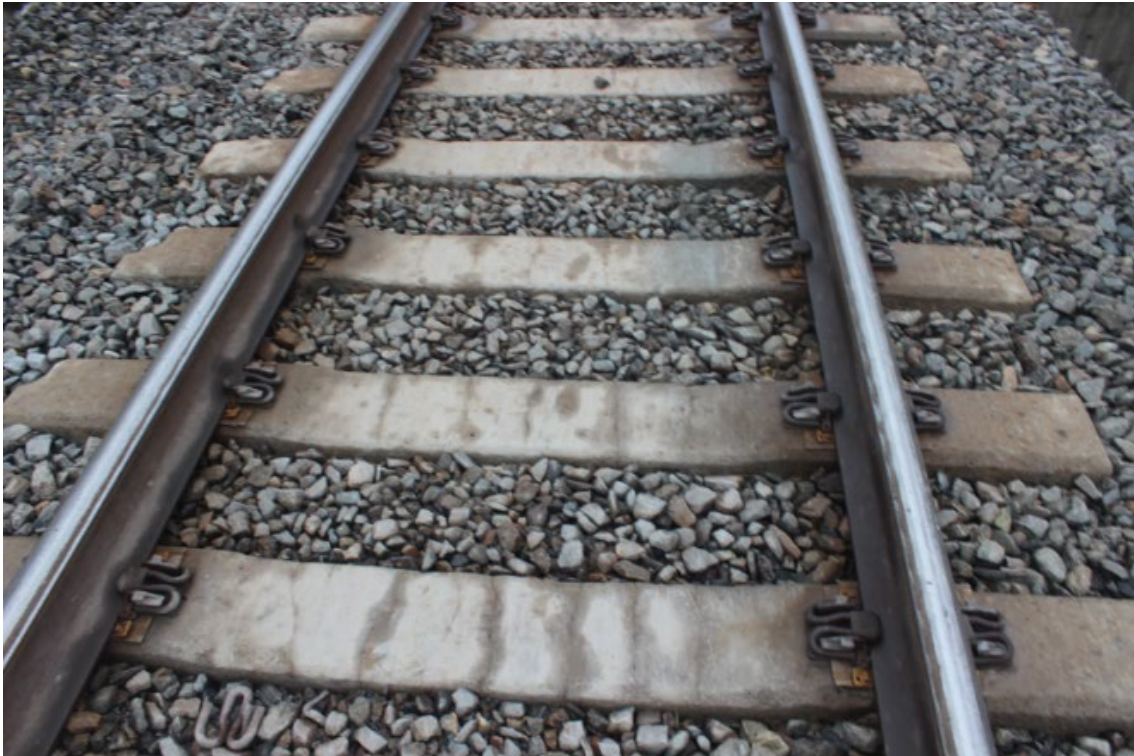
Figure A-17: Moderate center binding cracking, Bridge #3

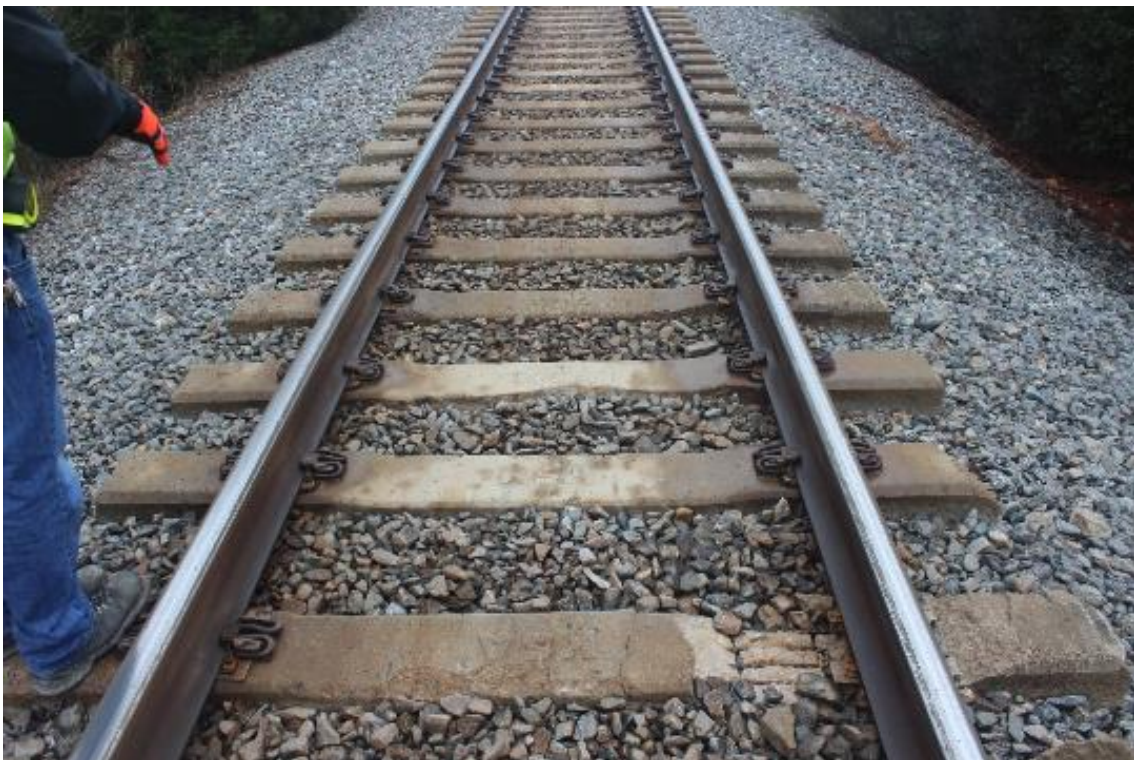
Figure A-18: Damaged and cracked ties in Bridge#3 approach

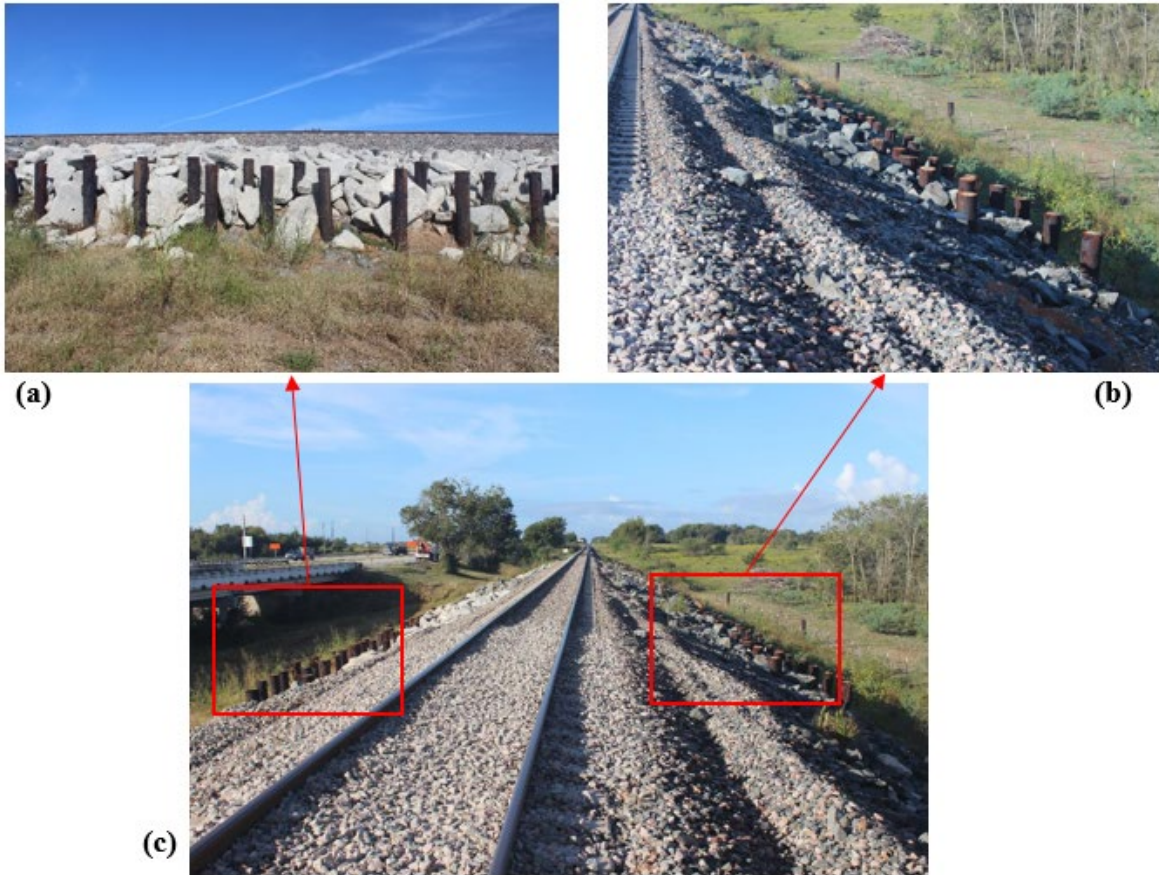
The bridge approach appeared to be in good condition. The track had surfacing issues in the past, probably because of the steep side slope. The railroad had installed rip-rap and wood posts to reinforce the track bed, as shown in Figure A-21. Track maintenance personal said that before this change, the track experienced water ponding because of fouling. Little wear was seen in the bottom of the ties in track. Ties taken from track and stored with the rip-rap still have side scallops and finishing roller marks, as shown in Figure A-22, indicating little abrasion damage. The recent track maintenance activities seem to be effective. Little abrasion damage was seen in track.

Figure A-21: Use of piles to stabilize the slope, Bridge Approach #1

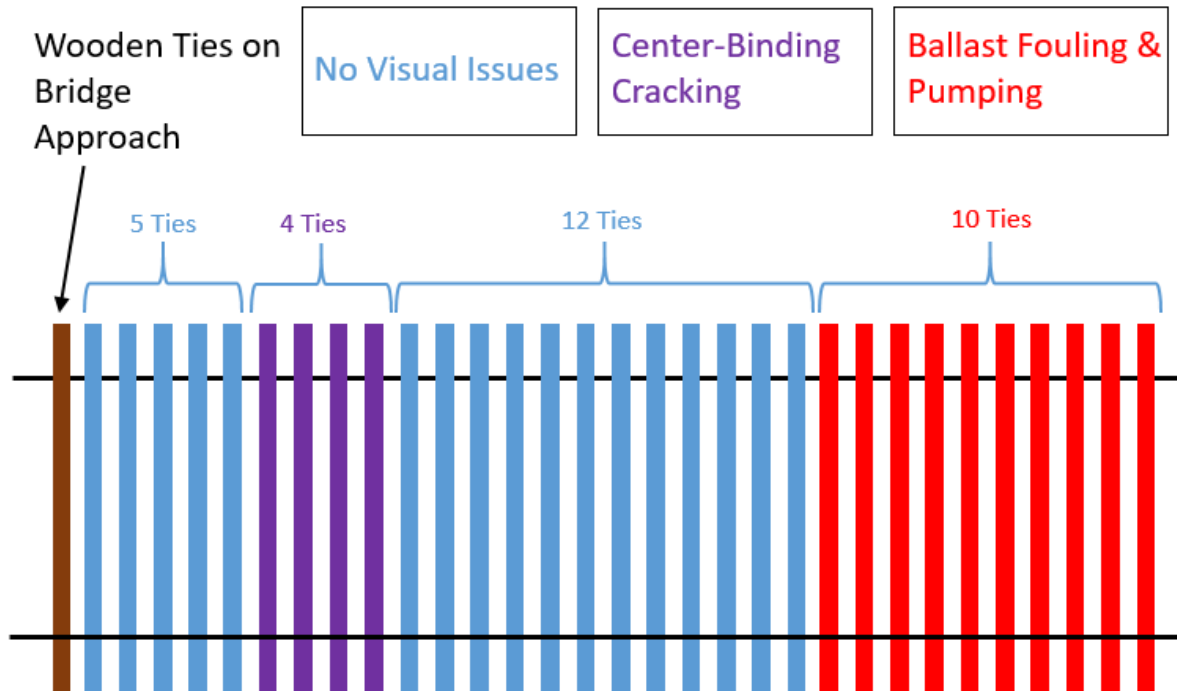
Figure A-26 shows a graphical representation of the general tie conditions along this track. The transition from wood ties to concrete ties is shown in Figure A-27. Longer wooden ties were used to give similar track stiffness as the concrete ties. The bridge appeared to be a few inches higher in elevation than the approach track. It is possible the change in elevation and a bump from the wood tie-to-concrete tie transition increased track dynamic loads and caused center-binding cracking in the concrete ties. The ties with center binding cracking had only minor cracks present, as shown in Figure A-28. Train vertical movement harmonics could result in higher loads where the fouling exists.

Figure A-26: Concrete tie condition, Bridge Approach #3

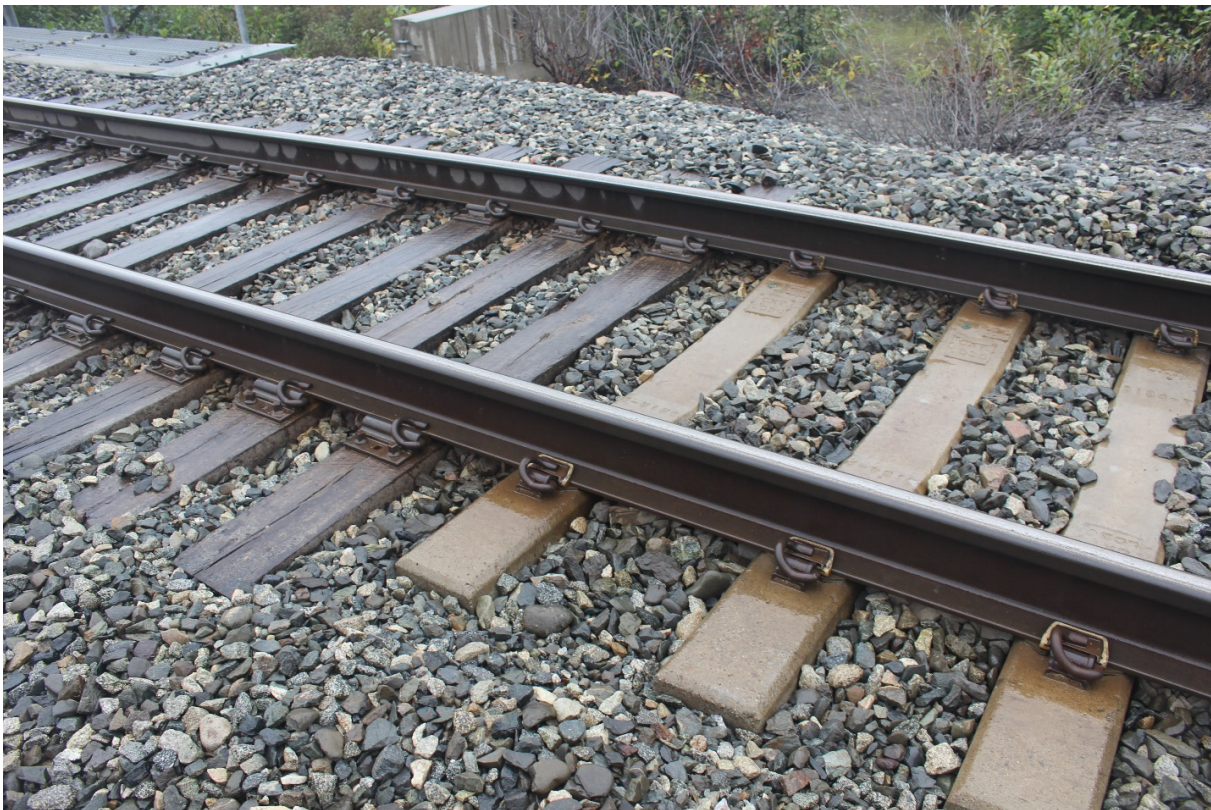
Figure A-27: Transition zone from concrete to wood ties, Bridge Approach #3

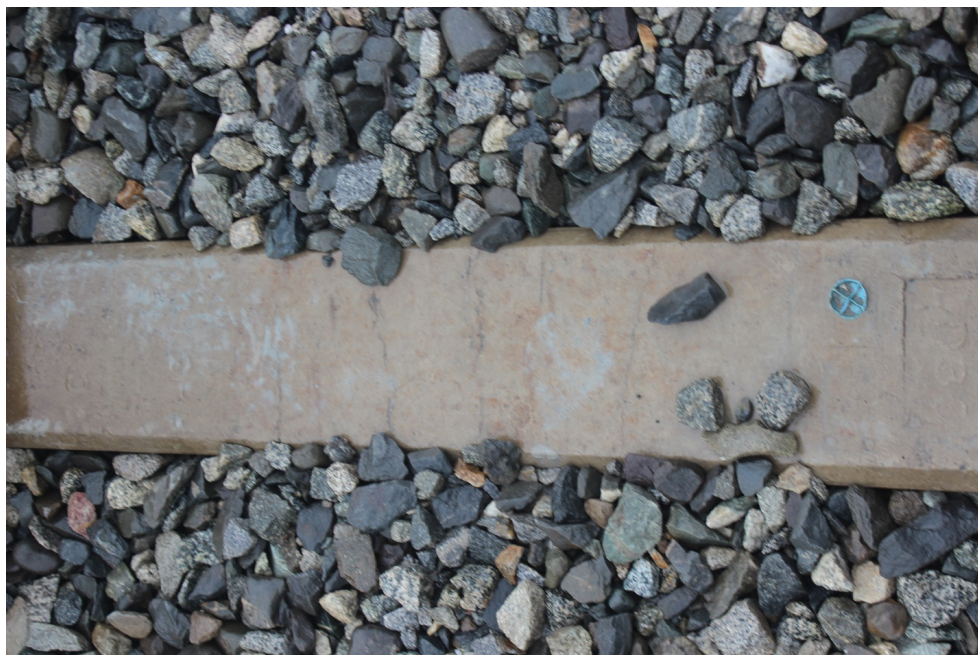
Figure A-28: Tie center cracking, Bridge Approach #3

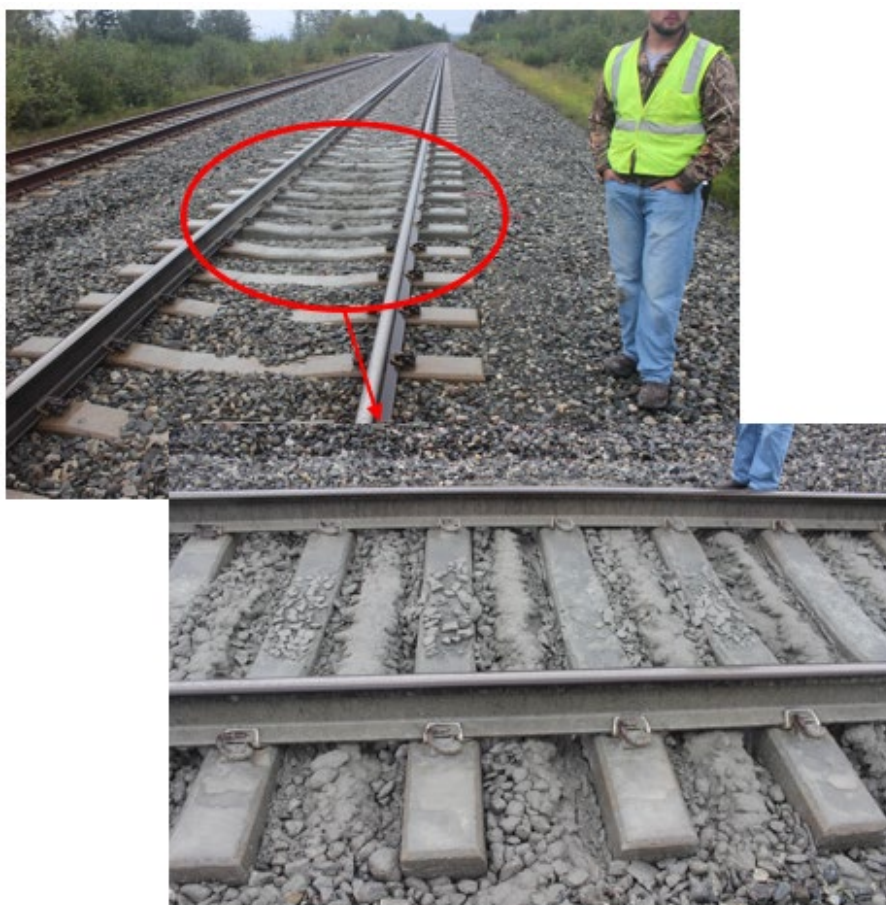
Figure A-29 shows the concrete ties with fouling and pumping present. Figure A-30 shows the gray colored fines on the site. Drainage appeared to be less than ideal in the location with ballast fouling. There was only limited drainage to the side of the track shared with another track. The area around the track showed evidence of water-loving vegetation, indicating that moisture is present much of the year. Utilities in track restrict maintenance to ballast tamping.

Figure A-29: Area with mud pumping, Bridge Approach #3

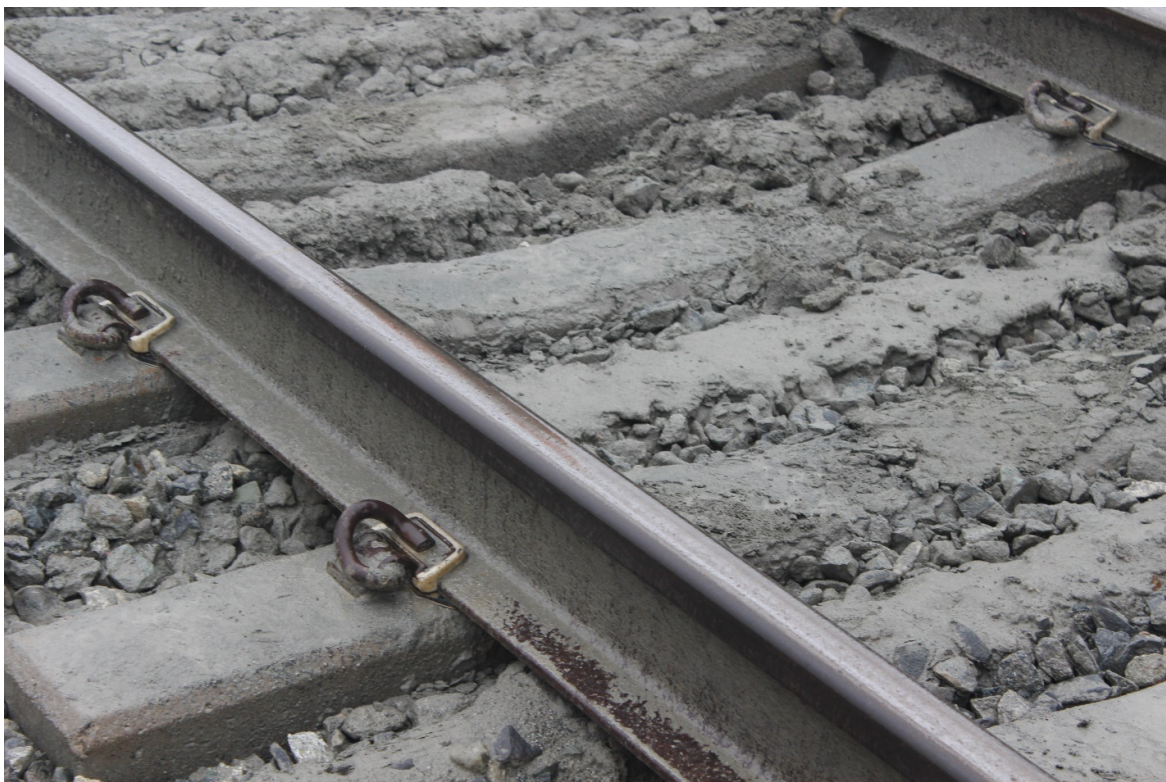
Figure A-30: Gray mud, Bridge Approach #3

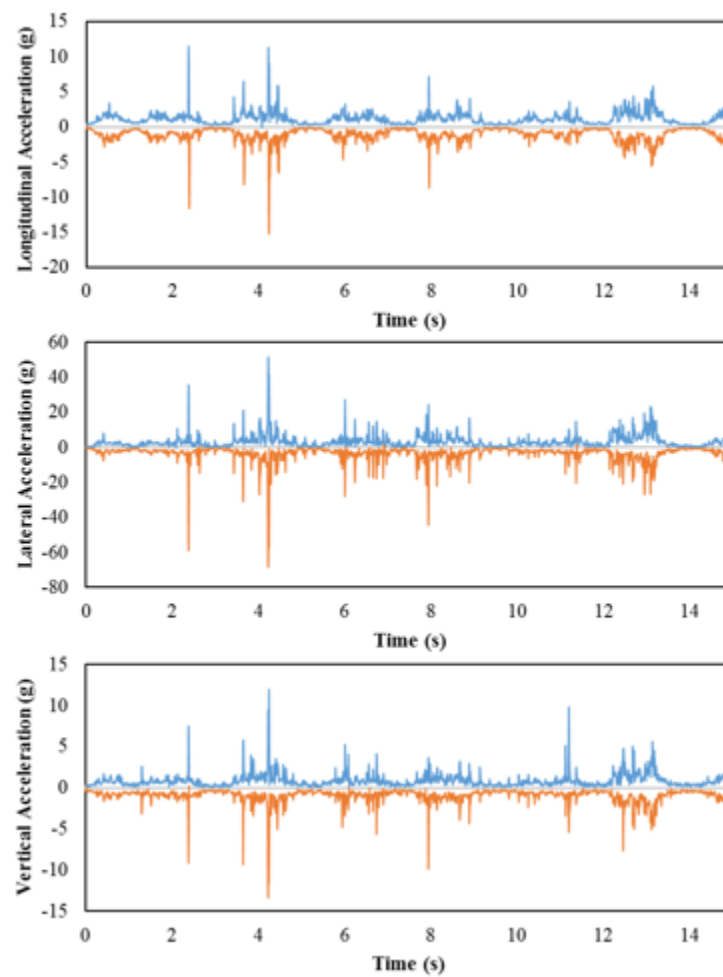
Researchers recorded tie acceleration during a train pass, Figure A-31. Video was taken of the train pass to document mud pumping and tie movement. The video shows a few ballast particles adjacent to the tie moving. Ballast movement during train passes could contribute to rubbing and wear. Figure A-32 shows the acceleration measured on the tie during train loading. The tie experienced significant vertical acceleration, indicating that there is a gap between the tie and ballast support. Tie lateral movement was higher than expected.

Figure A-32: Tie Acceleration data, Bridge Approach #3

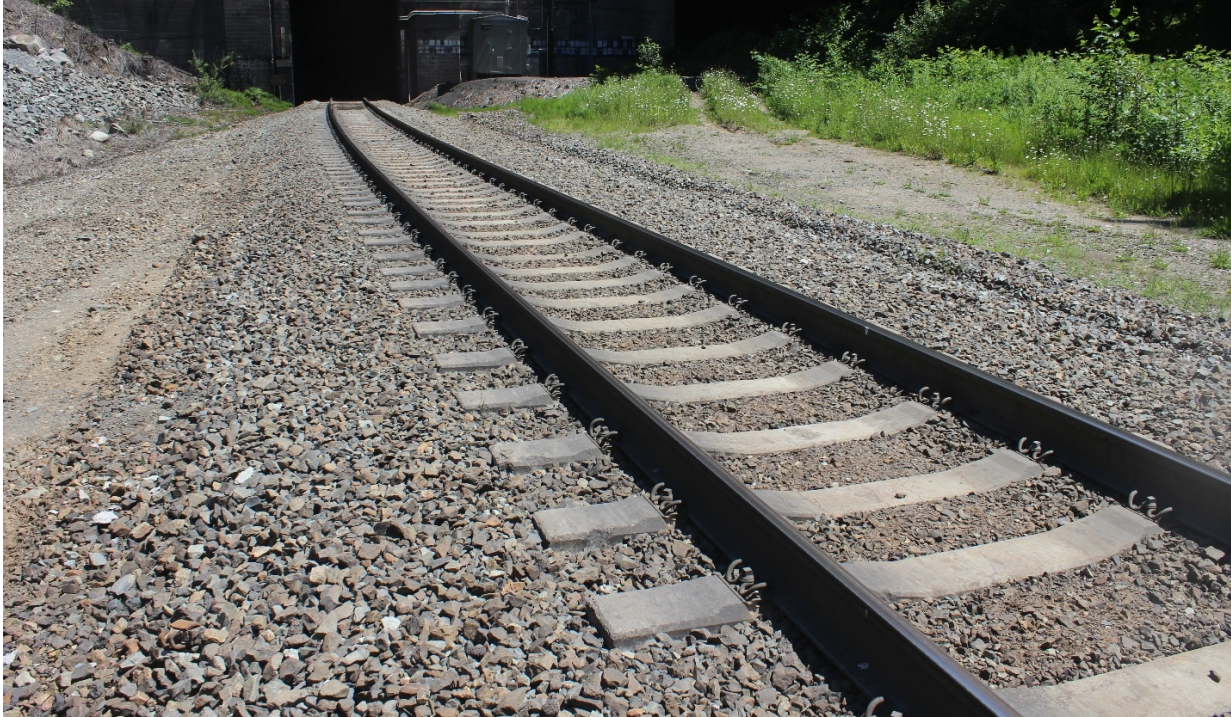
The railroad claims this site needs constant maintenance. The ties were replaced 2 years prior due to wear and deterioration. There were a few ties with center-binding cracking, and a few with longitudinal splitting cracks. The remainder of the ties near the tunnel entrance appeared to be in good shape, Figure A-34. Some ballast fouling was observed as shown in Figure A-35. The team was not allowed to access the track because of safety concerns from the short sight distance at the track tunnel. This precluded the team from taking ballast samples or measuring the tie thickness in track. Track drainage was not very good. Water was seen coming from the tunnel onto ditches on both sides of the track as shown in Figure A-36. The water on south side of tunnel was seen to go through the track to the ditch in the north side of the track. It is likely that the water movement through the track contributed to the track maintenance issues.

Figure A-34: Ties at tunnel approach

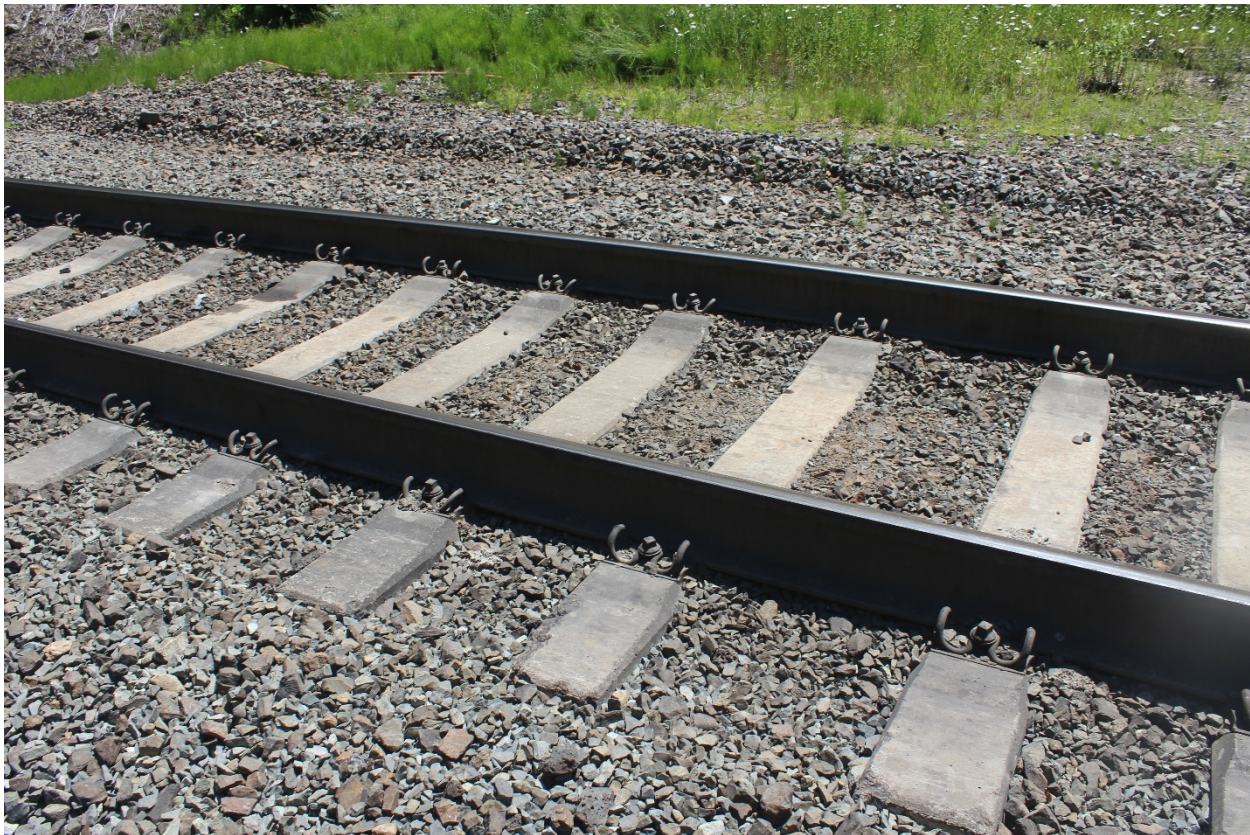
Figure A-35: Ballast fouling in track, tunnel approach

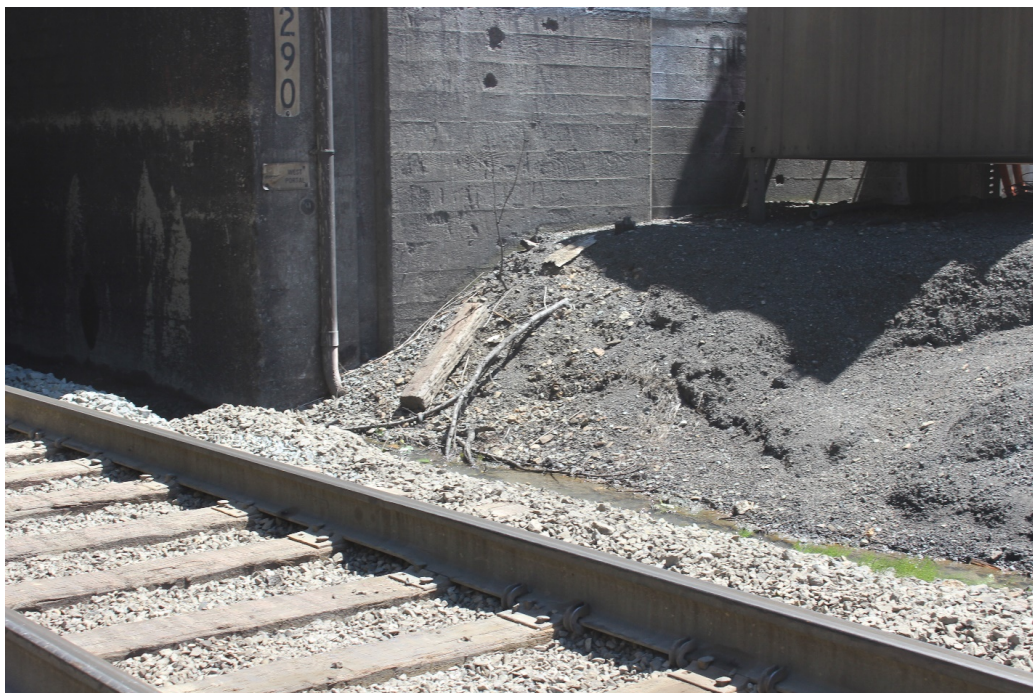
Figure A-36: Water from tunnel in ditch, tunnel approach

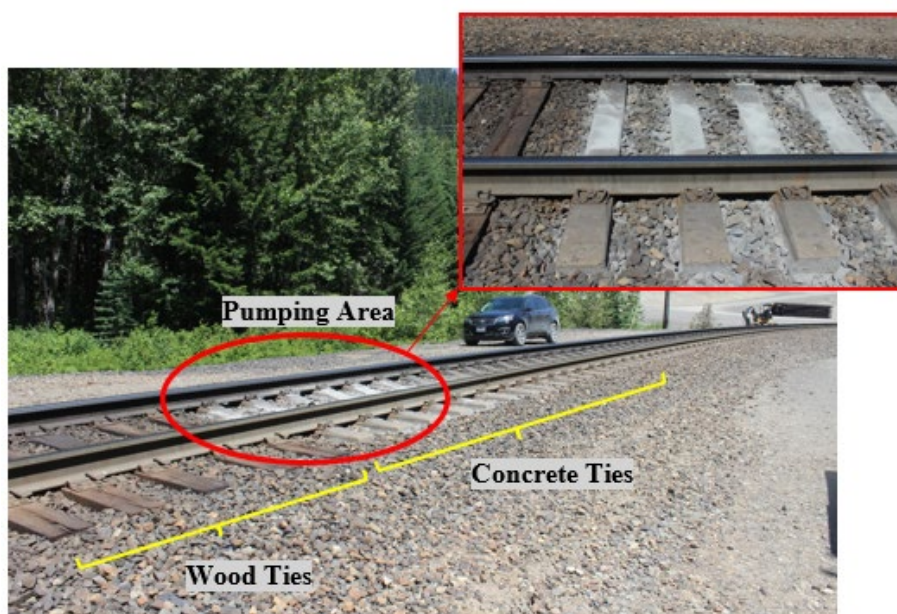
The tunnel east portal appeared to be in good shape except for the transition between wood and concrete ties. There was no standing water in ditches or signs of water in track, but the research team did not have access to the track to document moisture conditions with depth in the ballast. Given the high amounts of precipitation and lush vegetation in the area, it is very possible that moisture was present in the track structure. Ballast churn was evident from the gray fines present on the top of the ballast shown in Figure A-37.

Figure A-37: Ballast churn and center-binding cracking seen at wood-concrete tie transition area, tunnel approach

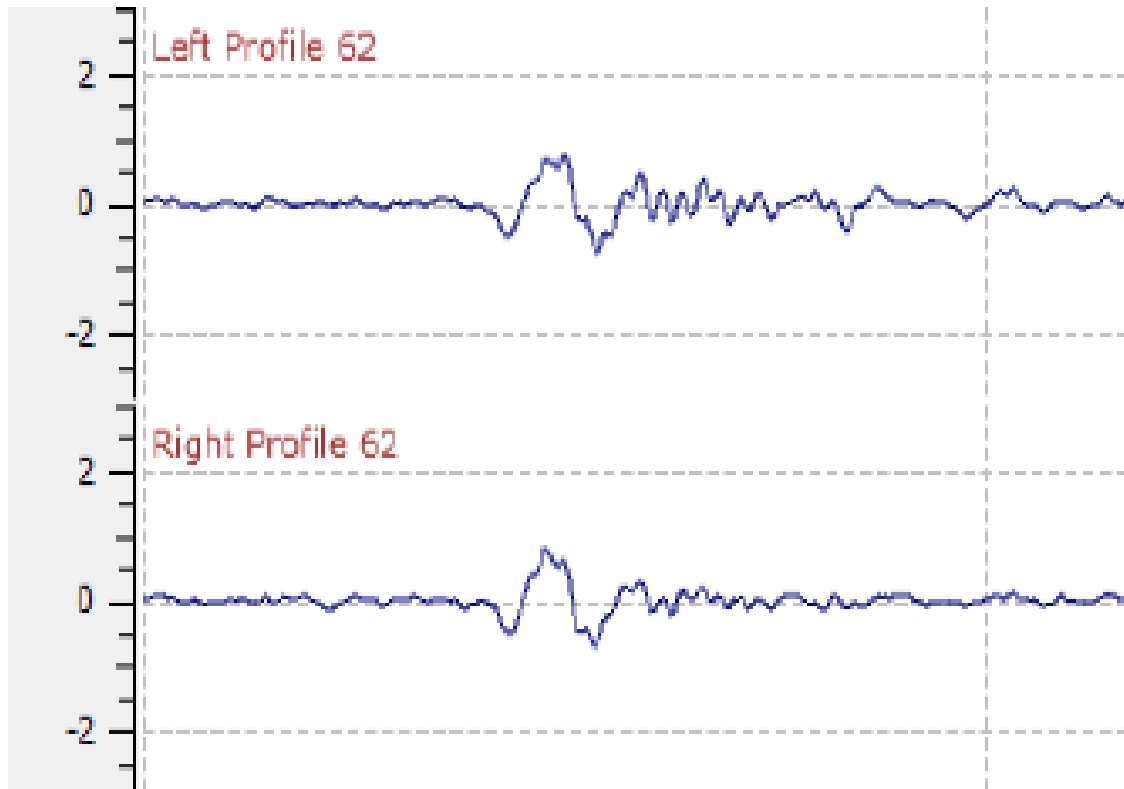
The ATIP geometry car visited the tunnel approach approximately 8 months before the research team. A small variation in profile was seen before the tunnel entrance, as shown in Figure A-38. The track profile variation was likely small because the ties were only 2 years old. Based on the track condition and the presence of a wood-to-concrete tie transition, the profile will likely grow with time.

Figure A-38: ATIP track profile measurements, tunnel approach

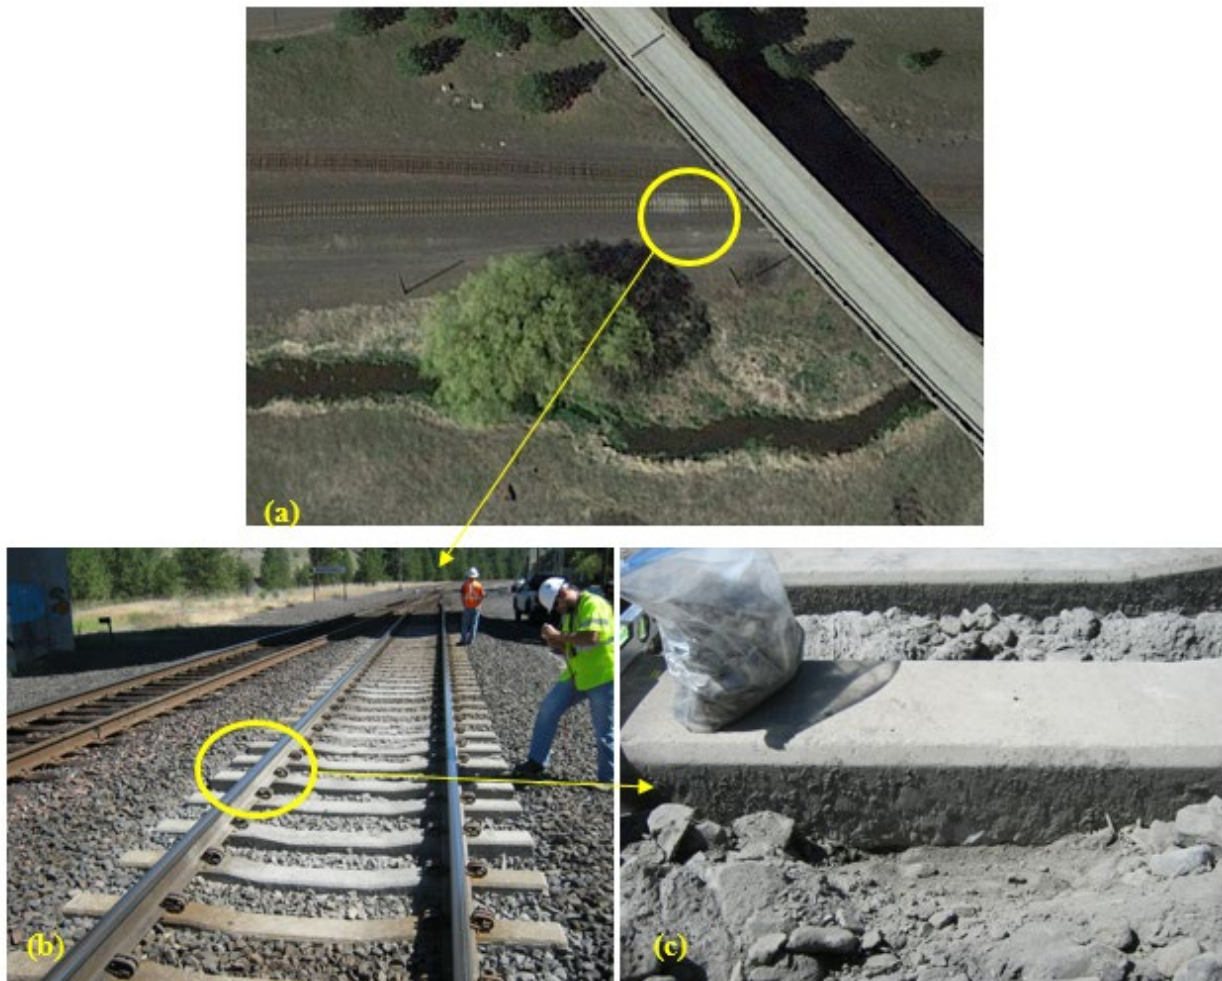
Figure B-1: Pumping area after a wood tie-to-concrete tie transition, Switch #1

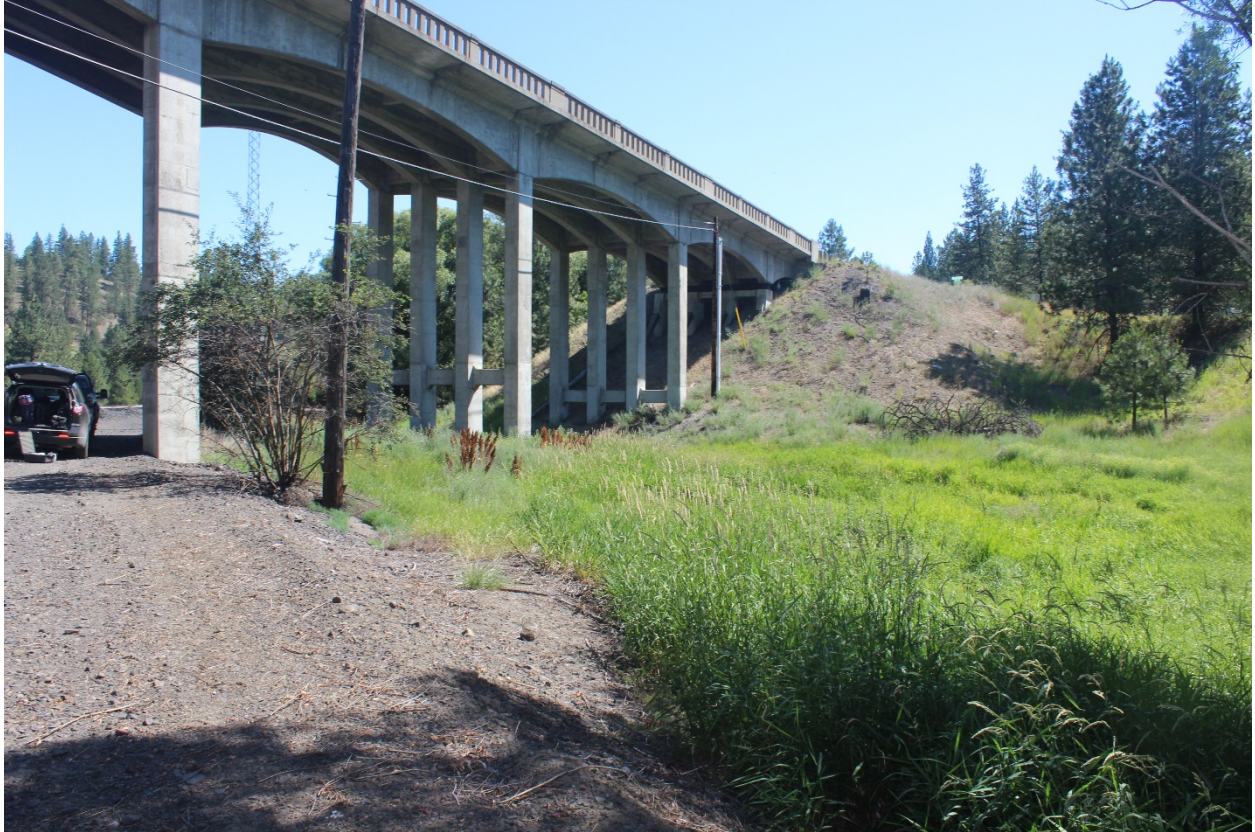
Figure B-3: Water-loving plants next to track, Switch #1

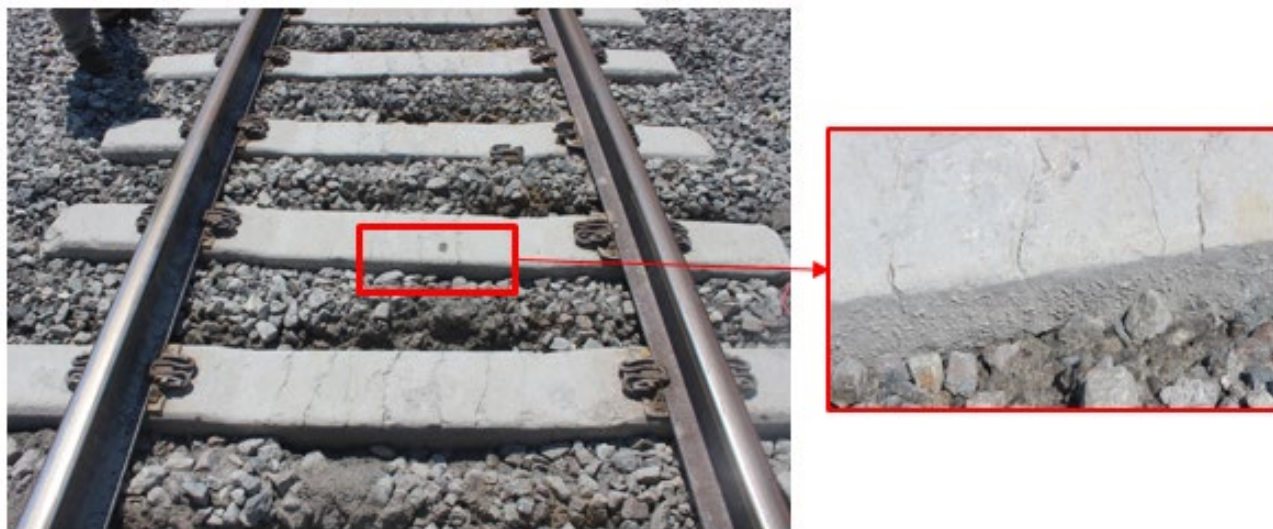
The railroad made repairs at this site. Six wooden ties replaced concrete ties due to fouling damage. Once mud is present in the site, the mud spot spreads quickly. The mud spot had already returned to the track when the research team visited the site. Most of the ties at the location had center binding cracking as shown in Figure B-12.

Figure B-12: Center binding cracking in the ties, Signal #2

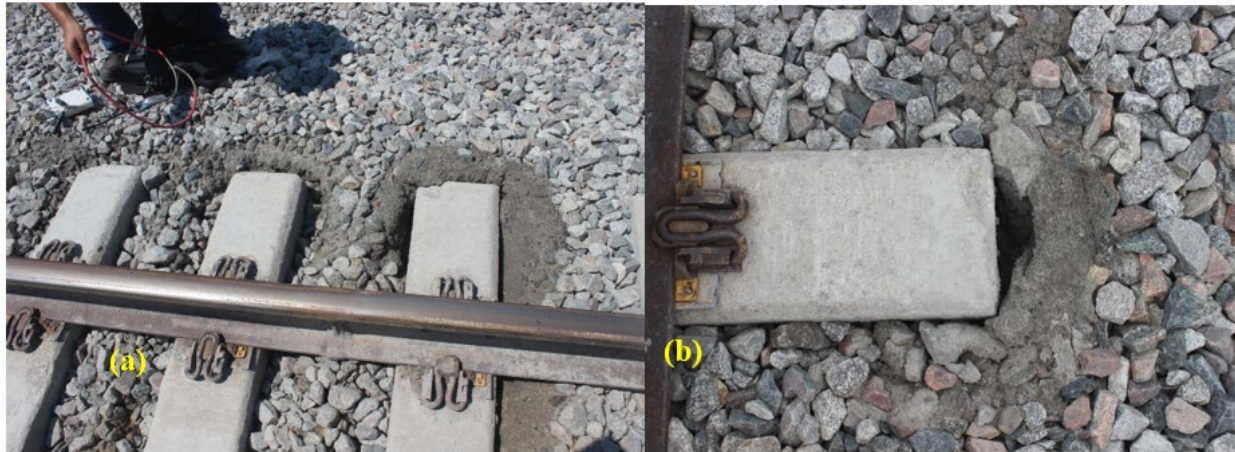
Figure B-14 show evidence of mud pumping and lateral tie movement. Fines migrating to the sides of the track provide evidence of ballast fouling and poor drainage, see Figure B-15.

Figure B-14: Pumping and lateral movement on the end of the ties, Signal #2

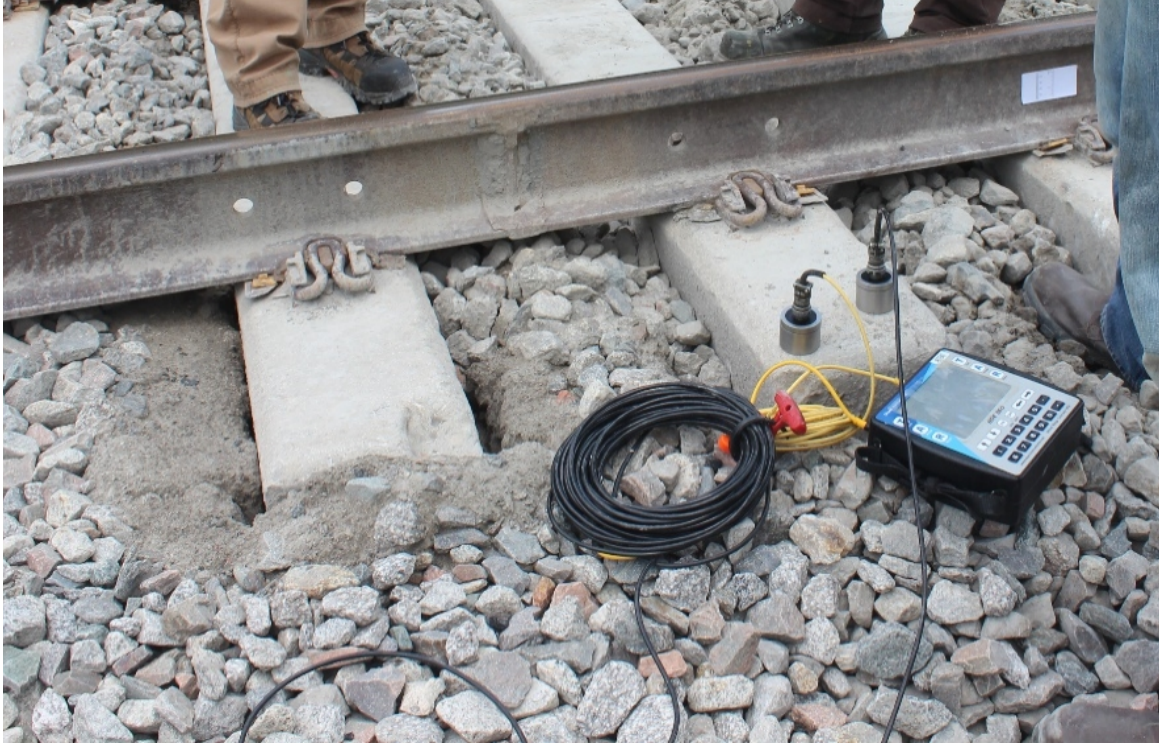
Ultrasonic pulse velocity (UPV) measurements taken from the Schmidt hammer tie measured. All readings were taken with the ultrasonic pulse source on the tie shoulder. Readings were taken with the receiver on the same shoulder as the source as shown in Figure B-17, on the top of the tie in the center, and on the top of the opposite tie shoulder from the source. Table B-6 shows the measured UPV readings. UPV measurements show that the UPV readings for center-to-shoulder and shoulder-to-shoulder measurements were lower than the one for the same shoulder because the center-binding cracks reduced the wave propagation speed through the concrete tie. The rail slope and tie superelevation was measured with a digital level. Figure B-18 shows the measured rail and tie levels.

Figure B-17: UPV readings from the same shoulder

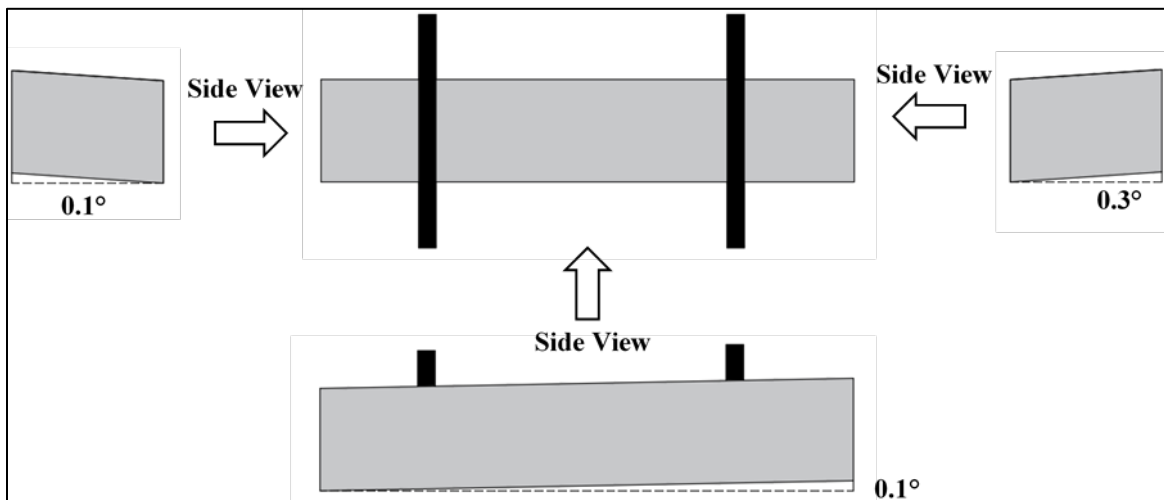
Figure B-18: Superelevation of the concrete tie and rail slope using digital level, Signal #2

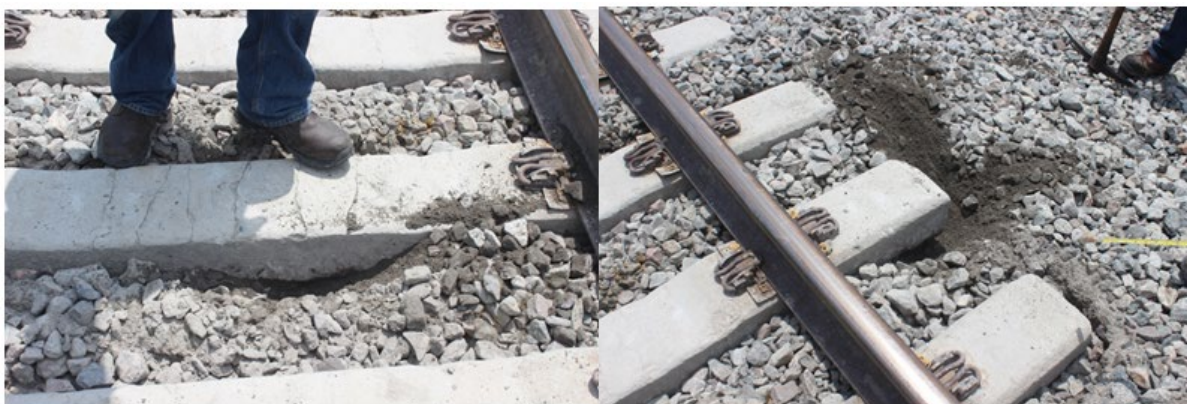
Figure B-21: Samples collected from ballast, Signal #2

Researchers collected four ballast and subgrade samples from the site, as shown in Figure B-21. Ballast samples were taken in the ballast at the depth of the bottom of the tie. Table B-7 shows the ballast analysis. The results showed that concrete material in the ballast was smaller than 10 mm, indicating that the concrete material was abraded away instead of being taken off by impact.

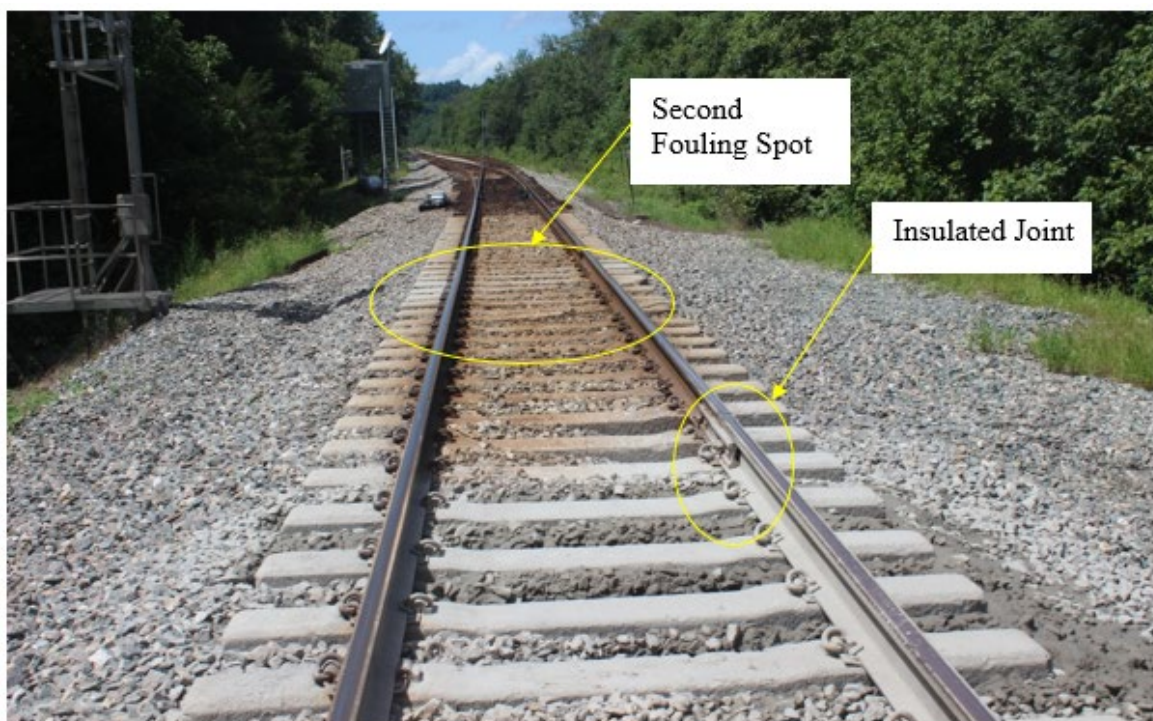
Train dynamics are influenced by the switch, the transition from wood-to-concrete ties, and an insulated joint at this location. Gray mud was fouling the ballast, Figure B-23. Significant mud pumping can be seen in Figure B-24. Fouling was present around nine ties in the primary mud pumping location. A second spot with minor amounts of fouling can also be seen in Figure B-24. A train that experiences vertical acceleration as it passes over an insulated joint would be expected to experience harmonics that increase wheel loads along the track. Vegetation was seen in the ballast-area of track as shown in Figure B-25. This is indicative of persistent water in the track structure, indicating poor drainage.

Figure B-23: Pumping next to the switch, Signal #3

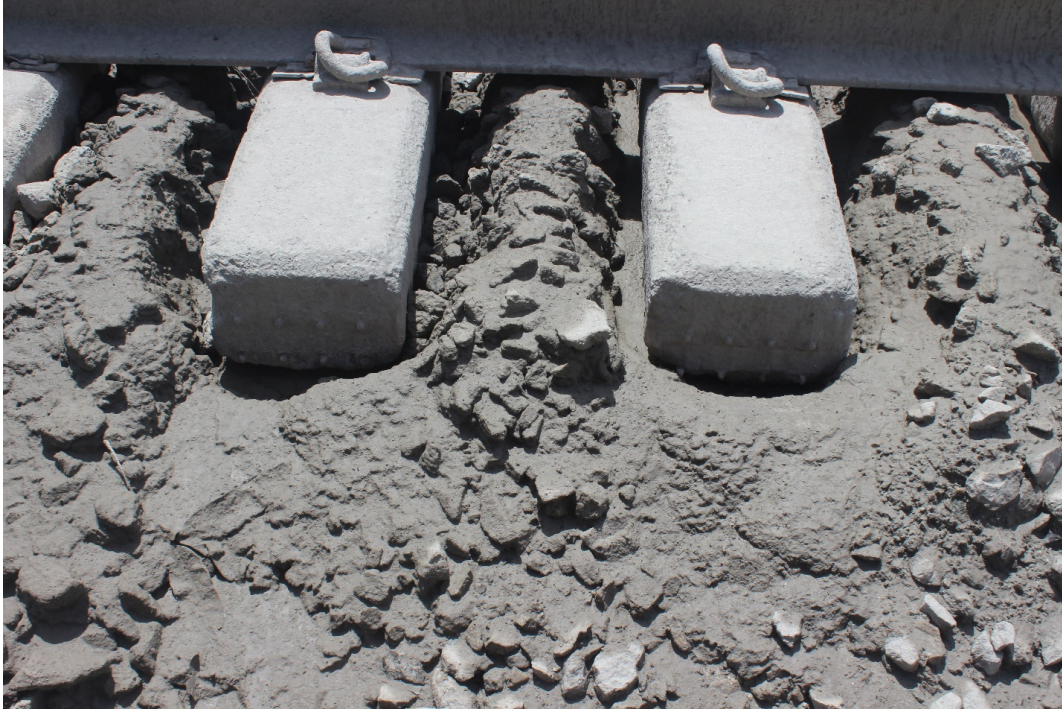
Figure B-24: Mud pumping, Signal #3

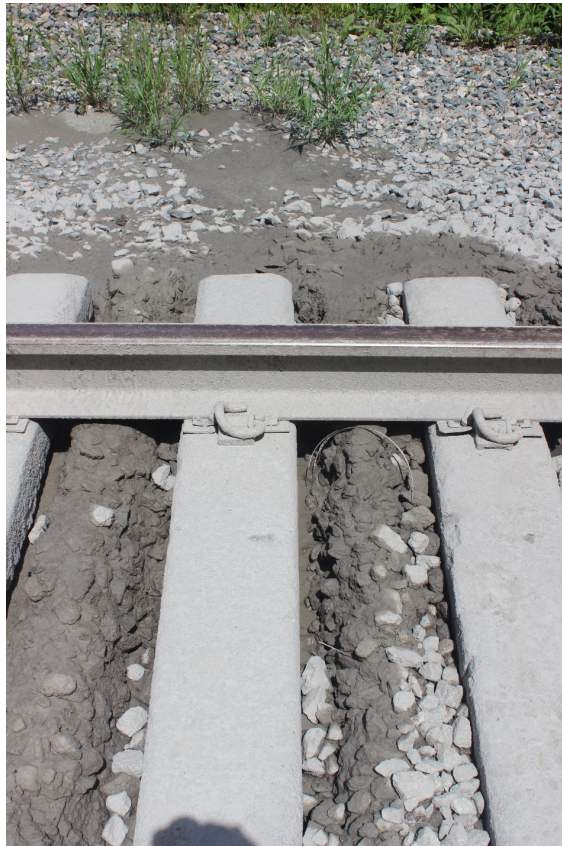
Figure B-25: Vegetation near track, Signal #3

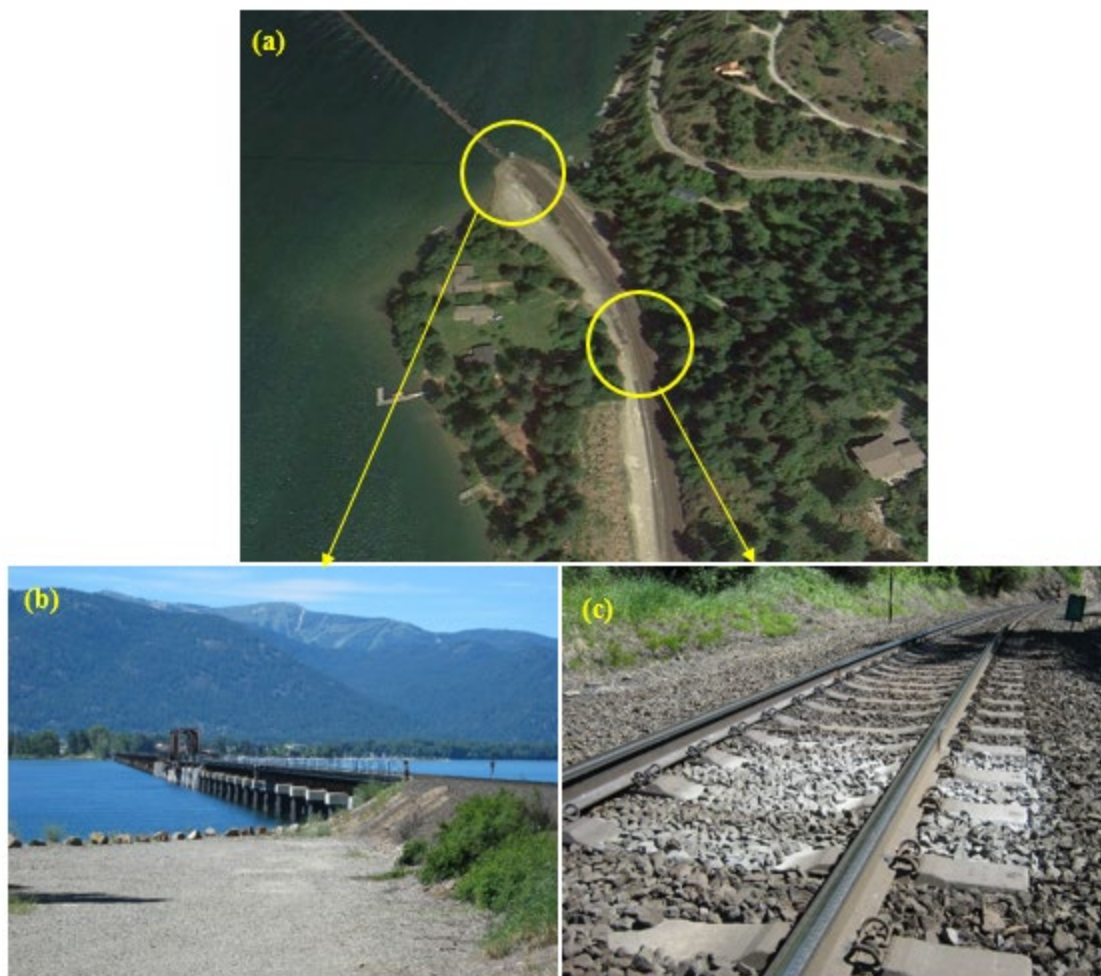
Figure C-1: Satellite view from Google Earth (a), photograph of inspected bridge (b) and (c) small area with ballast churn and fouling, Crossing #1
