**Federal Railroad
Administration**

A Study of Environmental and Track Factors that Contribute to Abrasion Damage of Concrete Ties

9. SPONSORING/MONITORING AGENCY NAME(S) AND ADDRESS(ES) U.S. Department of Transportation Federal Railroad Administration Office of Railroad Policy and Development Office of Research, Development and Technology Washington, DC 20590			10. SPONSORING/MONITORING AGENCY REPORT NUMBER DOT/FRA/ORD-19/38

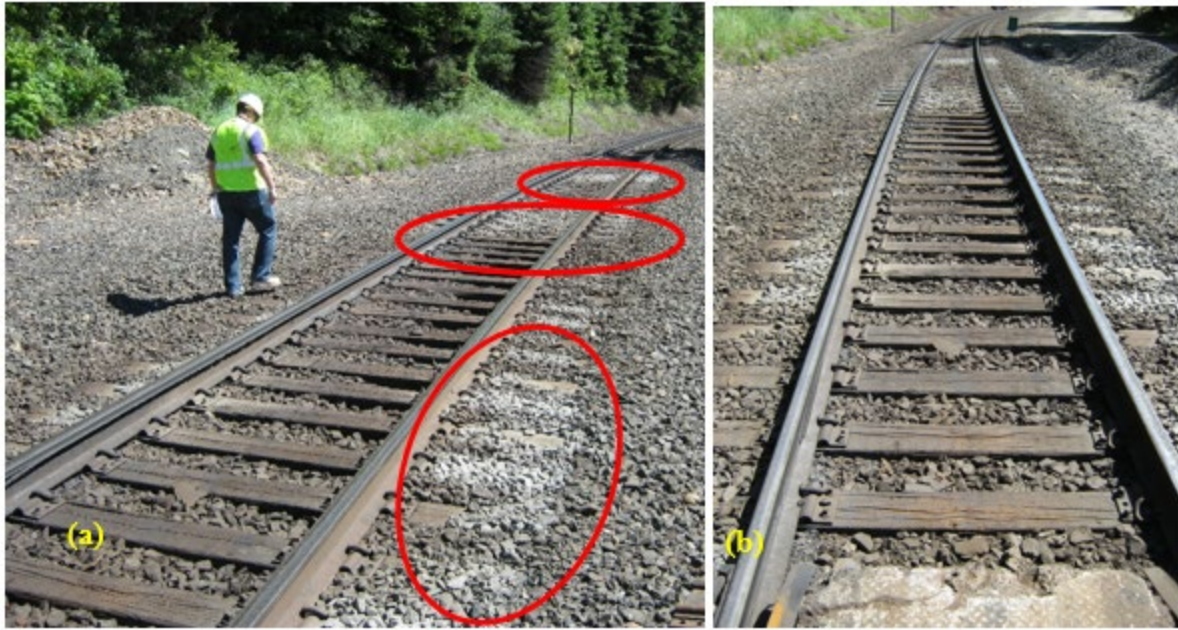
The concrete ties were relatively new and in good condition. There was a concrete road crossing in track, with 16 wood ties before and 19 wood ties located after the crossing, as shown in Figure C-2. The first tie after the wood transition had mild center-binding cracking.

There were periodic areas of ballast churn and breakdown. These spots are highlighted in Figure C-2 and shown from the reverse angle in Figure C-3. Rail welds were seen at the location of ballast churn, indicating possible previous surfacing issues that led to rail damage. A little more ballast churn was seen on the low rail side of the track. Ballast was removed in the churned area to inspect ballast condition with depth. Ballast fouling and organic matter were seen at the bottom of tie. There were signs of early abrasion wear on the sides of the tie at the ballast level as shown in Figure C-4, but no significant section loss. A discarded tie adjacent to the track showed the potential for tie abrasion damage in this track location, see Figure C-5. This curve had significant abrasion wear before new ties were installed. Railroad officials stated that tamping and ballast maintenance was performed, but no undercutting.

Figure C-2: Replaced concrete ties with wooden ties, Crossing #1

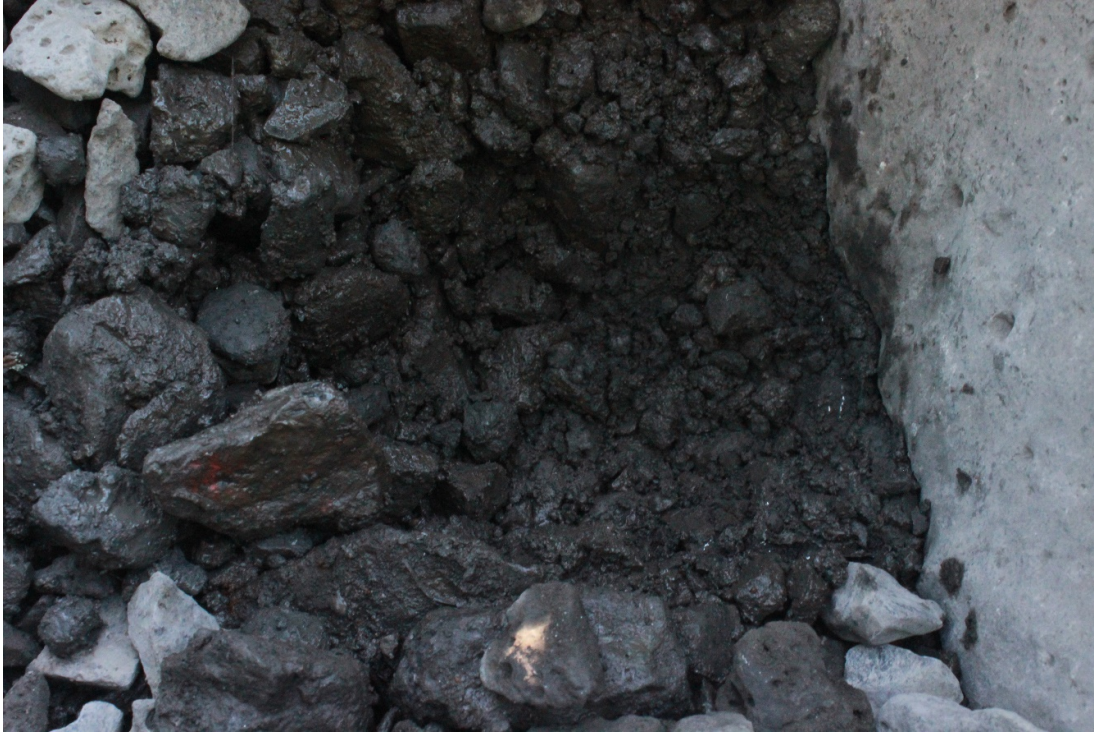
Figure C-4: Ballast fouling and beginning of concrete tie wear, Crossing #1

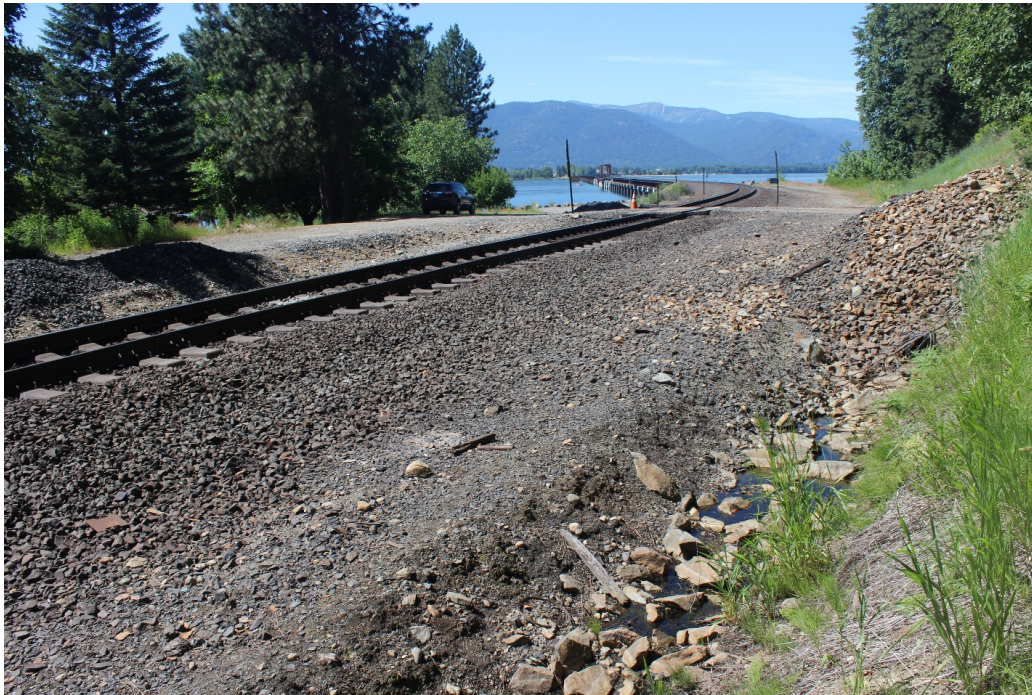
Water was present in this section of track, as evidenced by the moist ballast a few inches below the track surface and by standing water in the ditch, Figure C-6. The nearby vegetation indicates significant water availability. Some sections of track also had issues with grading because of hillside slope conditions, as shown in Figure C-7.

Figure C-6: Standing water and vegetation in ditch, Crossing #1

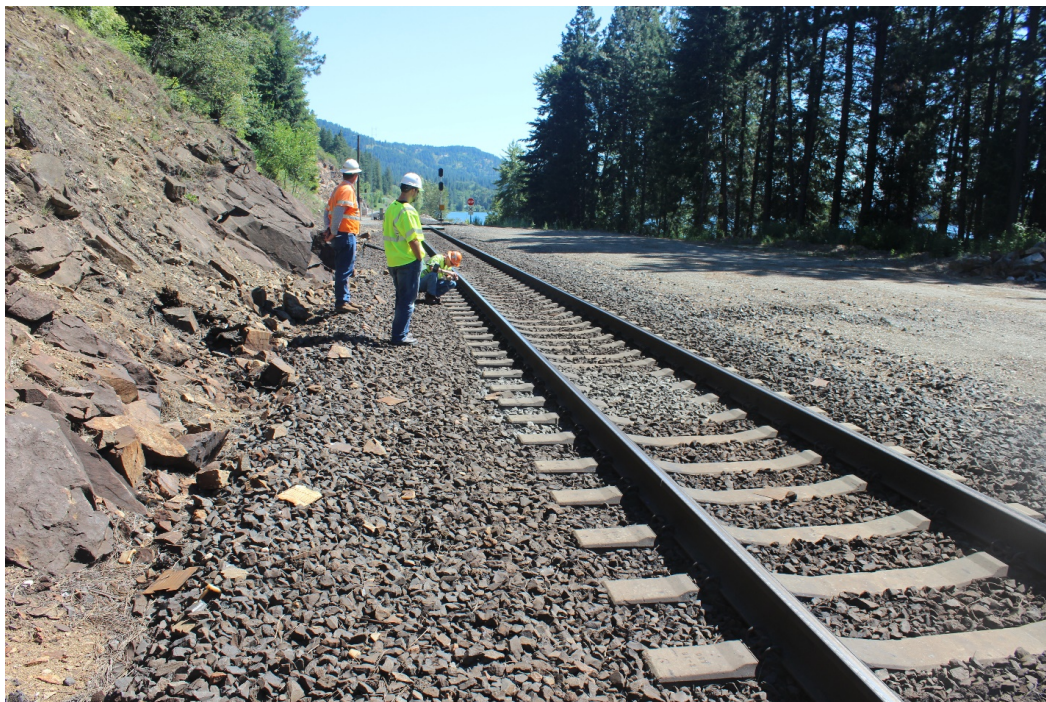
Figure C-7: Grading issues seen in some locations, Crossing #1

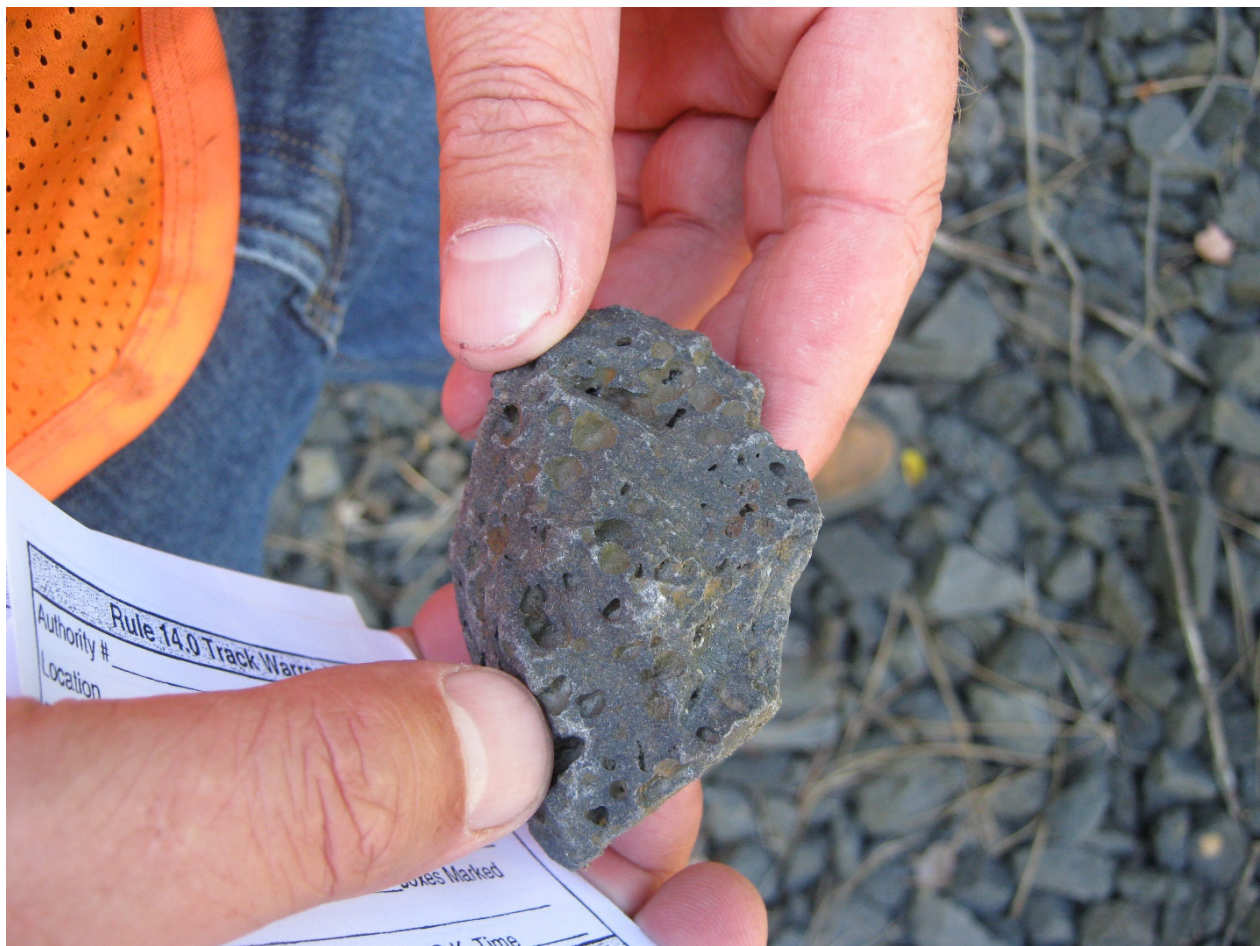
Two ballast and subgrade samples were collected. Although the aggregate is a good, hard basalt, it is also vesicular, as shown in Figure C-8. It is unknown what effect the vesicular nature of the ballast played in ballast fouling and concrete wear. Ballast samples were taken at the depth of the bottom of the tie. Table C-1 contains the ballast analysis results. The ballast sample did not show evidence of concrete fines, likely because of track maintenance activities and relatively new ties used. This could indicate that ballast breakdown occurs before concrete bottom tie abrasion at this location.

Figure C-8: Close-up picture of vesicular basalt ballast, Crossing #1

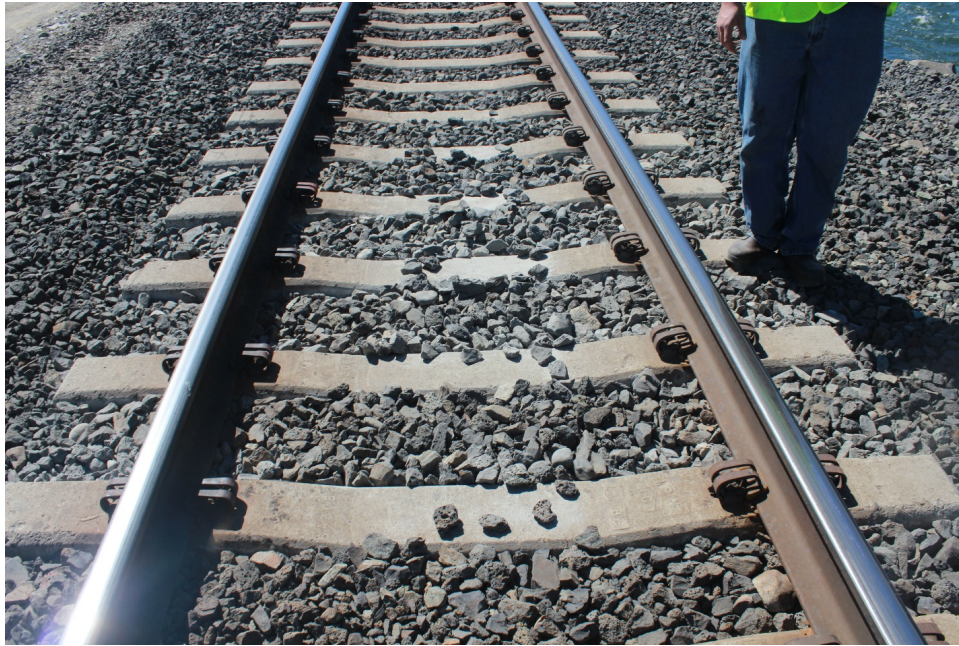
The ties were in good condition near the switch. Only three ties with minor center-binding cracking were seen in a few hundred yards of track and no abrasion damage was seen on the bottom or sides. The ballast appeared to be in good shape overall with only one spot with a little gray dust from ballast churn as shown in Figure C-10. A track-level view of the switch is seen in Figure C-11. The drainage was good with built up embankments. There were no water or damp spots in track at the bottom of ties.

Figure C-10: Minor gray dusting of ballast particles, Crossing #2

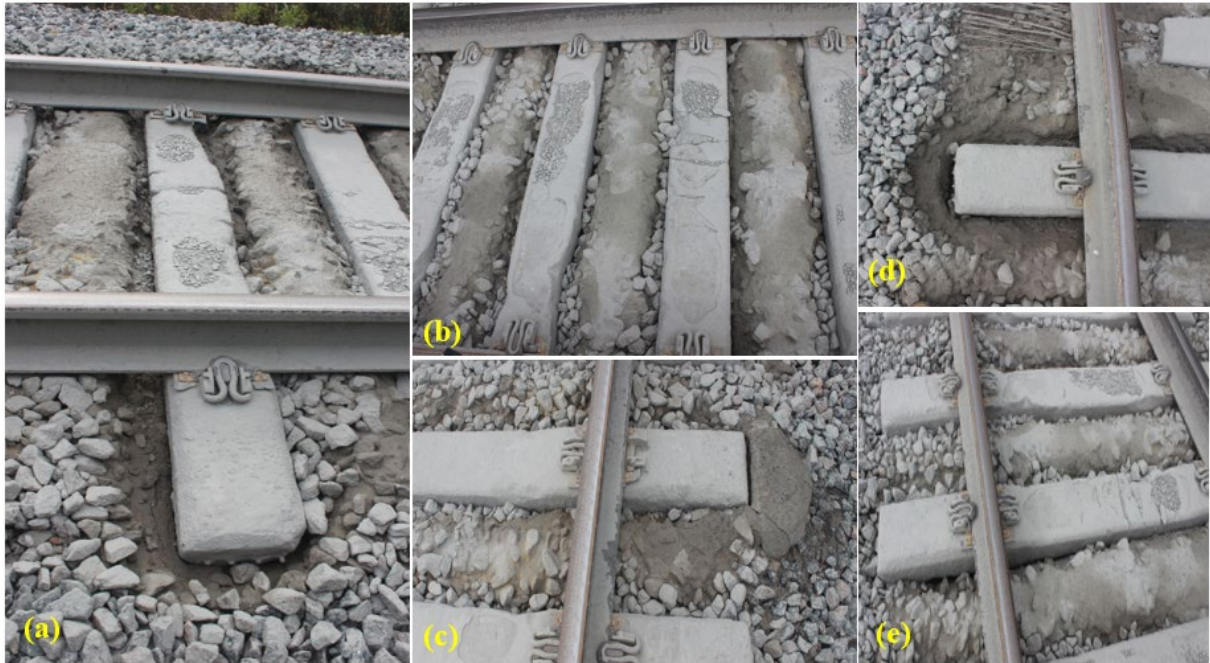
The railroad reported that some spot undercutting in problem areas was performed 5–6 years ago, with additional undercutting 3–4 years ago. Ballast fouling returned after each maintenance activity. Per the road master, the fouling occurs under the track surface and spreads farther than can be seen at the surface. Ballast fouling and pumping was seen at periodic intervals, as shown in [Figure 3-7](#). The fouled ballast spots were near a crossing and appeared to follow vertical dynamic harmonics of the train on either side of the crossing. Many additional spots were noticed in both directions that were similar in nature to the ones investigated. The road master commented that the track contained many similar spots similar for several miles in each direction. Water was seen ponding in the side of the track near the fouled ballast as shown in [Figure 3-7](#) indicating drainage problems in track. Standing water and plants were seen in and around the ditch, indicating a source of water present near the track. Figure C-13 shows several examples of ties in fouled ballast on site. Figure C-14 shows ties that were damaged at the track locations with pumping. Wear seen was non-uniform across the length of the tie however. Severe center-binding cracking was present in many ties. Damage was seen on the top surface of ties from a broken axle that was dragged by the train for several miles about 10 years prior, Figure C-15. This damage was separate from the center-binding cracking and did not appear to affect the tie abrasion performance. Figure C-16 shows shattered ties that may have resulted from center-binding cracking.

Figure C-13: Severe pumping that led to section loss, Crossing #3

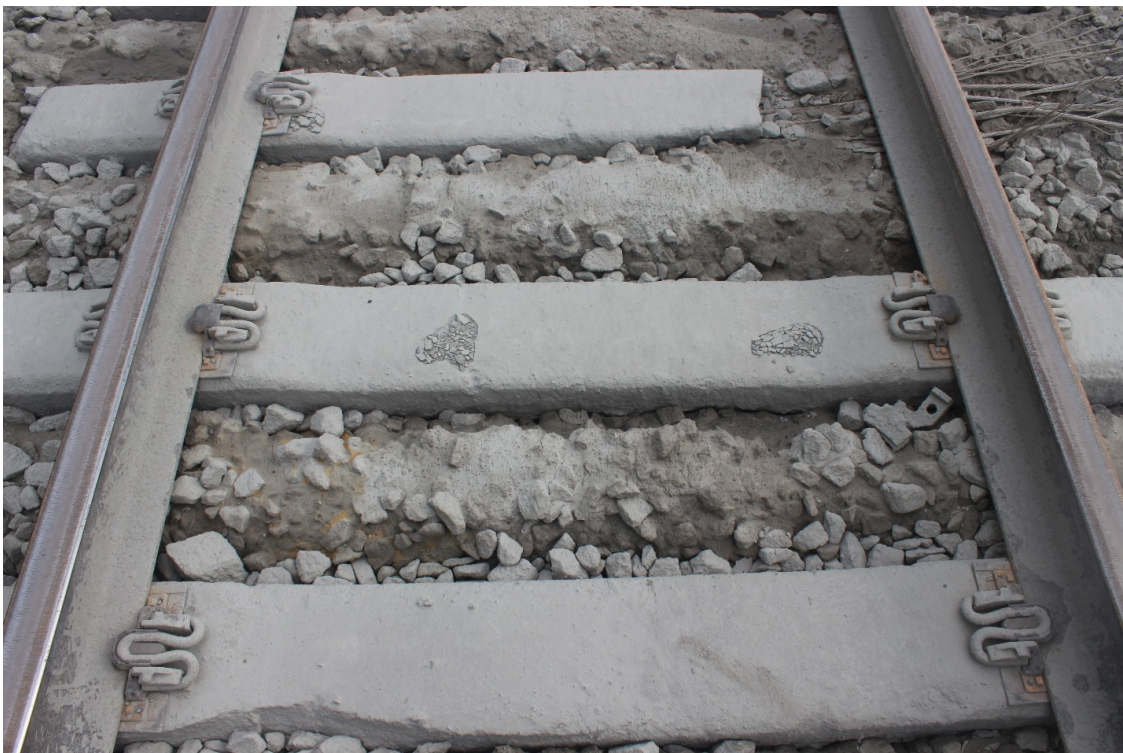
Figure C-14: Ties at locations with mud pumping with severe damage, Crossing #3

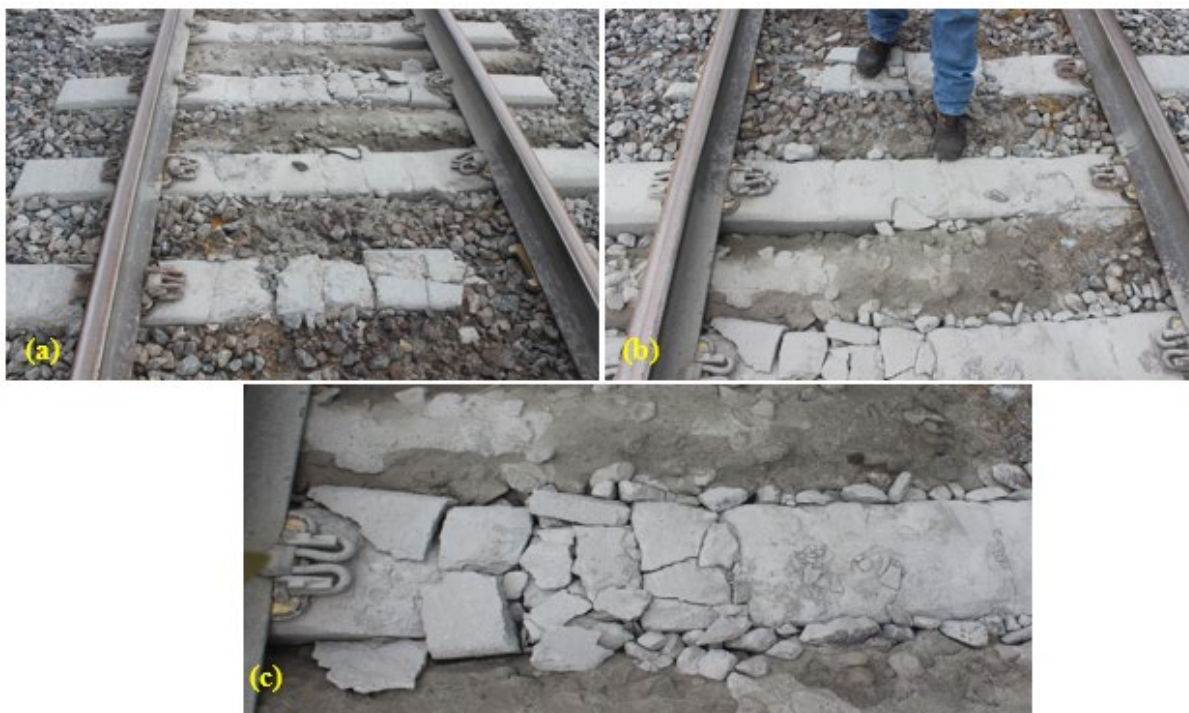
Figure C-16: Shattered ties that began as center-binding cracks, Crossing #3

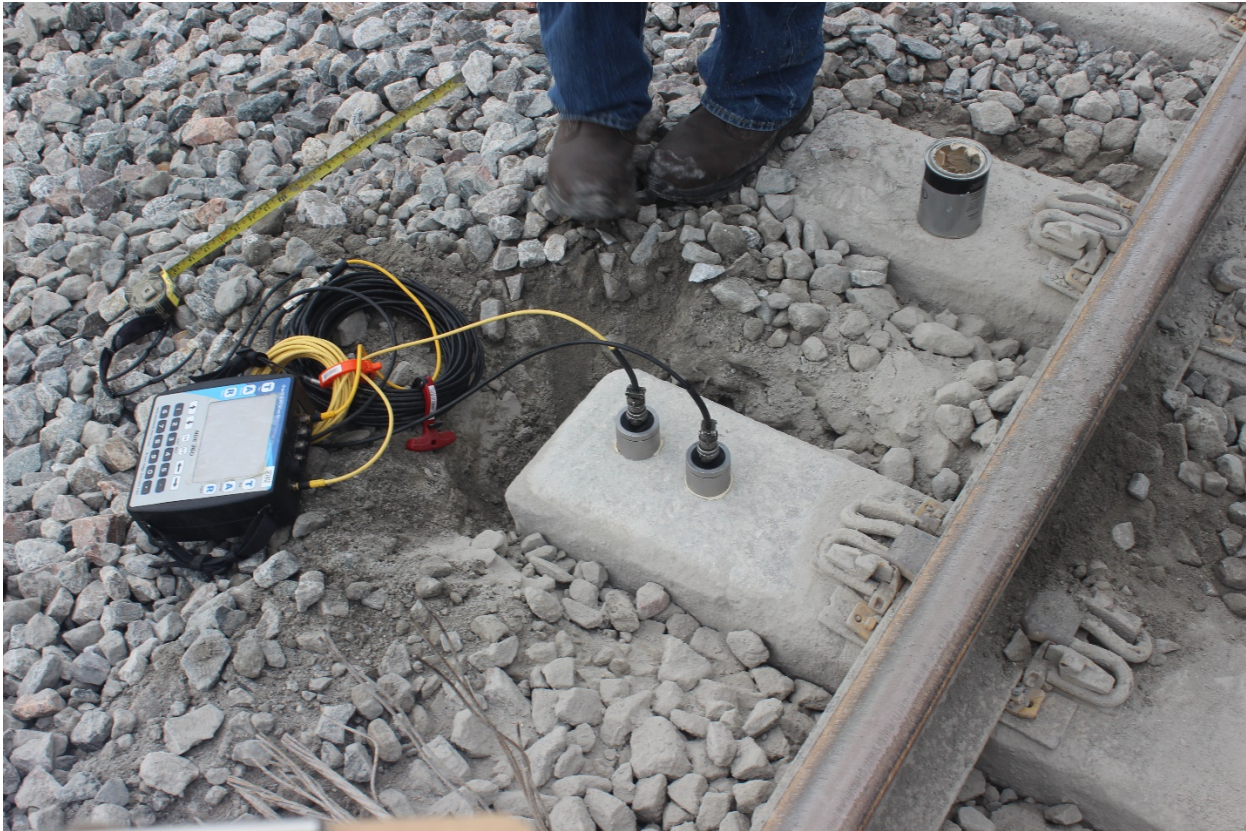
Figure C-18: UPV measurement setup, Crossing #3

Figure C-18 shows the UPV setup. Table C-4 shows the UPV reading from the same shoulder on the site. UPV measurements show that the UPV readings for center-to-shoulder and shoulder-to-shoulder measurements were lower than the one for the same shoulder because the center-binding cracks reduced the wave propagation speed through the concrete tie.

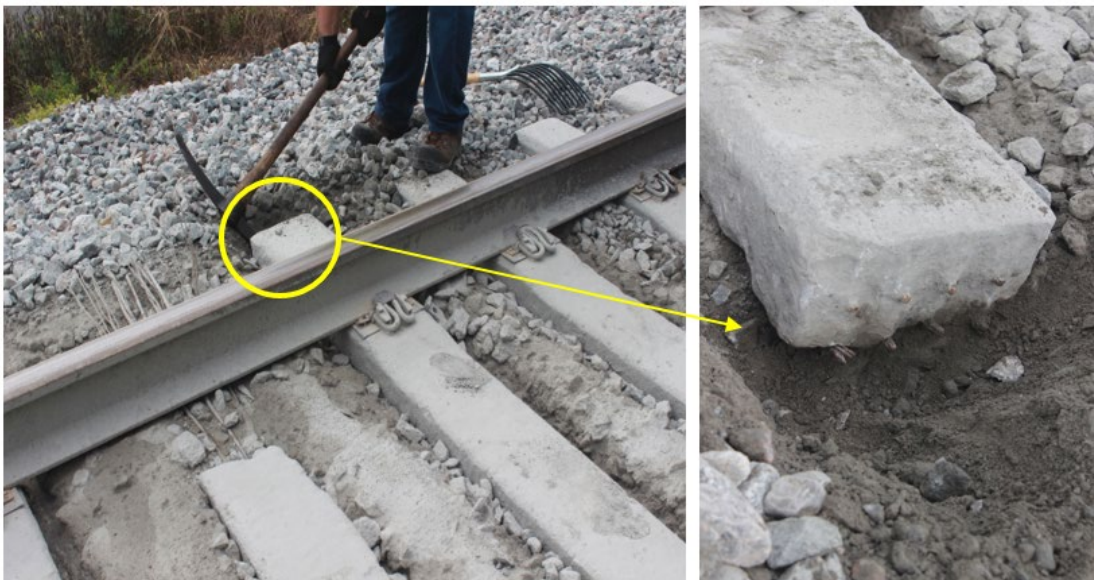
Figure C-19: Samples taken from subgrade and ballast, Crossing #3

Ballast samples were taken from area around the bottom of the tie. These ballast samples were gray in color, see Figure C-19. The gray color indicates the presence of cement particles from abraded concrete ties. Hydration of the unhydrated cement particles made the ballast stiff and it was difficult to dig through the ballast layer. The ballast sample was composed of granitoid/gneiss rocks and large amounts of fines. The fines reacted strongly with HCl, suggesting that a large percentage of the fines were ground-up concrete particles that came from the tie abrasion.

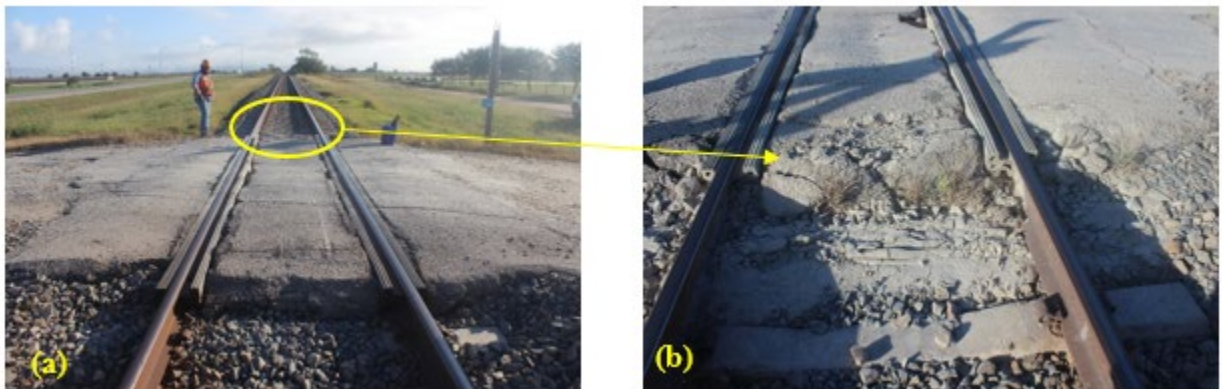
Figure C-21: Asphalt area with mud pumping, Crossing #4

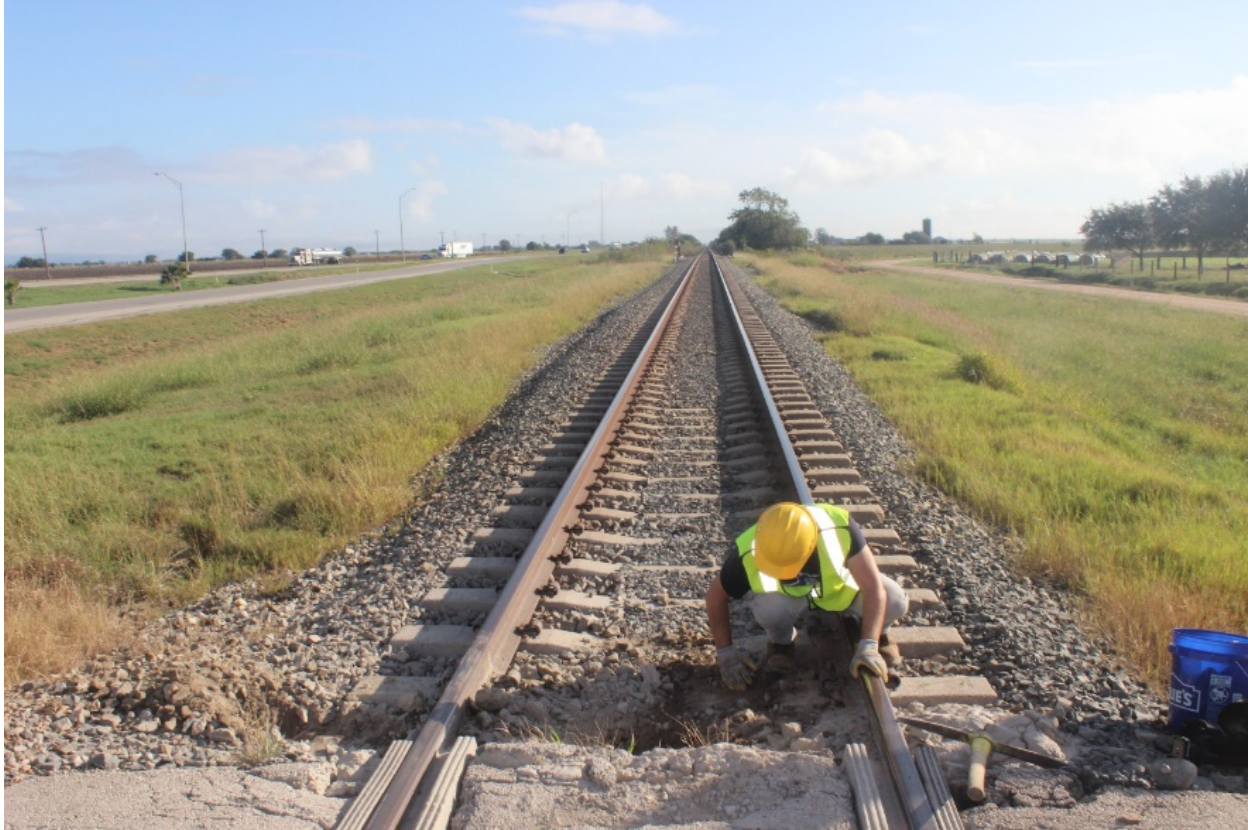
Figure C-24: Subgrade and ballast sample collection, Crossing #4

A ballast sample was taken from track at the depth of the bottom of the ties, as shown in Figure C-24. The sample contained some large concrete pieces (>10 mm). Some concrete fines were present. Silicate clasts were also present in the material, indicating some ballast breakdown.

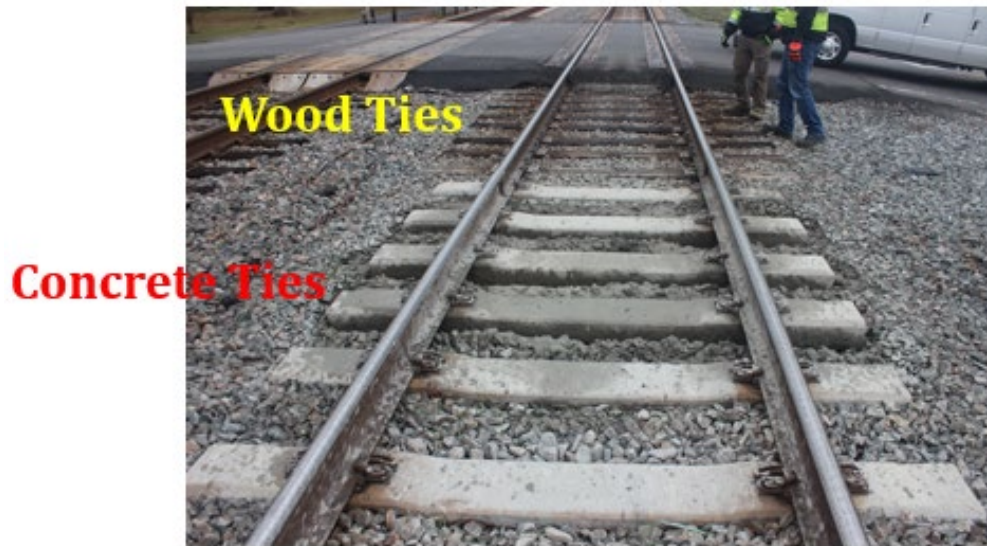
Figure C-27: Concrete-to-wood tie transition, Crossing #5

Mud pumping was evident at the site, Figure C-27. Figure C-28 shows a schematic view of the site and track condition determined from the visual observations. Figure C-29 shows a closer view of the concrete ties and water ponding in track. The pumping was most likely caused by dynamic forces from the trains passing over track with varying stiffness. Car and truck traffic over the intersection likely caused some ballast settlement and drainage is generally poor. There was a bungalow next to the track with a low grade as shown in Figure C-30, reducing track drainage. Some grass was seen present in track, confirming the regular presence of water and fines in track.

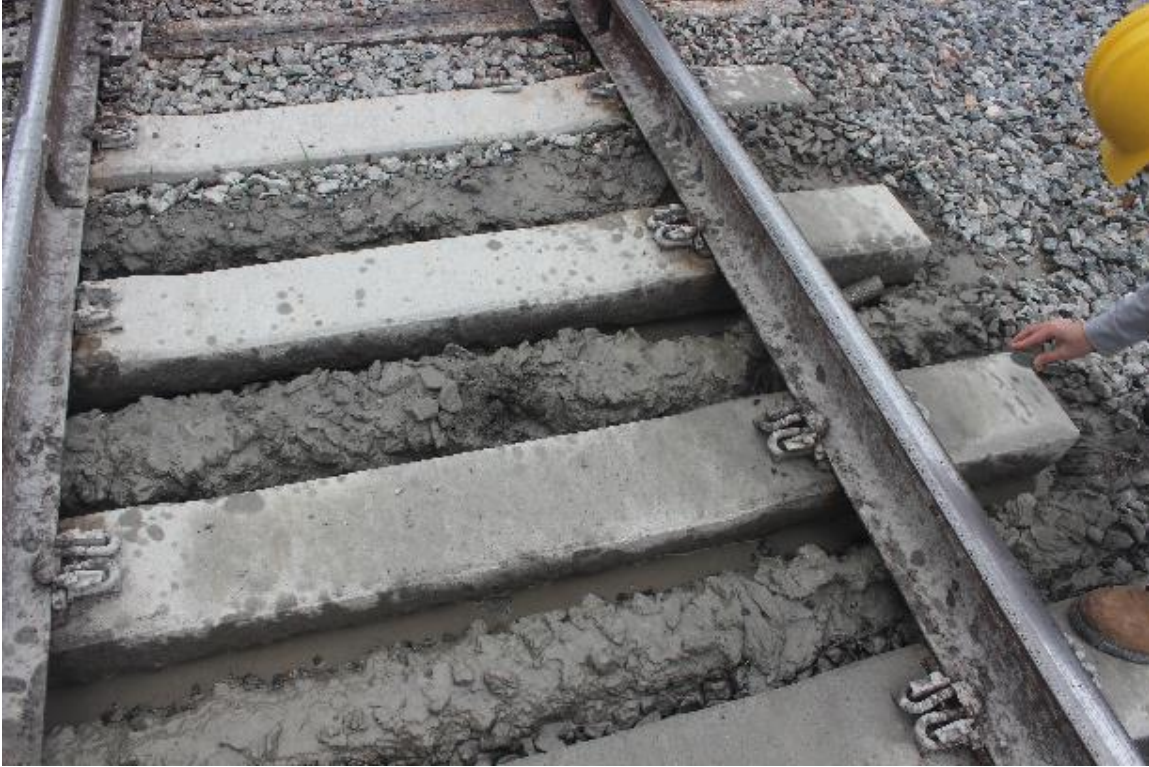
Figure C-29: Mud Pumping at Crossing#5

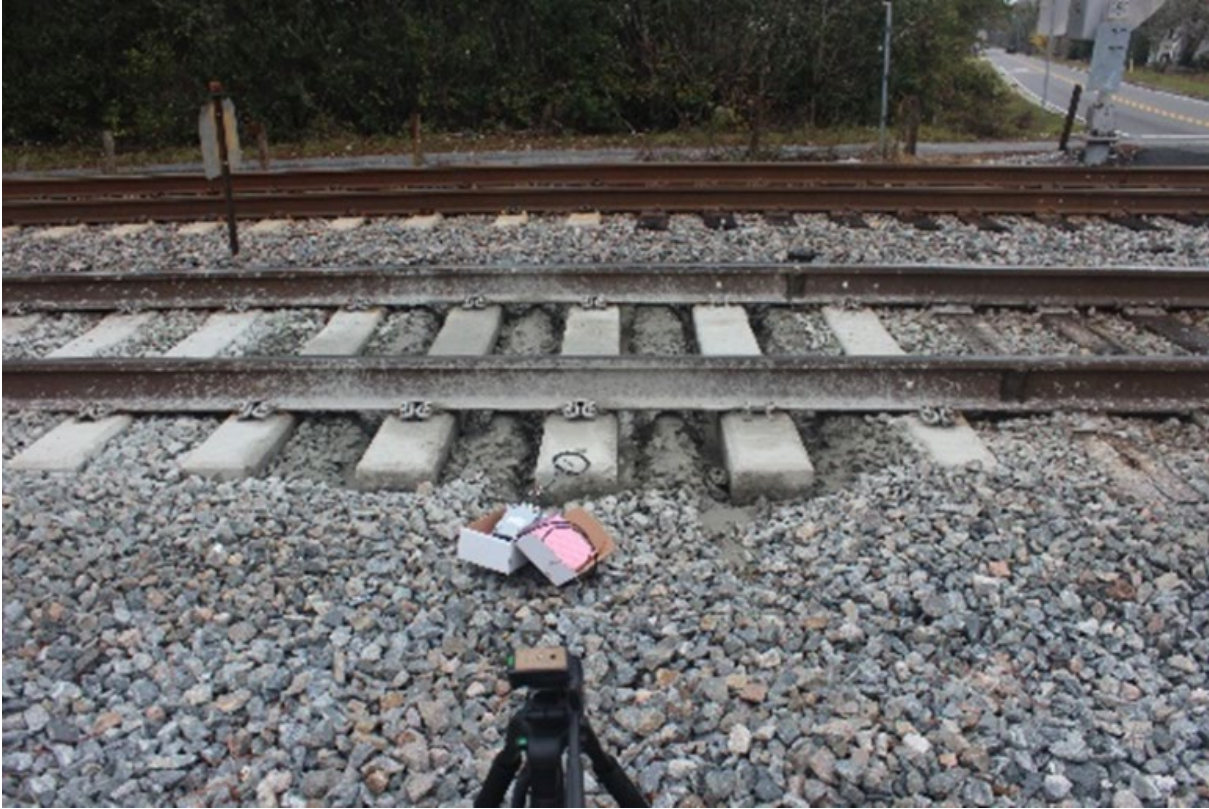
Figure C-31: Tie acceleration and deflection were measured using an accelerometer and high-resolution camera, Crossing #5

The vertical deflection of the tie with the most severe pumping was measured using high definition video. The camera was placed on a tripod and focused on a concrete tie, as shown in Figure C-31. The camera and tripod were held in place while the train passed to control vibration. The maximum deflection of the tie was 0.75 inches. Water in track rose with the applied loads and splashed over the tie. Figure C-32 and Figure C-33 are screenshots of the track video during a train pass with the ties in high and low positions in the track, respectively. Figure C-34 shows the tie vertical deflection measured from the high-speed video. An accelerometer was attached to the tie to measure the tie acceleration during loading, as shown in Figure C-31. Figure C-35 shows the measured acceleration of the tie three directions. The high level of vertical acceleration indicates poor ballast support. The lateral acceleration data indicates that the tie moves significantly to the sides of the track. This movement may contribute to abrasion losses on the tie.

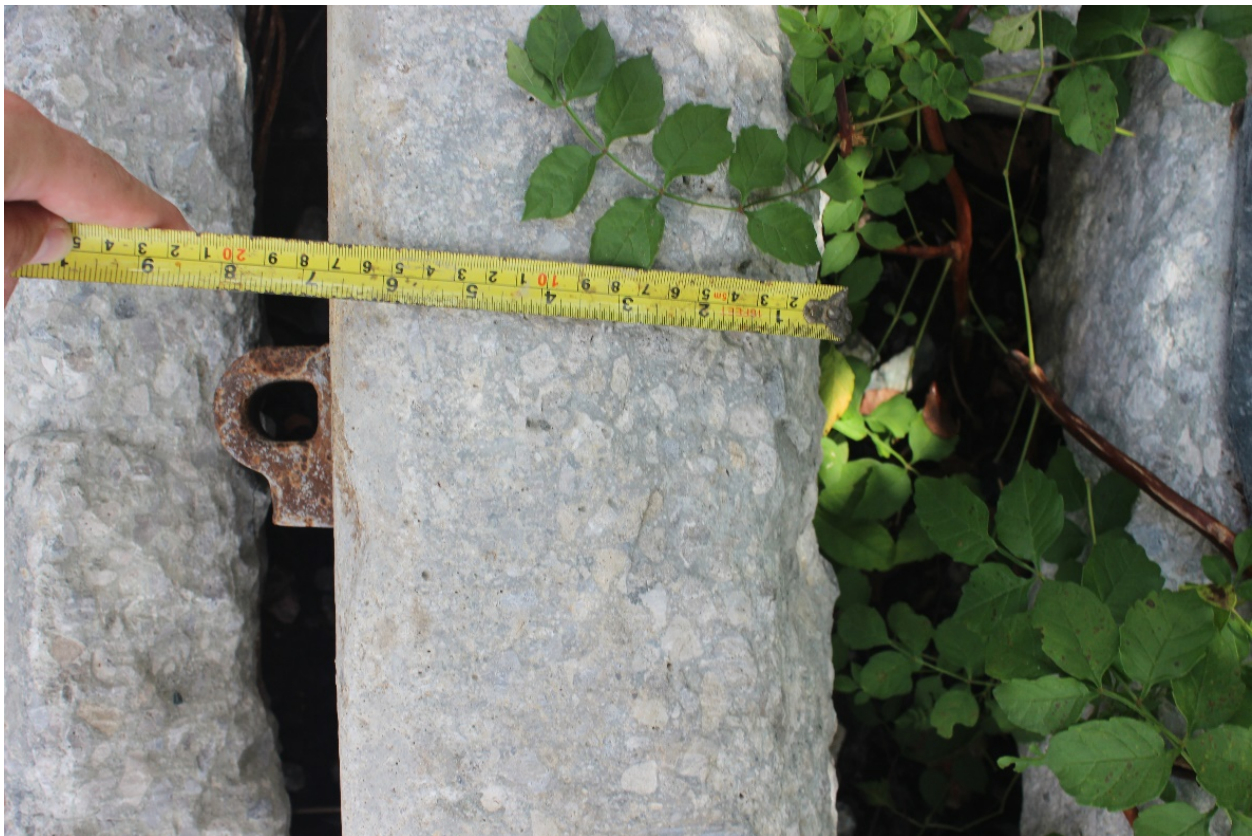
Researchers measured thickness of two ties, one in track and the other found beside the track. Table C-9 shows the tie thickness measured on the tie in track. Figure C-40 shows a picture of a tie beside the track. These ties were made with a relatively soft aggregate. Damage seen with this tie showed less surface roughness than ties made with harder aggregates.

Figure C-40: Tie found beside the track, Crossing #6

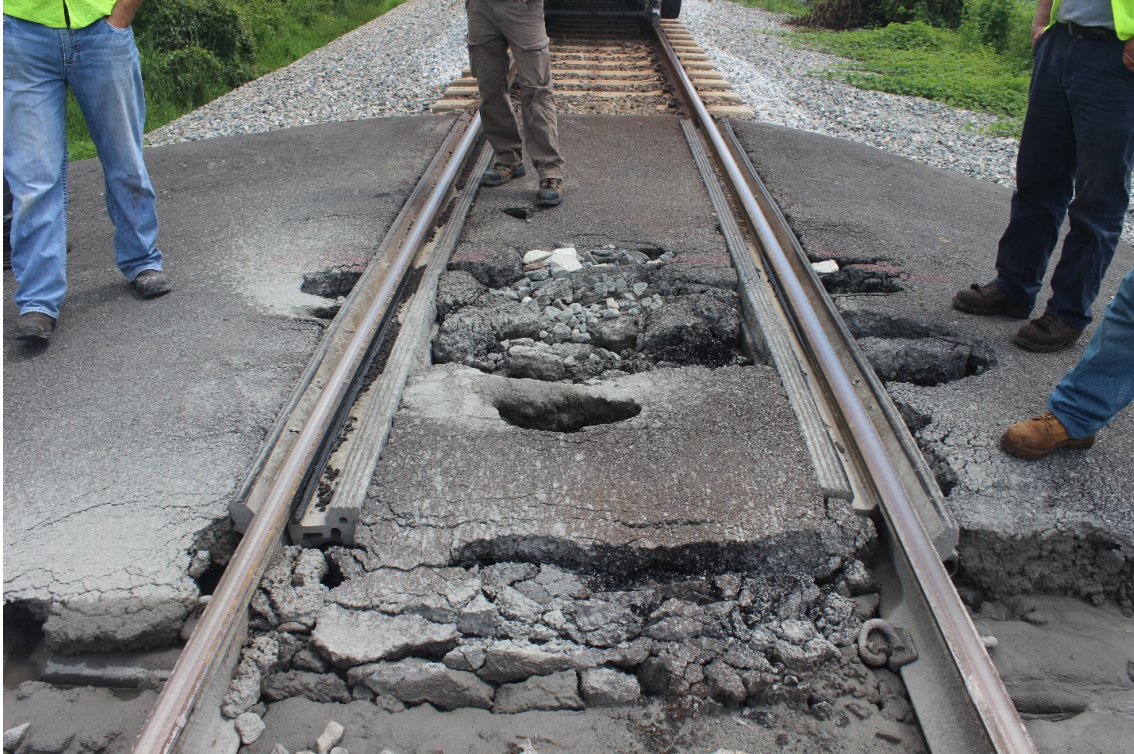
The asphalt crossing showed significant deterioration that appeared to originate underneath the asphalt causing erosion, Figure C-42. Water was seen present in the crossing and in the fouled ballast adjacent to the crossing. Fines from asphalt stripping were seen to have migrated from the asphalt topping in the crossing to the fouled ballast in track. Asphalt fines are cohesive and likely helped contribute to fines sticking together and clogging up ballast pores, enhancing water retention. The gray-colored fines and water are shown in [Figure 3-6](#). Figure C-43 shows a close-up picture of the ballast fouling at the edge of the crossing. Asphalt fines and water are documented in this picture.

Figure C-42: Crossing #7

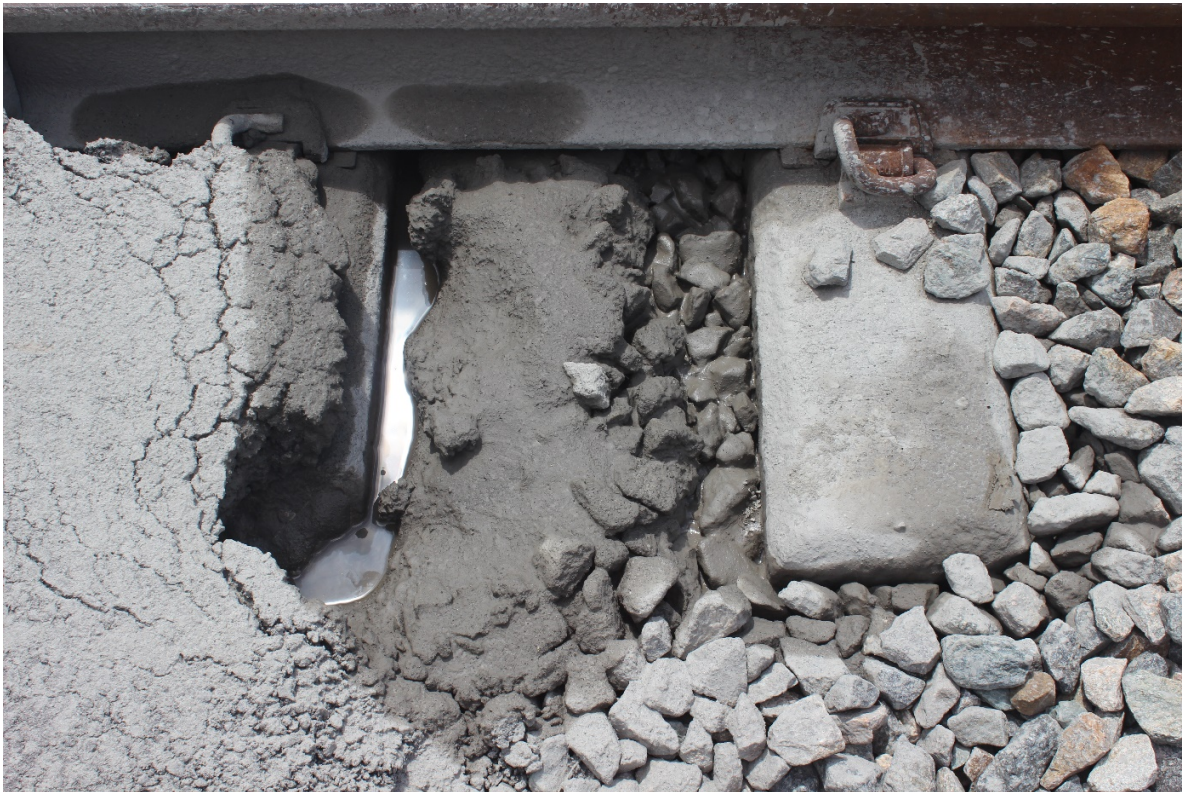
Figure C-43: Ballast fouling adjacent to Crossing #7

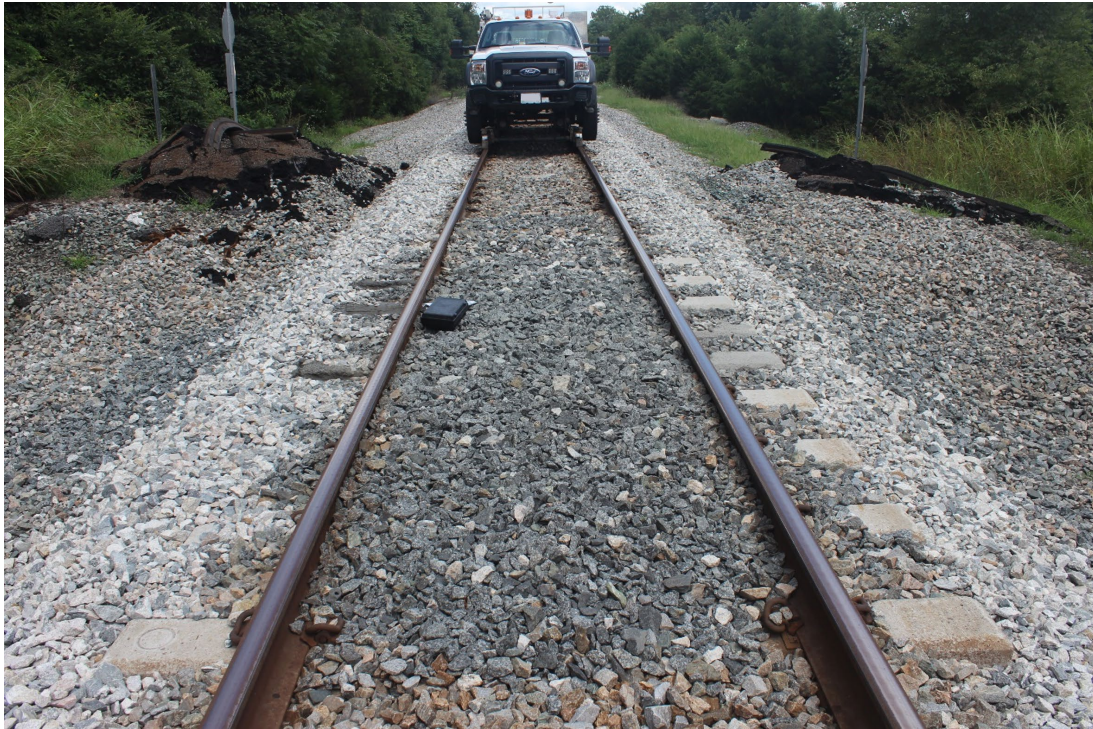
A mud spot was seen in track at the location where the road crossing once existed. The site had significant evidence of mud pumping. Figure C-45 shows the areas on the side of the track. Figure C-46 shows an up-close view of some of the ballast fouling. Pieces of asphalt are visible in the fouling. A culvert is located under the fouled track, as shown in Figure C-47. A culvert would likely increase track stiffness.

Figure C-45: Track section with removed crossing, Crossing #8

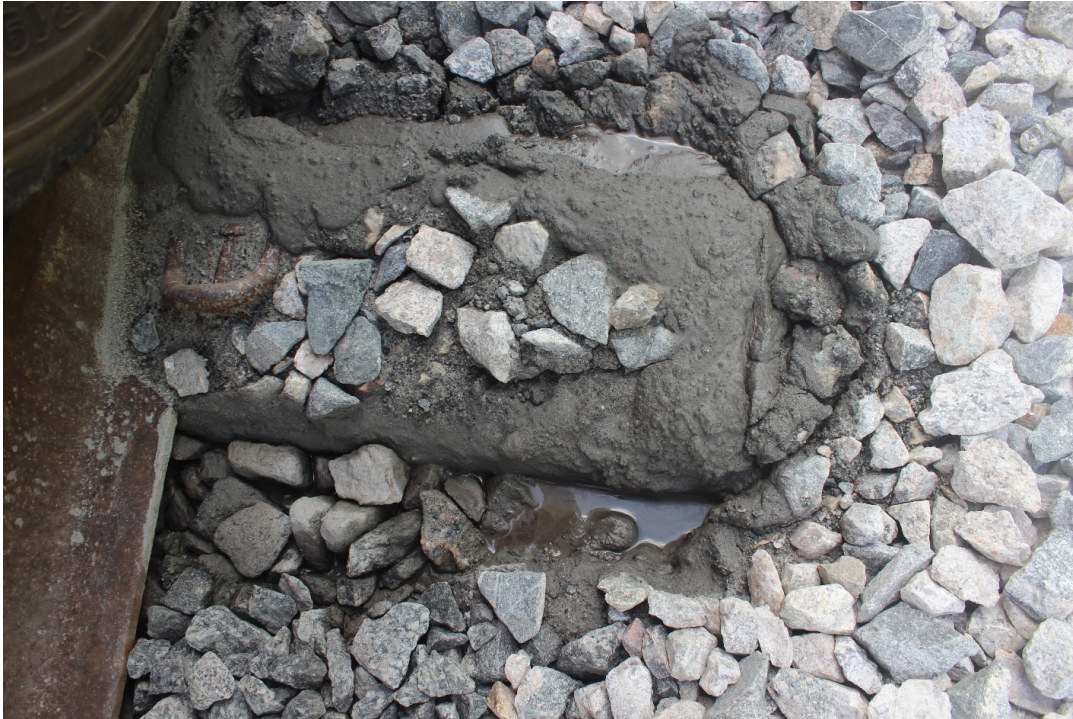
Figure C-46: Asphalt pieces are present in the fouled ballast, Crossing #8

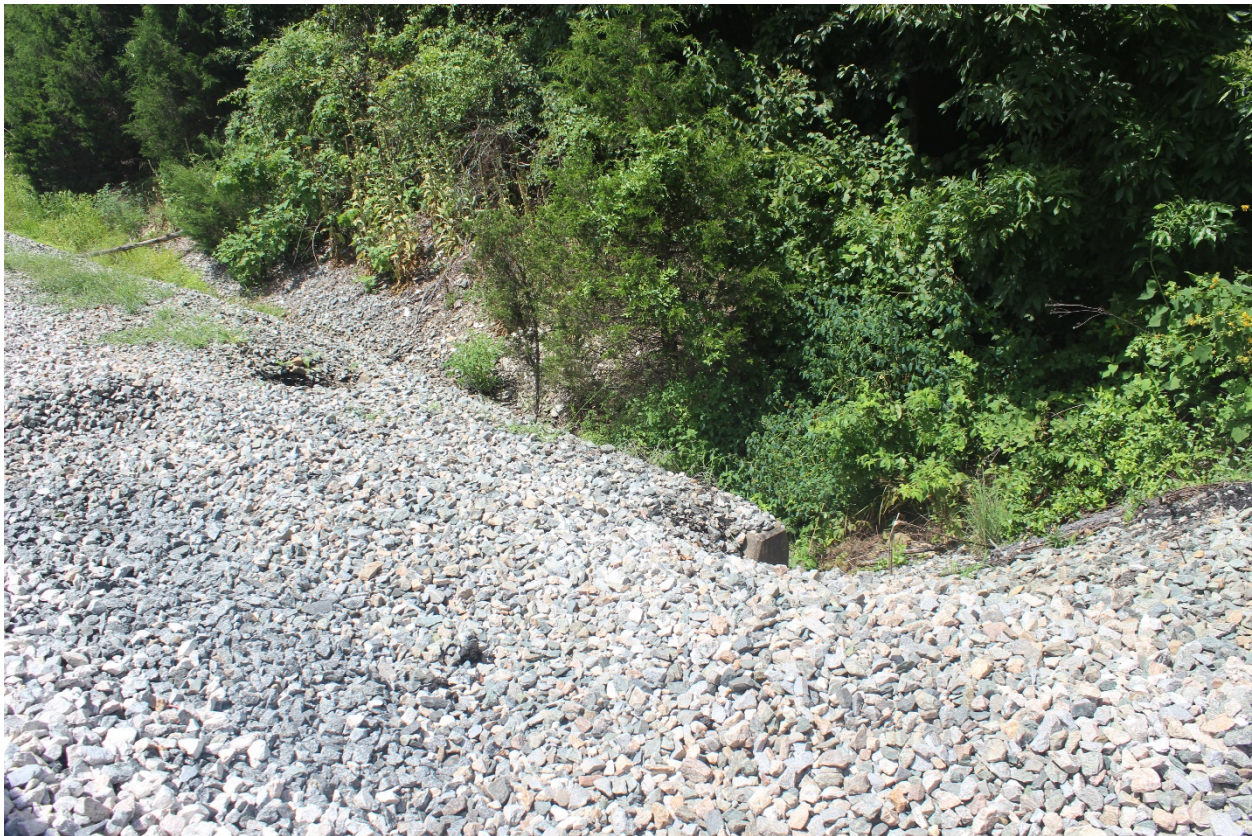
A culvert, combined with a nearby asphalt crossing, could have created stiff track conditions with drainage issues and high ballast stresses. Fines may have migrated from the crossing into the ballast, increasing fouling.

Figure C-47: Culvert at location of ballast fouling, Crossing #8

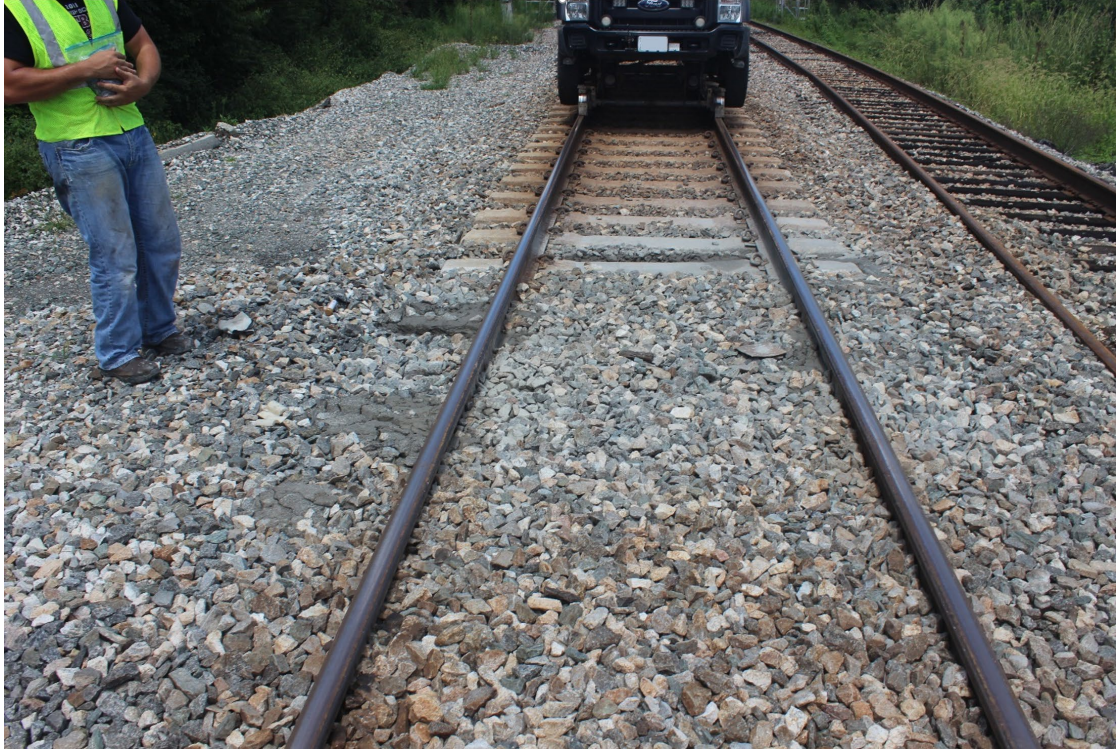
Figure C-54: Mud pumping coming up through crossing ballast and on the edge of Crossing #9
