**Federal Railroad
Administration**

A Study of Environmental and Track Factors that Contribute to Abrasion Damage of Concrete Ties

9. SPONSORING/MONITORING AGENCY NAME(S) AND ADDRESS(ES) U.S. Department of Transportation Federal Railroad Administration Office of Railroad Policy and Development Office of Research, Development and Technology Washington, DC 20590			10. SPONSORING/MONITORING AGENCY REPORT NUMBER DOT/FRA/ORD-19/38

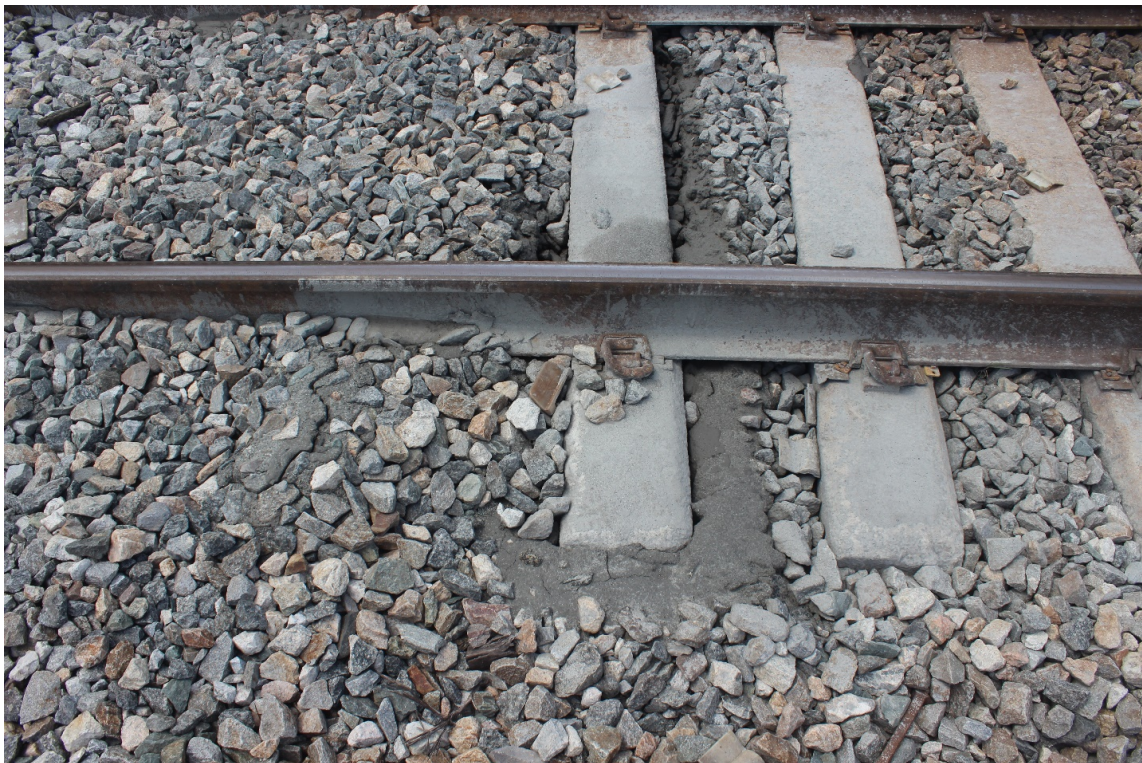
The crossing has a transition from wood-to-concrete ties. Center-binding cracking and shattered tie tops were seen in track right at the transition from wood-to-concrete ties, as shown in Figure C-53(a). Clean ballast appeared to be placed on top of the crossing to allow for better car movement over the tracks. Ballast fouling was seen to be present underneath the new ballast and on the outskirts of the crossing, as shown in Figure C-53(b). Asphalt fines appeared to be present in the ballast fouling in the concrete track. Figure C-54 shows the pumping around the tie immediately after the crossing on the opposite side of the crossing from the wood-to-concrete tie transition. Track grading and drainage appeared to be poor at the crossing as evidenced by the vegetation seen in Figure C-53 and the damp fines seen in Figure C-55, contributing to water retention in-track.

Figure C-55: Mud pumping, Crossing #9

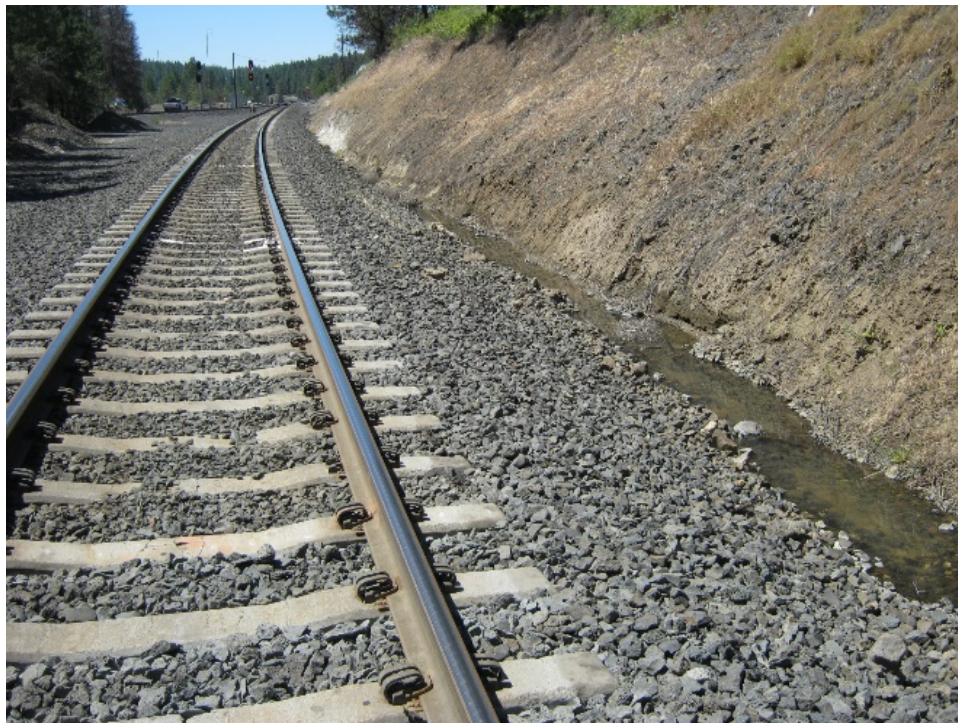
The track is in a section cut with higher elevation on both sides of the track. The ballast layer was undercut 3–4 months before the research team visited the site. The railroad claims there was a creek of water flowing through the track during undercutting. Standing water is adjacent to the track, Figure D-4. Figure D-5 illustrates how water could be flowing through the cut sections of hill, allowing for water damage in track. The steep slopes show recent erosion that is further evidence of local water.

Figure D-4: Water available on the site, Curve #1

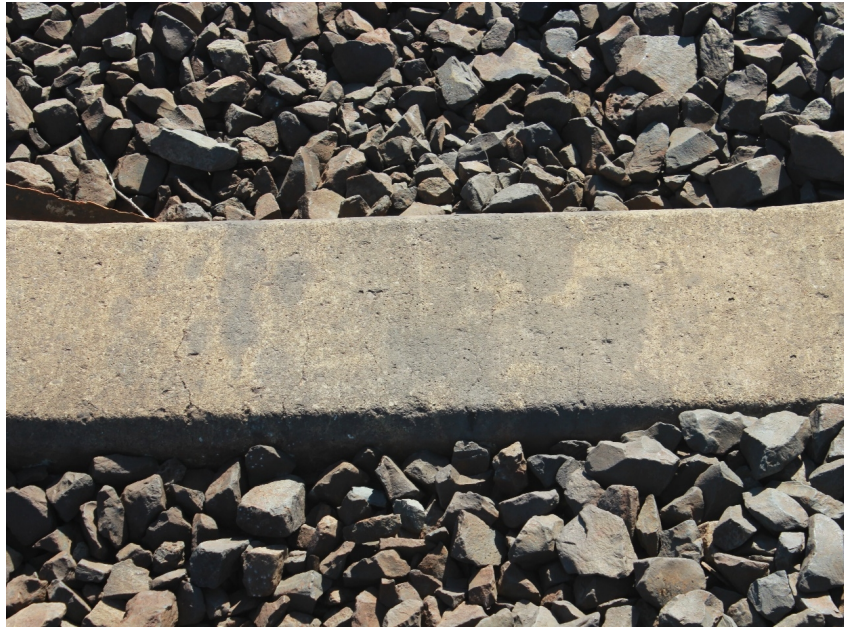
Figure D-6 shows gray mud present in some track segments. Three fouled-ballast patches were seen during the site visit. The ties had minor center-binding cracking and some had minor splitting cracks. Figure D-9 shows an example of the minor center-binding cracking present on the ties, while Figure D-10 shows vertical splitting cracks found on some ties. The site had been undercut 3 years before this inspection, and fouling had returned at three locations. There were rail welds near the fouled area, indicating potential surfacing issues and/or elevated rail stress.

Figure D-9: Minor center-binding cracks, Curve #2

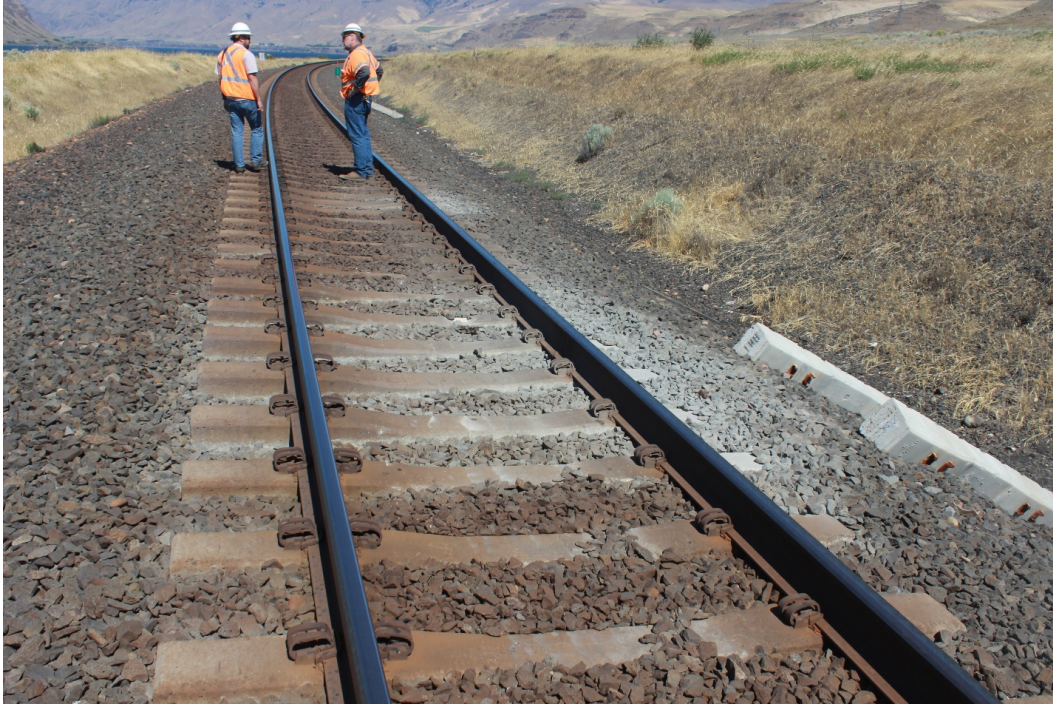
The railroad reported that the ballast was regularly maintained, however the site had not been undercut recently, only built up. Figure D-14 shows a picture of the track site with visible gray fouling present on ballast. The railroad was in the process of replacing individual ties in order to improve track conditions and remove the slow order, see Figure D-15. The tie shown in Figure D-15 has some abrasion damage on the sides. The railroad plans to replace all ties in the future due to center-binding cracking and cracks near of the fasteners. Figure D-16 is an example of the center-binding cracking.

Figure D-14: Gray-colored fouling present on ballast, Curve #3

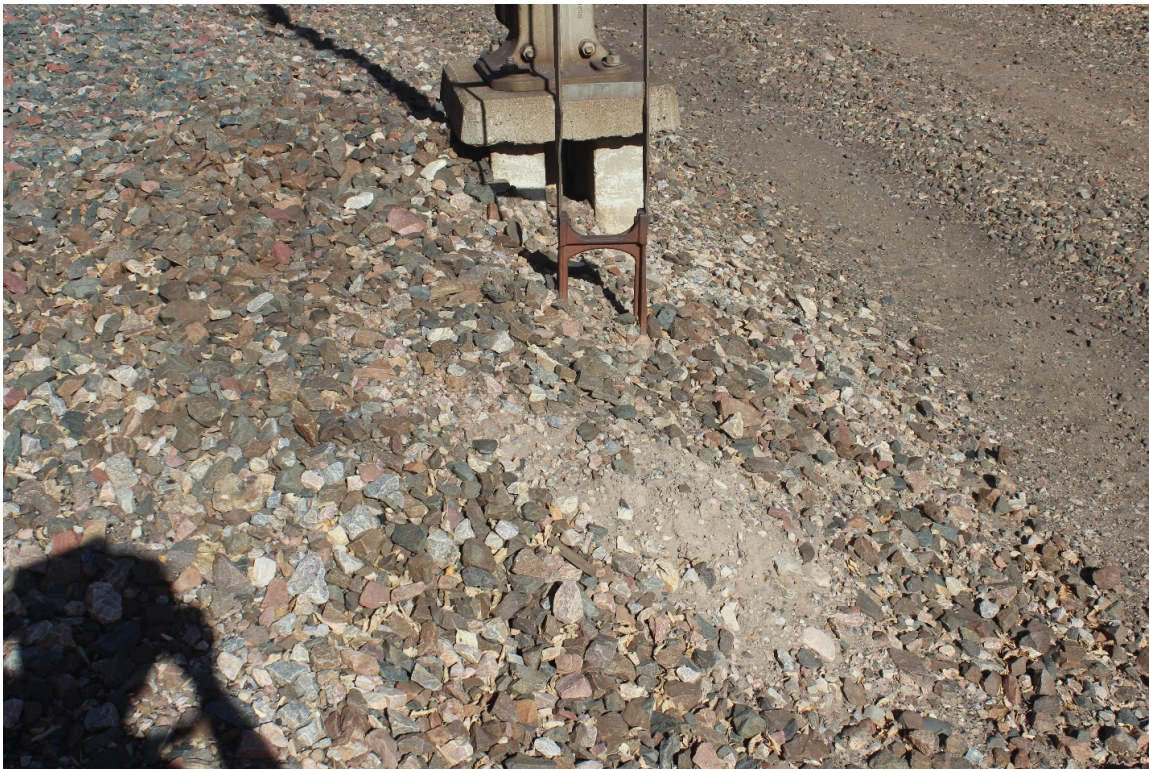
Figure D-18: Fines on the side of the track

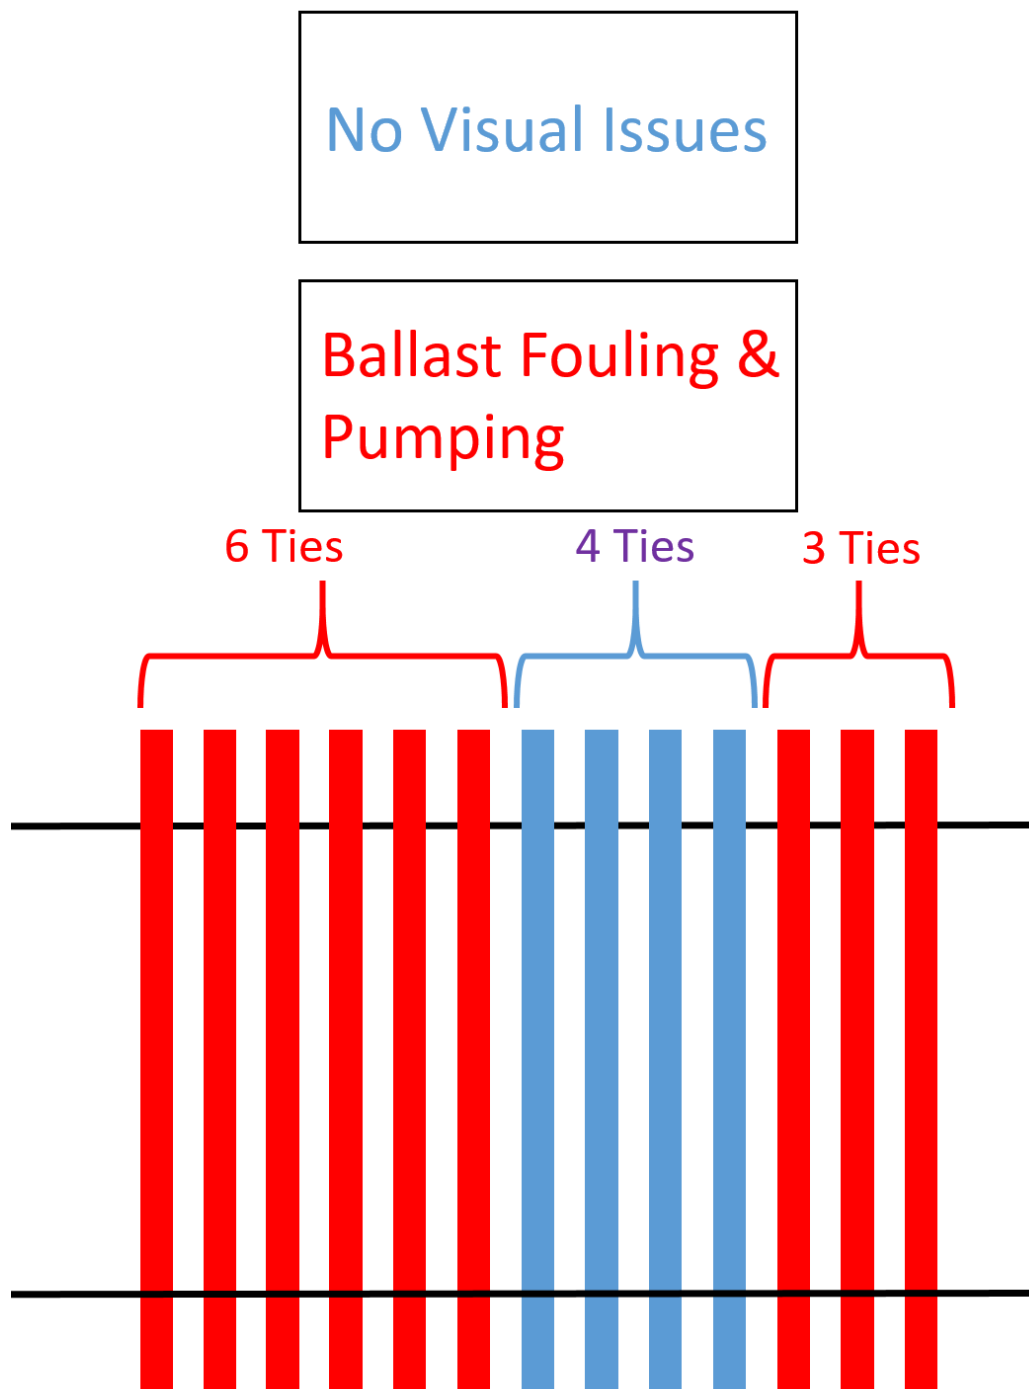
The site is an area that frequently has rock slides, as evidenced by the fallen rocks in the drainage ditch and the lack of vegetation on the hillside seen in Figure D-21. Figure D-22 shows a schematic of the tie deterioration in track. There were two sections with surface-visible fouled ballast. The fouled ballast had beige fines from mud pumping around the ties, as shown in Figure D-23 and Figure D-24. The fines were the same color as the surrounding soil, indicating that the majority of fines were from the subgrade. The ties had only minor abrasion wear.

Figure D-22: Schematic of tie condition, Curve #5

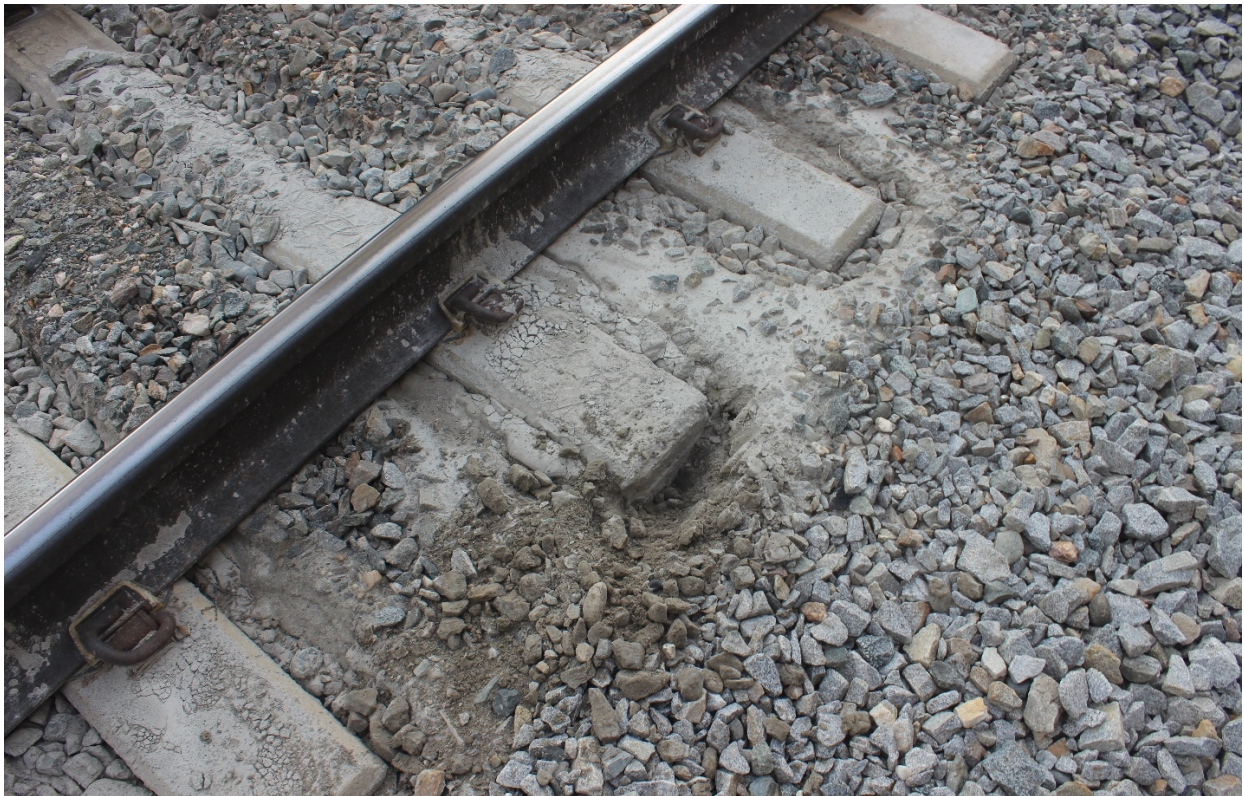
Figure D-24: Fine particles seen at the track surface, Curve #5

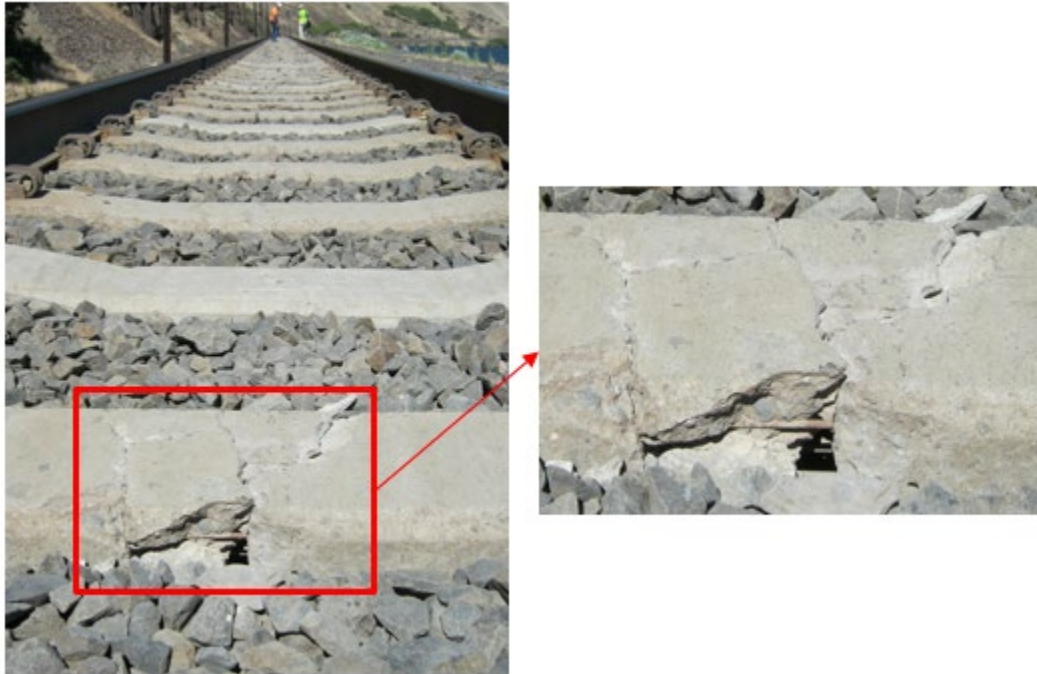
Researchers observed center-binding cracking over a long section of this track as shown in [Figure 3-24](#). Some ties had severe center-binding cracking that progressed to full delamination, exposing the steel reinforcements, Figure E-3. Some splitting cracks were also seen at this site.

Figure E-3: Severe center binding cracking and exposed reinforcements, Tangent #1

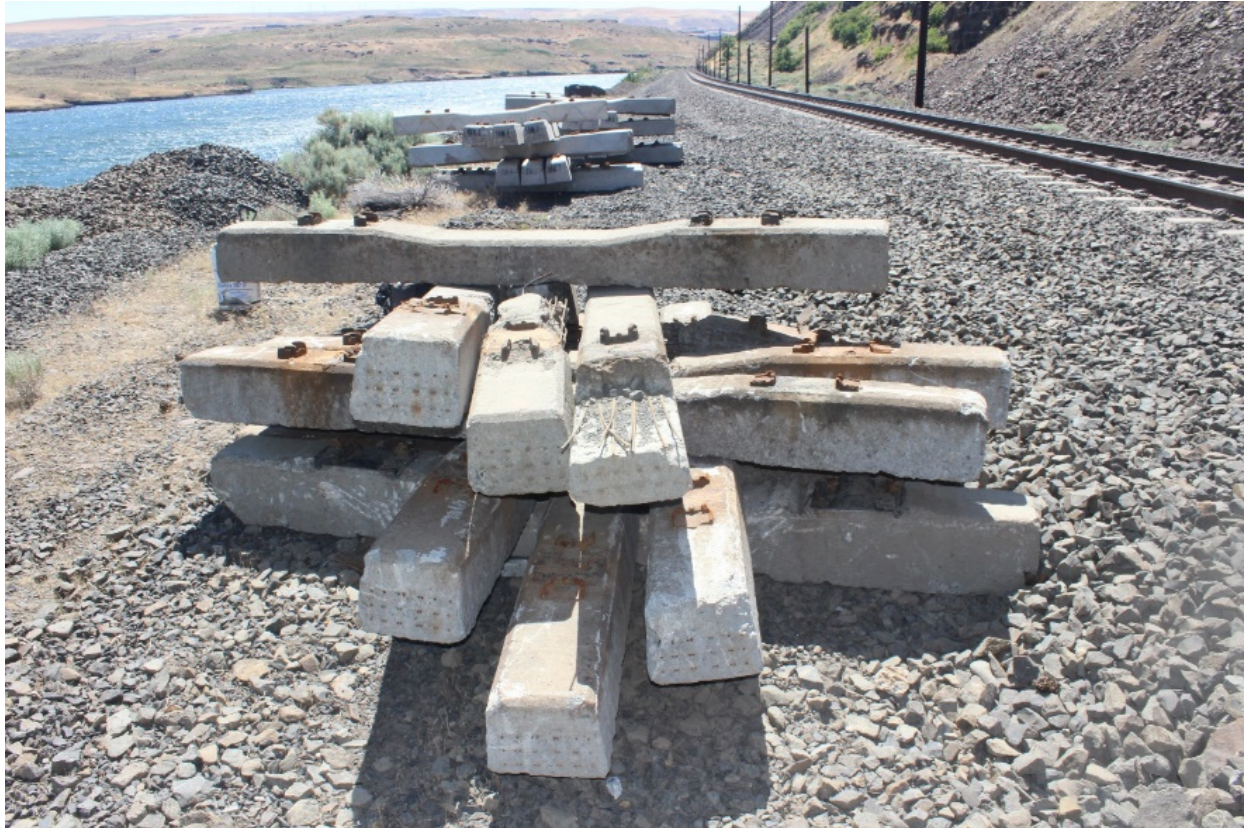
This site was experiencing rapid degradation following a shoulder cleaning operation 1 year prior. The track speed was reduced from 40 mph to 25 mph a couple of weeks before the inspection, and then down to 10 mph immediately following the inspection. Center-binding cracking started within a month after the shoulder cleaning. Track degradation may be the result of a lack of support under the tie ends after shoulder cleaning and/or improper tamping after the cleaning. Figure E-4 shows ties that were removed from track and stored on the side of the road. Very little abrasion was seen on the ties stored on the side of the road.

Figure E-4: Ties removed from track and stored on the side of the road, Tangent #1

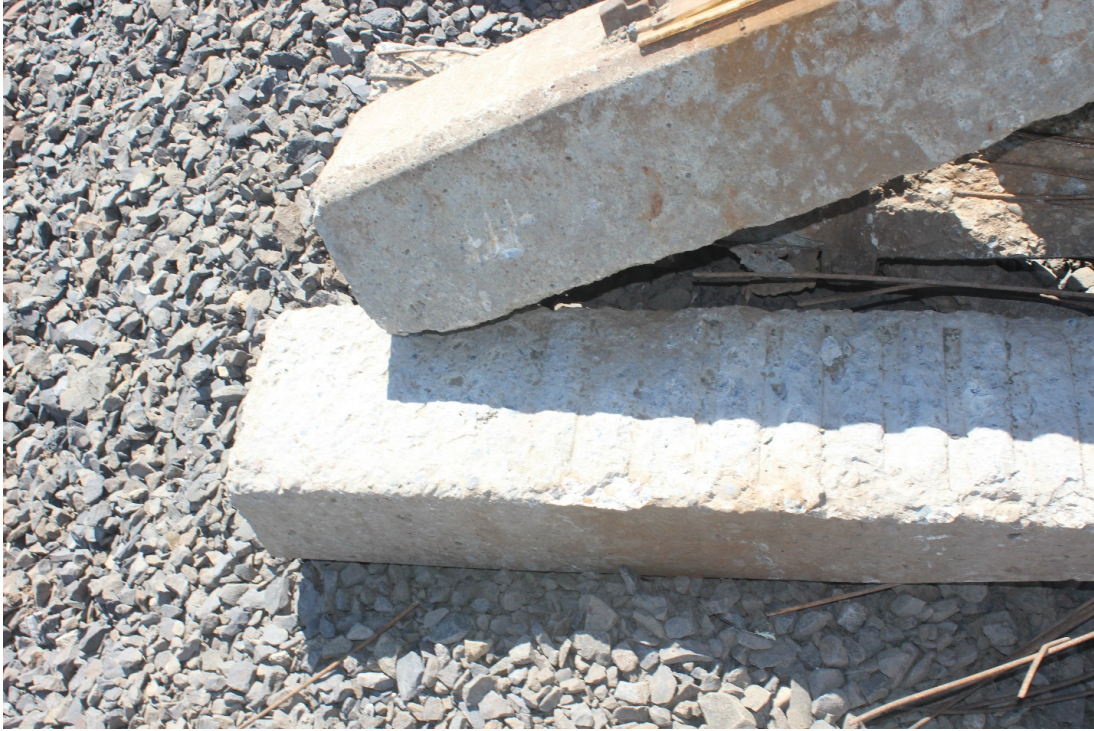
Figure E-6: Ties stored on the side of the road, Tangent #2

The thickness of a tie was measured at one location in track. Table E-2 shows the thickness data. Very little change in tie thickness was measured in track, matching the low amount of wear seen on the discarded ties shown in Figure E-6.

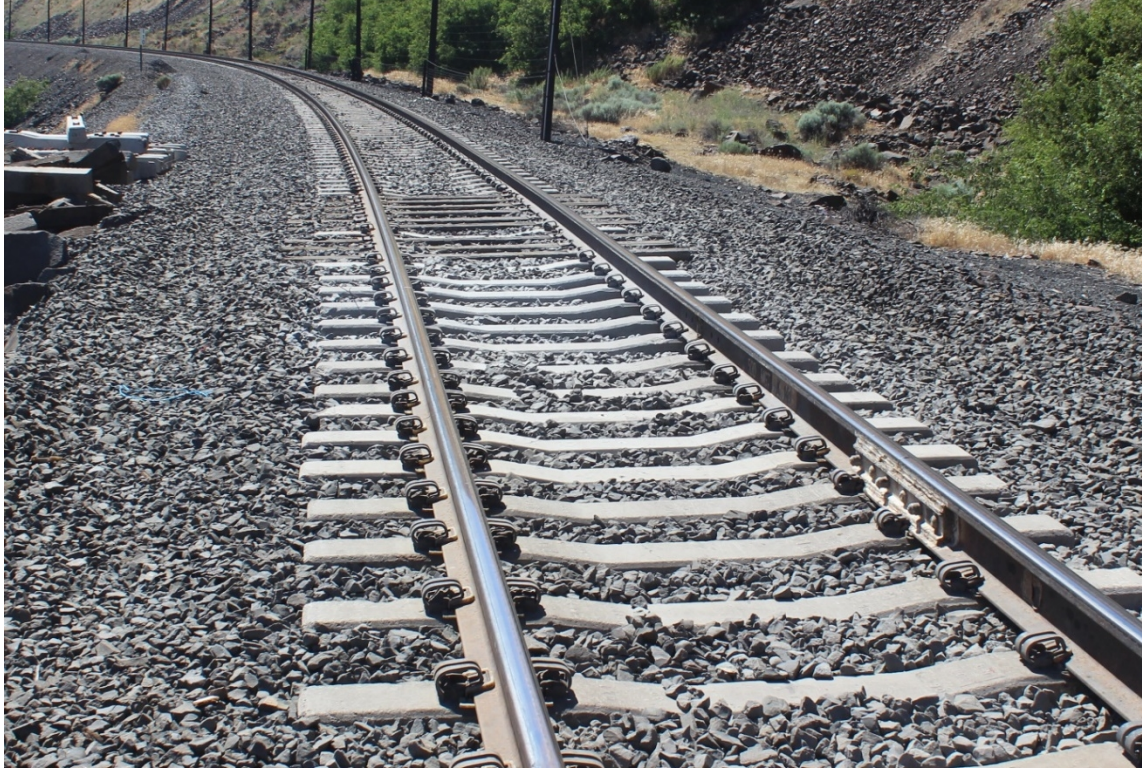
Figure E-8: Pumping on the concrete ties next to wooden ties, Tangent #2

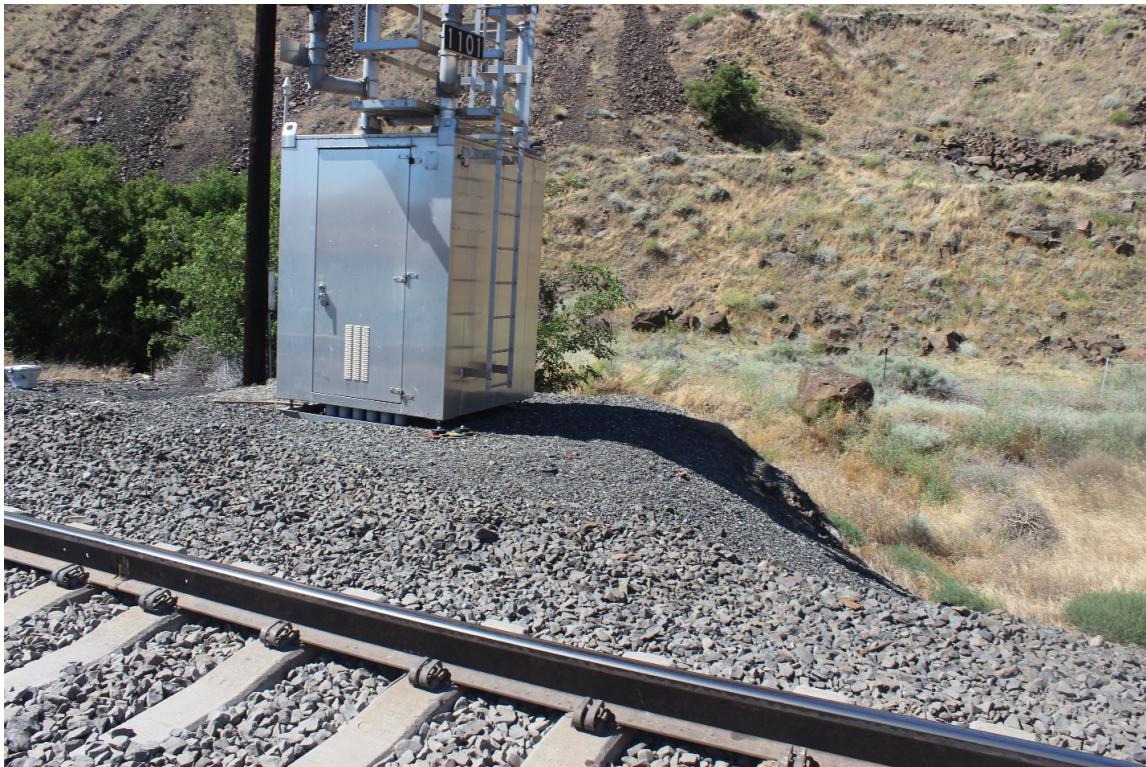
Some ties were removed from track and stacked nearby, see Figure E-6. There were isolated ties found in track that appeared to have side wear and corner rounding from local ballast conditions, as shown in Figure E-7. The tie did not appear to have any loss in thickness. Center binding cracking was seen on many ties in track. The tie shoulder ballast was cleaned a year before inspection of the research team. Center binding cracking appeared within a month after ballast cleaning, likely because of different stiffness in track under center and the end of the tie. Figure E-8 shows concrete ties with some ballast churn and fouling next to a section of wooden replacement ties next to an insulated joint. The track was elevated and had good grading and drainage, except at the signal location as shown in Figure E-9. The site was very arid with dry grass in the area.

Figure E-9: Poor grading at signal, Tangent #2

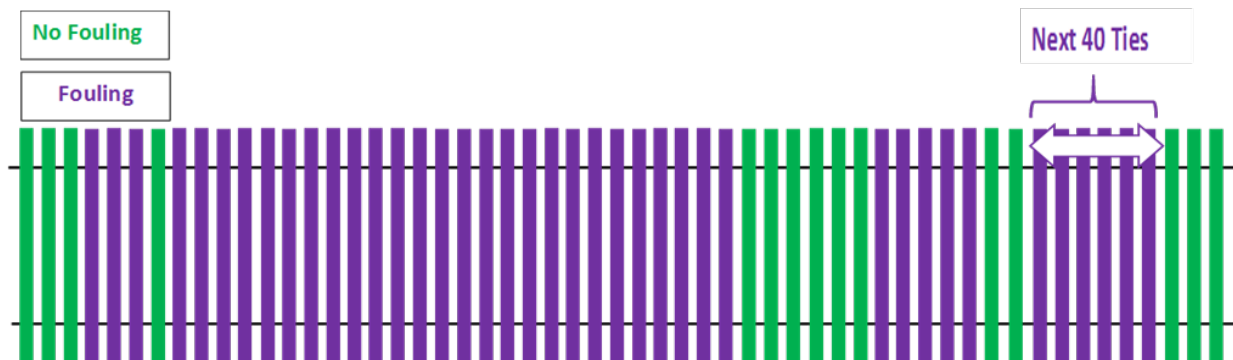
There were ditches on both sides of the track. The ditches were full of vegetation, indicating year-round moisture. The railroad reported that this section of track was undercut about 3 years prior due to surface issues. Significant track fouling was present, as shown in Figure E-11. Figure E-12 shows a schematic of the observed fouling conditions. A potential cause of fouling could be low ballast levels under the ties, leading to high pressures on subgrade and fines infiltration into the track structure.

Figure E-12: Schematic view of fouling, Tangent #3

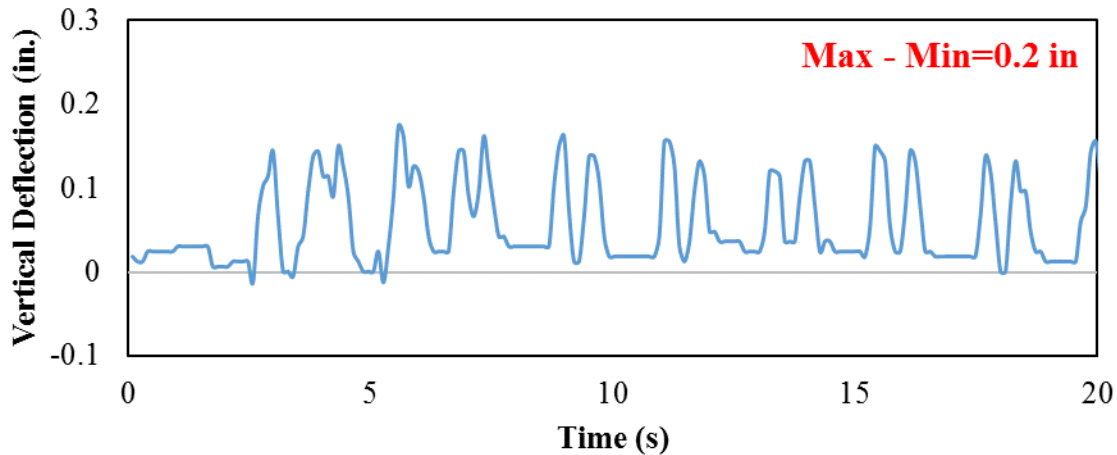
Researchers measured the vertical deflection of the tie with the most severe fouling using high definition video during a train pass. The camera and tripod were held in place while the train passed to eliminate vibration in the video images. The deflection was estimated from the vertical movement seen in the images and is shown in Figure E-13. The maximum deflection range was 0.2 inches. The maintenance personnel told the research team that this location pumps a lot when wet. It is likely that the deflection would be much higher at this site after a rain.

Figure E-13: Vertical deflection of tie measured with high-resolution camera, Tangent #3

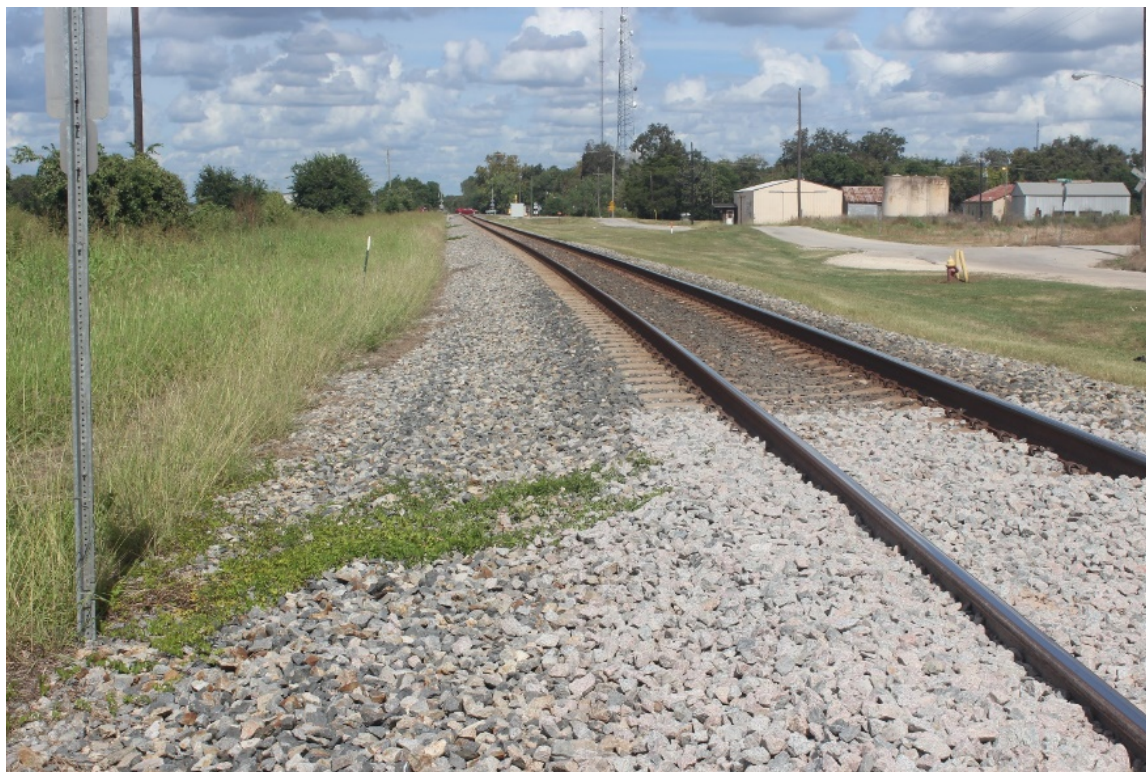
Insufficient tie support was provided by the track structure, causing fines from the subgrade to pump upwards into the track structure. As shown in Figure E-16, the pumped mud had the same color as subgrade, confirming that there was little ballast under the track and that subgrade fines were infiltrating the track structure. Water and fine subgrade particles present at the site allows grass and other vegetation to grow in the ditches and encroach in the track structure, as shown in Figure E-17.

Figure E-17: Vegetation encroaching on track, Tangent #4

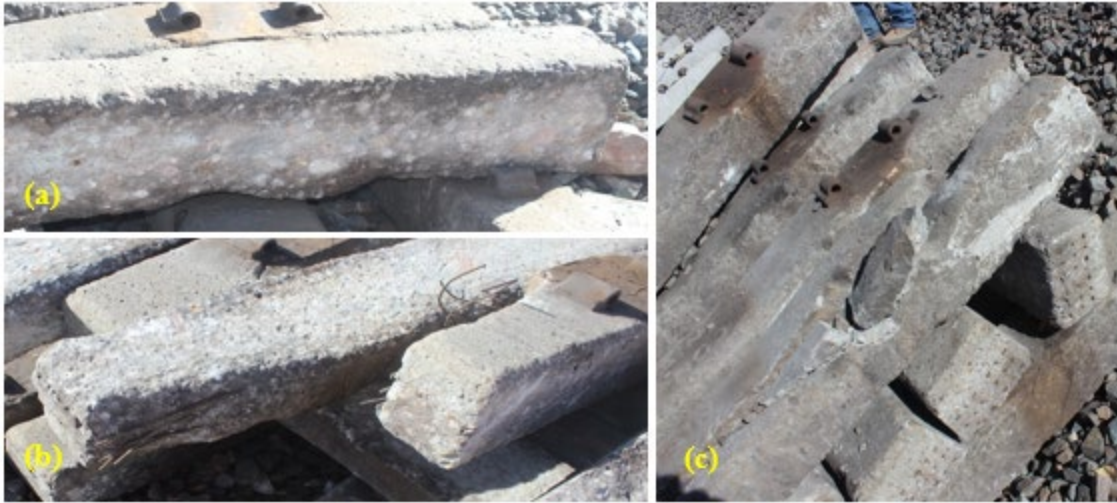
Some of the ties removed from track and displayed various wear conditions, as shown in Figure E-19, where (a) shows bottom abrasion, (b) shows exposed steel reinforcements, and (c) shows ties with spalling. Figure E-20 shows ties that were stored next to replacement ties. Overall, the level of abrasion damage seen in ties taken from track on this site was minor.

Figure E-19: Tie abrasion damage, Tangent #5

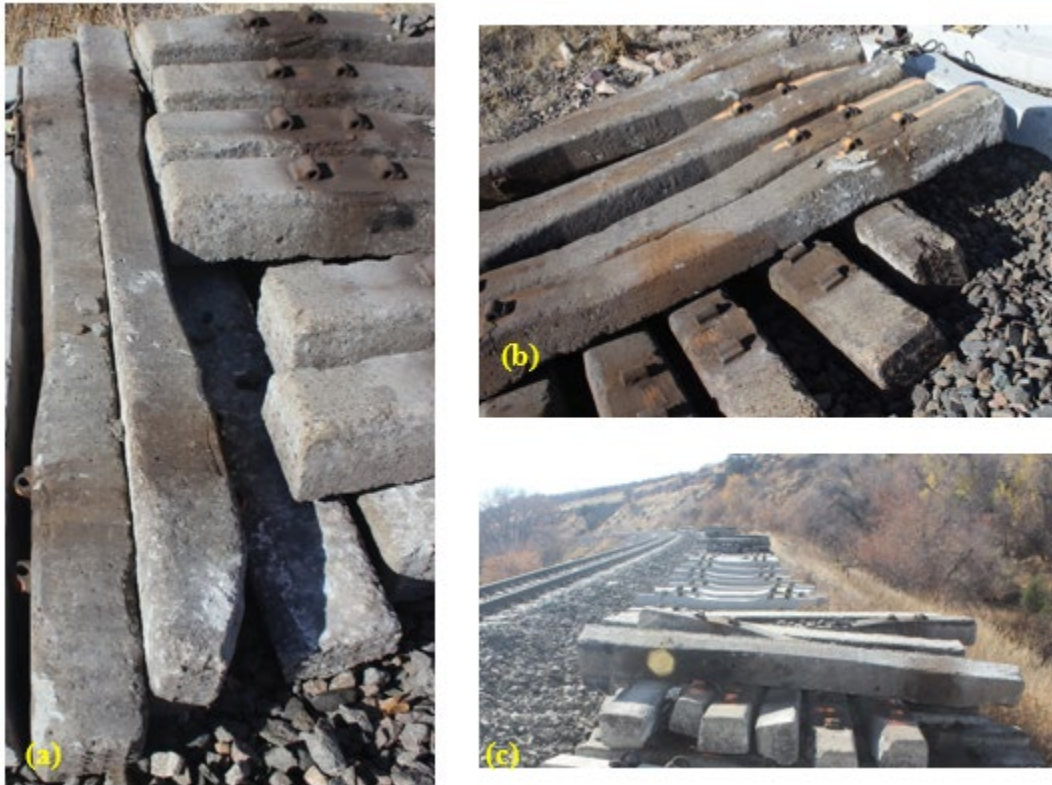
Figure E-20: Old ties pulled from track, Tangent #5

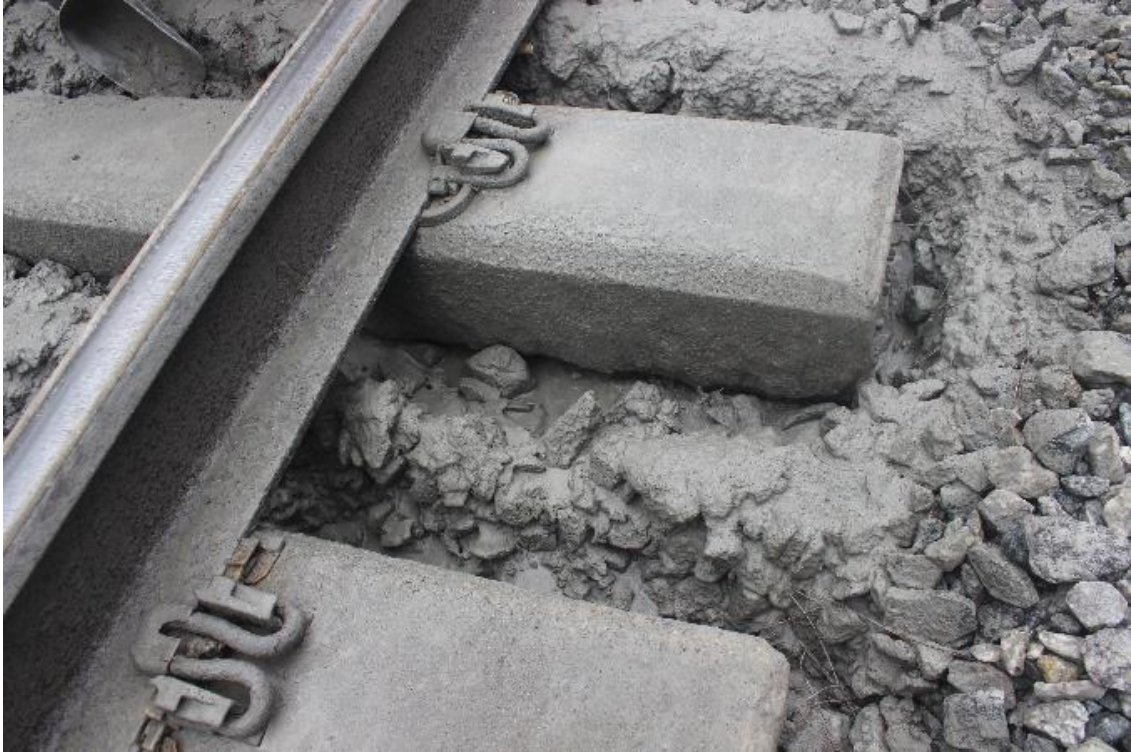
A small section of fouled ballast was found at this location, as shown in Figure E-23. Fouling and pumping was seen at the surface over a length of five ties shown in Figure E-24. The railroad had removed a few concrete ties during a prior maintenance action shown in Figure E-25. Moderate center-binding cracking was seen in the ties near the fouled ballast, Figure E-26. The center-binding cracking is evidence of track support issues. In addition, Figure E-27 shows one tie with unusual damage. This damage may be the result of ballast particles vibrating on the top of the tie during train passes.

Figure E-24: Pumping in track, Tangent #6

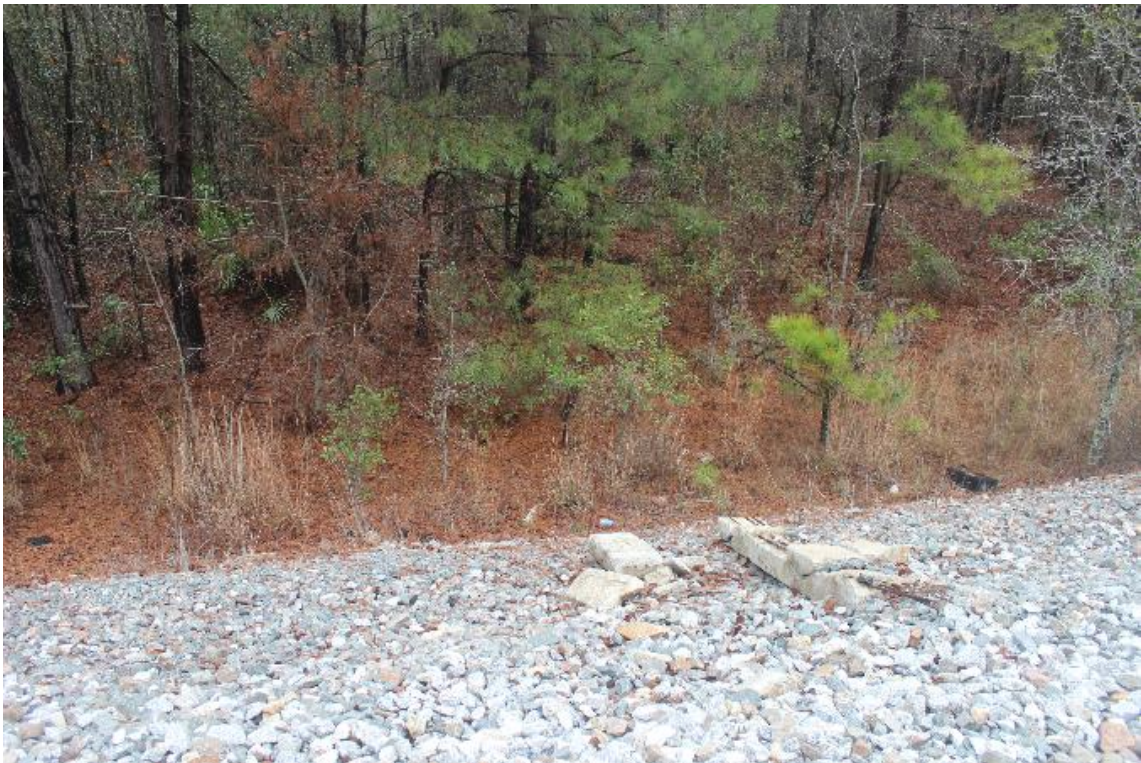
Figure E-25: Discarded ties stored on the side of the track, Tangent #6

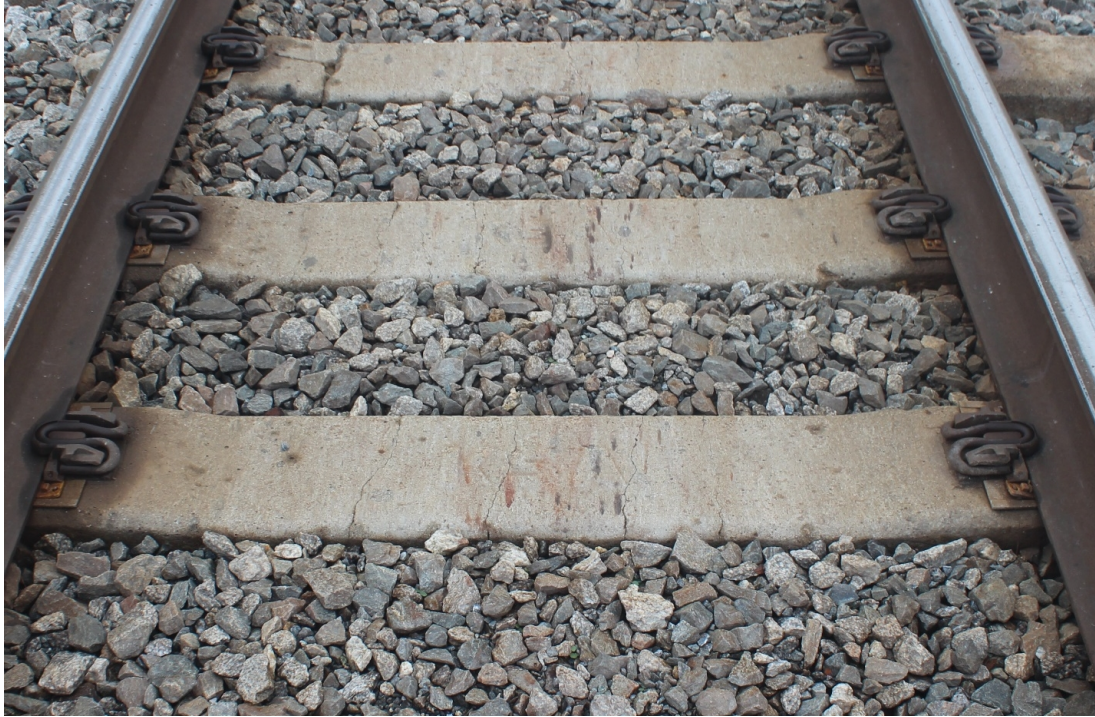
Figure E-26: Center-binding cracking in ties near the fouled ballast location, Tangent #6

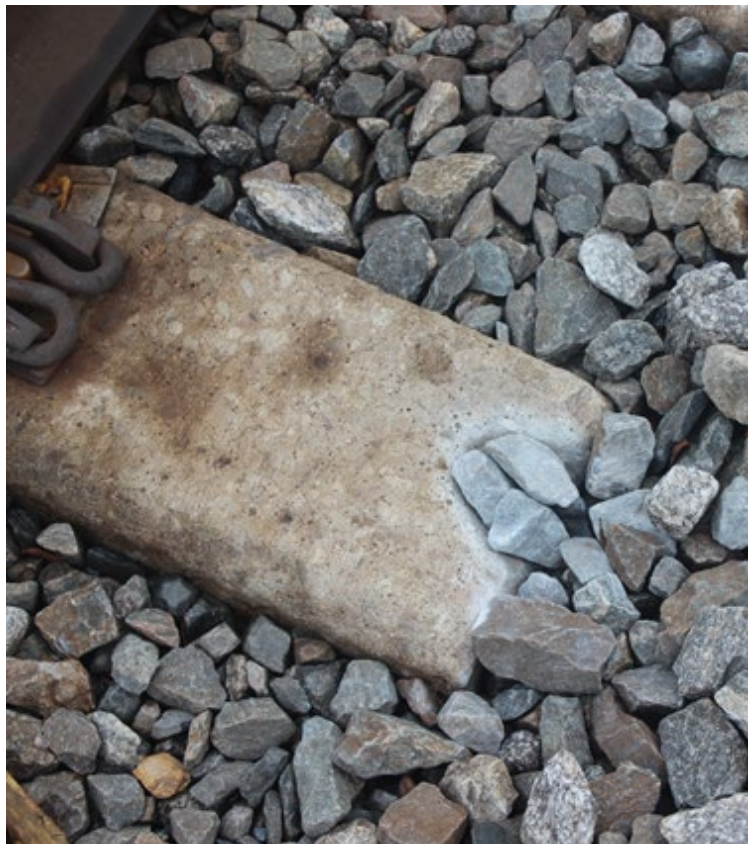
Figure E-27: Abrasion damage at unusual location, Tangent #6

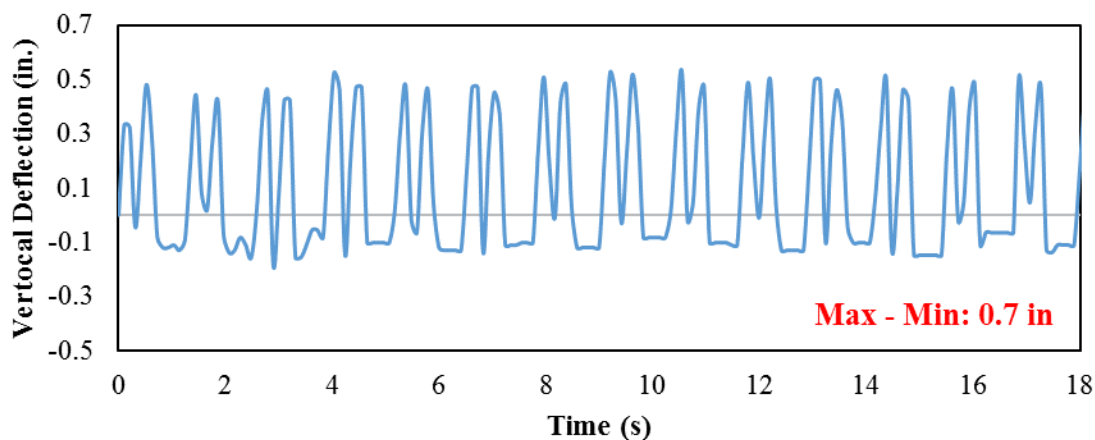
Researchers gathered high definition video of one of the ties in the fouled ballast section during a train pass. Video analysis was performed to estimate the tie deflection during loading shown in Figure E-29. The tie with highest level of pumping had 0.7 inch of deflection.

Figure E-29: Vertical deflection of tie with severe pumping, Tangent #6

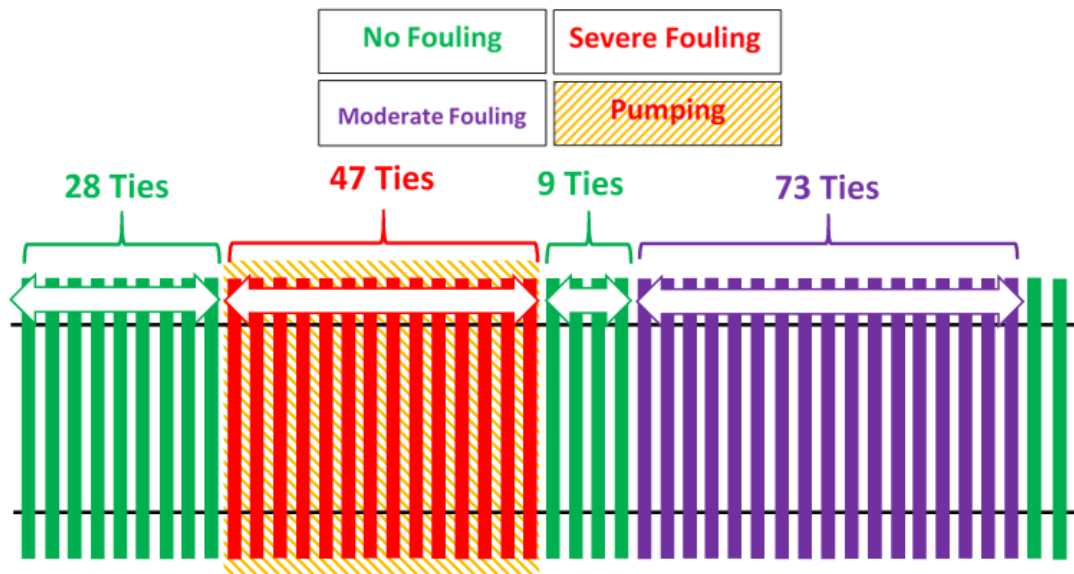
The site had large amounts of ballast fouling. Figure E-32 shows a schematic of the track fouling conditions. Evidence of pumping action was seen in the fine material surrounding the ties. The pore pressure in the fines during loading expels water and fines along the sides of the ties, pushing material away from the tie. Figure E-33, shows the photo of the section of track with severe fouling and pumping action. The fines were removed from the tie top surface as shown in Figure E-34, exposing center-binding cracking. Figure E-35 shows the ties that were shattered from center-binding cracking that delaminated at the top row of reinforcements.

Figure E-32: Schematic view of the fouling, Tangent #7

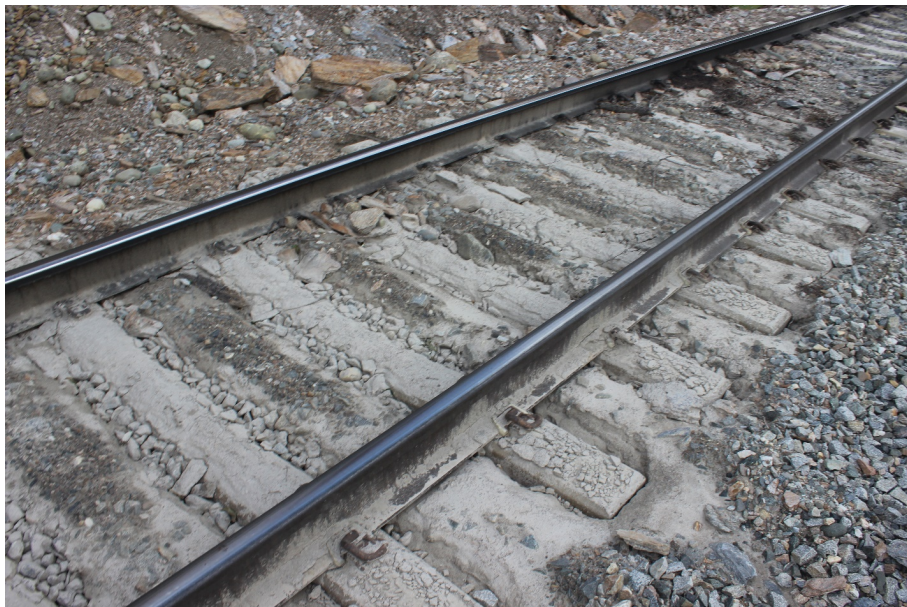
Figure E-33: Severe pumping, Tangent #7

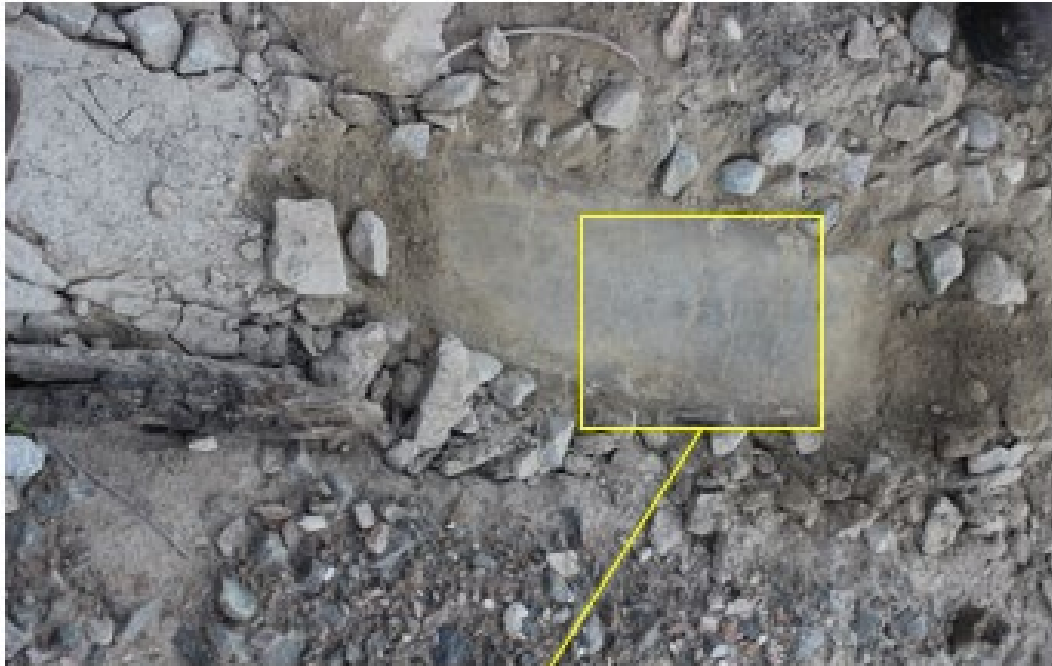
Figure E-34: Tie cracking, Tangent #7
