**Federal Railroad
Administration**

A Study of Environmental and Track Factors that Contribute to Abrasion Damage of Concrete Ties

9. SPONSORING/MONITORING AGENCY NAME(S) AND ADDRESS(ES) U.S. Department of Transportation Federal Railroad Administration Office of Railroad Policy and Development Office of Research, Development and Technology Washington, DC 20590			10. SPONSORING/MONITORING AGENCY REPORT NUMBER DOT/FRA/ORD-19/38

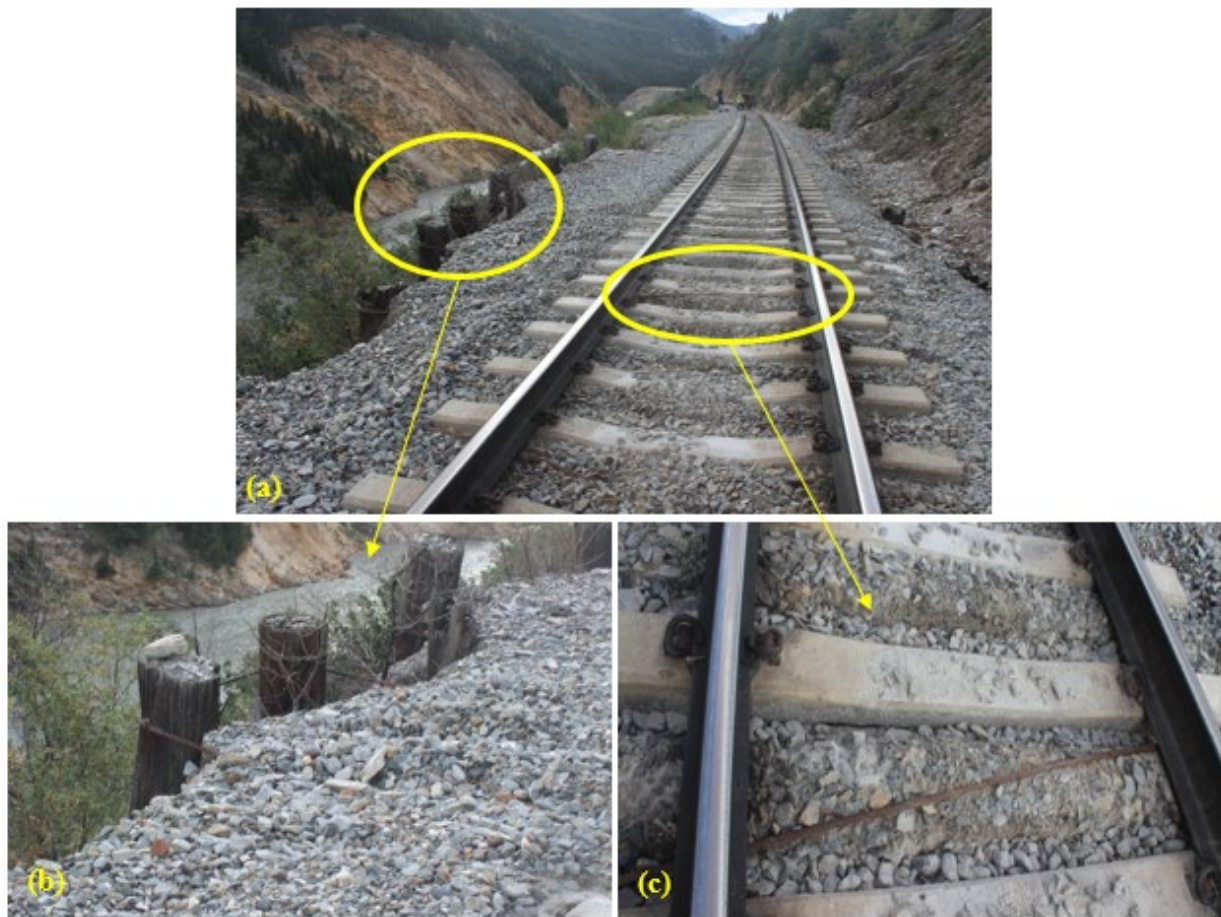
The area surrounding the track did not appear stable. There is evidence of occasional landslides on to the track, and poor slope stability under the track. In one location, wooden piles with steel cable tie-backs had to be installed in track to prevent further slope erosion, Figure E-36. Many ties appeared to have little or no ballast support. Some ties even appeared to be below grade.

Figure E-36: Wooden piles with tie-back cables to stabilize the track, Tangent #7

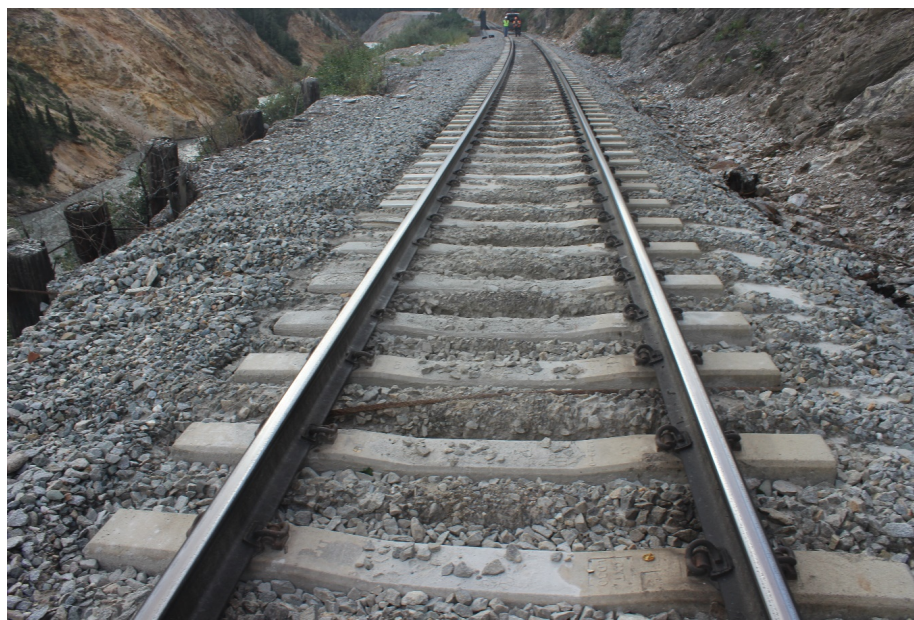
Track drainage issues were apparent. The railroad had dug trenches in track to drain water from the track in pumping locations, Figure E-37. Drainage ditches were clogged by debris in some areas from rack falls, Figure E-38. Algae was also seen covering standing water in the drainage ditch. A drainage pipe was installed in track to further assist with drainage, Figure E-39. One tie was seen with some wear seen on the tie end, as shown in Figure E-40. The damage went up to the ballast level and could have been caused by the ballast movement between the tie and a stiff spot in track to the side of the tie. Track maintenance is difficult in this section due to utility locations.

Figure E-37: Trenches dug in ballast to drain water ponding in track, Tangent #7

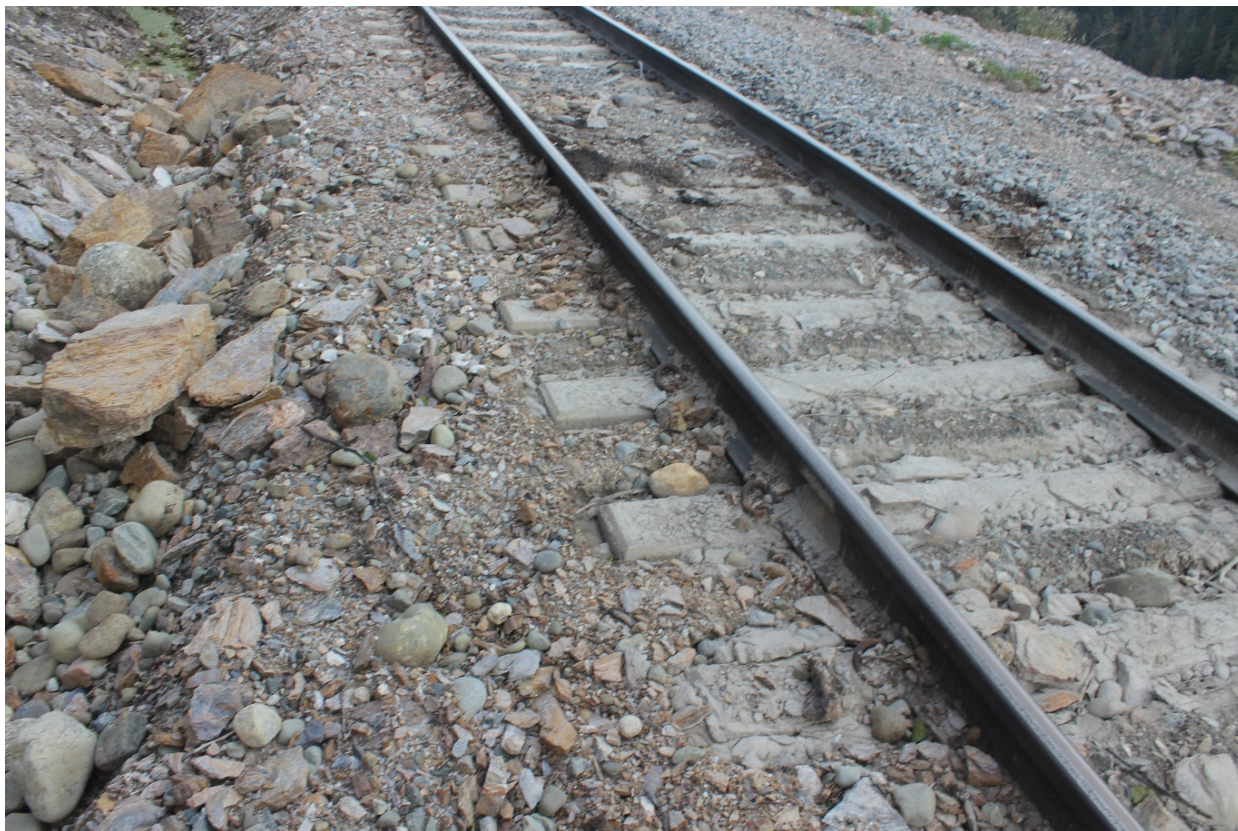
Figure E-38: Debris and algae covering standing water seen in drainage ditch, Tangent #7

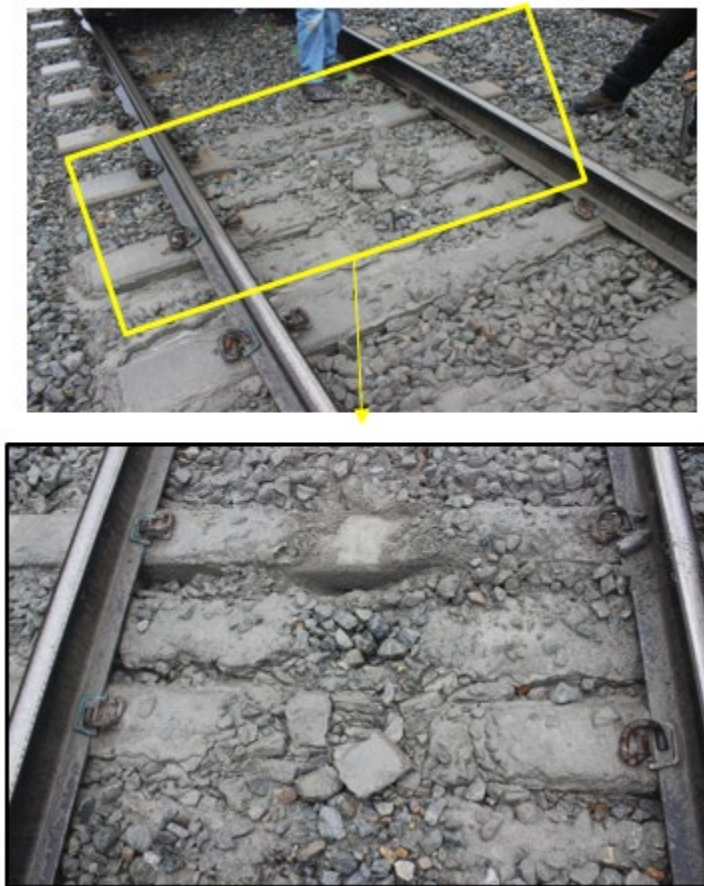
This location was in a tangent track on high embankments. Severe fouling was seen at the surface around six ties at one location. One of the ties was shattered as shown in Figure E-41. Figure E-42 shows the pumping products at one end of the tie. Fines in the track appeared to initiate underneath the surface and come to the top during pumping action.

Figure E-41: Shattered ties, Tangent #8

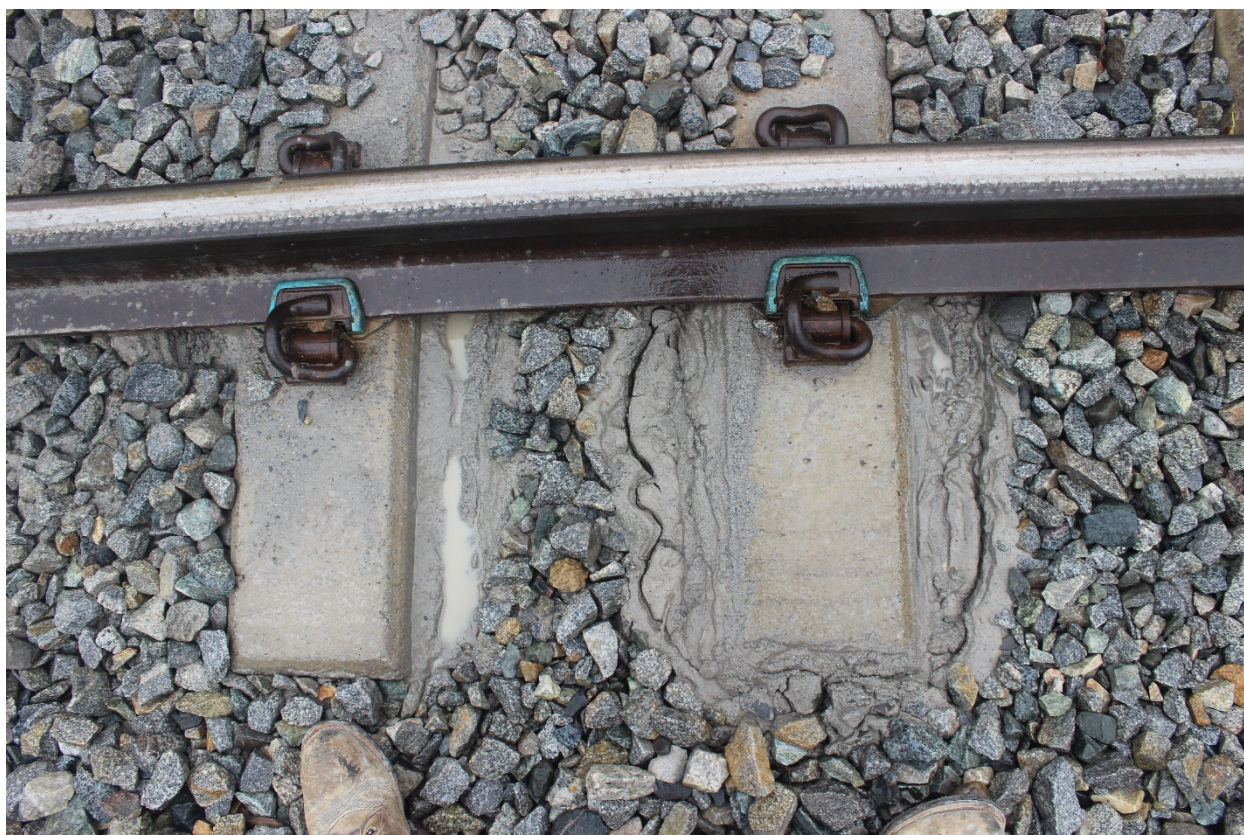
Figure E-42: Pumping produces fine particles around the tie, Tangent #8

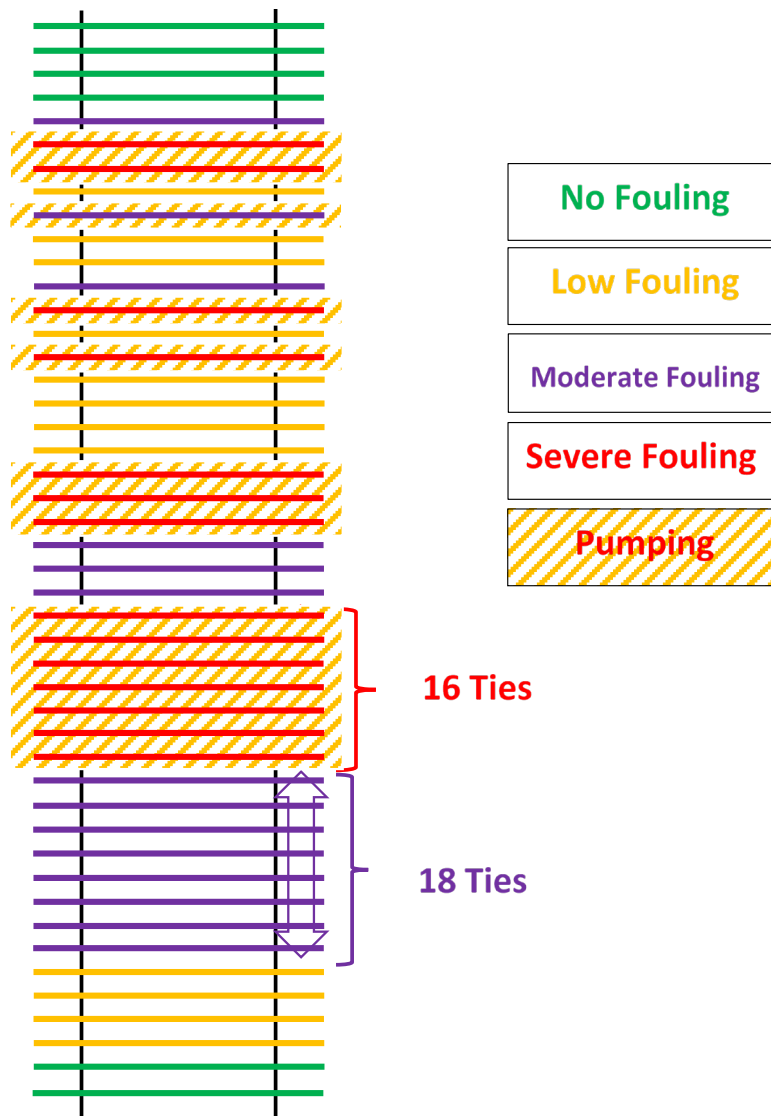
Railroad personnel reported that this location requires routine maintenance. Ballast fouling was seen in track beginning on the sixth tie after the wood-to-concrete tie transition. Figure E-45 shows a schematic of the ballast fouling visible on the track surface. Evidence of severe pumping was also seen in track, as shown in Figure E-46. The fouling had a different color than the typical gray mud typically seen in track locations with concrete abrasion damage. The color of the fines was like that of the soil next to the track. This is most likely because the track had only a thin layer of ballast underneath the ties and was in a low spot. Some ties with shattered top sections were seen in track, as shown in Figure E-47. In areas with excessive fouling and pumping, center-binding cracking was seen after the ties were uncovered as shown in Figure E-48. Figure E-49 shows a picture of welds in the rail after a section of the rail had to be replaced in 2010, only a few years after the concrete ties were installed. There were also small rock slides on the hill above the track, interfering with drainage and causing fouling in track.

Figure E-45: Schematic view of fouling condition, Tangent #9

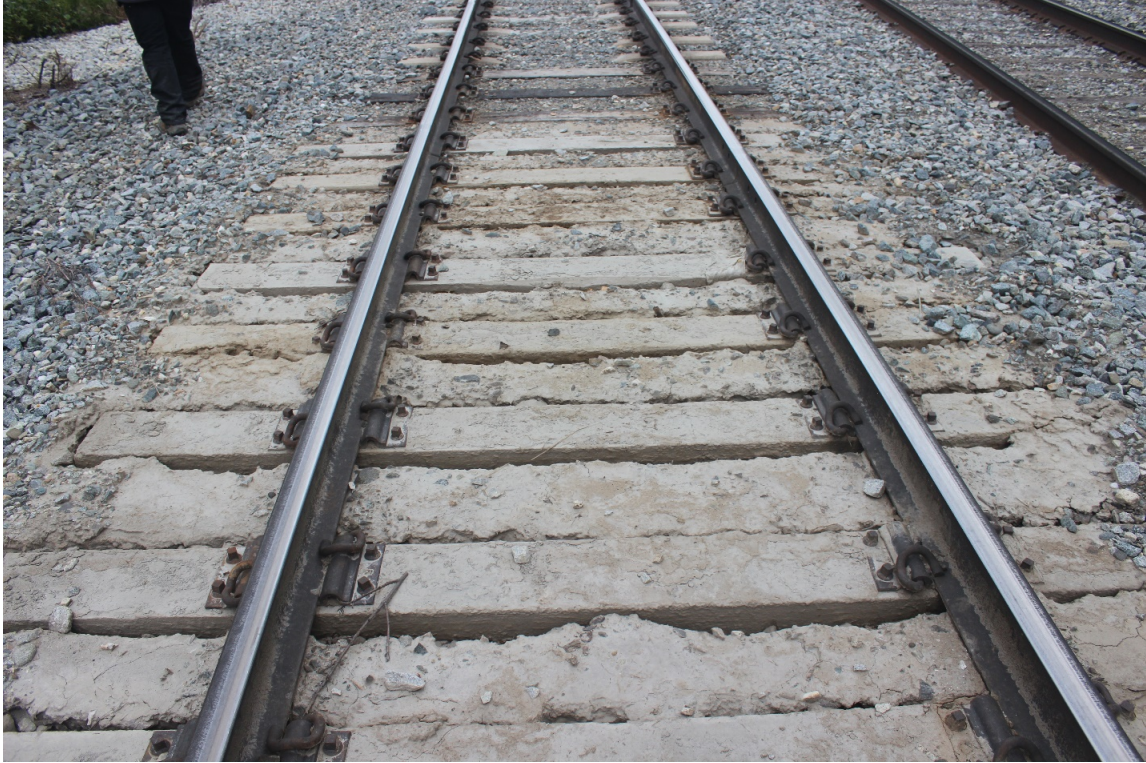
Figure E-46: Mud pumping, Tangent #9

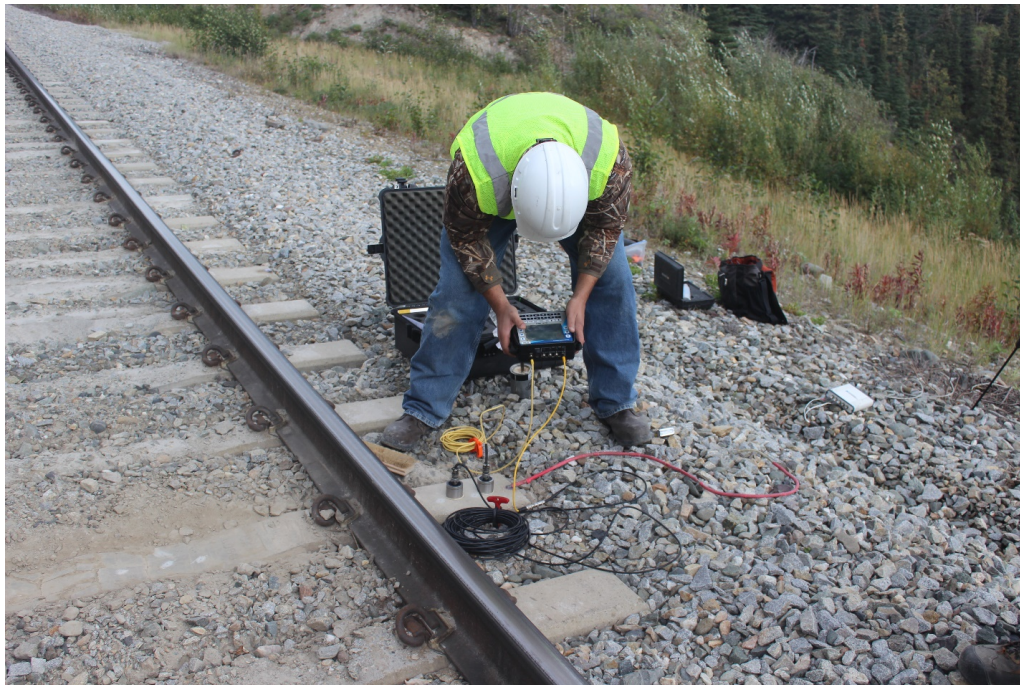
Ultrasonic pulse velocity readings were taken on a tie in track to measure the tie integrity. Table E-12 shows the UPV readings that were measured on-site. Figure E-50 shows the UPV reading being taken from the same tie shoulder. UPV measurements show that the UPV readings for center-to-shoulder and shoulder-to-shoulder is lower than the one for the same shoulder because of the center-binding cracking. Center-binding cracks impede the pulse movement through the tie, decreasing the velocity. The low shoulder-to-shoulder velocity confirms the visual observations of center-binding cracking.

Figure E-50: UPV testing, Tangent #9

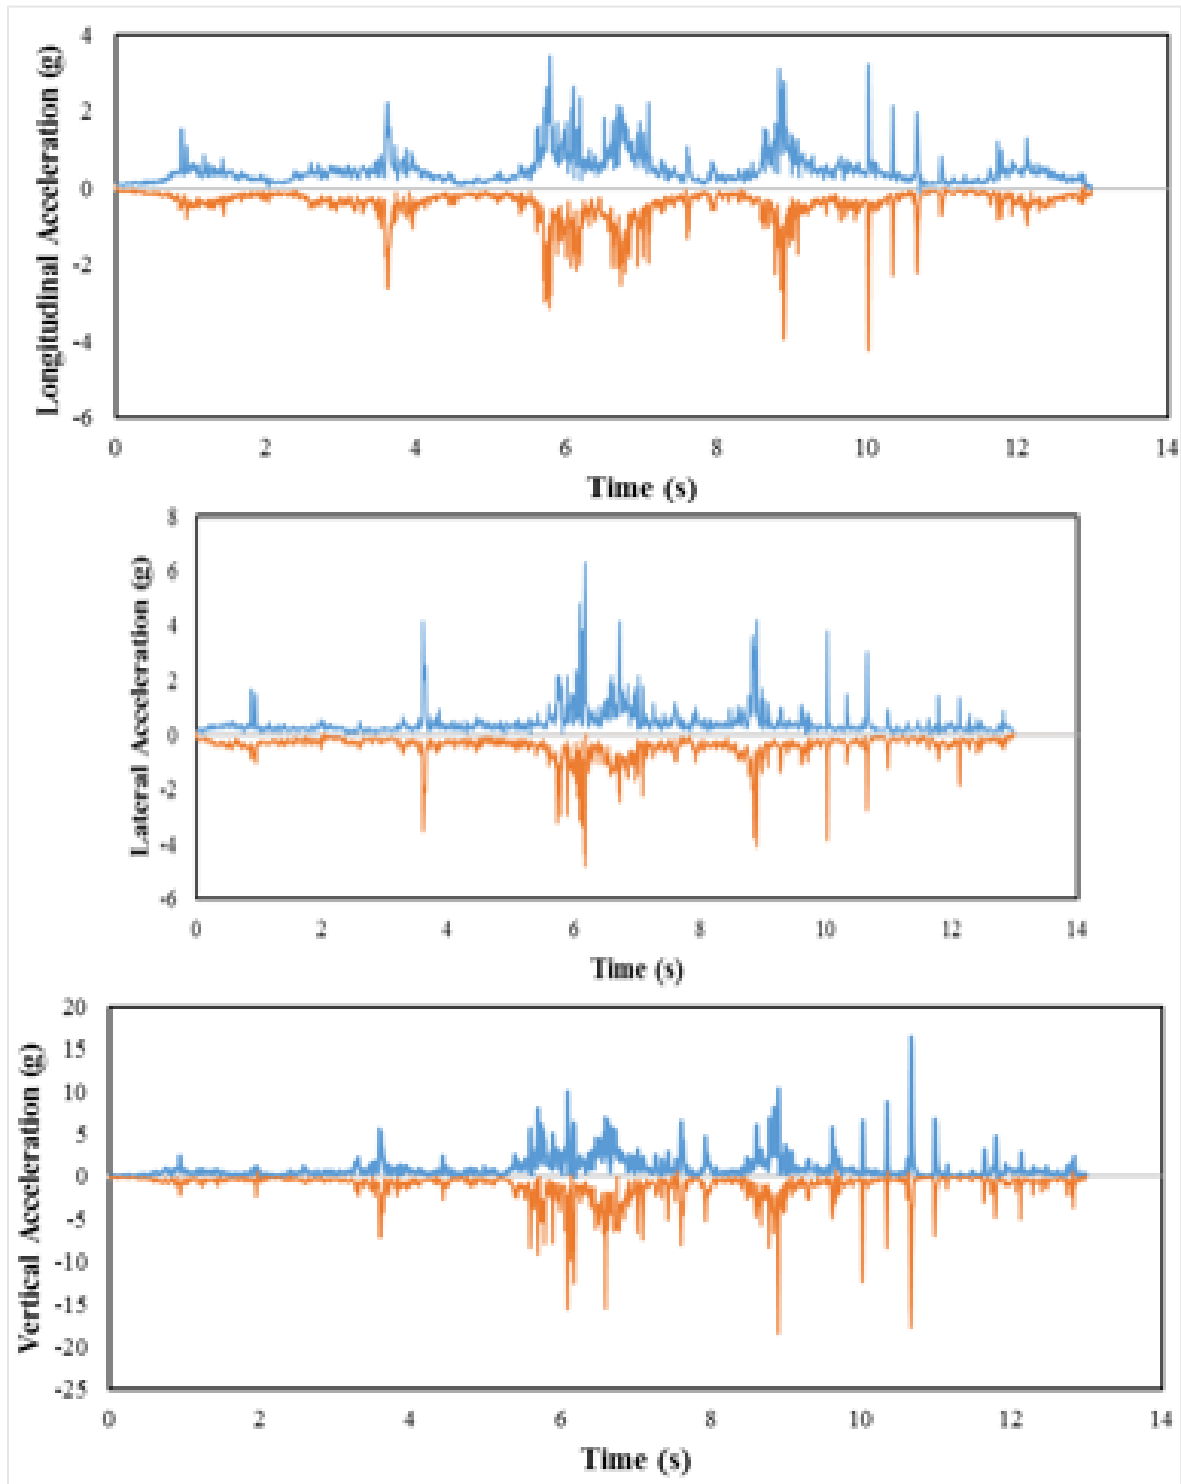
Tie acceleration measurements were taken on the UPV tested tie UPV during two train passes. A three-directional accelerometer was attached to the tie shoulder using hot glue. The tie acceleration was measured at a 20-kHz sample rate. Figure E-51 shows the acceleration as a passenger train passed, while Figure E-52 shows the tie acceleration as a freight train passed. High accelerations were measured in the vertical direction, indicating poor support under the tie.

Figure E-51: Measured tie acceleration during a passenger train pass, Tangent #9

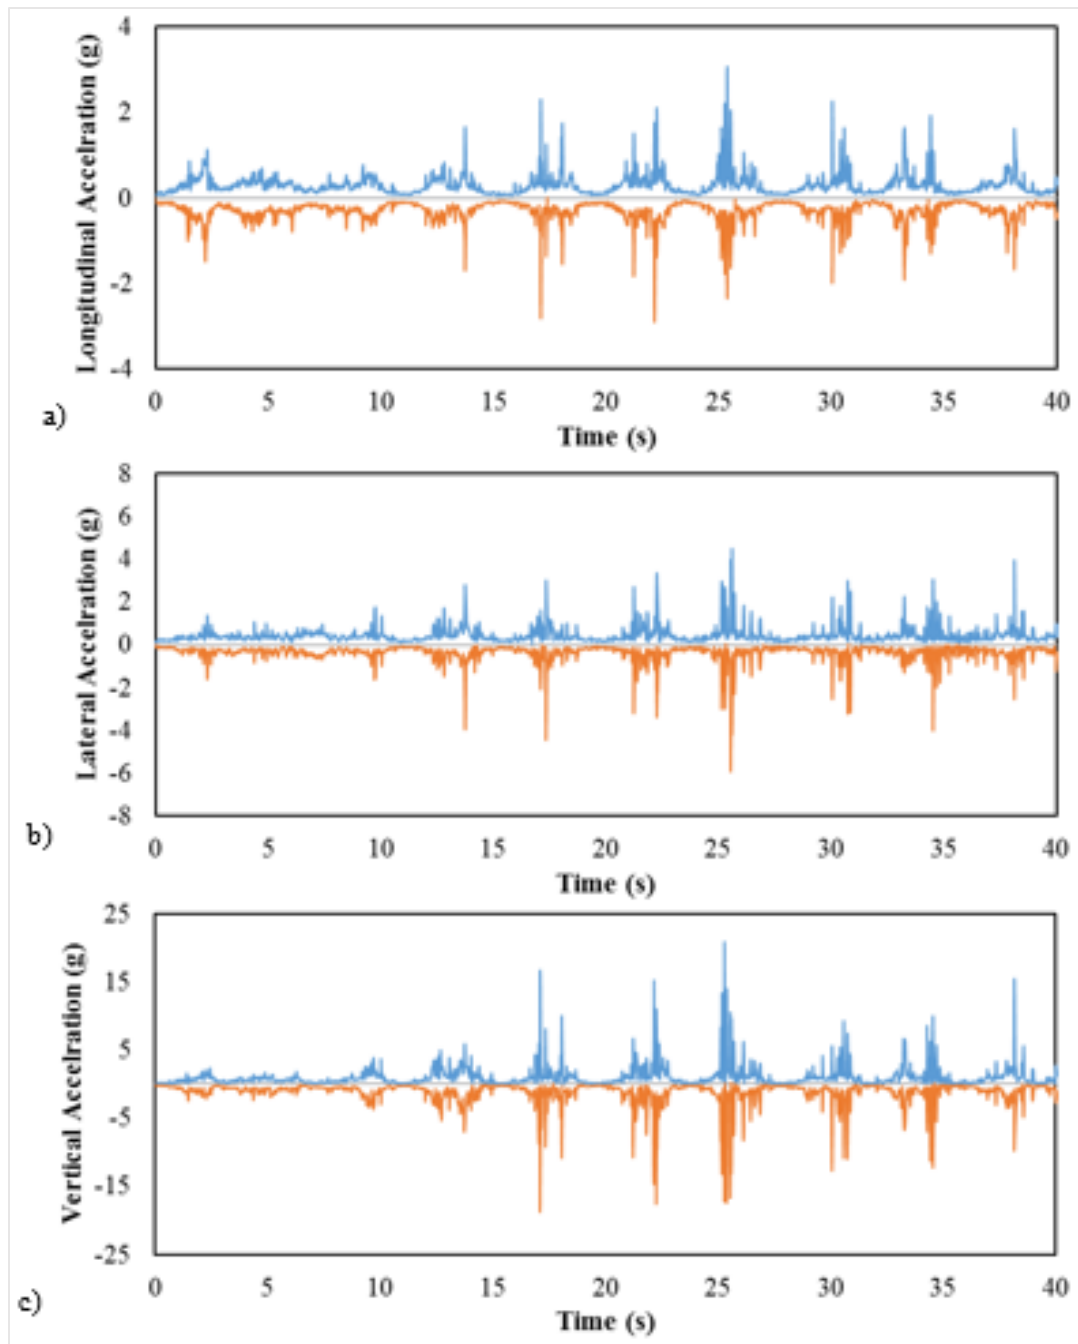
The tie showed slightly higher accelerations in the vertical direction from the freight train likely because of the higher loads.

Figure E-52: Measured tie acceleration during a freight train pass, Tangent #9

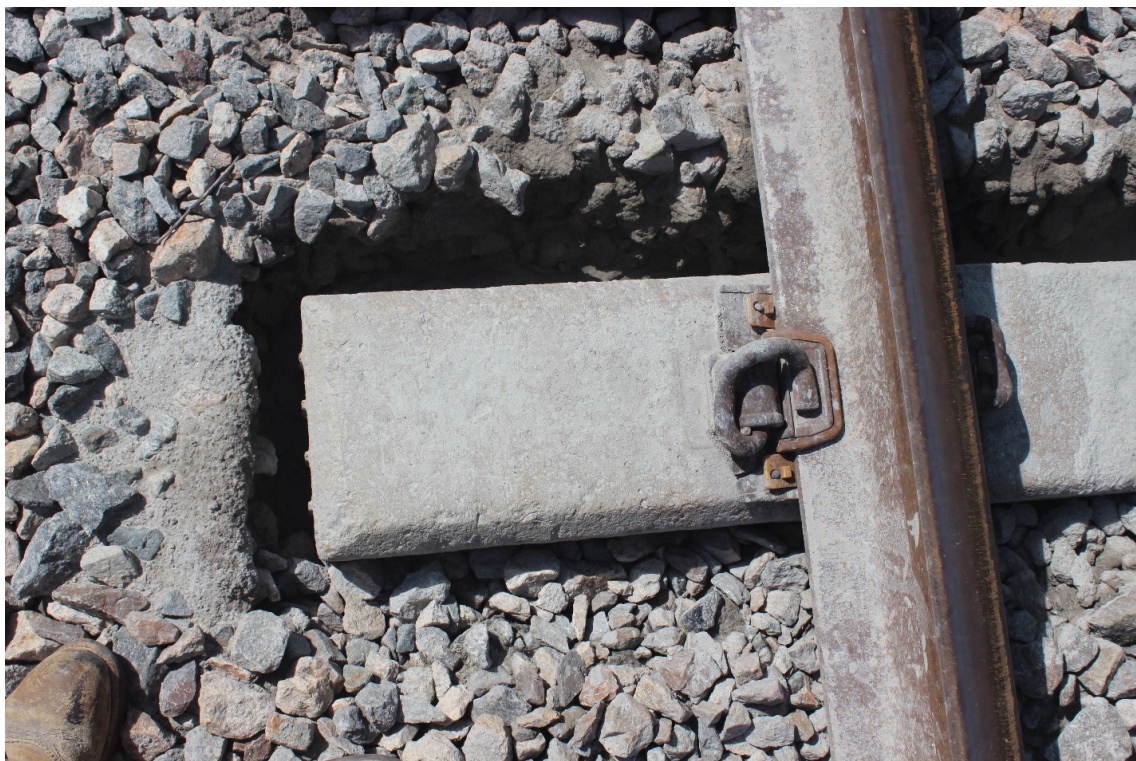
Recent mud pumping was evident from examining the track conditions, Figure E-56. Moderate center binding cracking was seen on the site. Fines were seen deposited on the edge of the ballast on the side of the road where the water drains out of the track structure, as shown in Figure E-57. Vegetation was also seen encroaching on the track structure, indicating that water is available at least during the summer season. The railroad indicated that they had been stacking trains to run at night. The weather patterns in this region showed that it was more likely to rain while the trains were running at night, increasing the amount of mud pumping.

Figure E-56: Tie pumping, Tangent #11

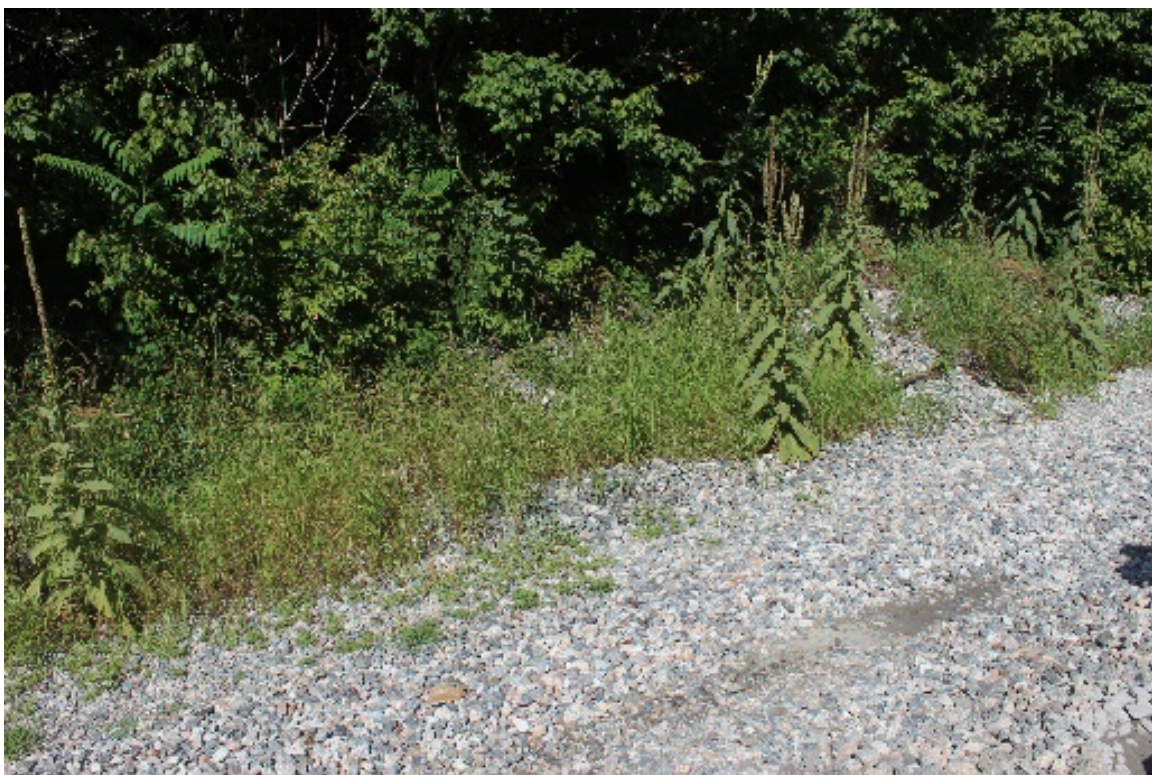
Figure E-57: Fines and vegetation adjacent to track, Tangent #11

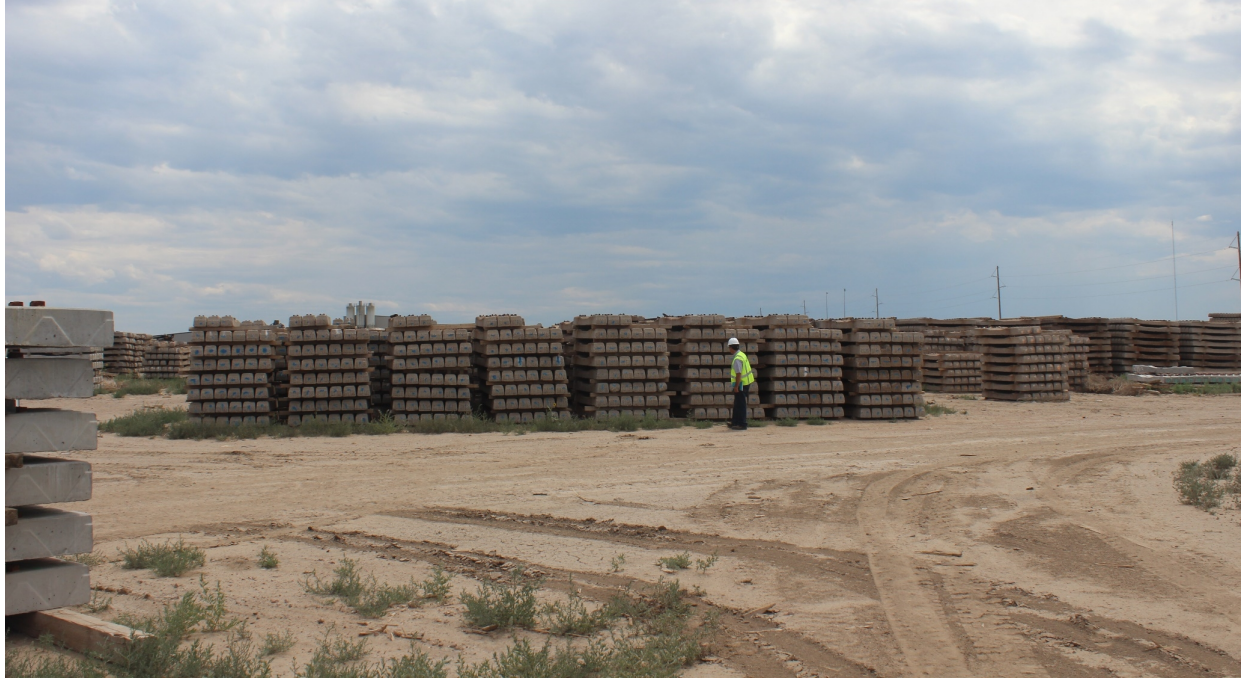
Ties were stacked in large piles on dunnage to separate layers of ties, Figure F-1. Out of the thousands of ties stored on site, only 6 were found with severe abrasion damage, and 12 were found with moderate abrasion damage. The ties with abrasion damage were clustered together, indicating that they came from the same location in track. This matches what was seen in track inspections. Ties with abrasion damage in track are clustered in groups. [Figure 3-16](#) shows one tie found in the boneyard with significant abrasion loss. The original center thickness of this tie was 6.25 inches. The tie also had significant center-binding cracking on the top that bifurcated, resulting in delamination in the top. Abrasion damaged ties in this boneyard non-uniform damage, with very rough bottom surfaces, Figure F-2. Figure F-3 and Figure F-4 show pictures of additional ties seen at the boneyard with severe abrasion damage, while Figure F-5 shows a picture of tie ends with minor-to-moderate abrasion damage.

Figure F-1: Ties stacked in large concrete tie boneyard, Boneyard #1

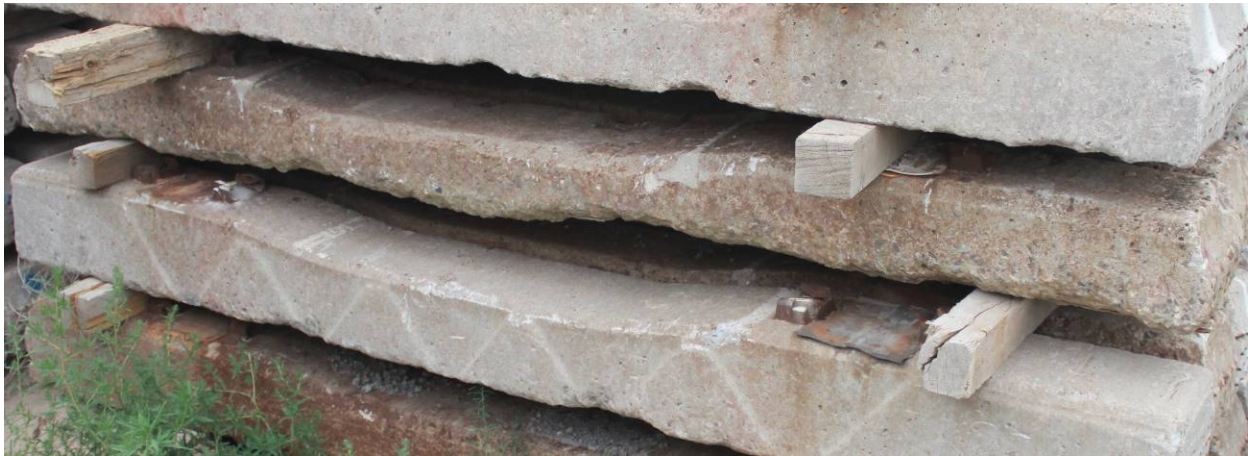
Figure F-2: Tie with significant non-uniform abrasion damage, Boneyard #1

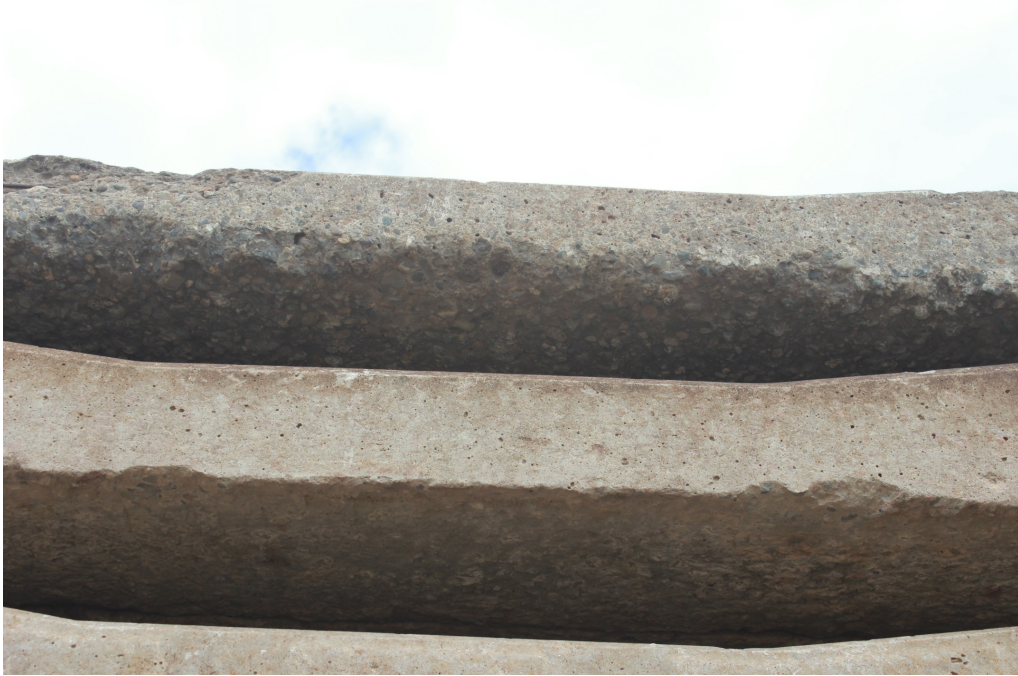
Figure F-3: Picture of tie bottom with severe abrasion damage, Boneyard #1

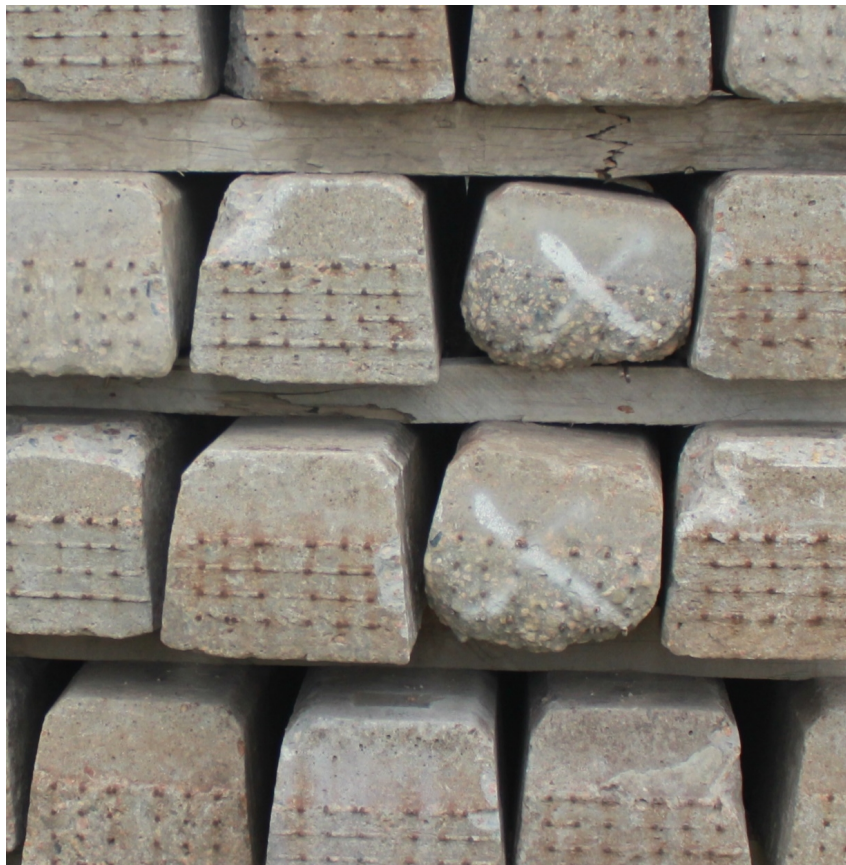
Figure F-4: Tie ends with moderate-to-severe abrasion damage, Boneyard #1

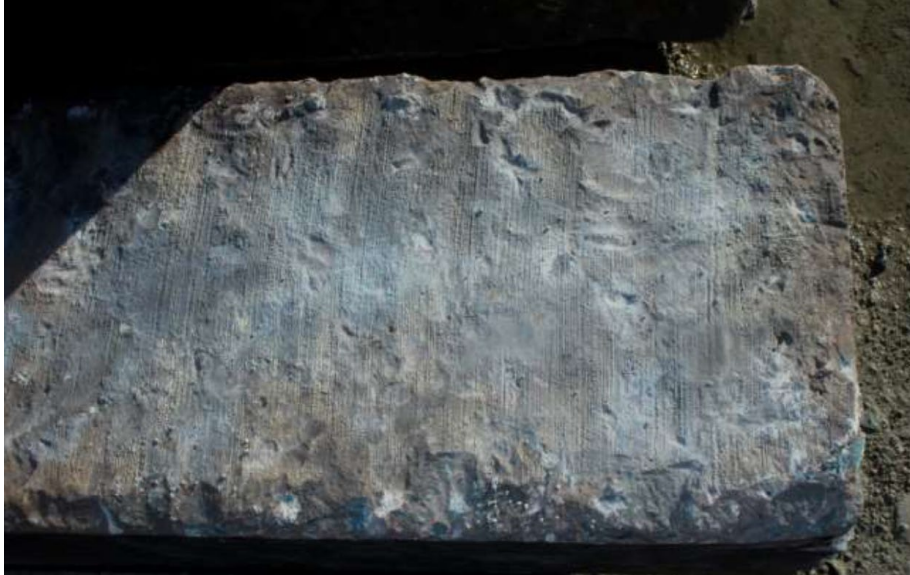
The ties in stack 1 consisted primarily of ties made in 1995 with eight smooth reinforcement strands. Most of the ties in stack 1 were in good condition, with very little abrasion damage. Many of the ties still had the original broom finish visible on the bottom, as shown in Figure F-7. Some ties showed a moderate amount of abrasion, such as the tie shown in Figure F-8. Some minor rail seat deterioration was present on several ties. Longitudinal splitting cracks were more common in ties in stack 1 than abrasion damage. The cracking extended to the top row of strands, Figure F-9. Cracking was observed in 5–7 percent of the ties in stack one, however, it is not known if these cracks were the result of tie removal and handling process or in-service conditions.

Figure F-7: Broom finish still visible on bottom of many ties in stack 1, Boneyard #2

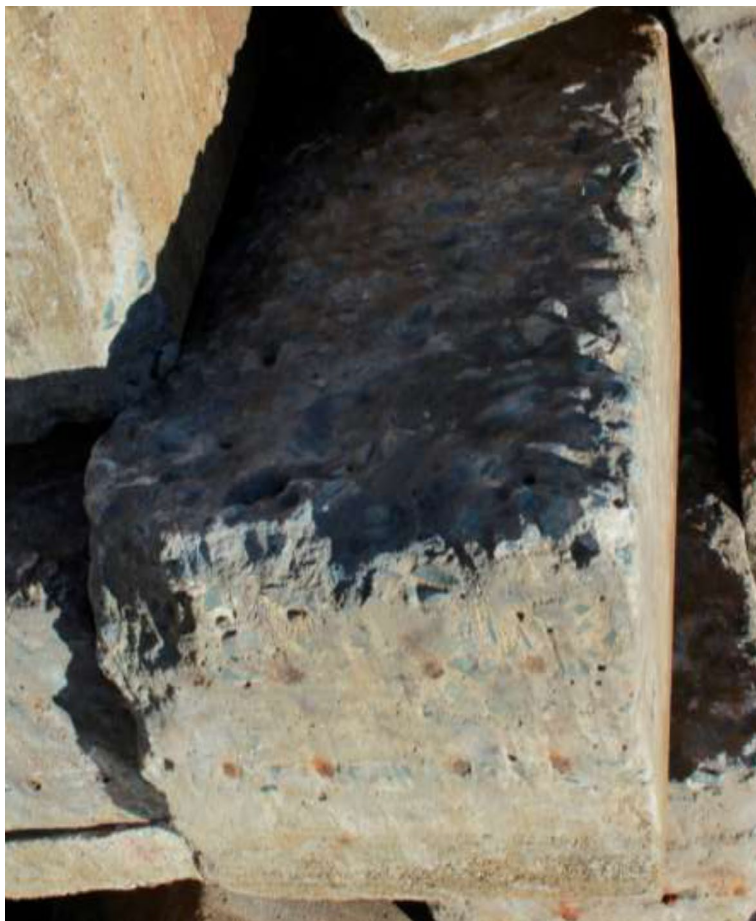
Figure F-8: Minor abrasion present in tie in stack 1, Boneyard #2

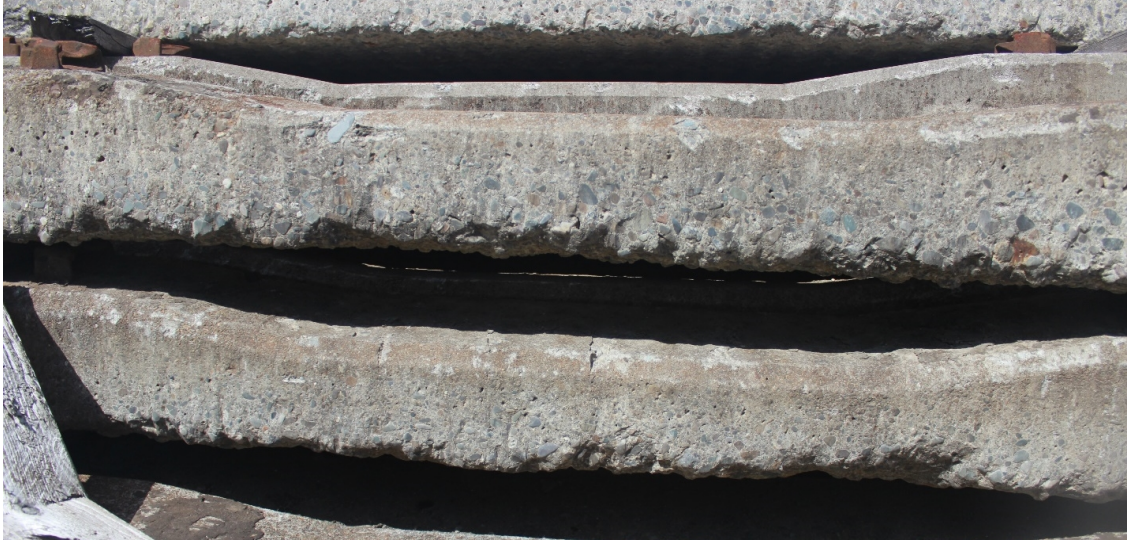
Figure F-11: Abrasion on the bottom of the tie, Boneyard #3

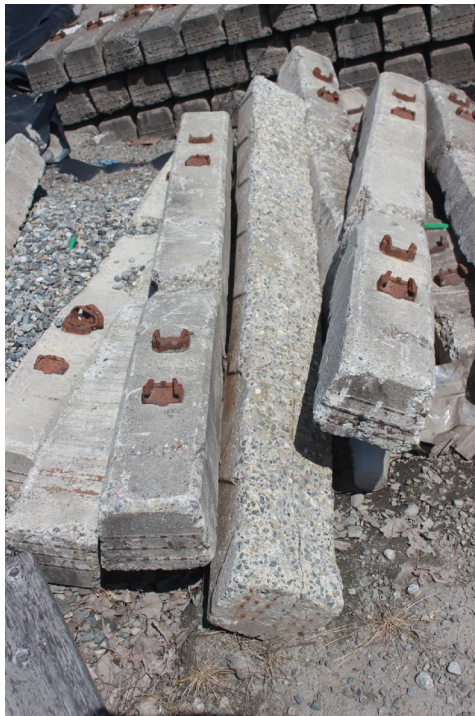
corner rounding commonly seen in the ties. The tie bottom rounding could indicate either torsional forces on the ties during loading, a rocking action on the ties during loading, or hydro-abrasive effects on the tie during pumping. The difference in tie thickness from abrasion damage is also evident in the middle row of ties in Figure F-13. The tie second from the right in the middle row is considerably thinner than the other ties.

Figure F-12: Tie with some abrasion damage, Boneyard #3

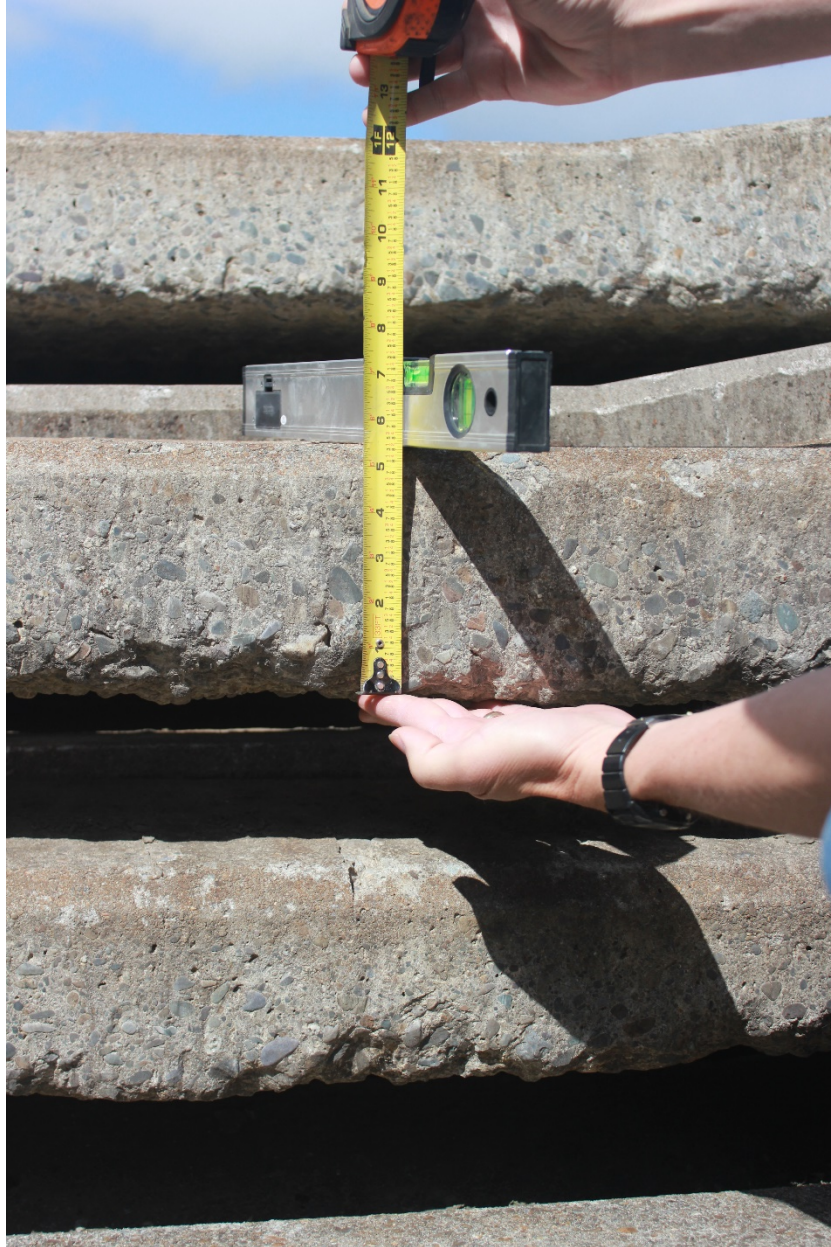
Figure F-14: Tie thickness measurement, Boneyard #3

Location	Design thickness at location (in.)	Measured thickness (in.)	Estimated wear (in.)
Center	6.25	5.625	0.625
Center	6.25	5.125	1.125

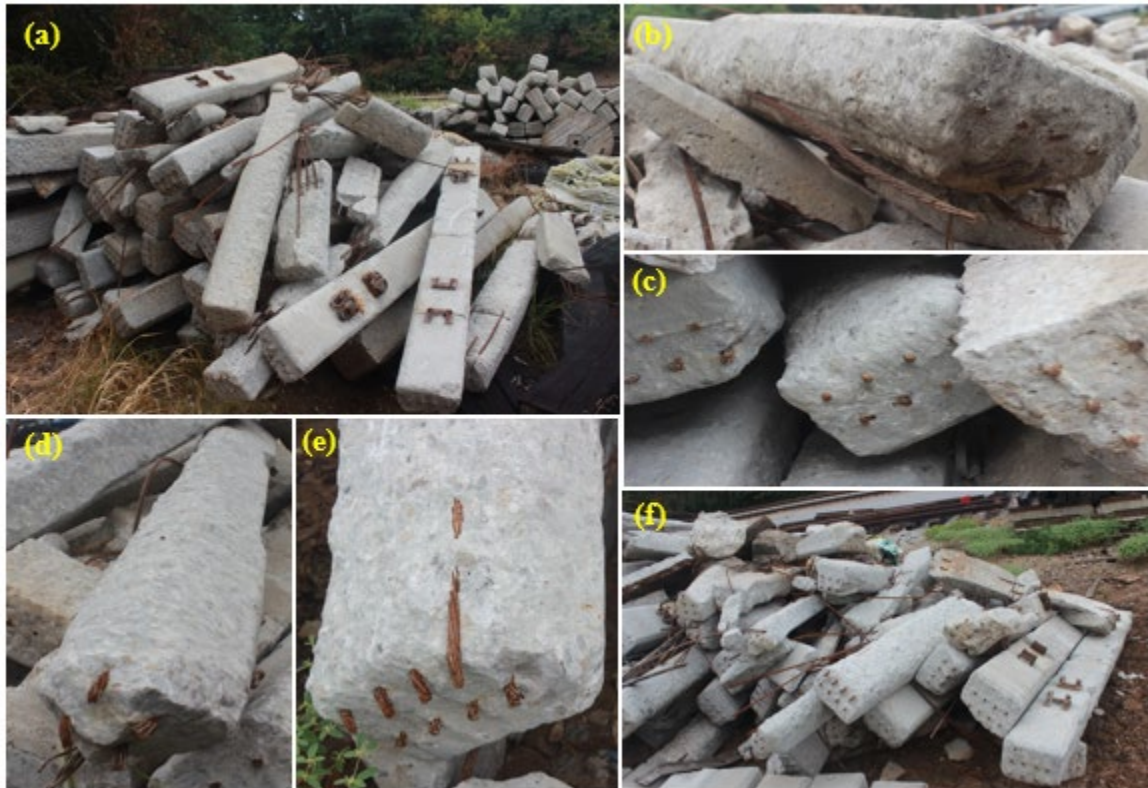
Many of the ties stored here had large amounts of bottom and side abrasion. Figure F-15 shows ties with abrasion damage that were stored in the boneyard. As shown in Figure F-15e, abrasion often rounds the bottom of the ties.

Figure F-15: Concrete ties found in the boneyard at a maintenance yard in the U.S. Southeast, Boneyard #4

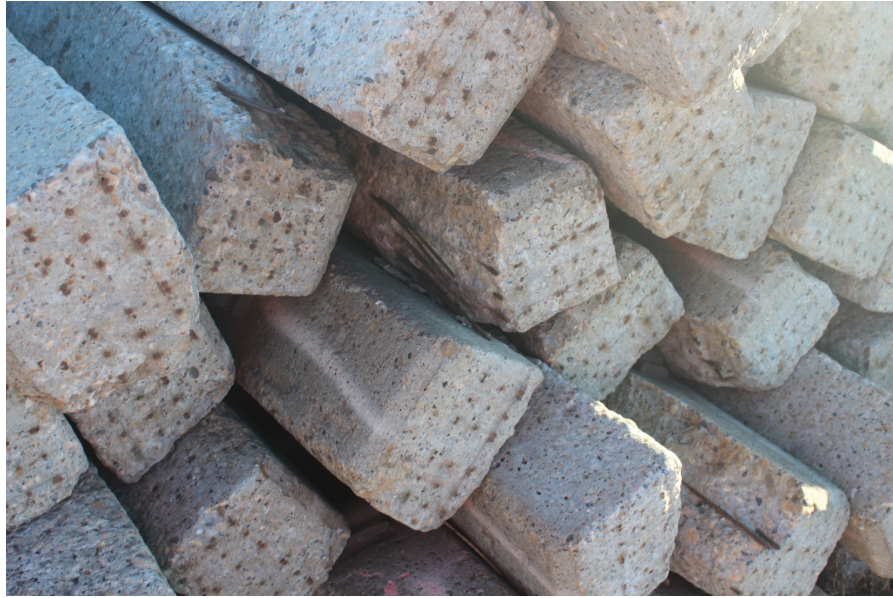
Figure F-16: Ties with minor abrasion, Boneyard #5

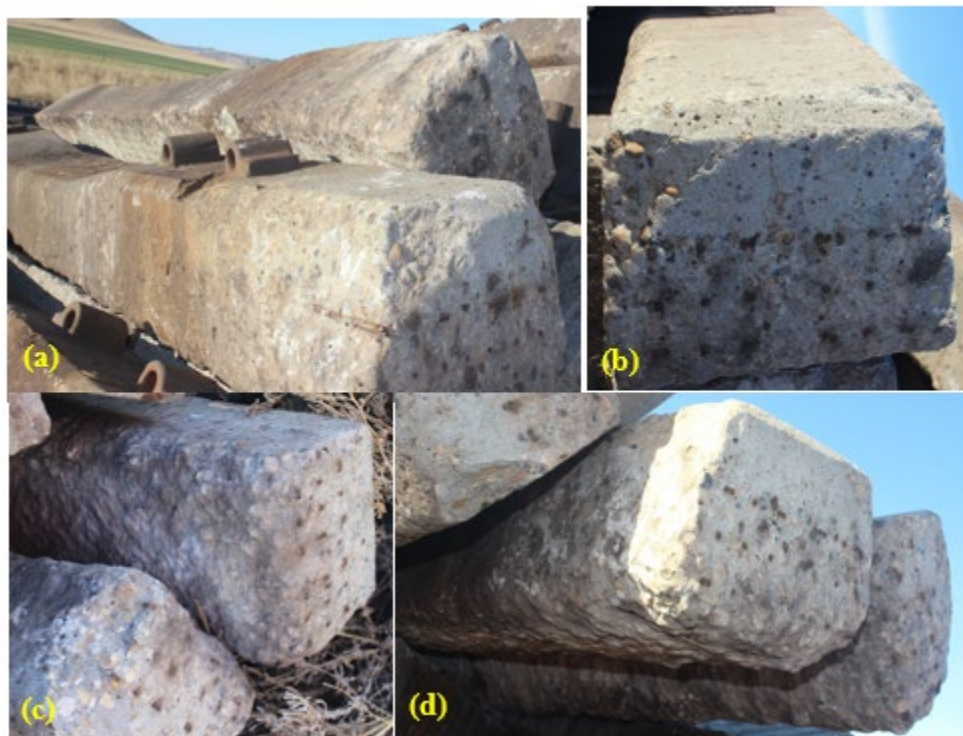
The nearby track carries large quantities of high-value commodities annually and is economically important to the railroads. Per the local road master, the track receives regular maintenance and has good ballast. The boneyard ties had only minor bottom-tie abrasion. Figure F-17 shows different ties with minor abrasion.

Figure F-17: Ties with minor abrasion, Boneyard #5
