**Federal Railroad
Administration**

A Study of Environmental and Track Factors that Contribute to Abrasion Damage of Concrete Ties

9. SPONSORING/MONITORING AGENCY NAME(S) AND ADDRESS(ES) U.S. Department of Transportation Federal Railroad Administration Office of Railroad Policy and Development Office of Research, Development and Technology Washington, DC 20590			10. SPONSORING/MONITORING AGENCY REPORT NUMBER DOT/FRA/ORD-19/38

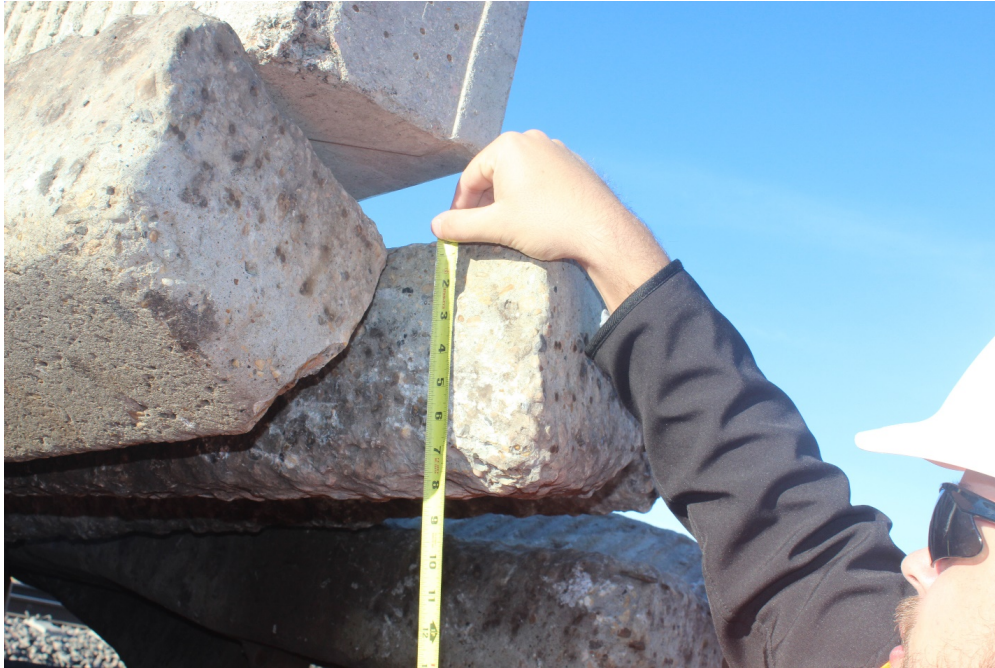
Figure F-18: Abrasion measurement, Boneyard #5

Location	Design thickness at location (in.)	Measured thickness (in.)	Estimated wear (in.)
Tie End	8.1875	7.5	0.6875
Tie end	8.1875	7.75	0.4375

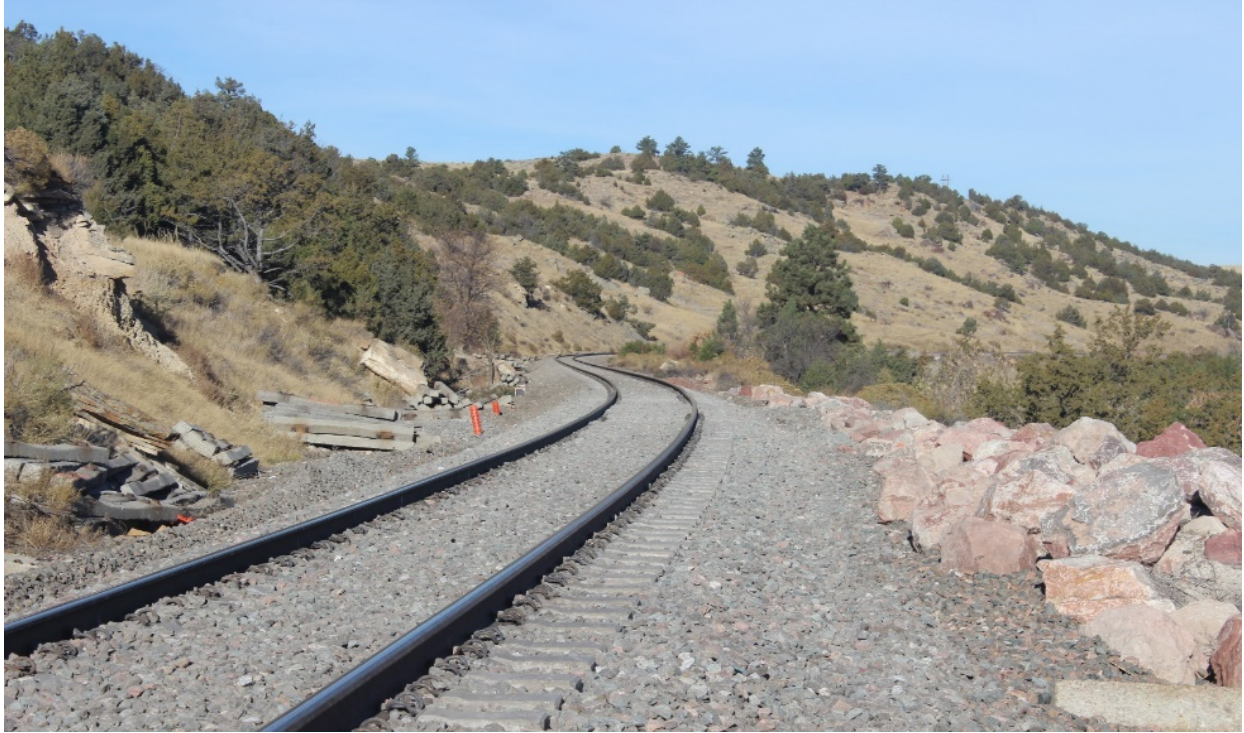
Figure F-19: Discarded ties on the side of the track, Boneyard #6

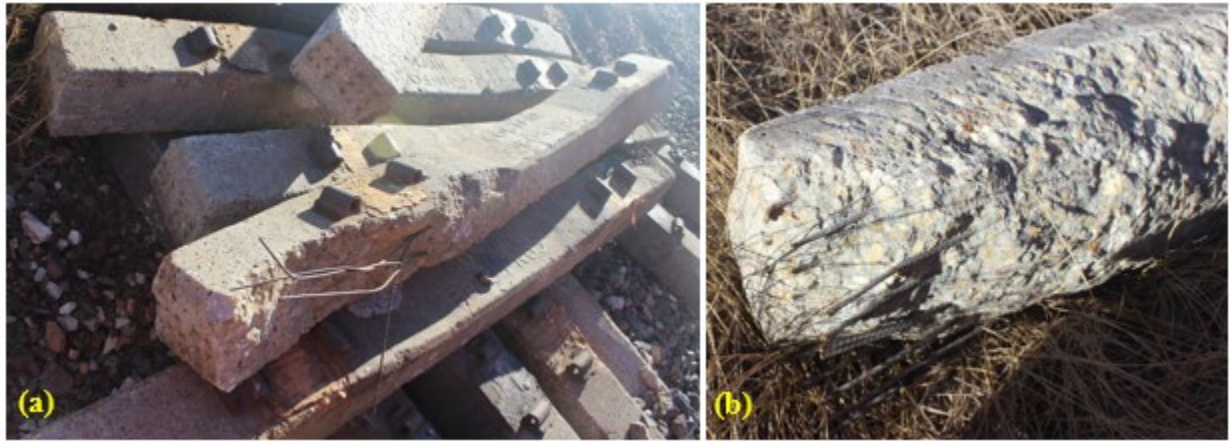
One tie examined had severe abrasion damage on one end, as shown in Figure F-21. The rest of the ties had no abrasion damage or some minor abrasion damage with corner rounding. Some concrete ties had minor center-binding cracking. The track was in very good condition with good ballast thickness under the ties and proper drainage. Some dry grass was seen at the site,

indicating low moisture availability on-site. The dry climate likely contributed to the low numbers of abraded ties at this site.

Figure F-21: Highly abraded concrete tie, Boneyard #6
