EVALUATION OF WORK ZONE BARRICADES AND TEMPORARY SIGN SUPPORTS

Report No. 5388-1F Research Study No. 585xxA3014 Research Study Title: Development of New Designs for Barricades and Sign Supports in Work Zones

> Sponsored by the Texas Department of Transportation

> > February 1996

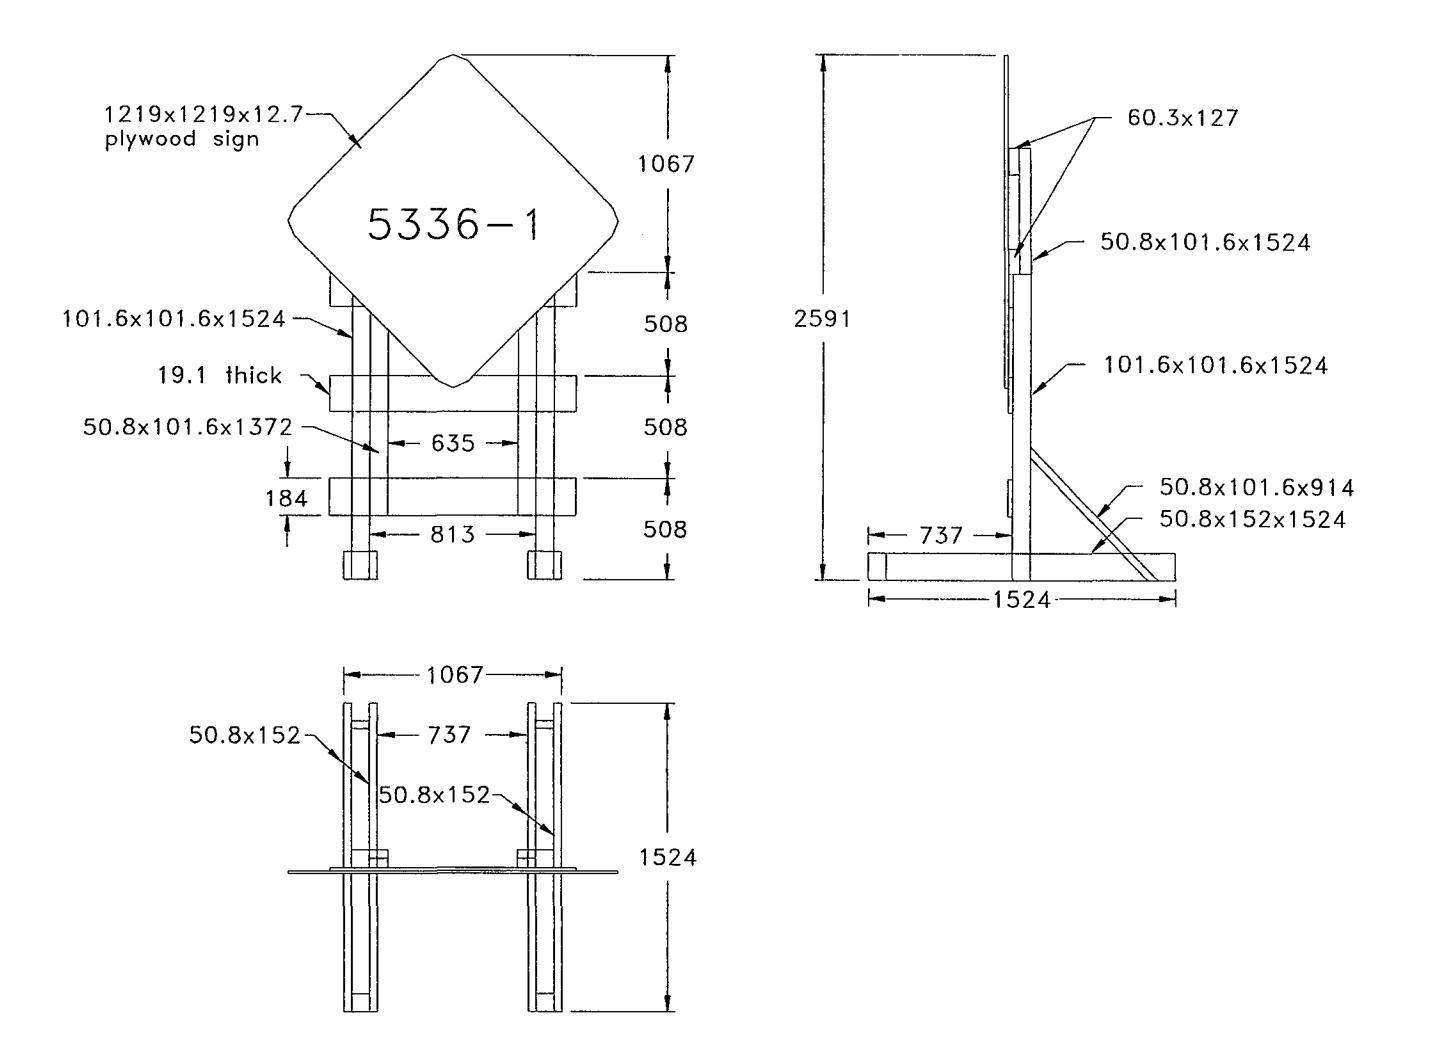
Figure 1. Schematic of Type III Wooden Barricade with Wooden Sign Panel (Test No. 453360-1)

Figure 1 shows s schematic of the Type III barricade with a 1219 mm x 1219 mm sign panel mounted at a height of 914 mm. The test vehicle was a 1981 Honda Civic 3-door, as shown in Figure 2. Appendix Figure 88 gives dimensions and information on the vehicle. The test vehicle impacted the barricade head-on with the centerline of the vehicle aligned with the centerline of the barricade, traveling at a speed of 101.2 km/h.

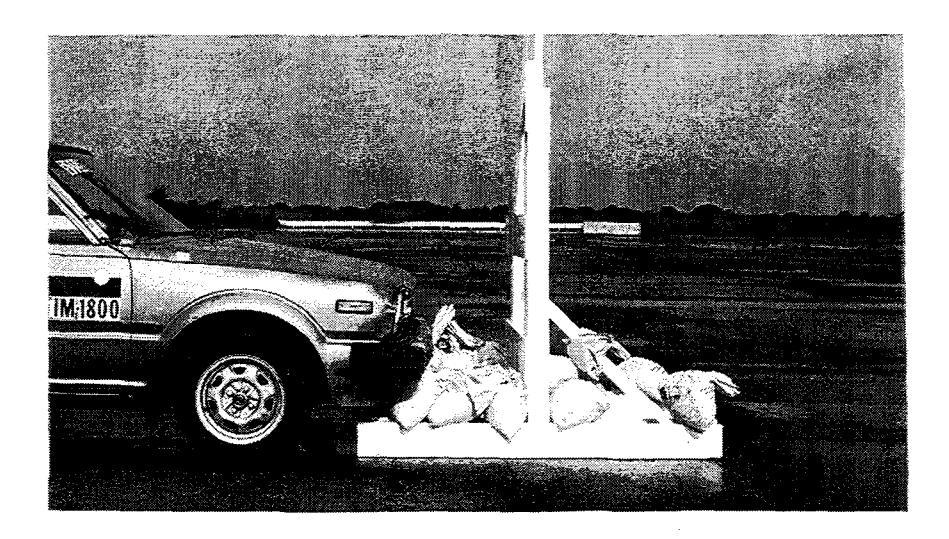
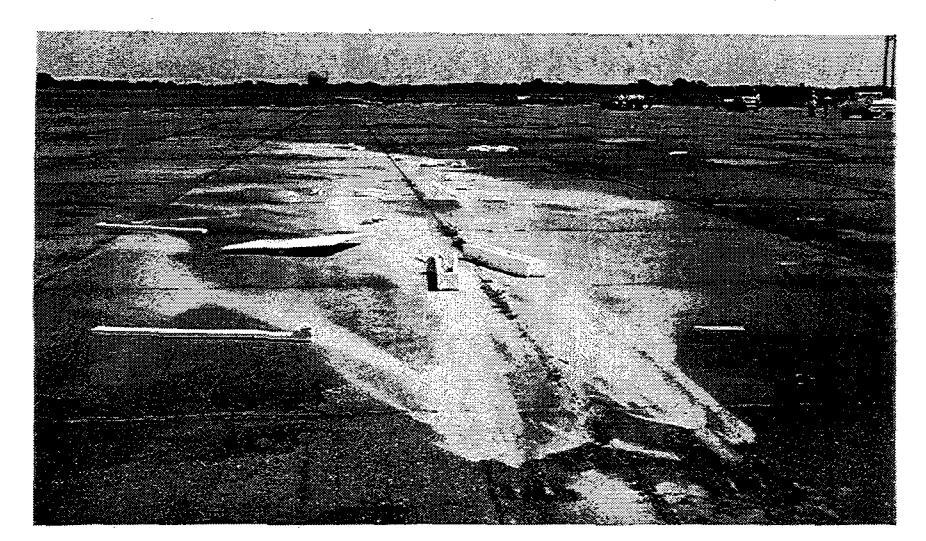
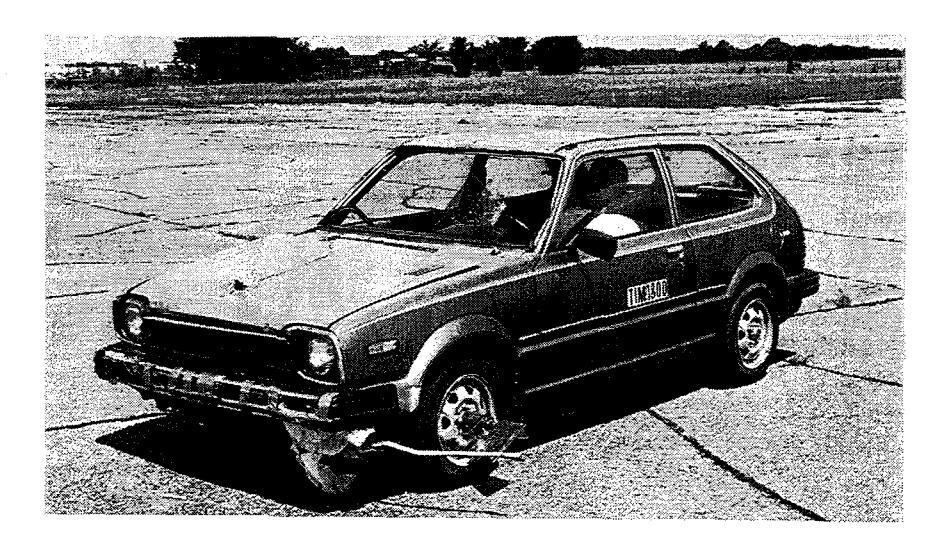
Figure 2. Vehicle and Barricade for Test No. 453360-1

As can be seen in Figure 2, the Type III Wood Barricade separated upon impact. Debris and sand were strewn along the path of the vehicle in an area 11 m wide by 37 m long. Figure 2 shows damage to the vehicle. There were two dents in the bumper, 38 mm and 19 mm from

impact with the vertical supports of the barricade. There was a 40 mm x 200 mm dent in the hood, the windshield was broken and had fallen into the occupant compartment, and there was a small dent in the rear roof near the hatch.

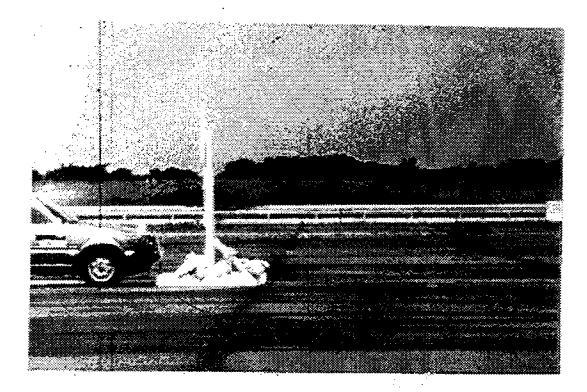
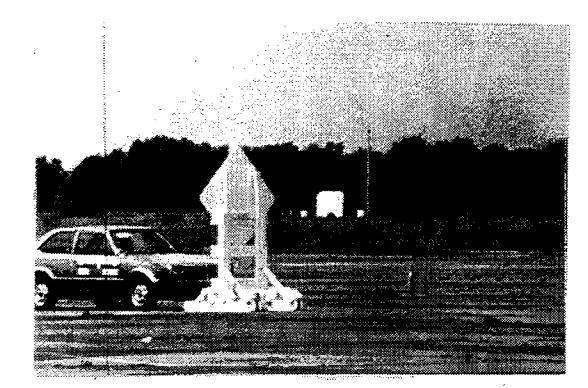
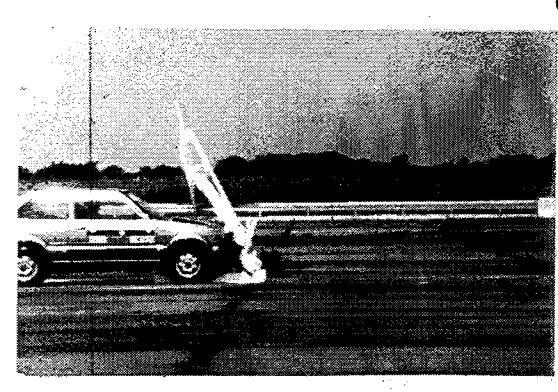
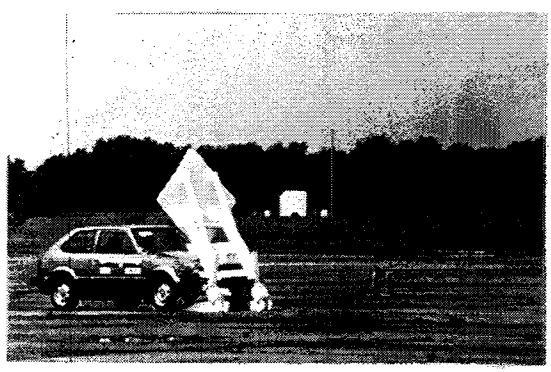
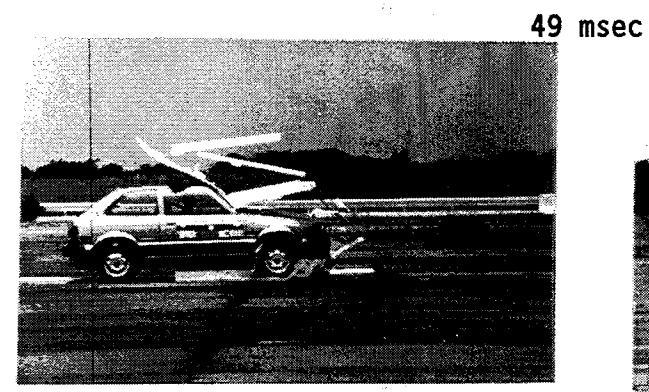
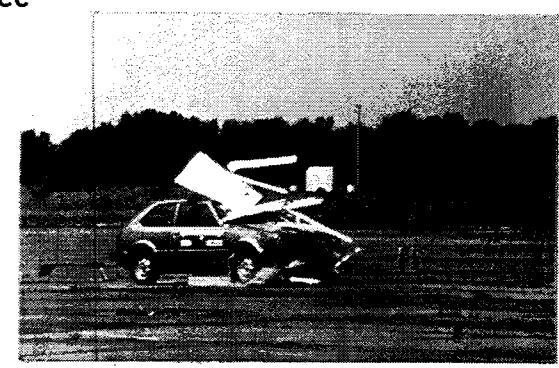
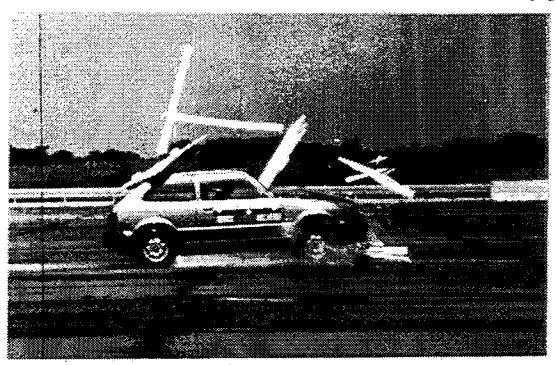
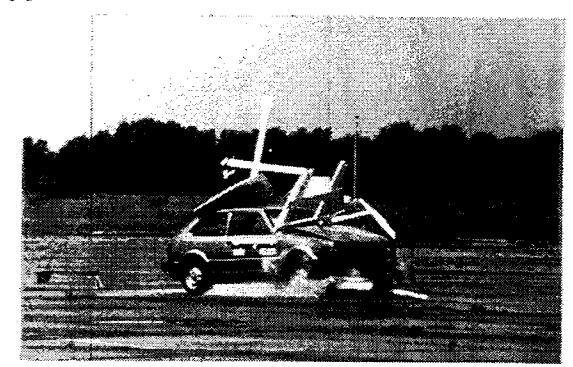
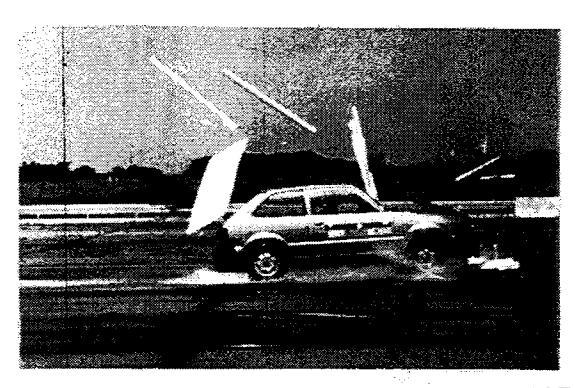
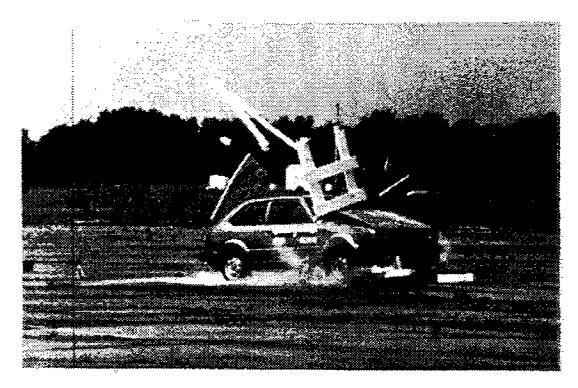
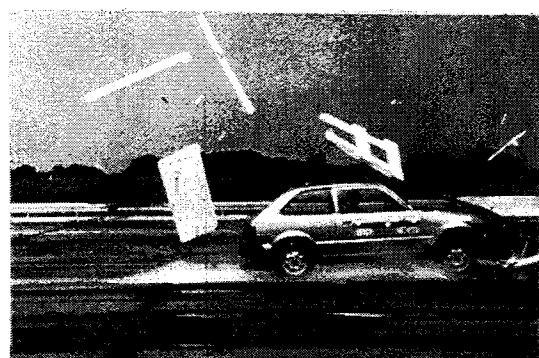
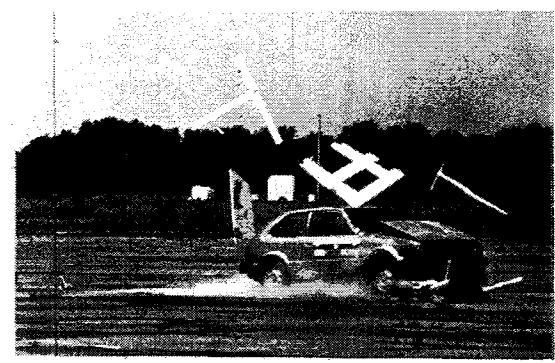
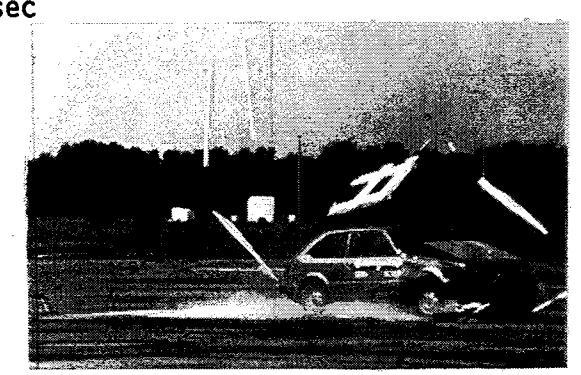
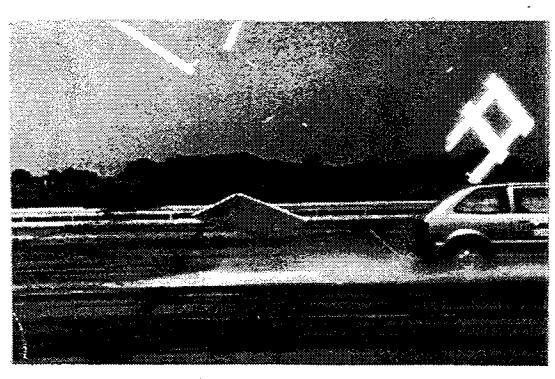
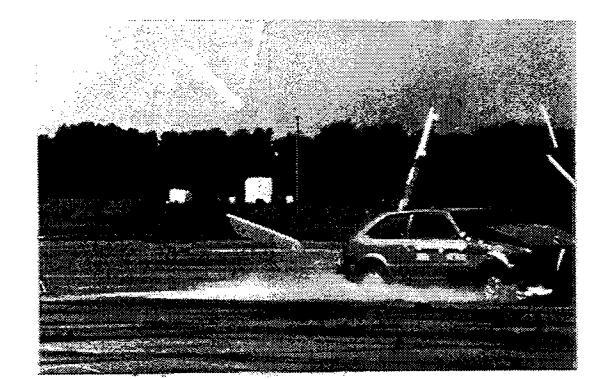
Figure 3. Sequential Photographs for Test No. 453360-1

At 10 msec after initial impact, the sign panel broke loose from the barricade, and the vertical supports began to break loose from the bases. The sign panel struck the roof just above the windshield at 62 msec. The top of the vertical supports, which had broken off at the base, impacted and penetrated the windshield at 74 msec. As the vehicle continued forward, the sign panel rotated up and over the vehicle, striking the telemetry antenna resulting in loss of data transmission at about 93 msec. The time at loss of contact with the barricade, i.e., when the support ended contact with the vehicle, was 209 msec and the vehicle had slowed to 84.5 km/h. The support rotated as it went over the vehicle, and one leg momentarily contacted the rear portion of the roof just above the rear hatch at about 307 msec. Brakes on the vehicle were applied at 1.05 seconds after impact, which was after the vehicle cleared the immediate test site. Prior to brake application, the test vehicle was traveling on a relatively straight-forward path. However, one brake did not actuate upon application, causing the vehicle to yaw in a clockwise rotation. The vehicle subsequently came to rest 137 m down and 37 m to the right of the point of impact. Figure 3 shows sequential photographs of the test period.

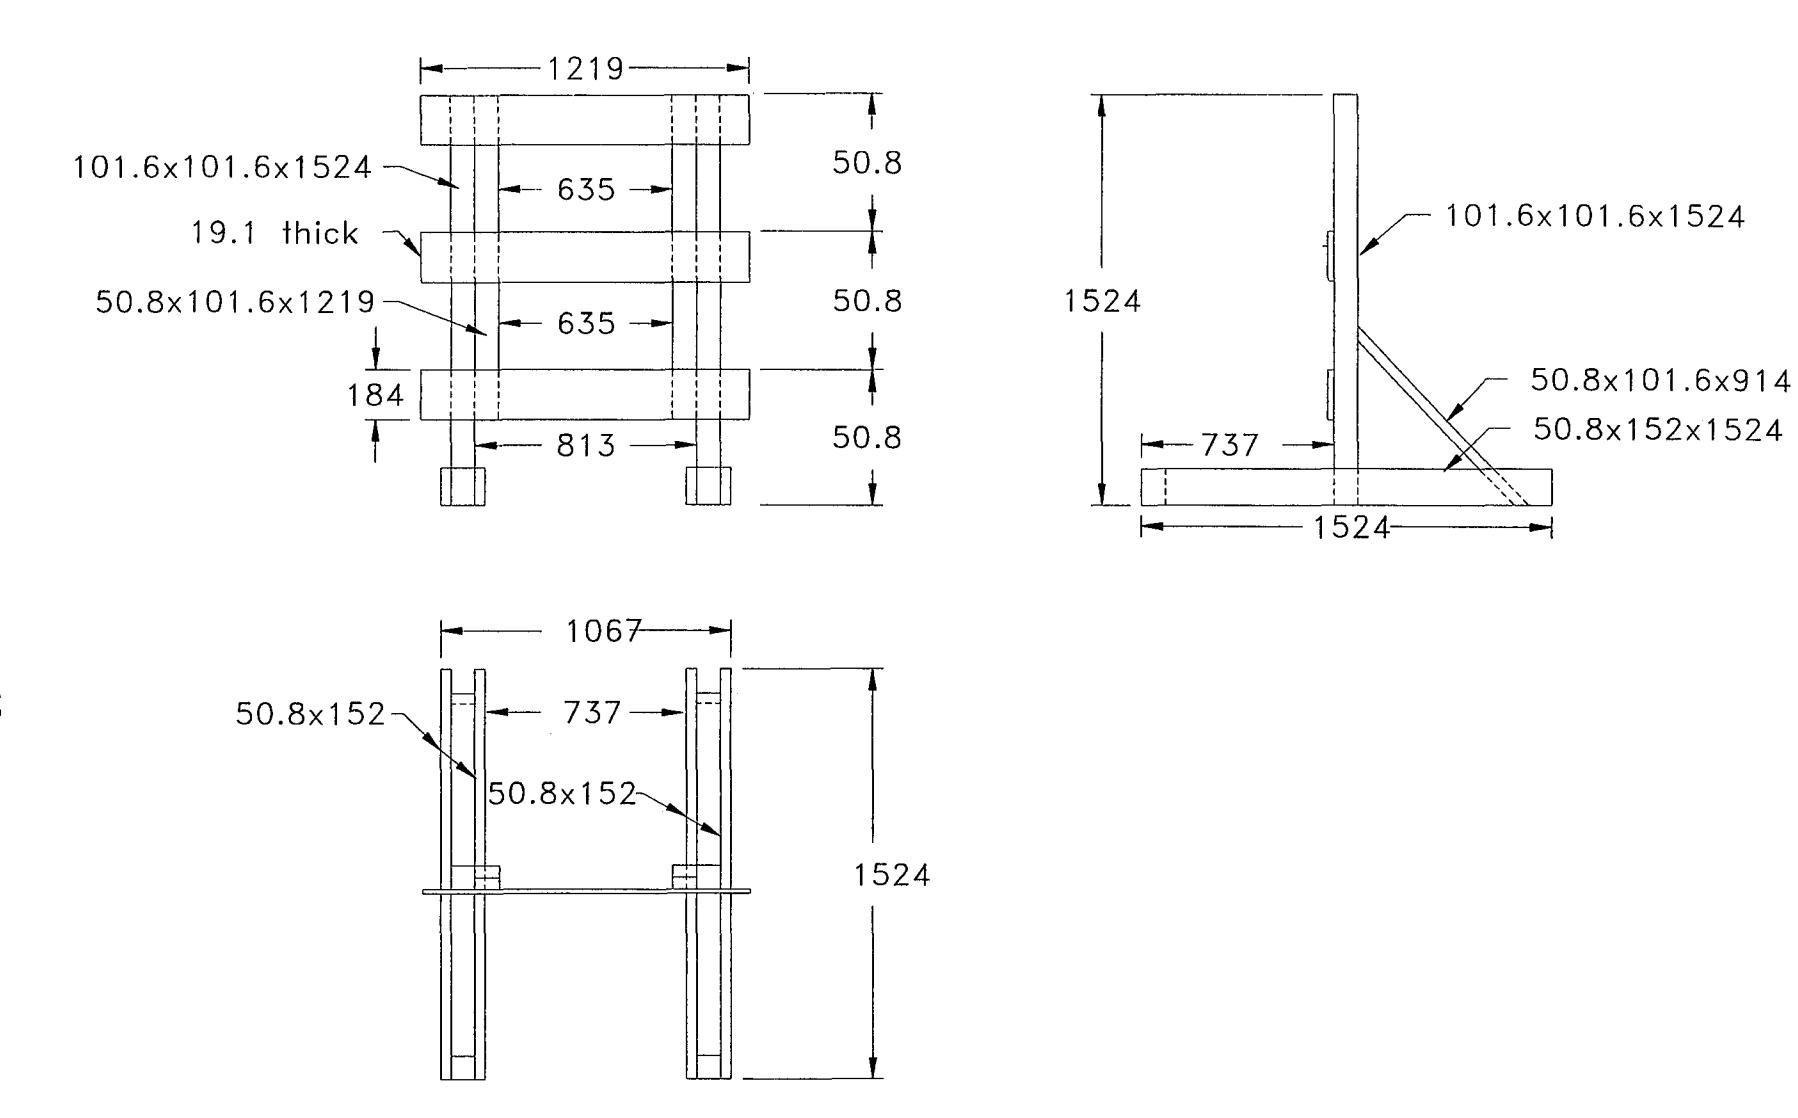
Figure 5. Schematic of Type III Wooden Barricade without Sign (Test No. 453360-4)

Figure 5 shows a schematic of the Type III barricade. The test vehicle was a 1986 Yugo GV, as shown in Figure 6. Appendix Figure 89 gives dimensions and information on the vehicle. The test vehicle impacted the barricade head-on with the centerline of the vehicle aligned with the centerline of the barricade, traveling at a speed of 102.5 km/h.

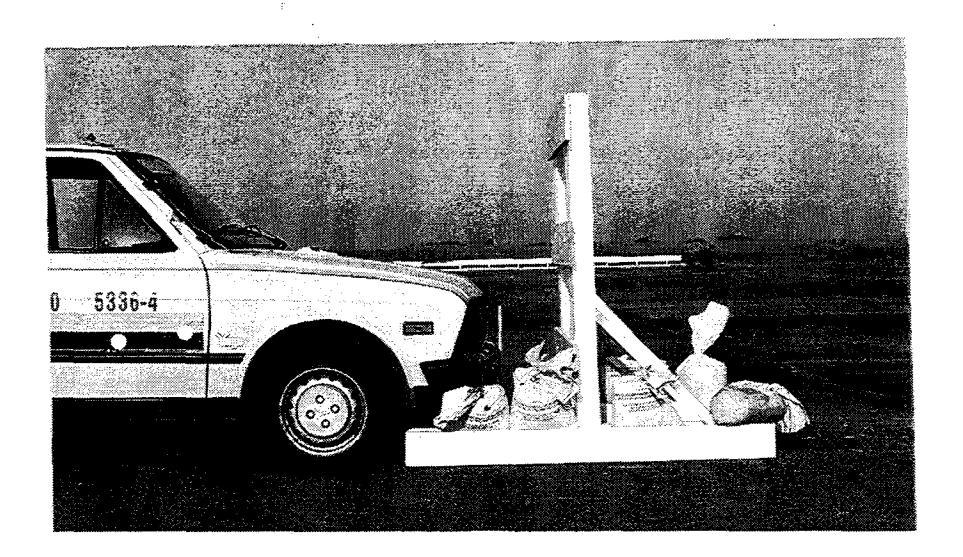
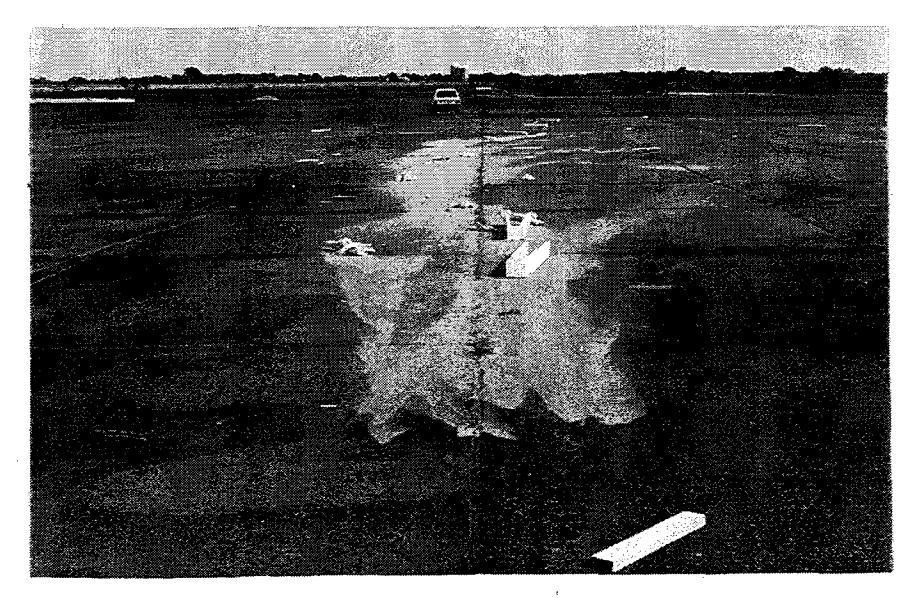
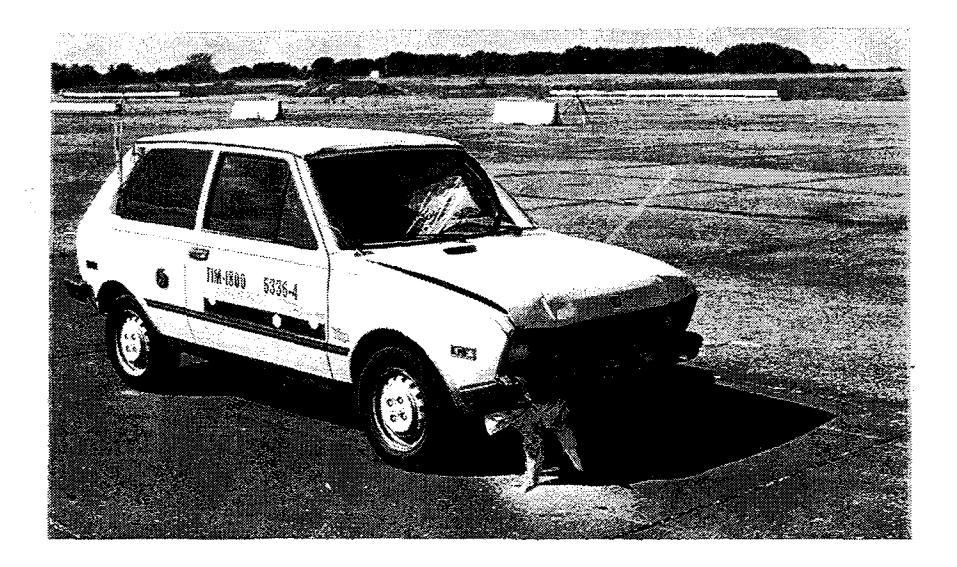
Figure 6. Vehicle and Barricade for Test No. 453360-4

The barricade shattered upon impact, as can be seen in Figure 6. Debris and sand were strewn along the path of the vehicle in an area 18 m wide by 56 m long. Figure 6 shows damage to the vehicle. There were two dents in the bumper, 89 mm and 64 mm from impact with the vertical supports. The windshield was broken and had fallen into the occupant compartment,

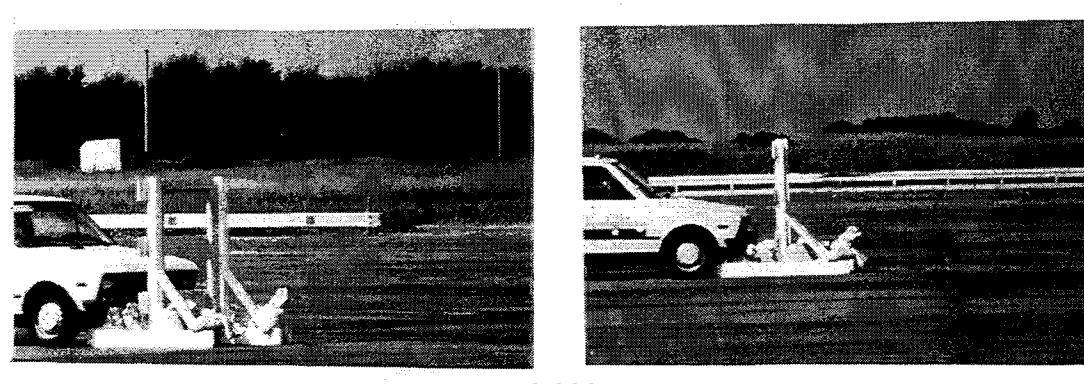
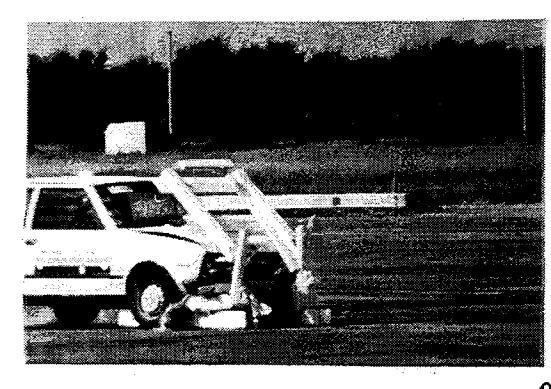
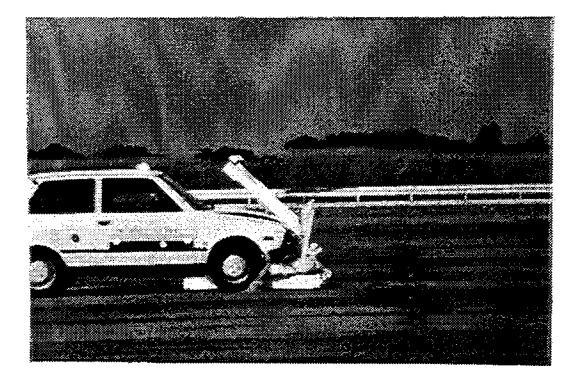
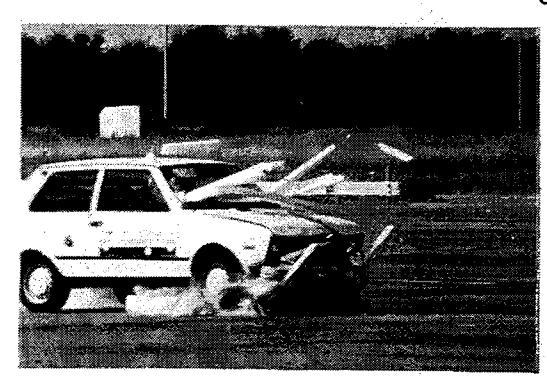
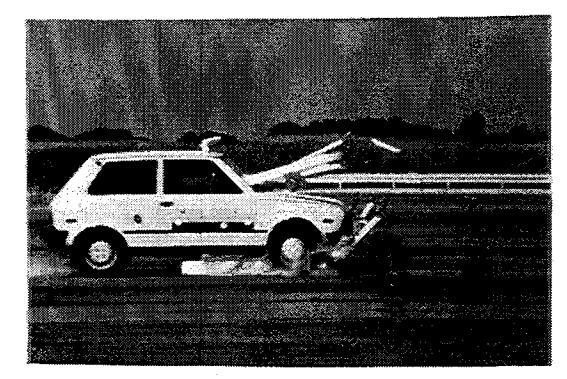
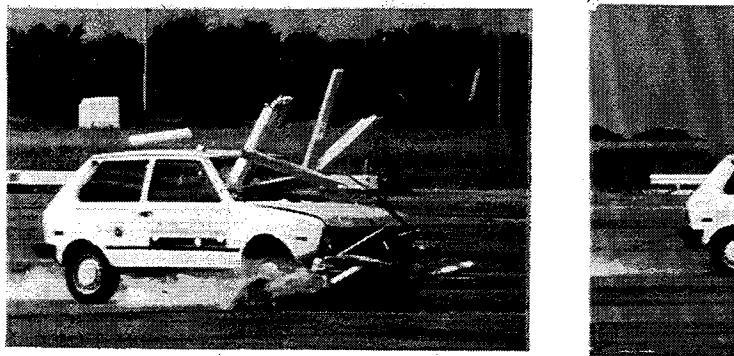
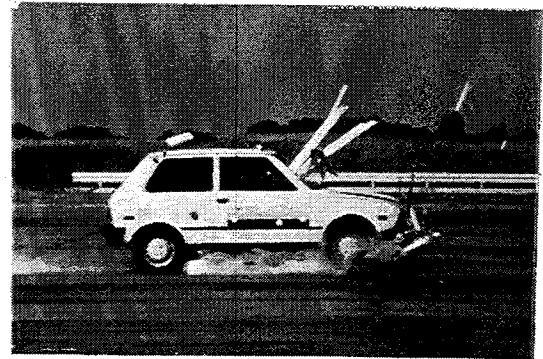
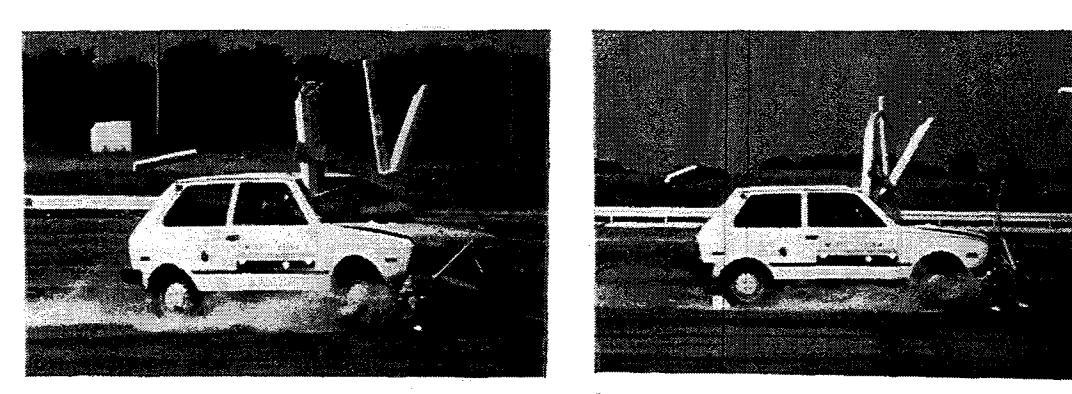
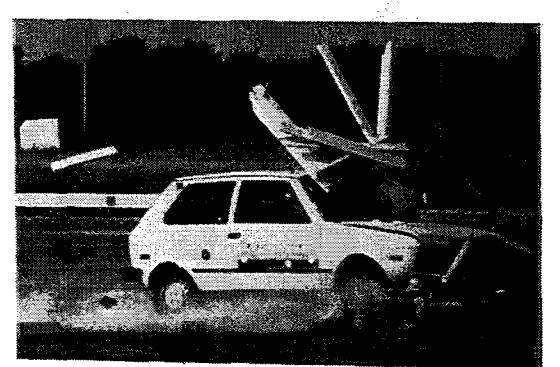
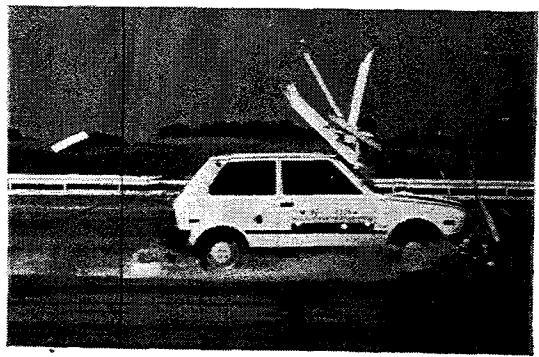
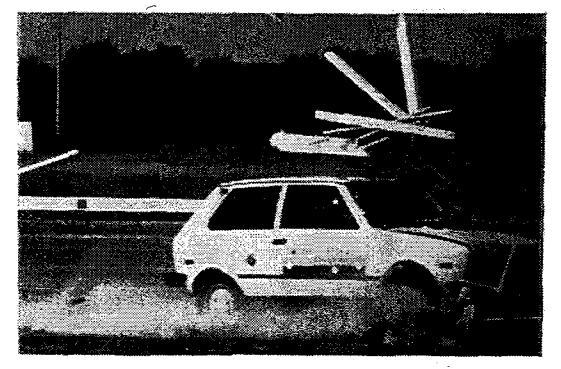
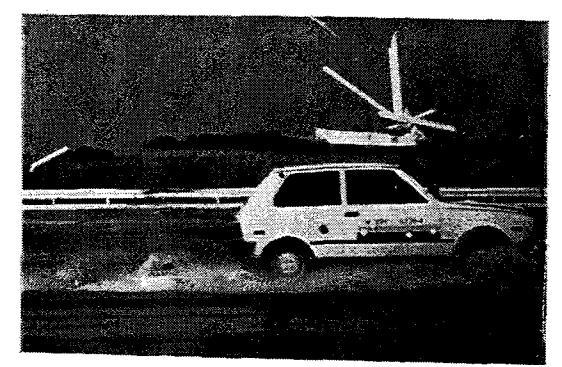
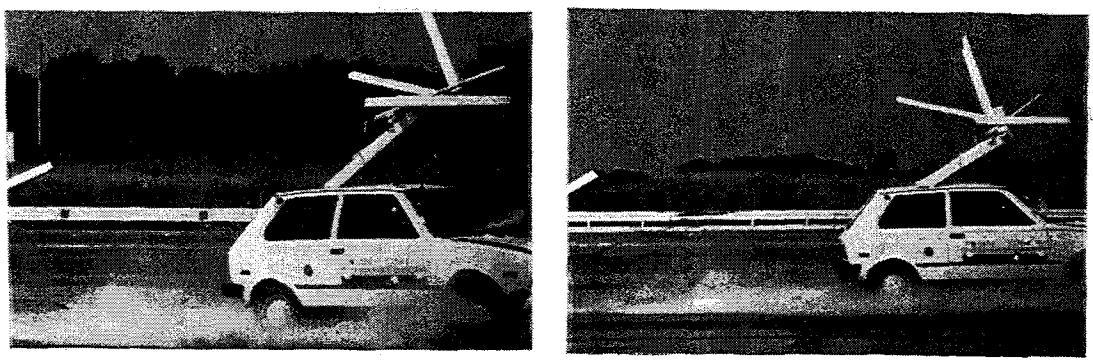
Figure 7. Sequential Photographs for Test No. 453360-4 (continued)

Upon impact, the vertical supports fractured and contacted the hood of the vehicle while the vehicle traveled over the bases. The top rear section of the barricade separated at 17 msec and made contact with the windshield at 40 msec. The windshield broke at 45 msec, and a fragment of the barricade entered the occupant compartment at 72 msec. As the vehicle continued forward, the other fragments contacted the roof of the vehicle just above the windshield at 117 msec and then lost contact at 164 msec. At this time, the vehicle had slowed to 84.5 km/h. The fragments rotated as they went over the vehicle and momentarily contacted the left rear portion of the roof at about 226 msec. After the vehicle cleared the immediate test site, brakes on the vehicle were applied at 860 msec. Prior to brake application, the test vehicle was traveling on a relatively straight-forward path. The vehicle subsequently came to rest 71 m down from the point of impact. Figure 7 shows sequential photographs of the test period.

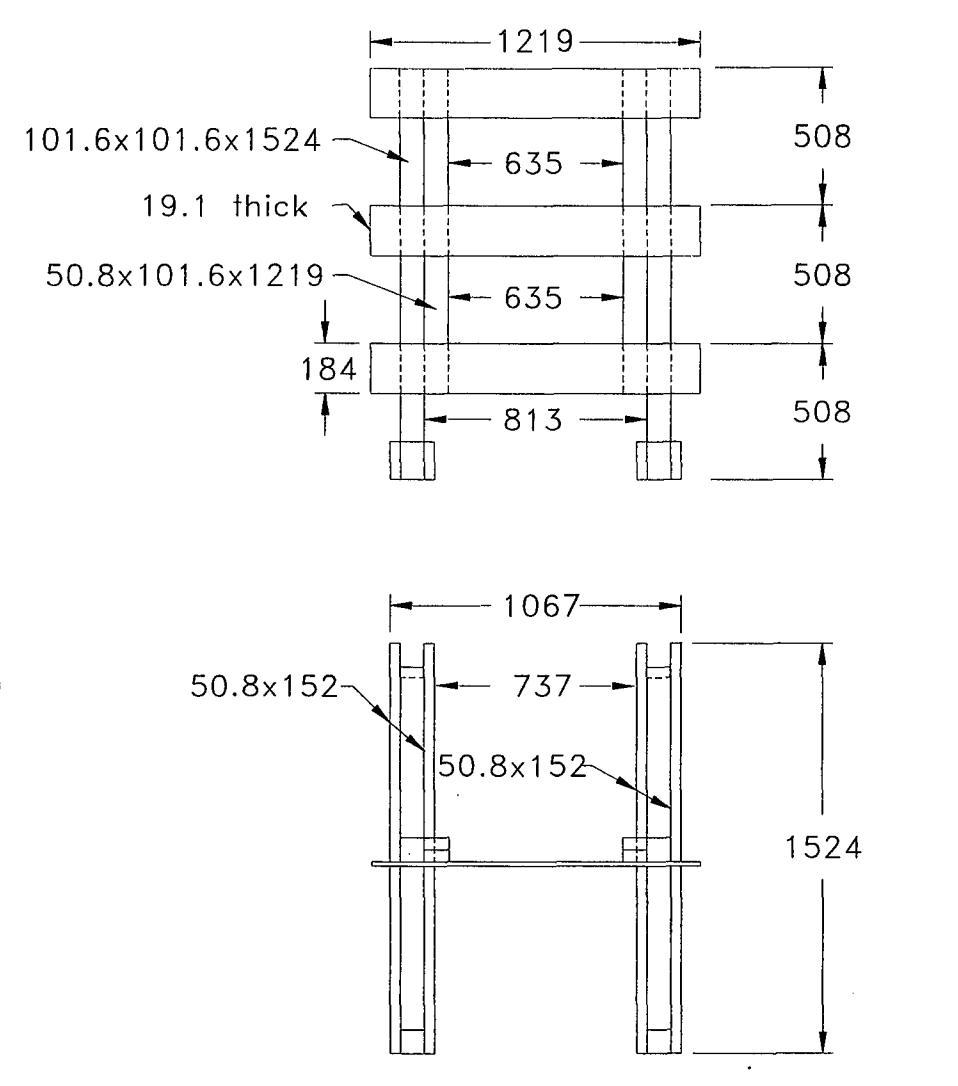
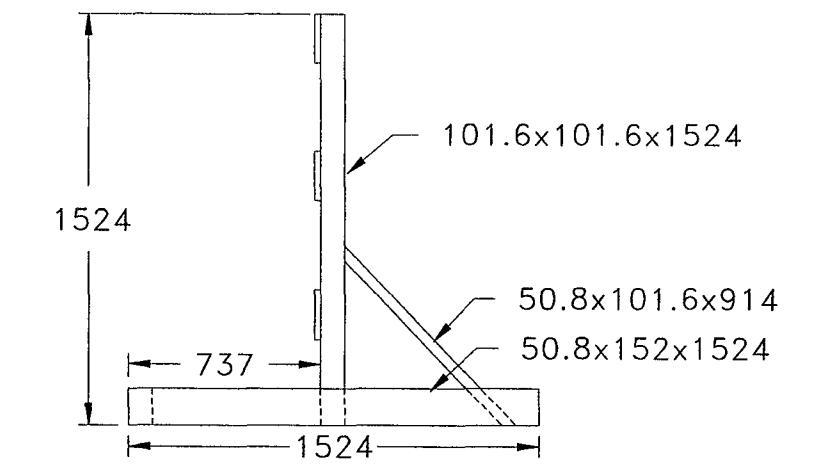
Figure 9. Schematic of Type III Wooden Barricade without Sign (Test No. 453880-4)

Figure 9 shows a schematic of the Type III barricade without sign attachment. The test vehicle was a 1989 Chevrolet Sprint as shown in Figure 10. Appendix Figure 90 gives dimensions and information on the vehicle. The test vehicle impacted the barricade end-on with the centerline of the vehicle aligned with the centerline of the barricade, traveling at a speed of 99.6 km/h.

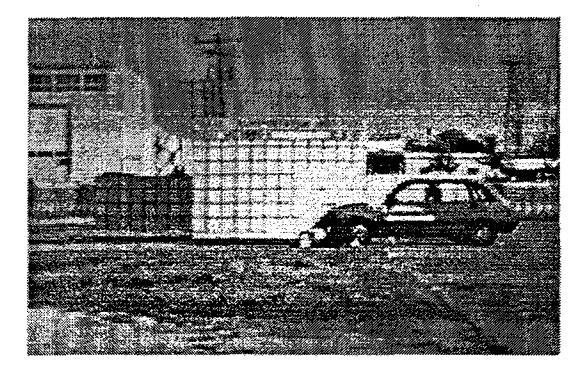
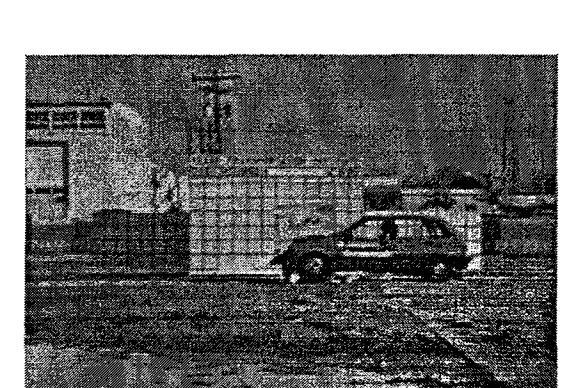
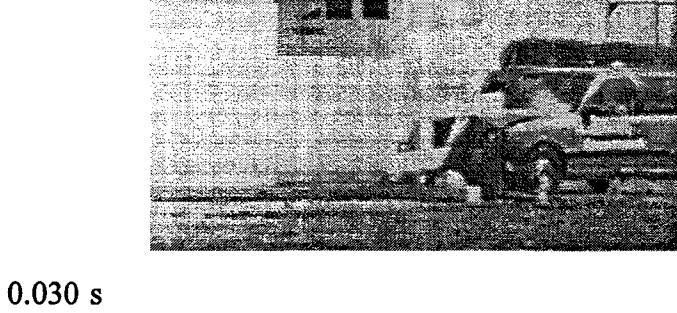
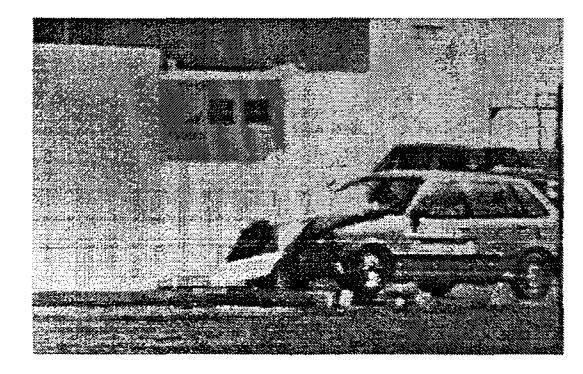
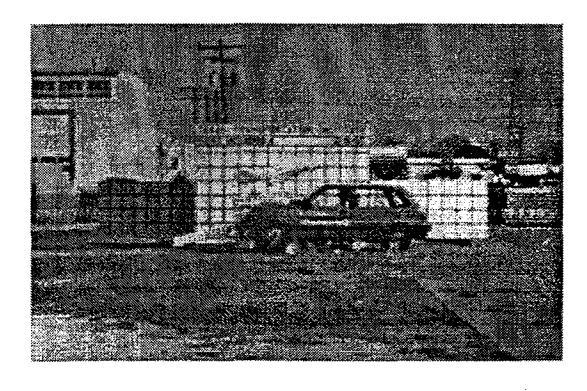
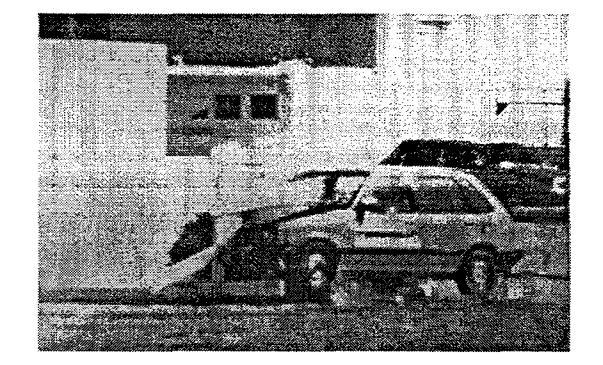
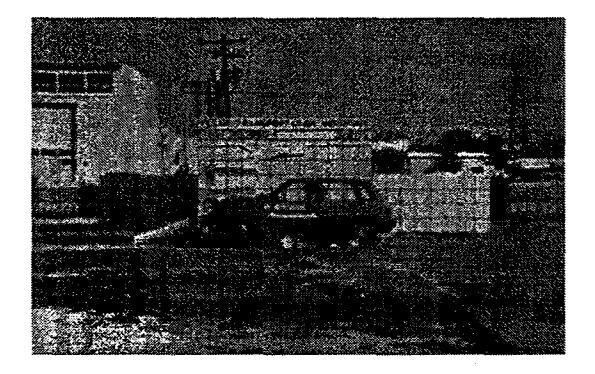
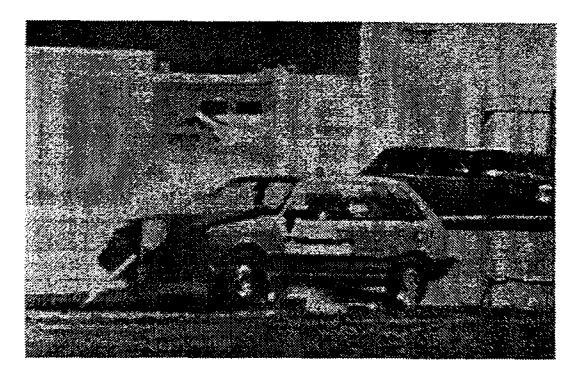
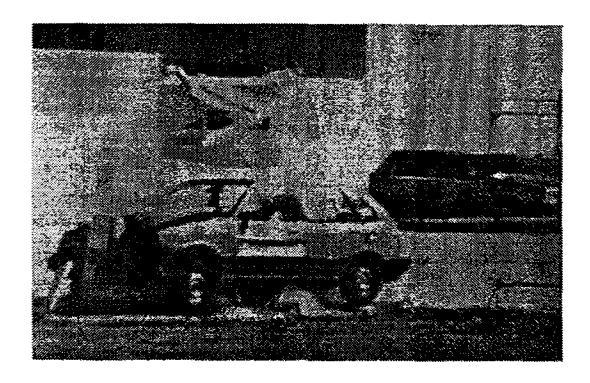
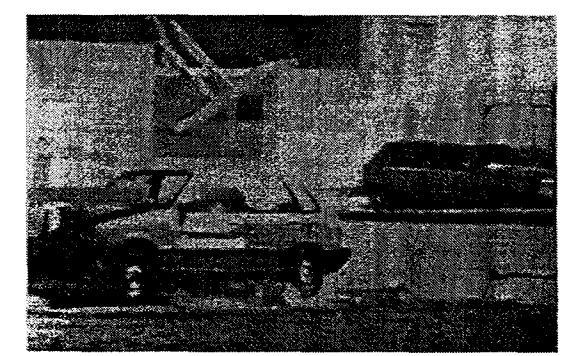
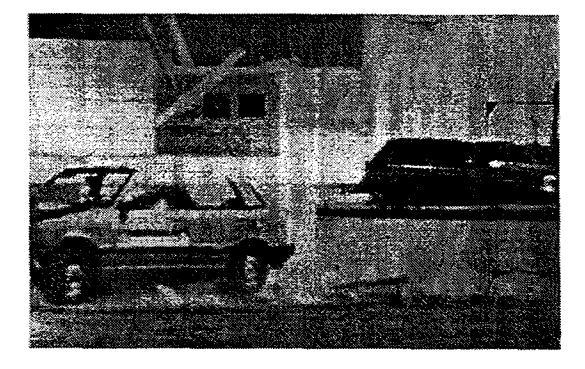
Figure 11. Sequential Photographs for Test No. 453880-4

As the vehicle impacted the end of the rail elements, the right vertical support separated from the base. The vehicle contacted the right vertical support at 7 msec. At 12 msec, the lower rail element separated from the vertical supports. At 17 msec, the middle rail element separated from the vertical support and contacted the hood of the vehicle at 20 msec. The front tires of the vehicle rode over the right base, which separated from the vertical support. The left vertical support separated at 48 msec, and the vehicle rode over the left base, carrying the remaining debris of the barricade with it. At 221 msec, the vehicle cleared the installation site traveling at a speed of 93.1 km/h. Prior to brake application, the vehicle was tracking straight forward. The vehicle subsequently came to rest 102.4 m down and 1.7 m to the right of the point of impact. Figure 11 shows sequential photographs of the test period.

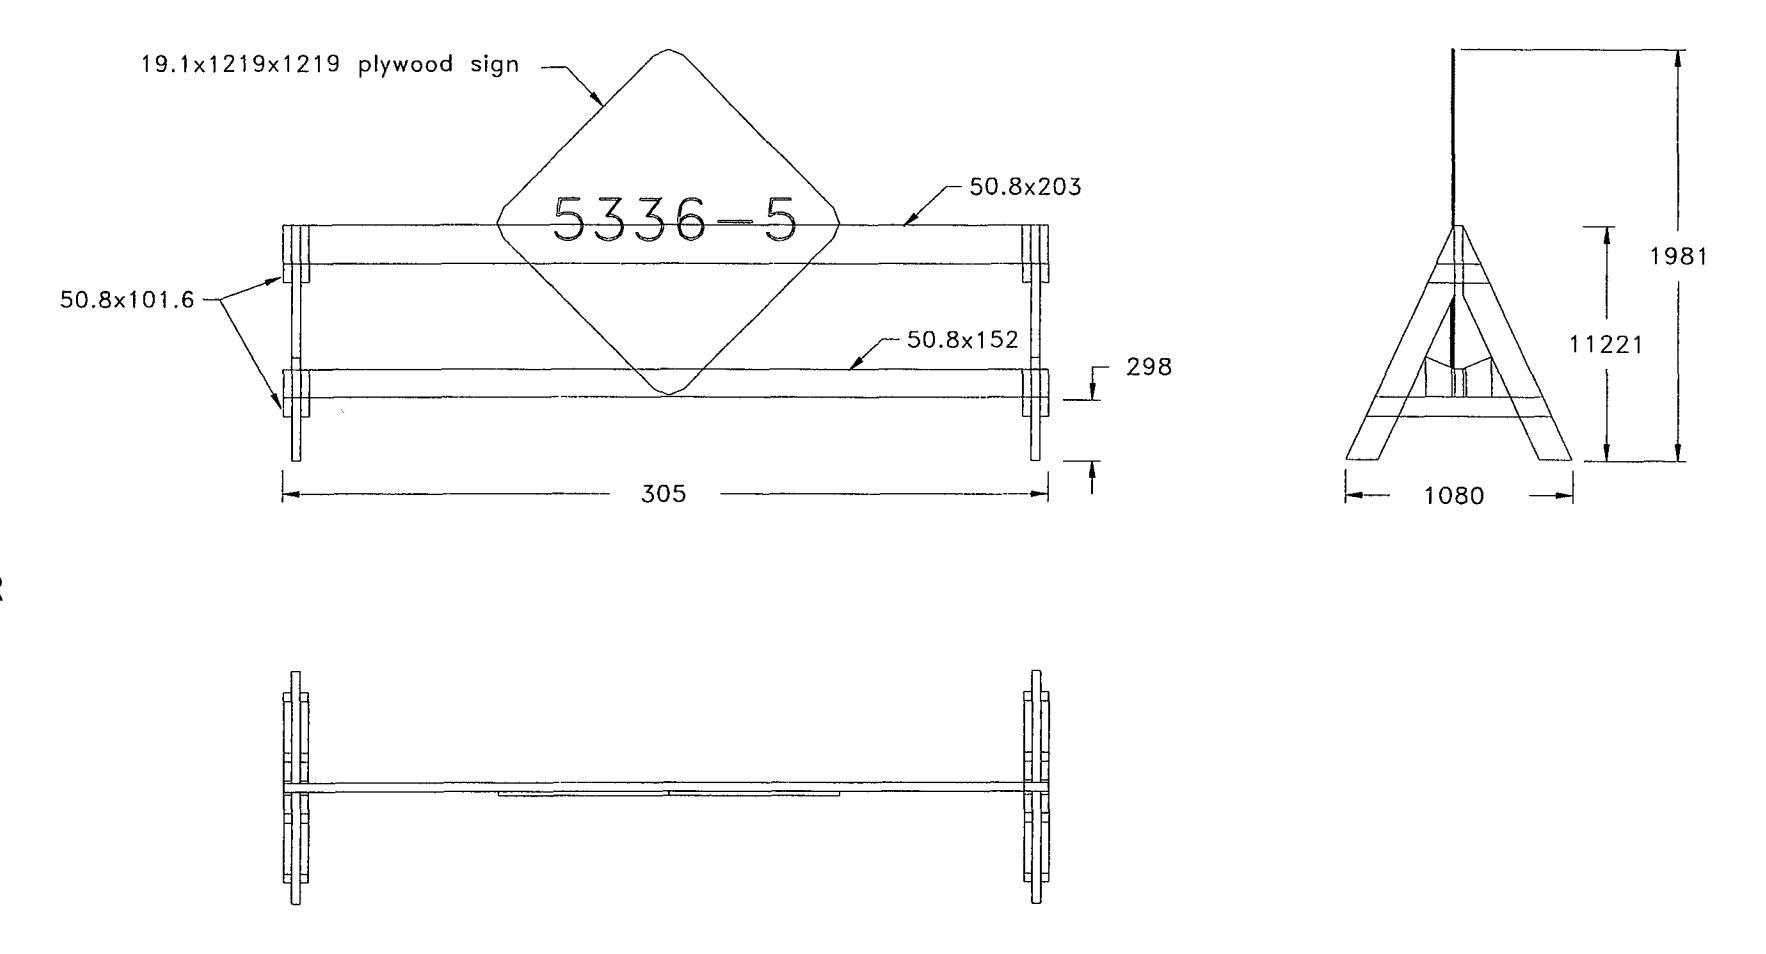
Figure 13. Schematic of Type I Wooden Barricade with Wooden Sign Panel (Test No. 453360-5)

Figure 13 shows a schematic of the Type I barricade with a 1219 mm x 1219 mm sign panel mounted at a height of 305 mm. The test vehicle was a 1989 Yugo GV, as shown in Figure 14. Appendix Figure 91 gives dimensions and information on the vehicle. The test vehicle impacted the barricade head-on with the centerline of the barricade, traveling at a speed of 99.4 km/h.

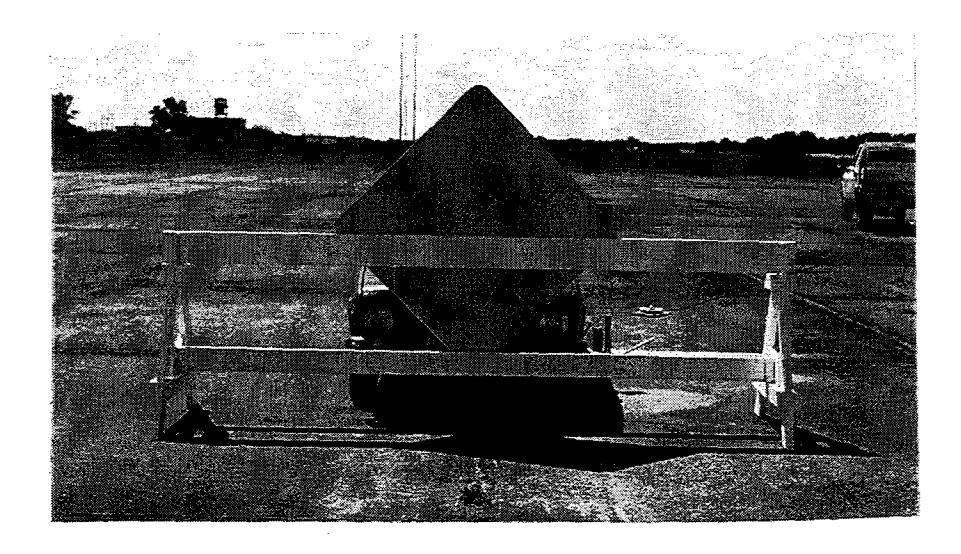
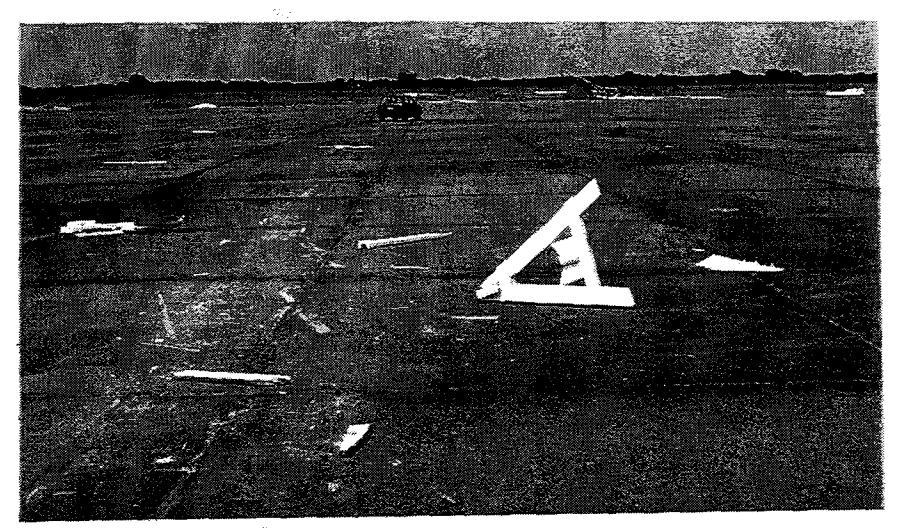
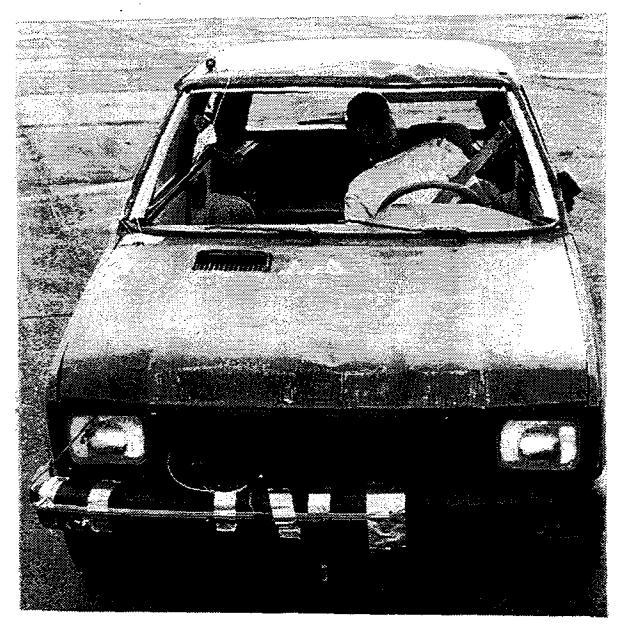
Figure 14. Vehicle and Barricade for Test No. 453360-5

The barricade shattered upon impact, as can be seen in Figure 14. Debris and sand were strewn along the path of the vehicle in an area 15 m wide by 53 m long. Figure 14 shows damage to the vehicle. There were two dents in the bumper, 38 mm and 19 mm from impact with the rail elements. There were scrapes in the hood leading up to the windshield, the windshield was broken and fallen into the occupant compartment, and there were dents on the A-pillars starting 152 mm above the bottom of the windshield frame and ending at the top edge of the roof.
