EVALUATION OF WORK ZONE BARRICADES AND TEMPORARY SIGN SUPPORTS

Report No. 5388-1F Research Study No. 585xxA3014 Research Study Title: Development of New Designs for Barricades and Sign Supports in Work Zones

> Sponsored by the Texas Department of Transportation

> > February 1996

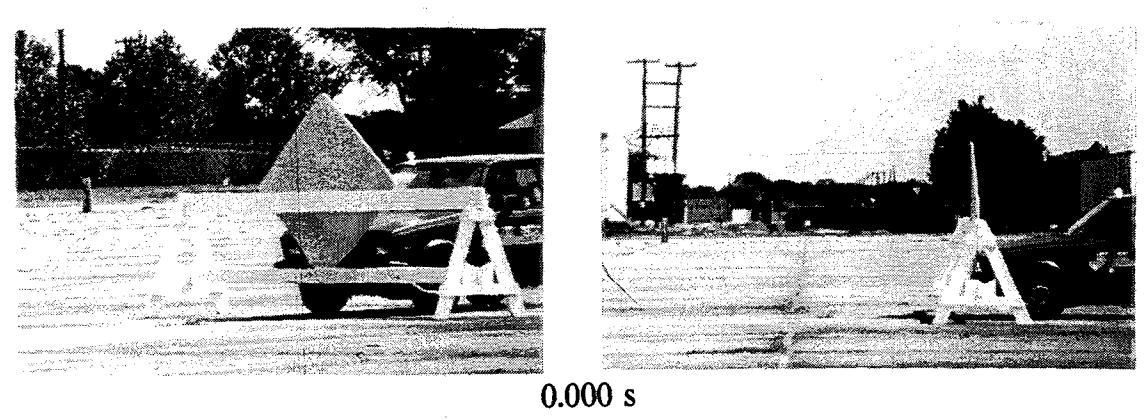
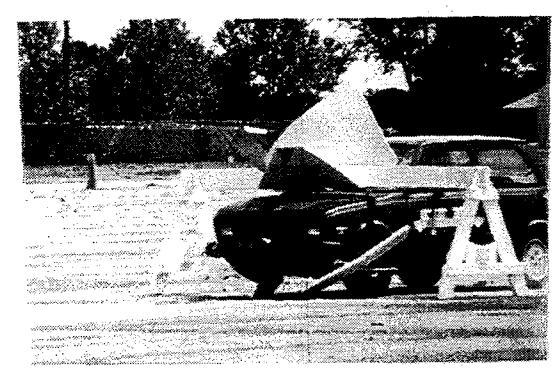
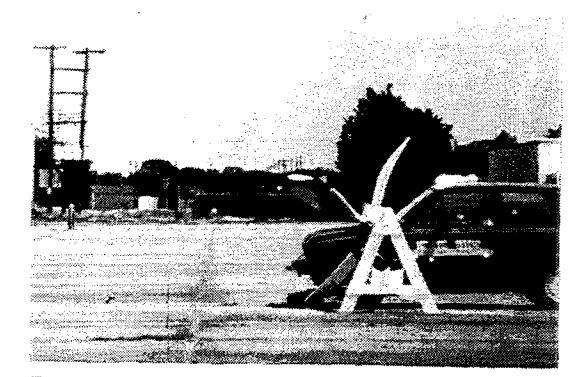
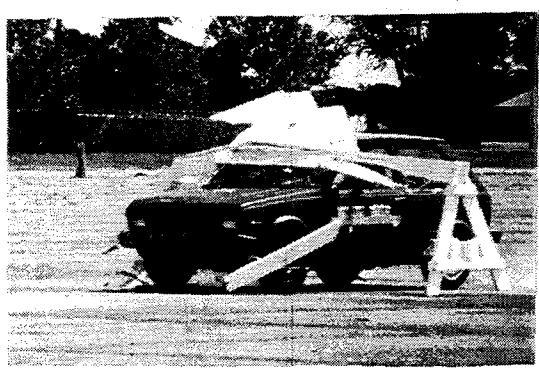
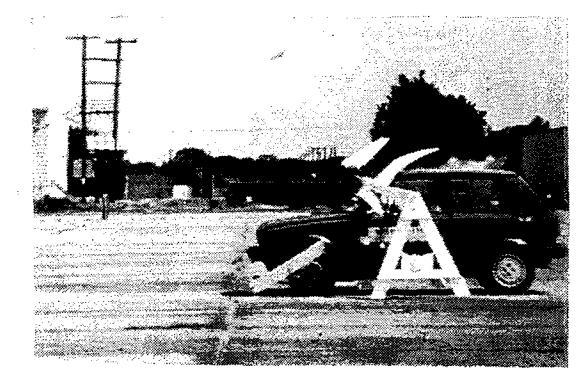
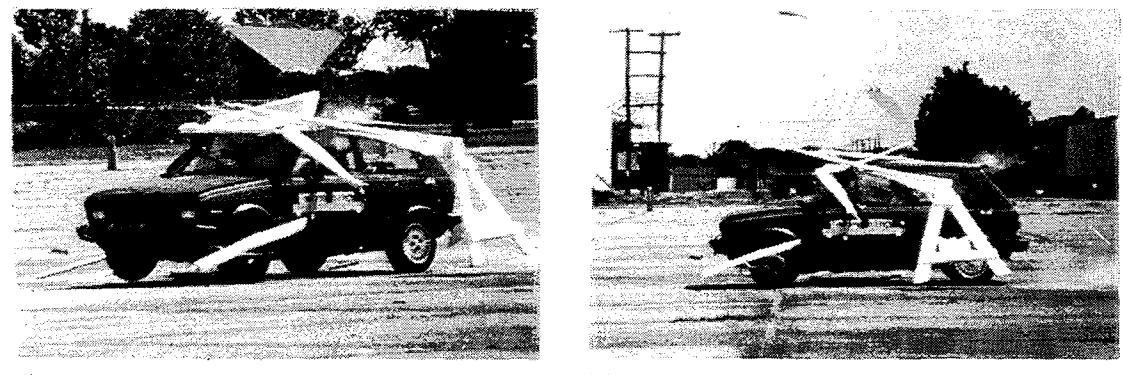
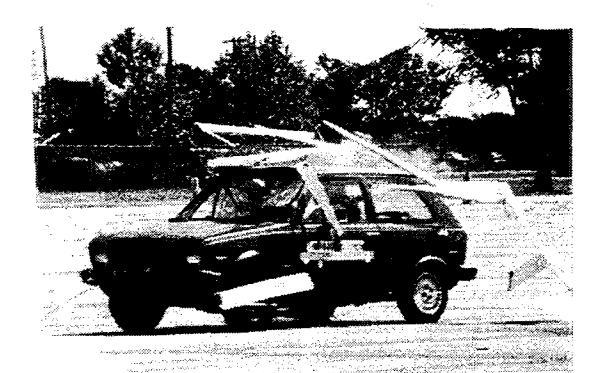
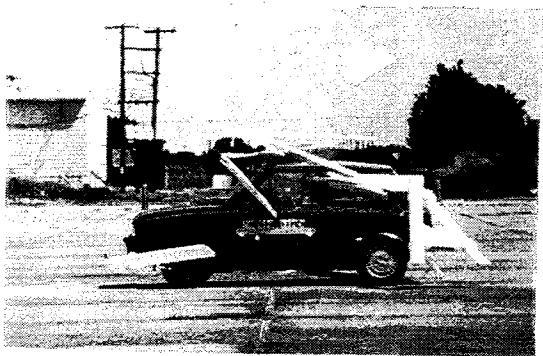
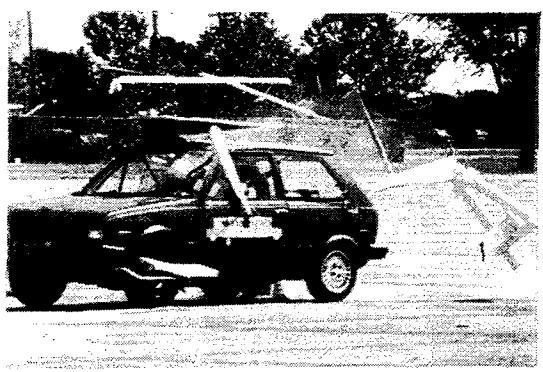
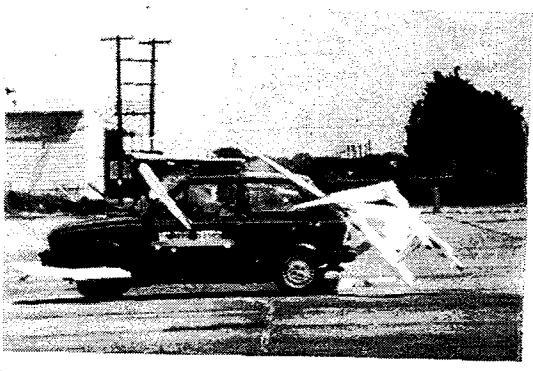
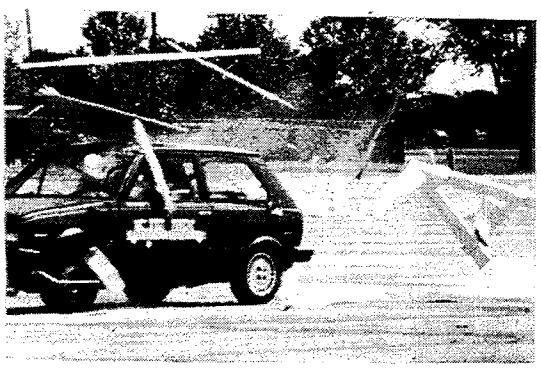
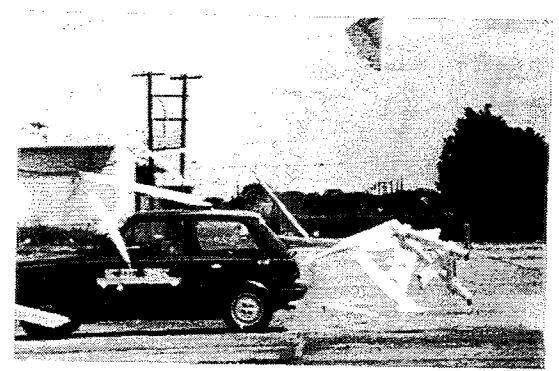
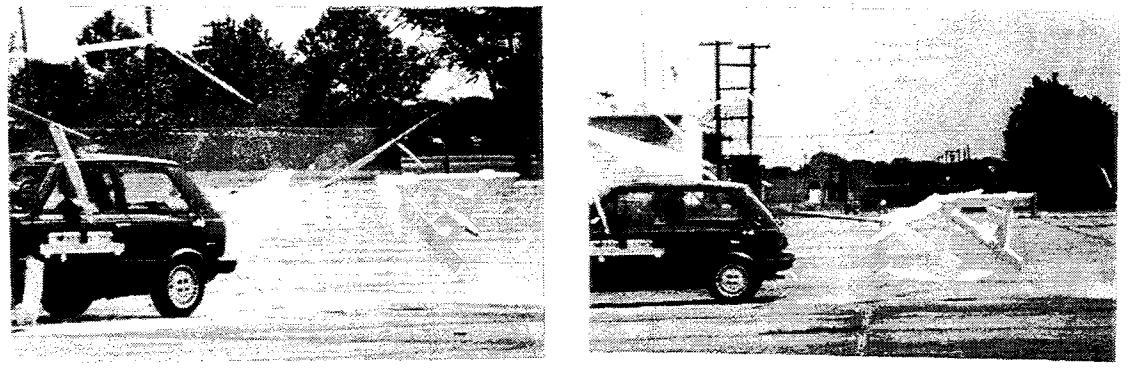
Figure 15. Sequential Photographs for Test No. 453360-5

Upon impact, the bottom rail element broke. At 15 msec after impact, the sign panel cracked. As the vehicle continued forward, the fragments rose and struck the windshield, which broke at 57 msec. At the same time, the top rail element of the barricade contacted the A-pillars of the vehicle. The sign panel continued to go up and lost contact with the vehicle at 122 msec, while the remaining fragments of the rail elements lost contact at 156 msec. The vehicle had slowed to 91.2 km/h by this time. After the vehicle cleared the immediate test site, brakes on the vehicle were applied at 960 msec after impact. Prior to brake application, the test vehicle was traveling on a relatively straightforward path. The vehicle subsequently came to rest 68 m down from the point of impact. Figure 15 shows sequential photographs of the test period.

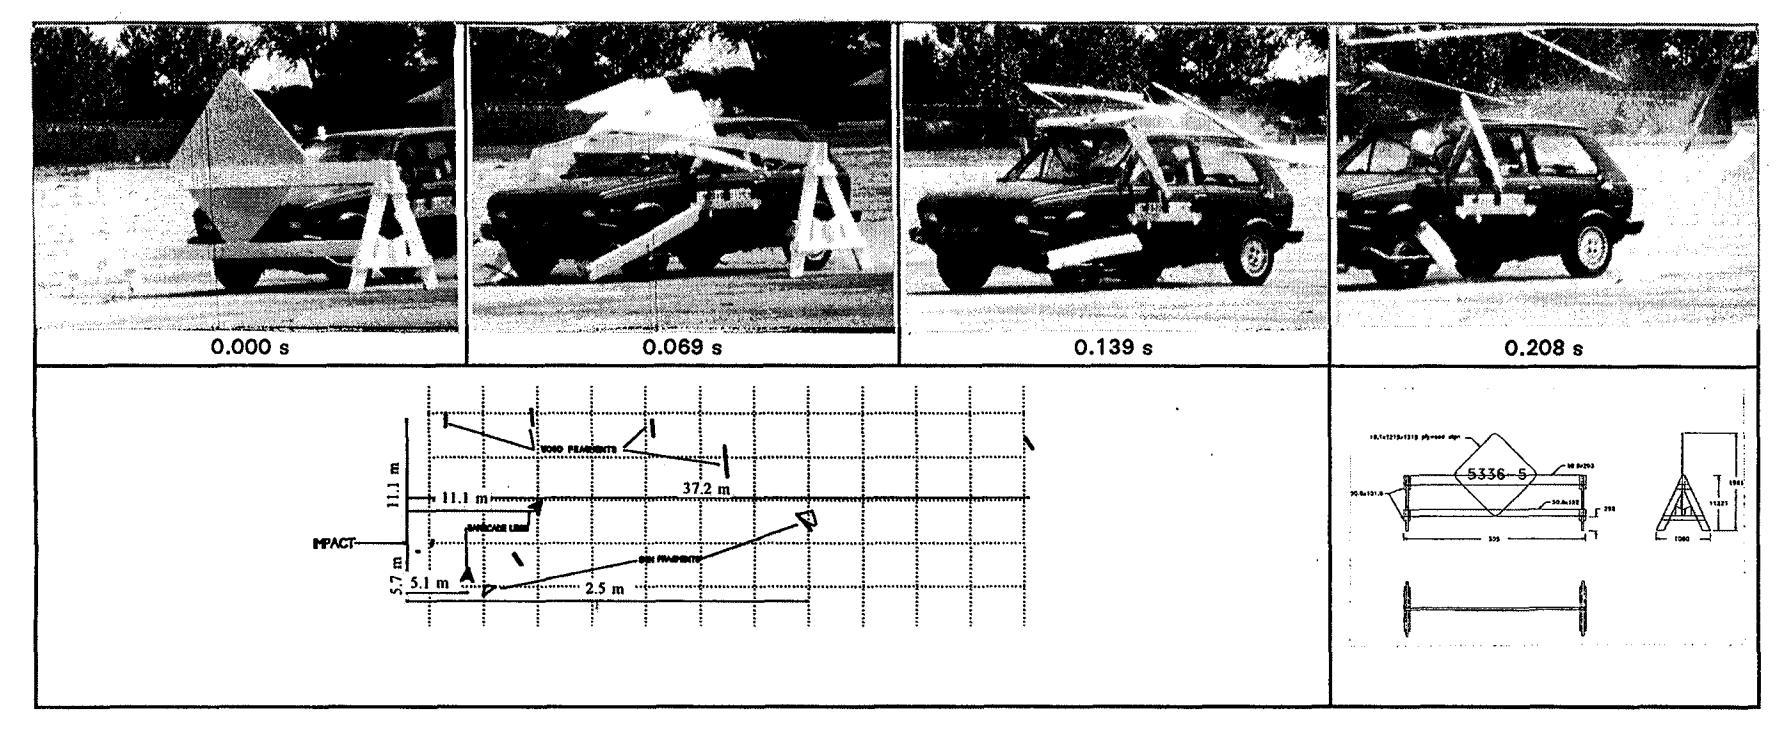
fragments of the barricade were scattered along an area 15 m wide by 53 m long. Some fragments were fairly large, which could pose potential hazard to oncoming traffic in adjacent lanes and to workers in the area. Sand was also scattered on the pavement, which could lead to loss of control of other vehicles. The longitudinal occupant impact velocity was 0.8 m/s and the highest 10-msec average ridedown acceleration was -0.1 g. There was no lateral occupant contact during the test period. The 50-msec average accelerations were -1.1 g in the longitudinal direction and 0.5 g in the lateral direction. The vehicle exited the immediate test site in a relatively smooth, stable manner and showed no potential for intrusion into adjacent traffic lanes.

In summary, the performance of the barricade was judged to be unsatisfactory due to penetration of the windshield and the occupant compartment by the fractured vertical supports of the barricade.

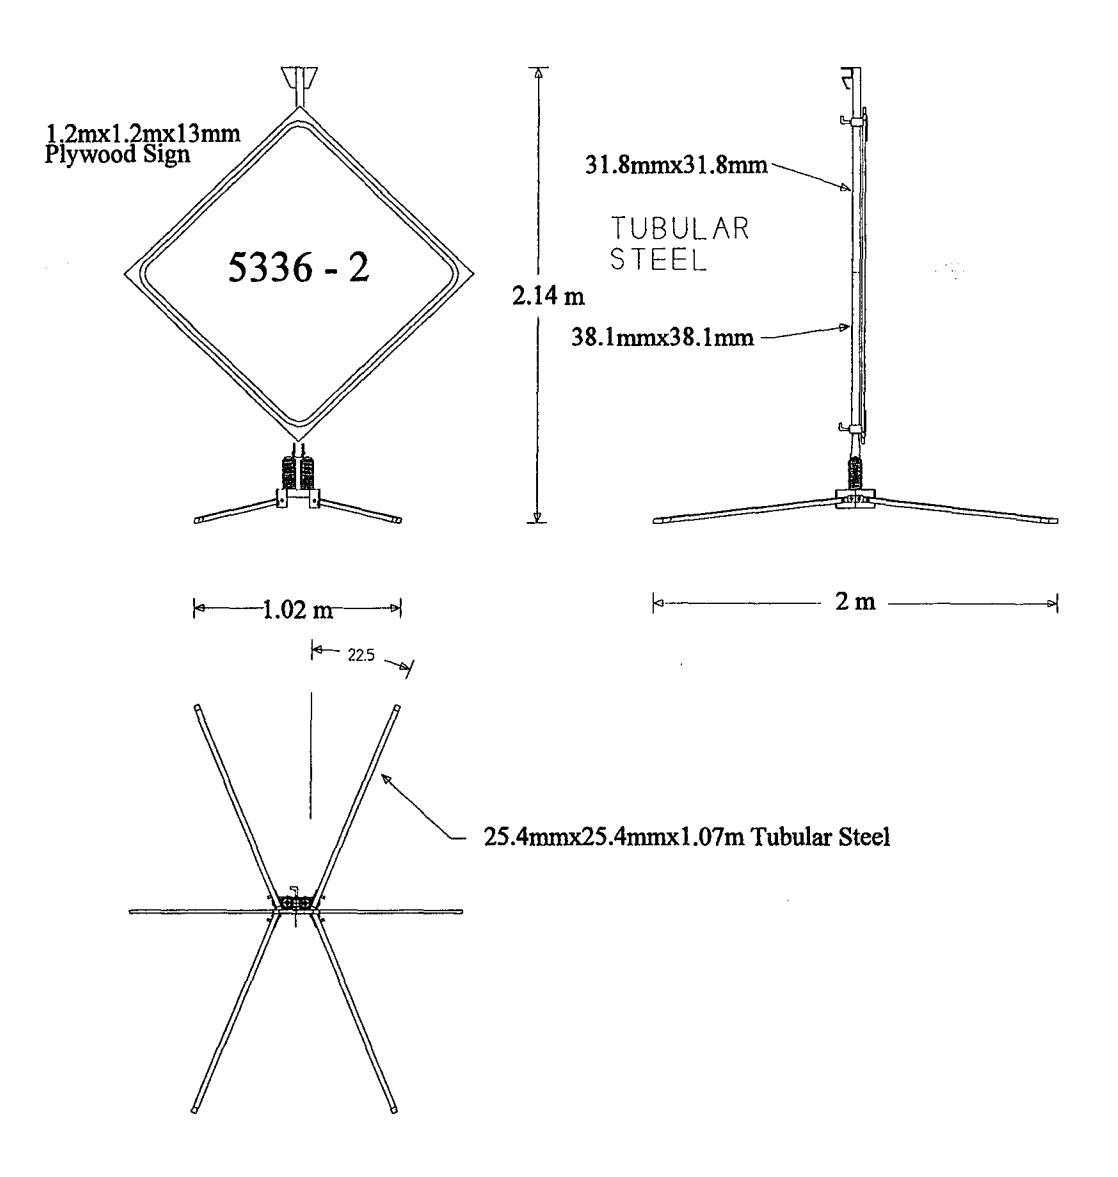
Figure 17. Schematic of Spring Mounted Sign Support with Wooden Sign Panel (Test No. 453360-2)

Figure 17 shows a schematic of the spring-mounted portable sign support with a 1219 mm x 1219 mm wooden sign panel mounted at a height of 305 mm. The test vehicle was a 1988 Yugo GV, as shown in Figure 18. Appendix Figure 92 gives dimensions and information on the vehicle. The test vehicle impacted the sign support head-on with the centerline of the vehicle aligned with the centerline of the sign support, traveling at a speed of 97.0 km/h.

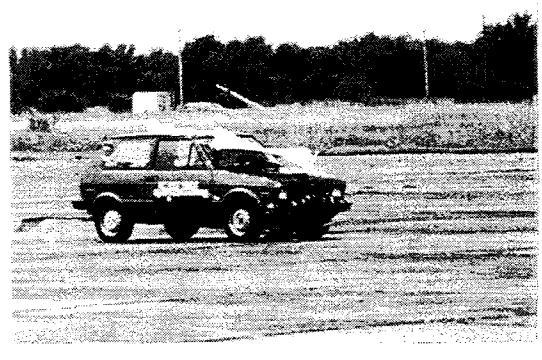
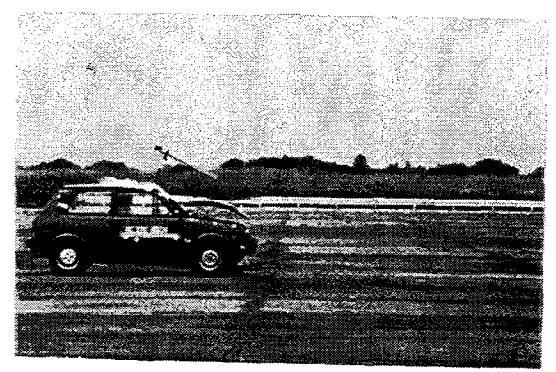
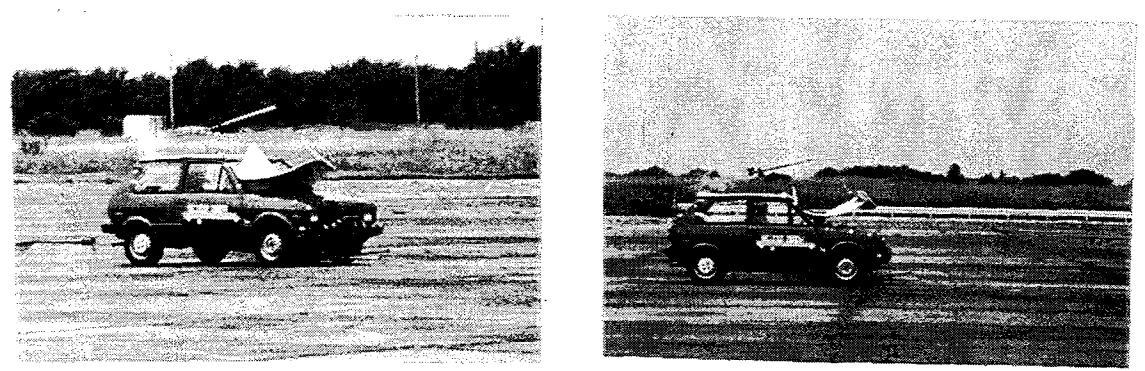
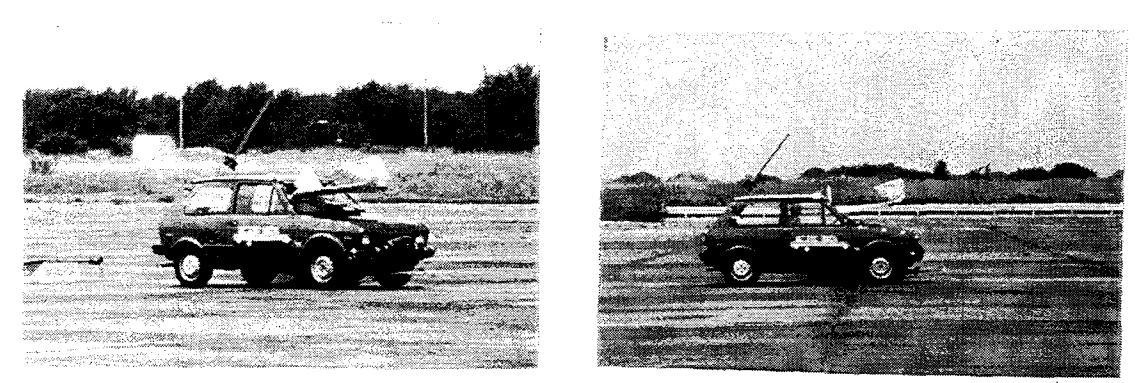
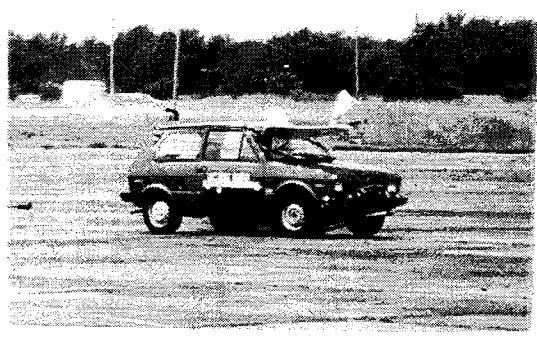
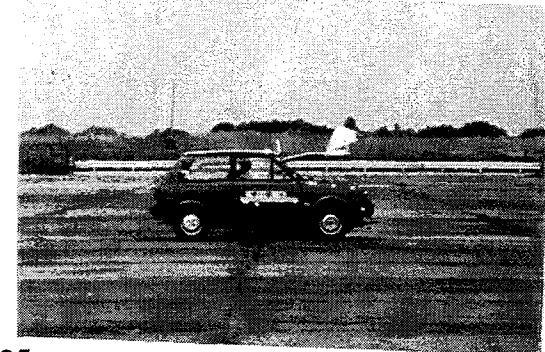
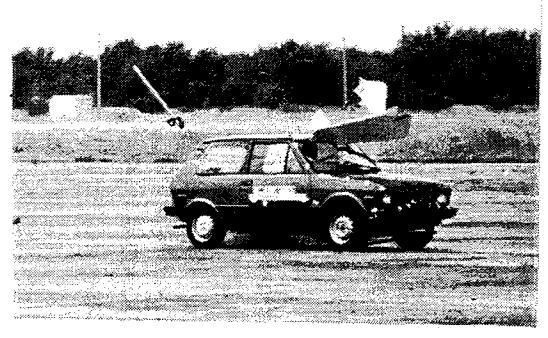
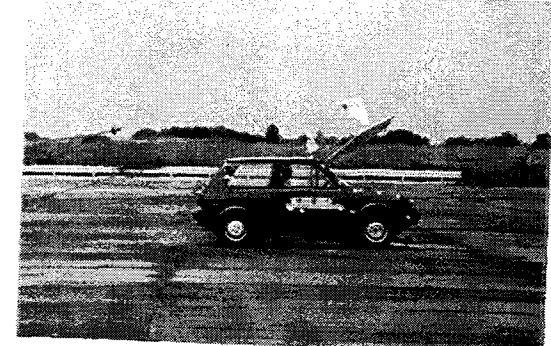
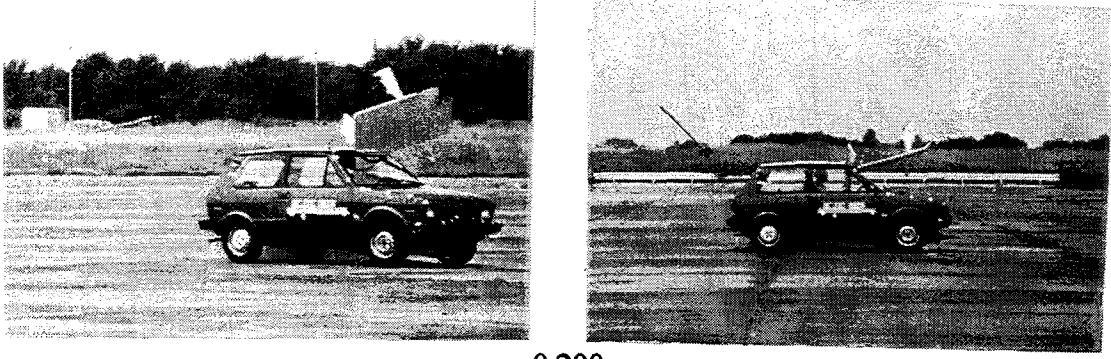
Figure 19. Sequential Photographs for Test No. 453360-2

At approximately 10 msec after impact, the sign panel began to crack. The bracket supporting the sign panel broke at 17 msec, and at 22 msec the sign panel slipped out of the bracket. The sign panel continued moving upward and contacted the edge of the roof of the vehicle just above the windshield. As the vehicle continued forward, the sign panel deformed, impacted and penetrated the windshield, the bracket went over the roof, and the base hung up on the undercarriage of the vehicle. The panel rotated up and over the vehicle and lost contact at 200 msec, at which time the vehicle had slowed to 91.4 km/h. After the vehicle cleared the immediate test site, brakes on the vehicle were applied at 937 msec after impact. Prior to brake application, the test vehicle was traveling on a relatively straight-forward path. The vehicle subsequently came to rest 59 m down and 6 m to the east of the point of impact. Figure 19 shows sequential photographs of the test period.

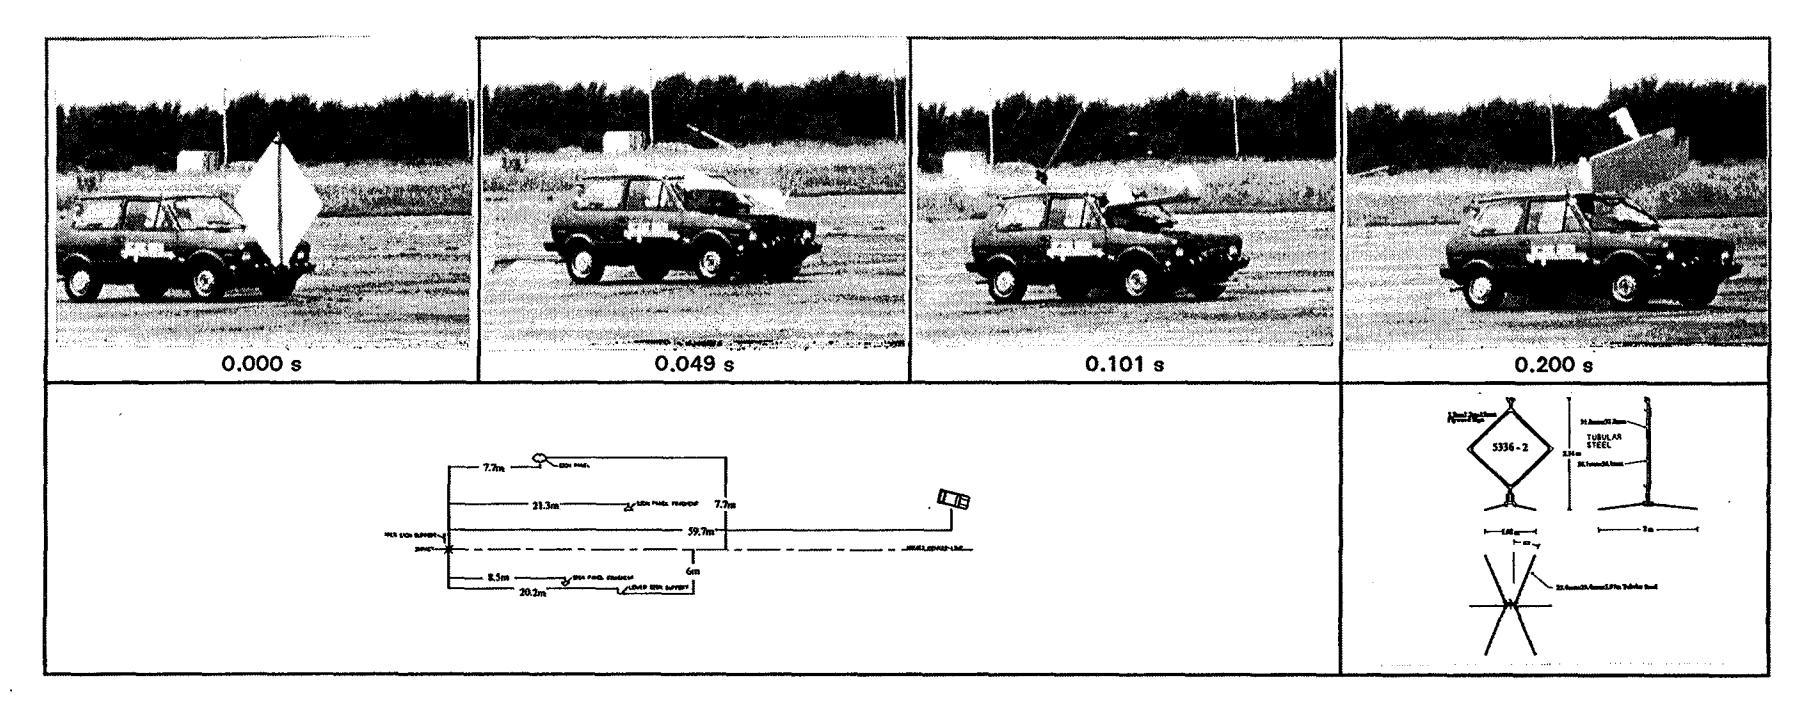
A brief summary of the results of this test is presented in Figure 20. The sign support shattered upon impact. The wooden sign panel and a segment of the sign support impacted and penetrated the windshield, showing potential risk to occupants in the vehicle. Debris of the sign support were scattered along an area 17 m wide by 21 m long. Some of the fragments were fairly large, which could pose potential hazard to oncoming traffic in adjacent lanes and to workers in the area. The vehicle sustained damage to the front bumper, hood, windshield and roof. The longitudinal occupant impact velocity was 1.7 m/s, and the highest 10-msec average ridedown acceleration was -1.5 g. There was no occupant contact in the lateral direction during the test period. The maximum 50-msec average accelerations were -1.3 g in the longitudinal direction and 0.6 g in the lateral direction. The vehicle exited the immediate test site in a relatively smooth, stable manner and showed no potential for intrusion into adjacent traffic lanes.

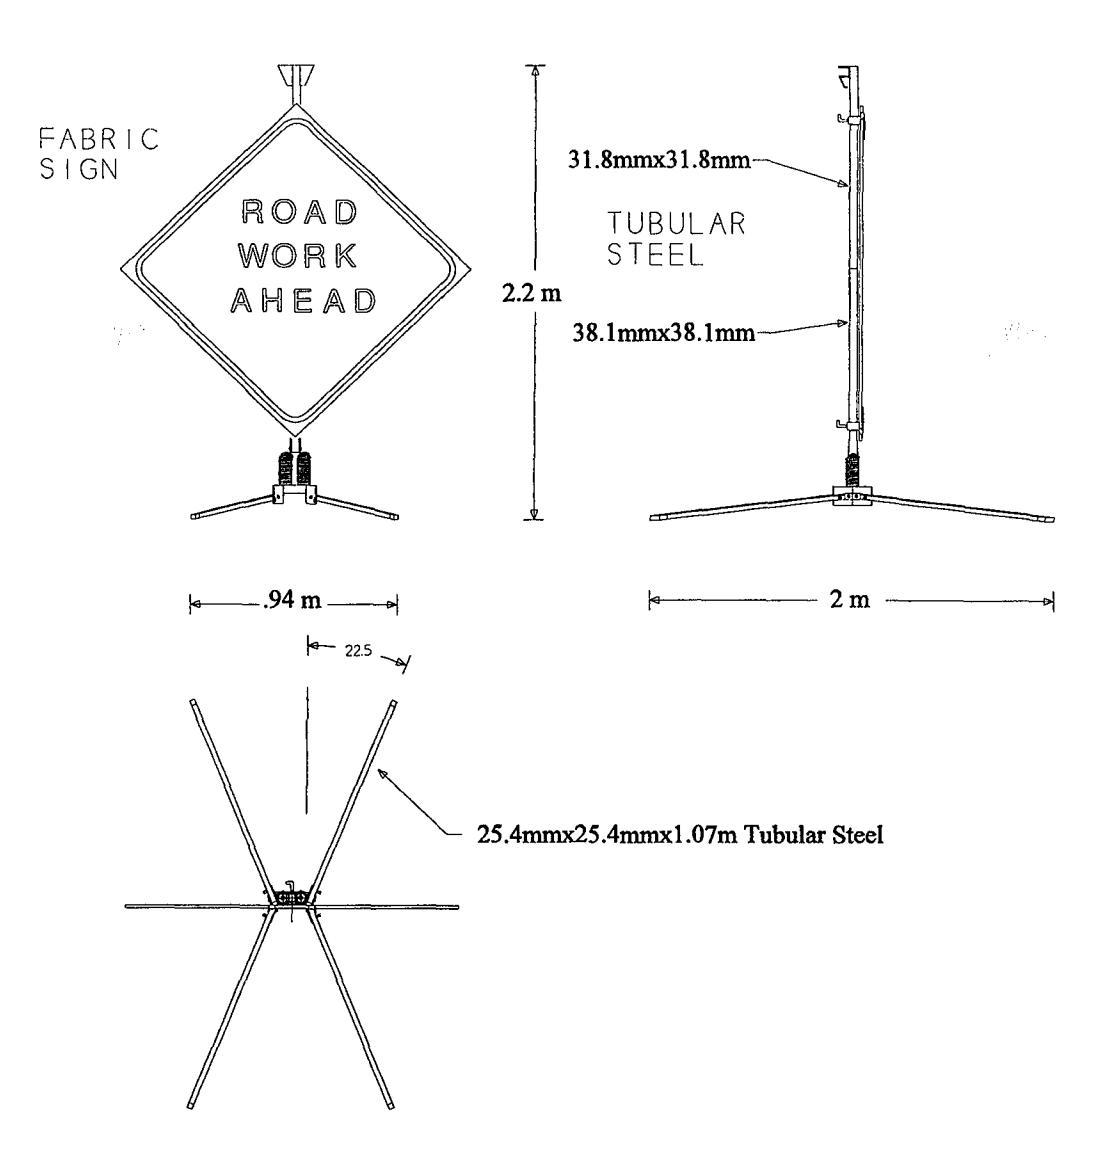
Figure 21. Schematic of Spring Mounted Sign Support with Plastic/Fabric Sign (Test No. 453580-1)

Figure 21 shows a schematic of the spring-mounted portable sign support with a 1219 mm x 1219 mm plastic/fabric sign mounted at a height of 305 mm. The test vehicle was a 1987 Yugo GV, as shown in Figure 22. Dimensions and information on the vehicle are given in Appendix Figure 93. The test vehicle impacted the sign support head-on with the centerline of the vehicle aligned with the centerline of the sign support, traveling at a speed of 99.0 km/h.

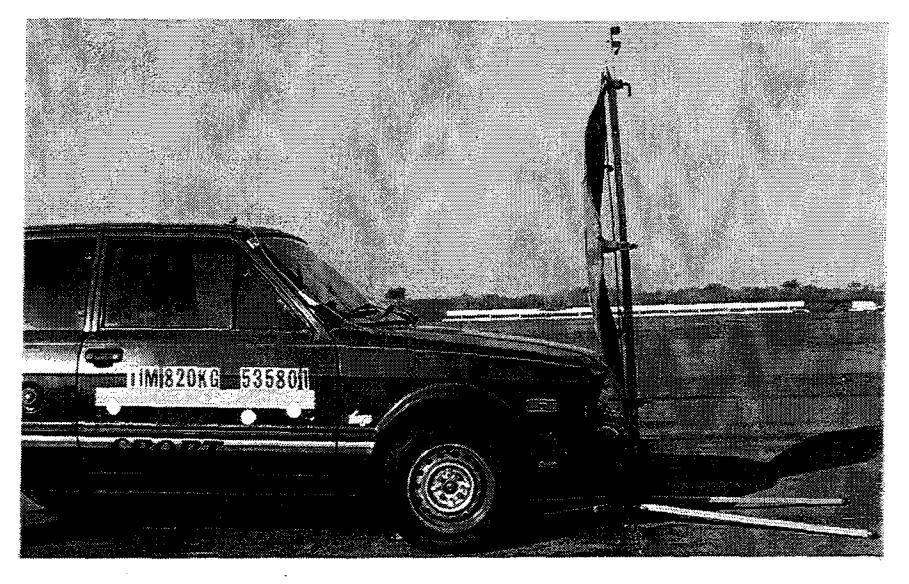
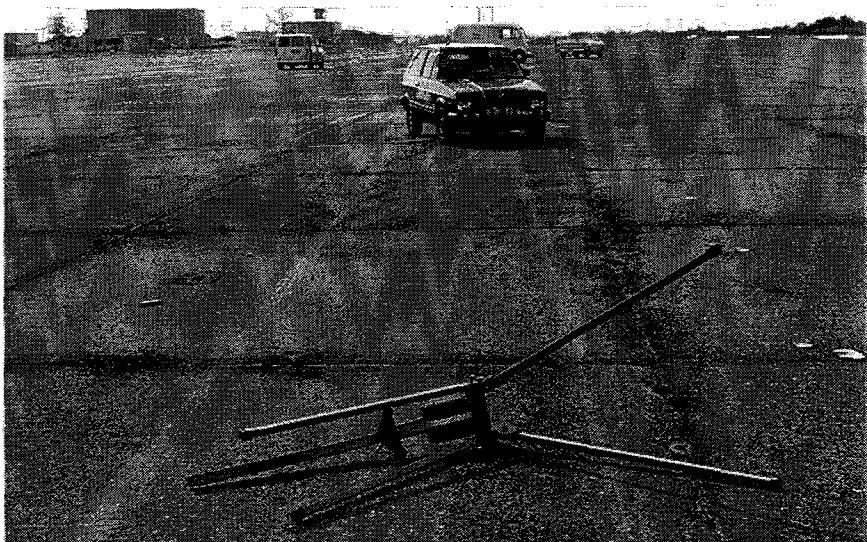
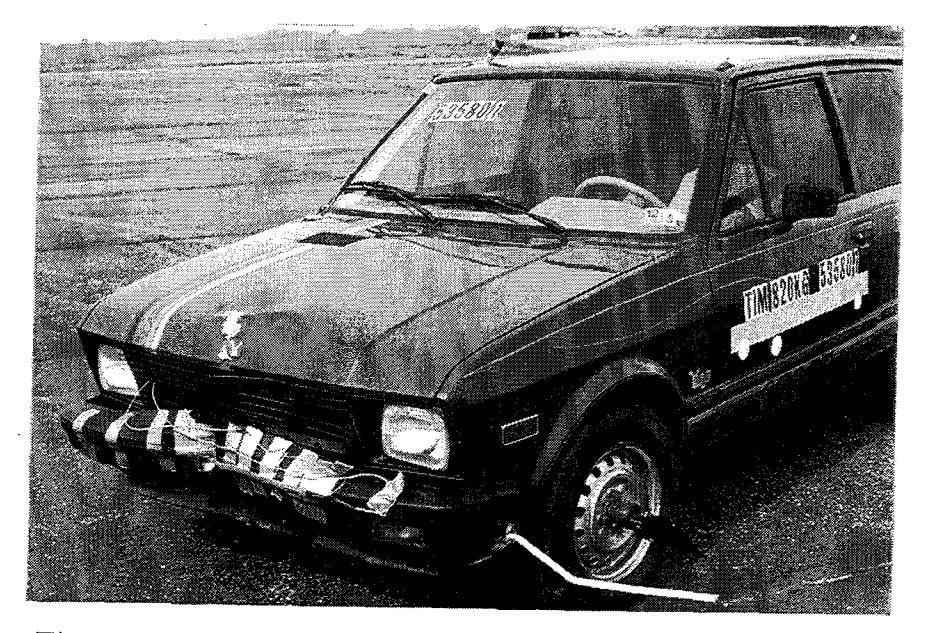
Figure 22. Vehicle and Sign Support for Test No. 453580-1

The spring-mounted portable sign support separated upon impact, as can be seen in Figure 22. Debris were strewn along the path of the vehicle in an area 3 m wide by 73 m long. Figure 22 shows damage to the vehicle. There was a maximum crush in the bumper of 70 mm from impact with the support. There was a 32 mm deep dent in the roof toward the rear, the windshield received a small chip, and the hood, bumper, and grill were dented and scratched.

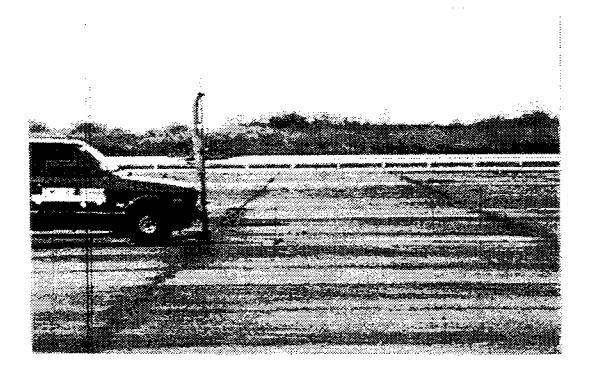
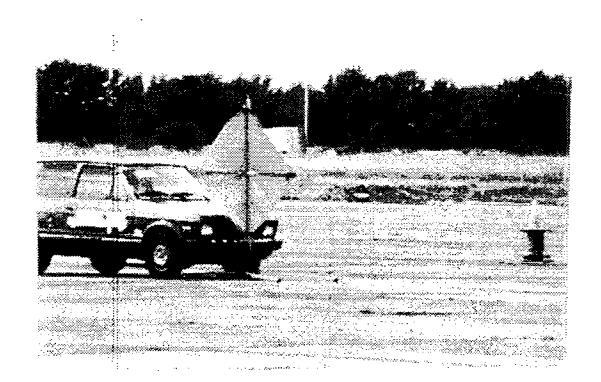
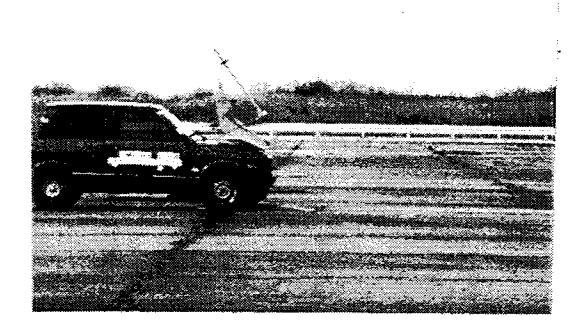
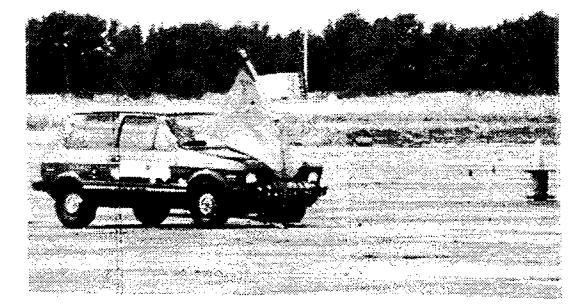
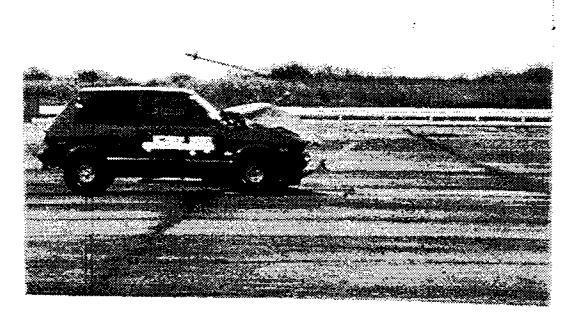
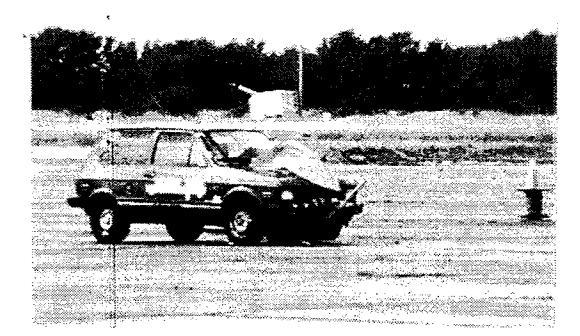
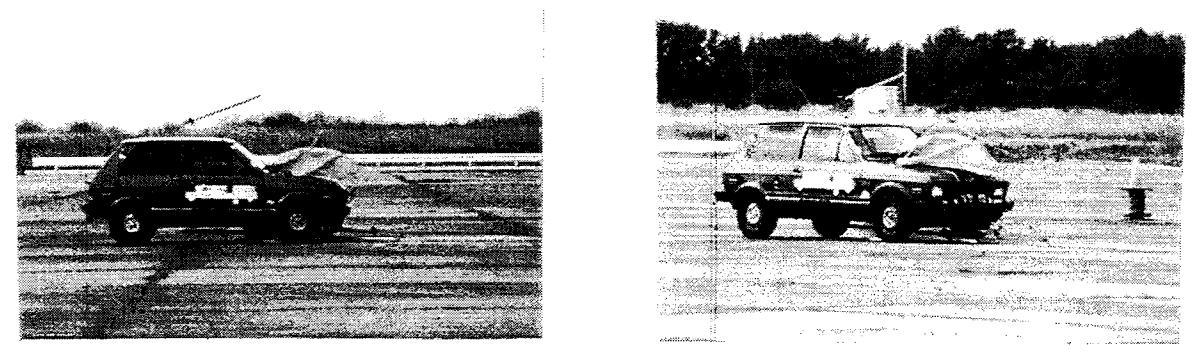
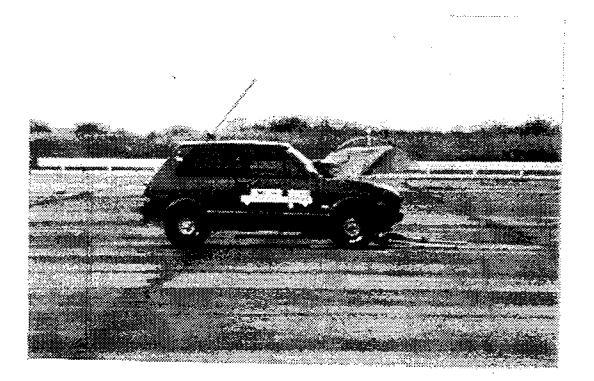
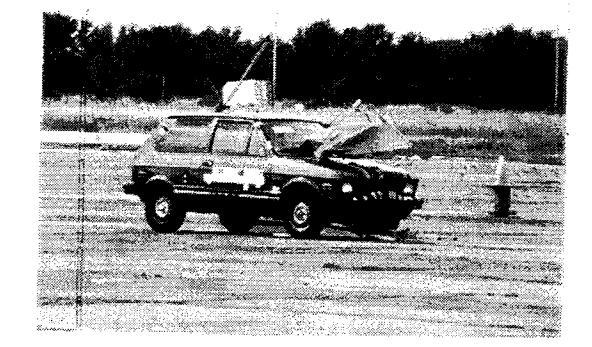
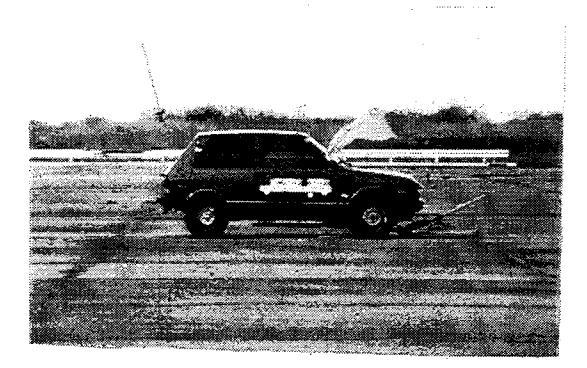
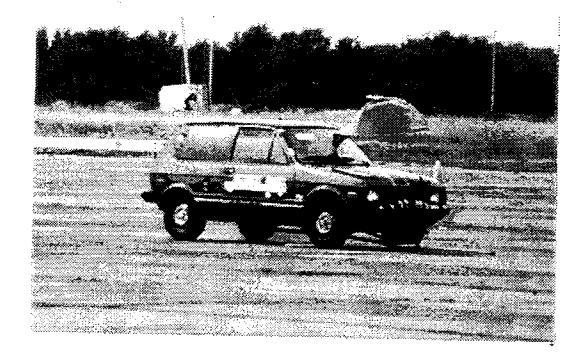
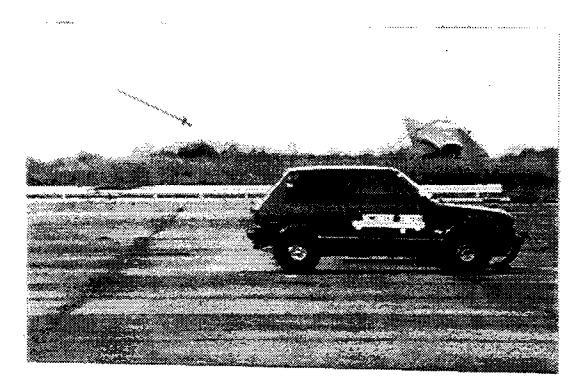
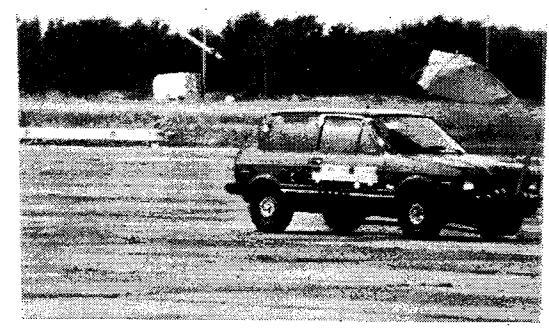
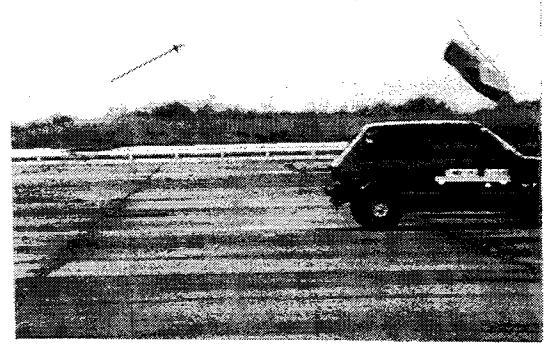
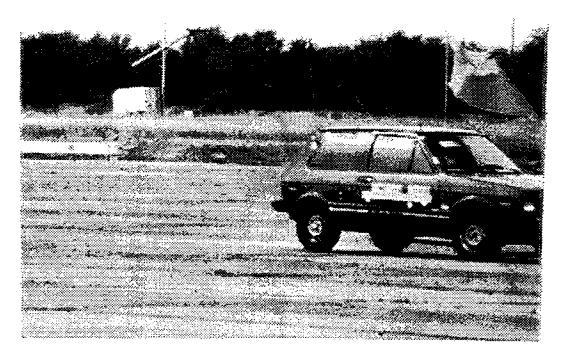
0.075 s Figure 23. Sequential Photographs for Test No. 453580-1

Upon impact, the plastic/fabric sign panel and the upper support arm began to deform on the hood. At 20 msec after impact, the upper support arm separated from the lower support arm, and the upper corner of the sign panel released. The lower corner of the sign panel released at 39 msec. The upper support arm and sign panel flipped up and contacted the roof of the vehicle at 98 msec. The support and panel lost contact at 119 msec, as the vehicle was traveling at a speed of 93.6 km/h. The support base hung up on the undercarriage of the vehicle and rode along with the vehicle. After the vehicle cleared the immediate test site, brakes on the vehicle were applied at 500 msec after impact. Prior to brake application, the test vehicle was traveling on a relatively straightforward path. The vehicle subsequently came to rest 58 m down and 3 m to the west of the point of impact. The base support continued forward another 15 m after the vehicle had stopped. Figure 23 shows sequential photographs of the test period.

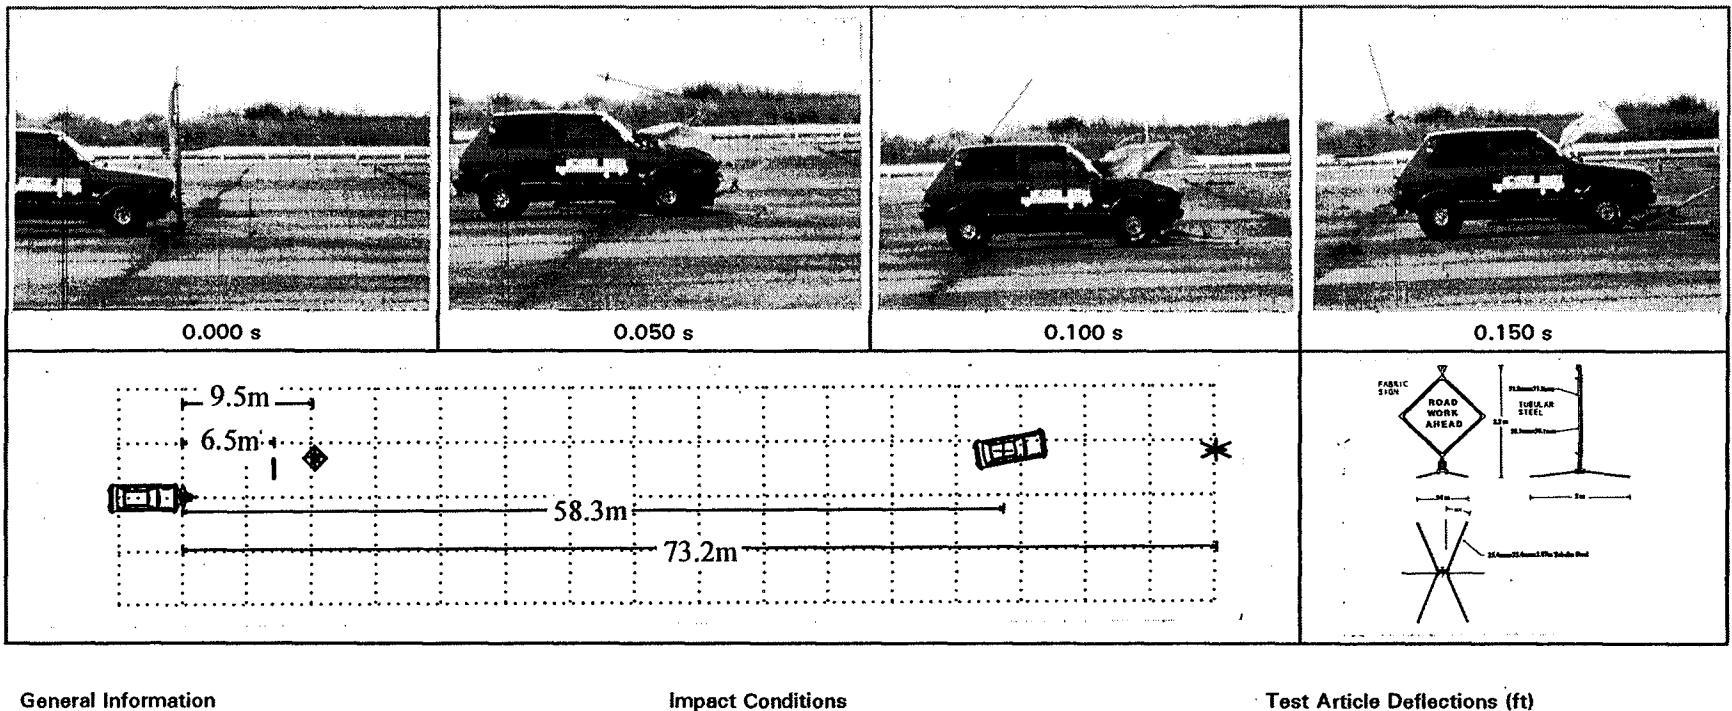
Figure 24. Summary of Results for Test No. 453580-1

A brief summary of the results of this test is presented in Figure 24. The plastic/fabric sign panel and upper support arm of the spring-mounted portable sign support separated and went up and over the vehicle, contacting the roof, but did not show potential risk of intrusion into the passenger compartment. Debris from the sign support remained along the path of the vehicle posing only minor potential hazard to other traffic or workers. The vehicle sustained damage to the front bumper, hood, windshield and roof. The longitudinal occupant impact velocity was 2.2 m/s, and the highest 10-msec average ridedown acceleration was -1.1 g. There was no occupant contact in the lateral direction during the test period. The maximum 50-msec average accelerations were -1.4 g in the longitudinal direction and -0.3 g in the lateral direction. The vehicle exited the immediate test site in a relatively smooth, stable manner and showed no potential for intrusion into adjacent traffic lanes.

In summary, the spring-mounted portable sign support with plastic/fabric sign panel was judged to have met all evaluation criteria set forth in NCHRP Report 350.

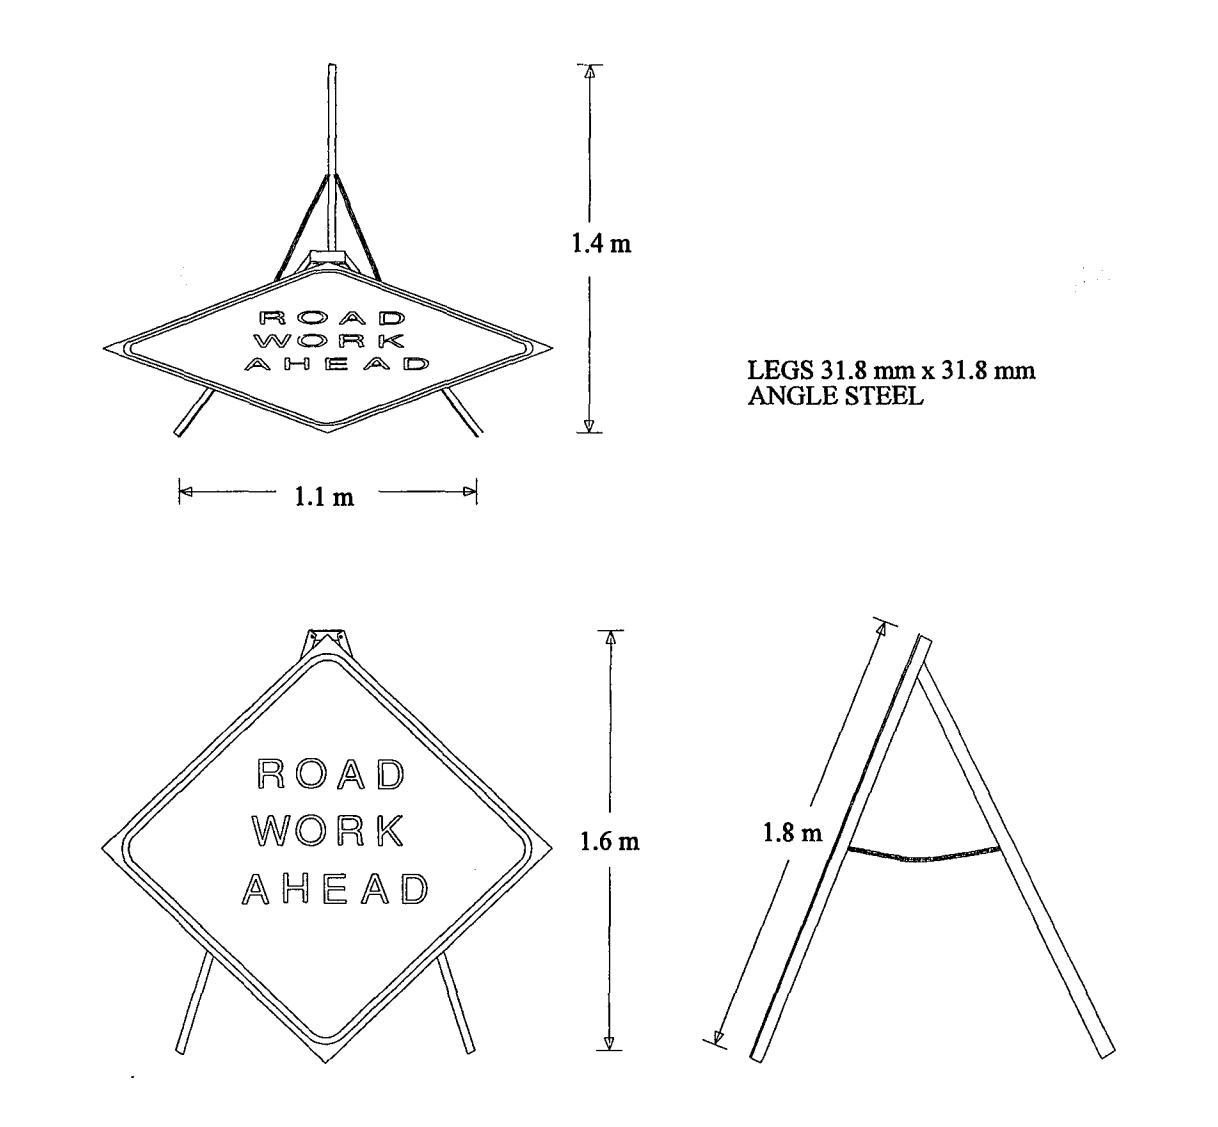
Figure 25. Schematic of Easel Sign Support with Plastic/Fabric Sign (Test No. 453580-2)

Figure 25 shows a schematic of the easel portable sign support with a 1219 mm x 1219 mm plastic/fabric sign mounted at a height of 305 mm. The test vehicle was a 1987 Yugo GV, as shown in Figure 26. Appendix 93 gives dimensions and information on the vehicle. The test vehicle impacted the sign support head-on with the centerline of the vehicle aligned with the centerline of the sign support, traveling at a speed of 98.8 km/h.

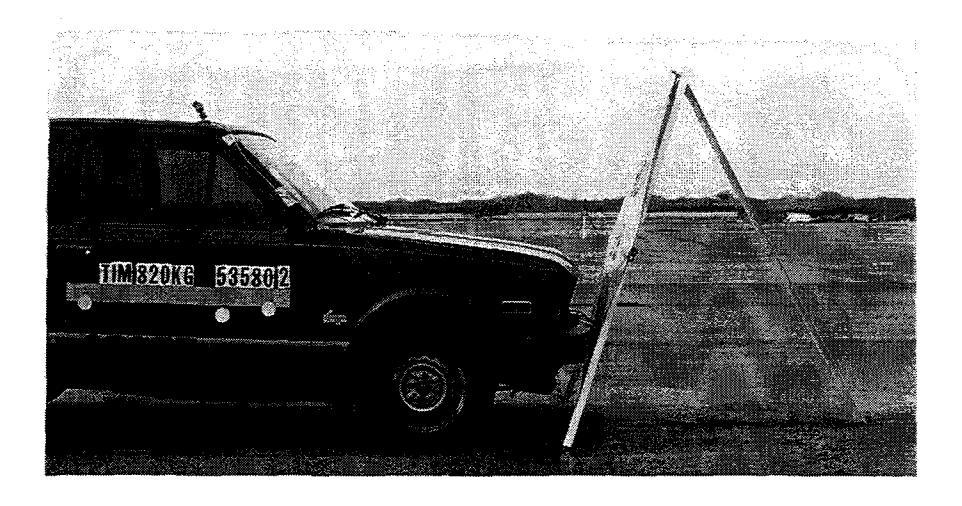
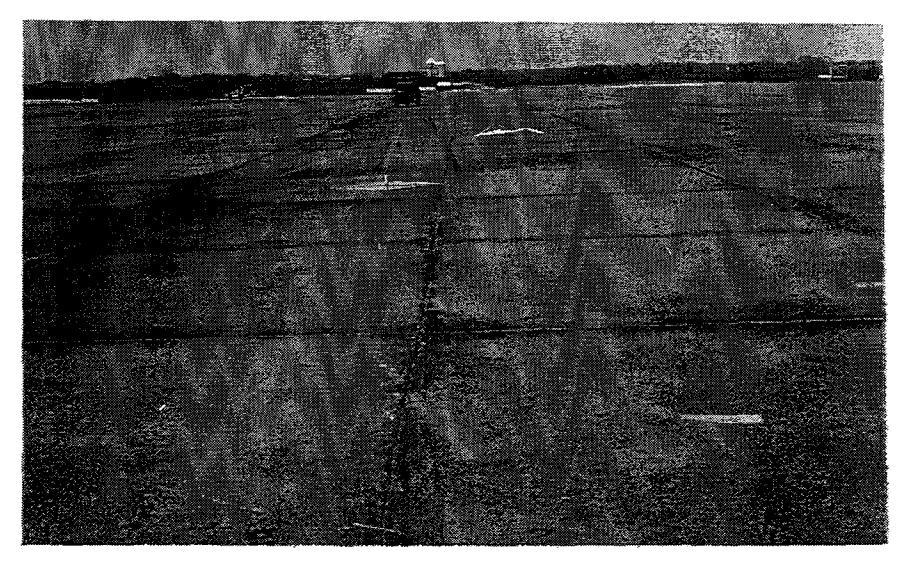
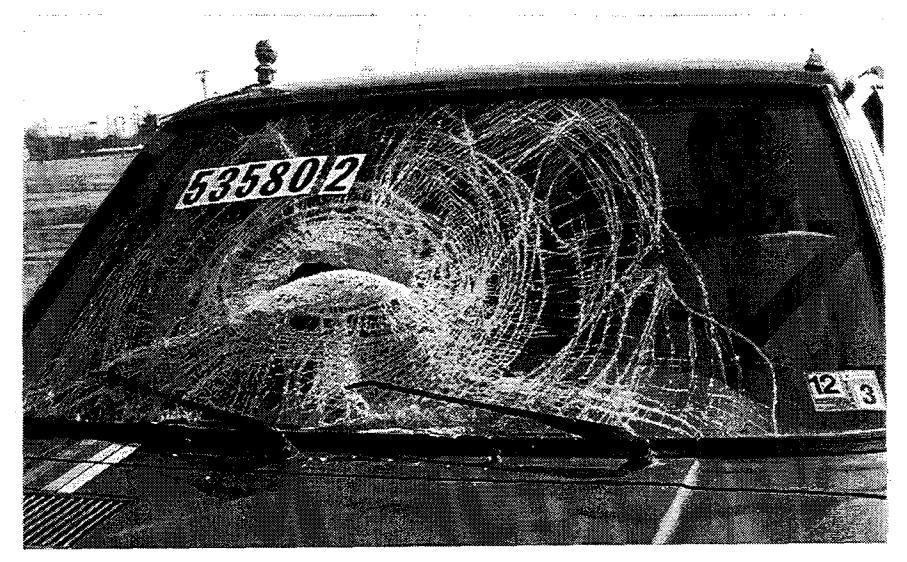
Figure 26. Vehicle and Sign Support for Test No. 453580-2

As Figure 26 shows, the sign panel of the easel sign support released, and the support came apart upon impact. Debris were strewn along the path of the vehicle in an area 4 m wide by 32 m long. Figure 26 shows damage to the vehicle. There was no measurable crush to the exterior of the vehicle. There was a small hole in the windshield caused by penetration of the top of the easel support and a small dent in the hood.

In summary, the easel portable sign support failed to meet the evaluation criteria set forth in NCHRP Report 350 and is not recommended for further field use.

penetrating the windshield of the impacting vehicle. The use of the easel portable sign support is therefore not recommended.
