EVALUATION OF WORK ZONE BARRICADES AND TEMPORARY SIGN SUPPORTS

Report No. 5388-1F Research Study No. 585xxA3014 Research Study Title: Development of New Designs for Barricades and Sign Supports in Work Zones

> Sponsored by the Texas Department of Transportation

> > February 1996

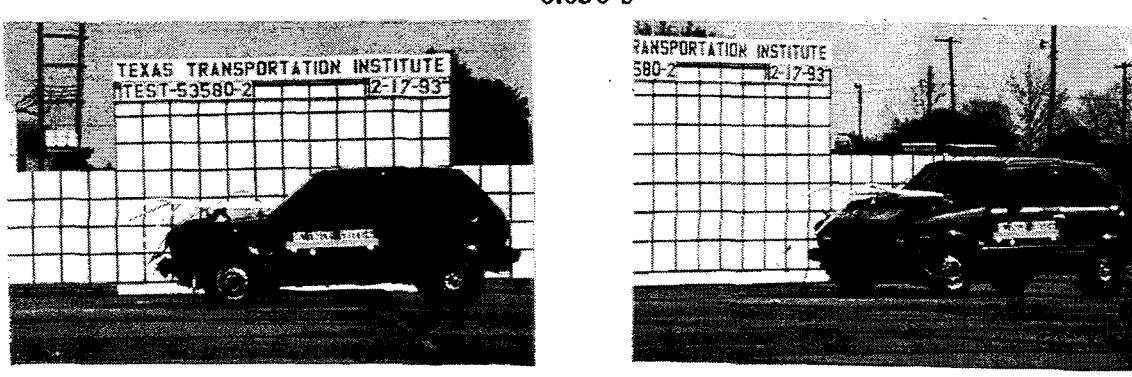
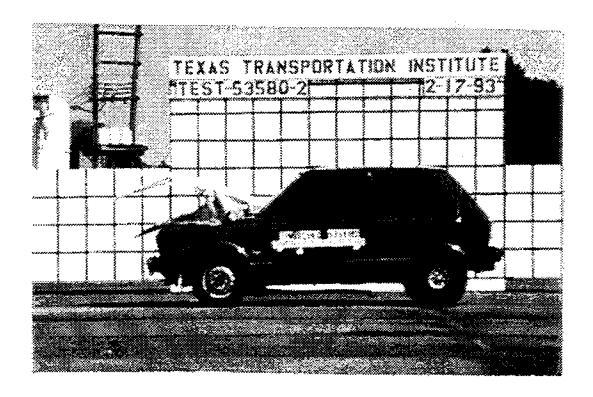
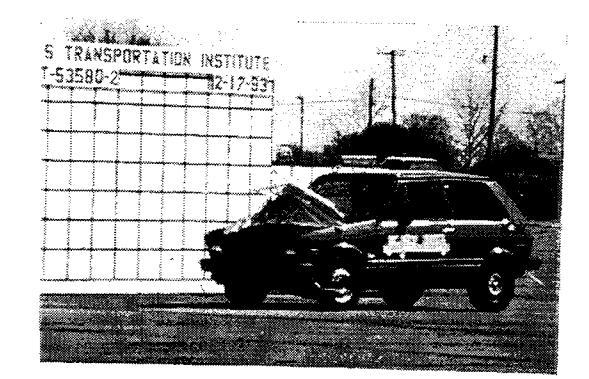
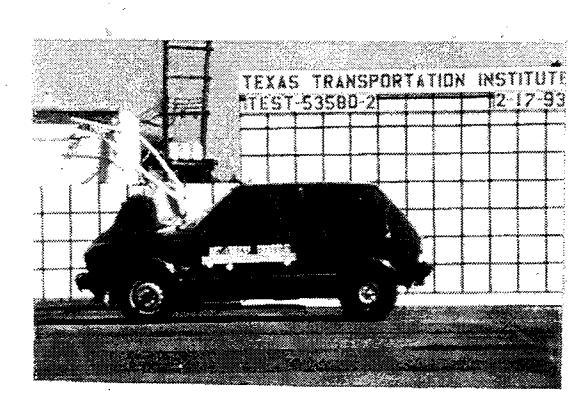
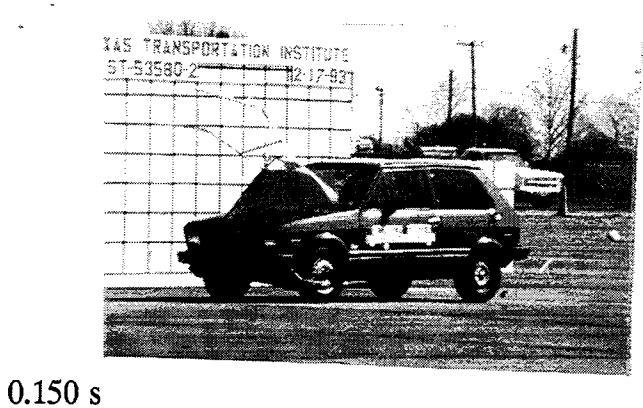
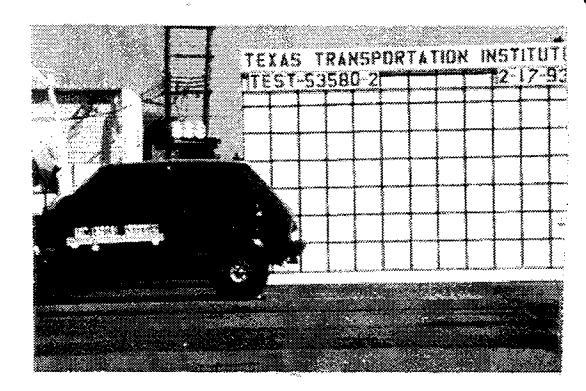
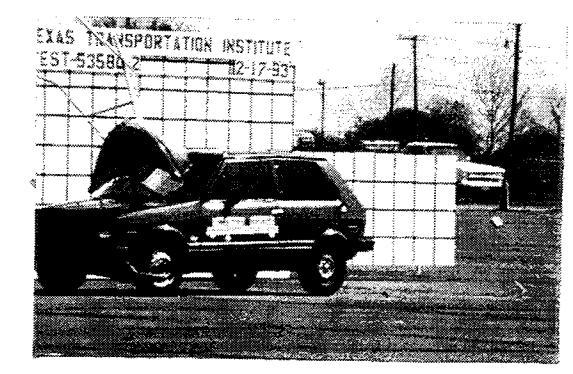
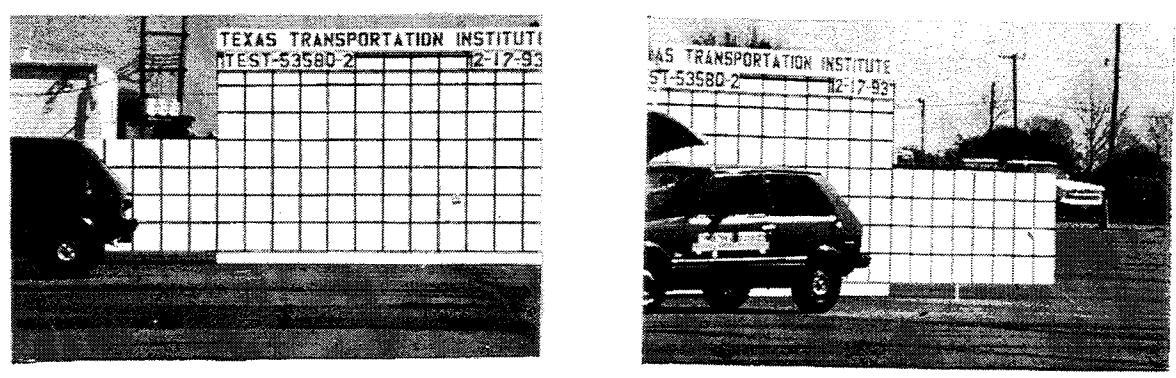
Figure 27. Sequential Photographs for Test No. 453580-2 (continued)

Upon impact, the front legs of the support bent at bumper height. At 17 msec, the top of the sign panel released from the top of the support. The easel support flipped up and the top of the support contacted and penetrated the windshield at 60 msec. At 251 msec, the easel support lost contact with the vehicle and windshield. Speed of the vehicle at loss of contact was 95.1 km/h. After the vehicle cleared the immediate test site, brakes on the vehicle were applied at 1.3 seconds after impact. Prior to brake application, the test vehicle was traveling on a relatively straightforward path. The vehicle subsequently came to rest 71 m down and 3 m to the left of the point of impact. Sequential photographs of the test period are shown in Figure 27.

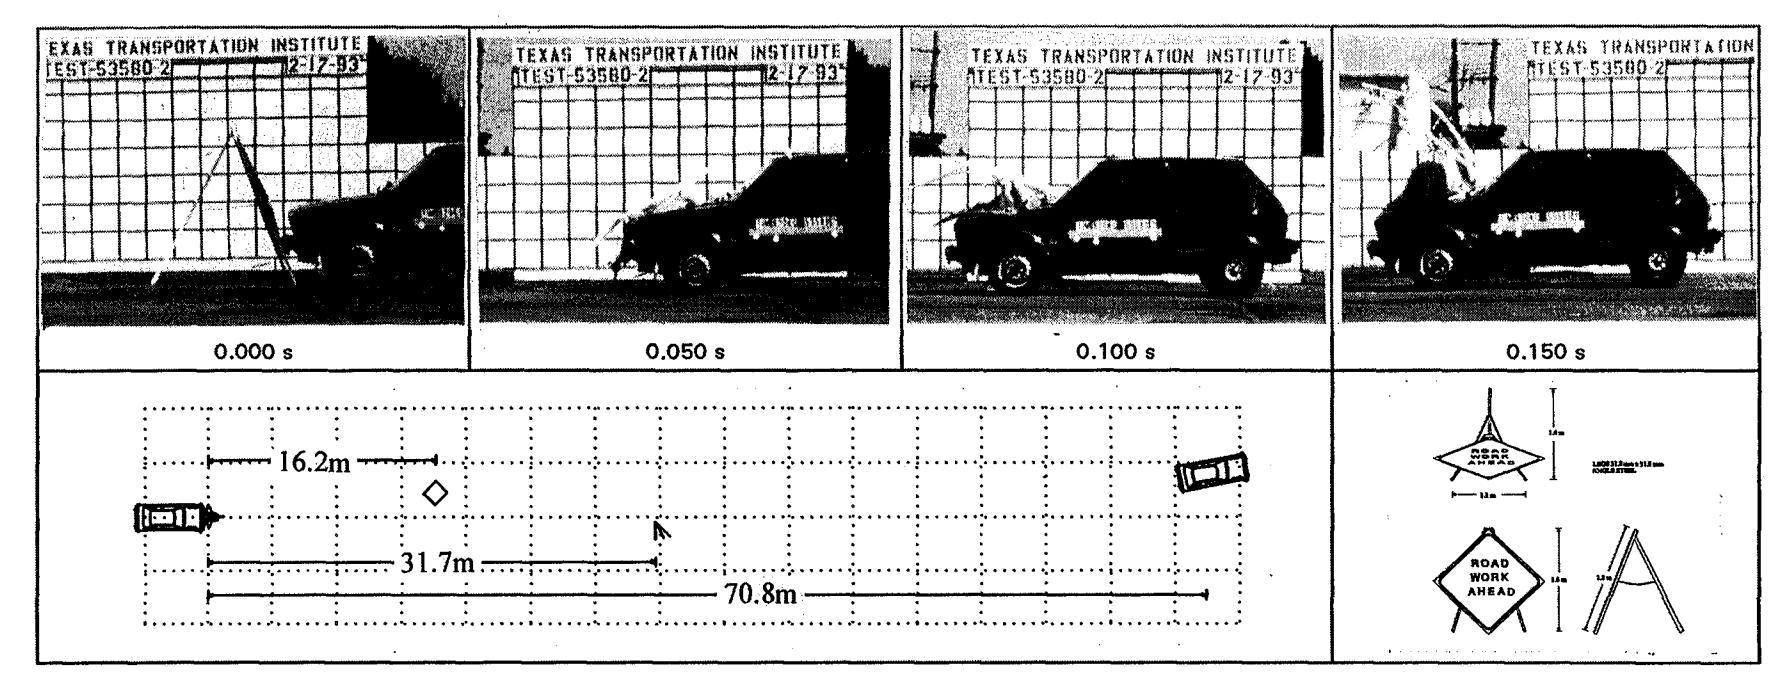
Figure 28. Summary of Results for Test No. 453580-2

Figure 28 shows a brief summary of the results of this test. The sign panel, upon release from the support, went up and contacted the windshield and then went over the top of the vehicle. The easel support rotated upon impact, and the top of the easel support impacted and penetrated the windshield, exhibiting potential risk of intrusion into the occupant compartment. Debris from the sign support remained along the path of the vehicle, posing only minor potential hazard to other traffic or workers in the area. Other than the penetration of the windshield by the top of the easel support, there was little damage to the vehicle. There was no occupant contact in the longitudinal or lateral direction during the test period. The maximum 50-msec average accelerations were -0.7 g in the longitudinal direction and -0.1 g in the lateral direction. The vehicle exited the immediate test site in a relatively smooth, stable manner and showed minimal intrusion into adjacent traffic lanes.

In summary, the easel portable sign support failed to meet the evaluation criteria set forth in NCHRP Report 350 and is not recommended for further field use.

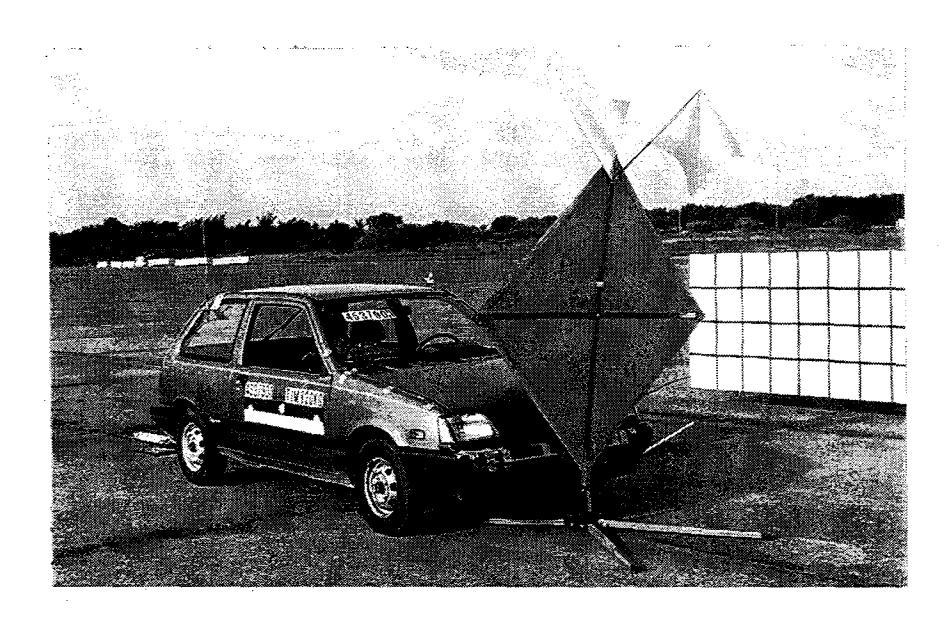
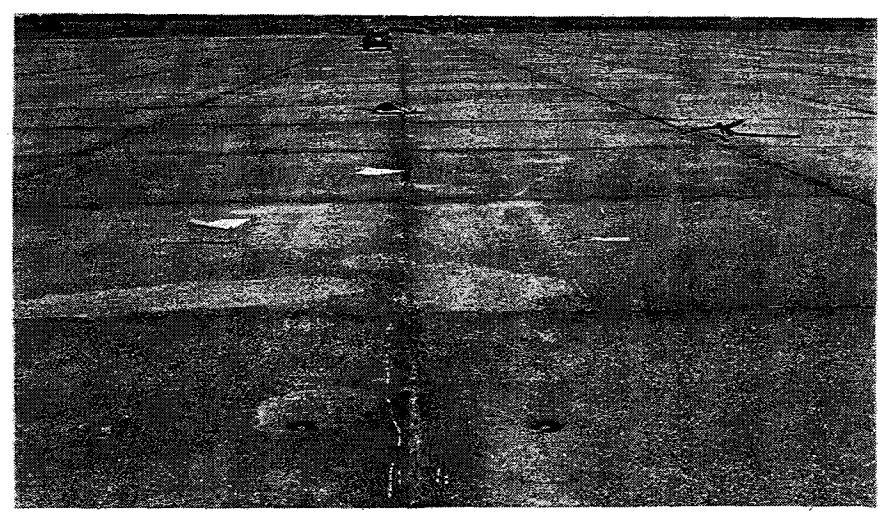
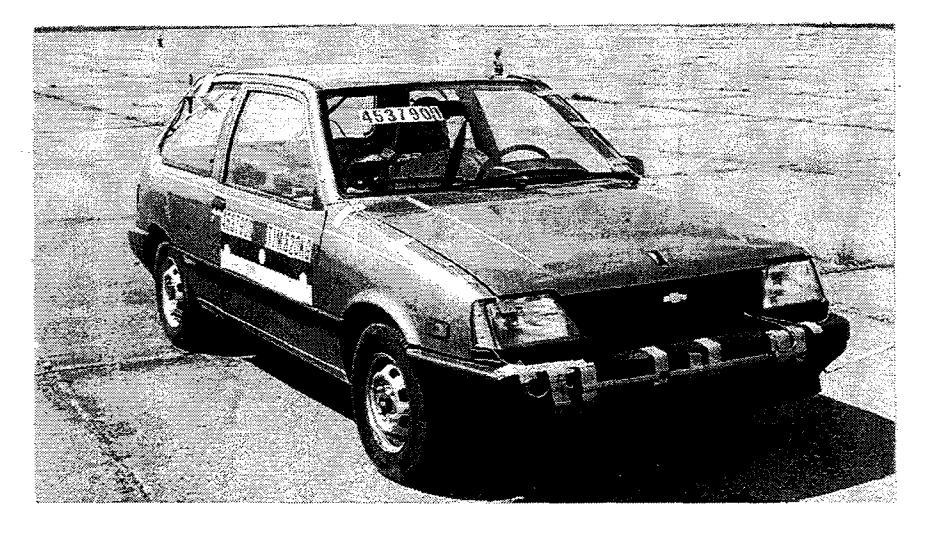
Figure 30. Vehicle and Sign Support for Test No. 453790-1

The portable sign support separated upon impact, as can be seen in Figure 30. Fragments of the sign were strewn along the path of the vehicle in an area 5.5 m wide by 19.3 m long. Figure 30 shows damage to the vehicle. There was no measurable crush to the exterior of the vehicle, only scratches on the hood and on the roof where the flags made contact.

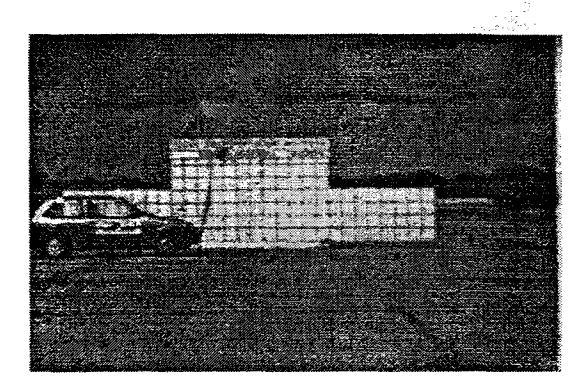
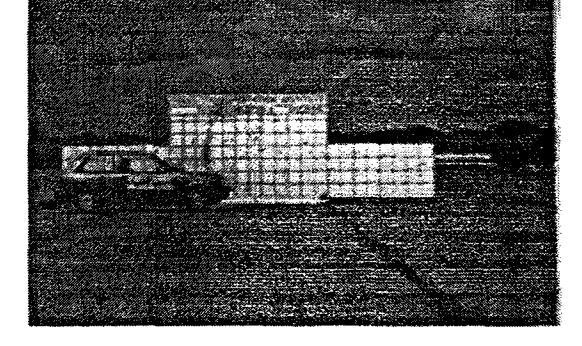
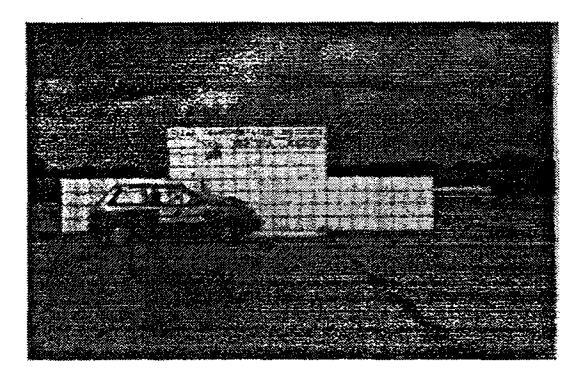
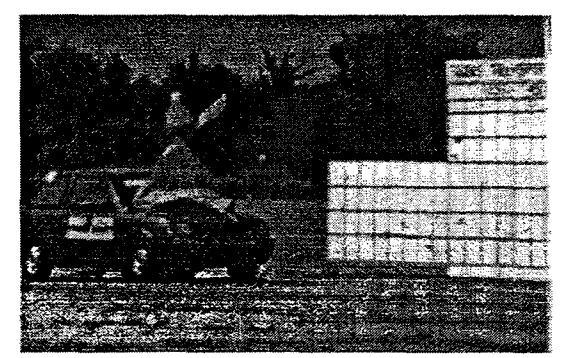
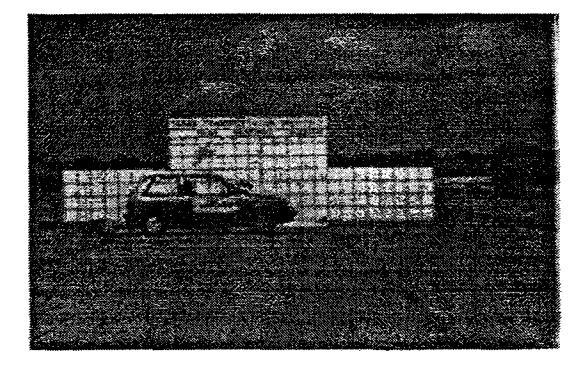
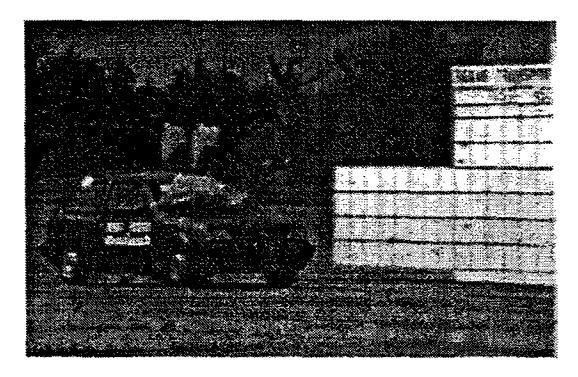
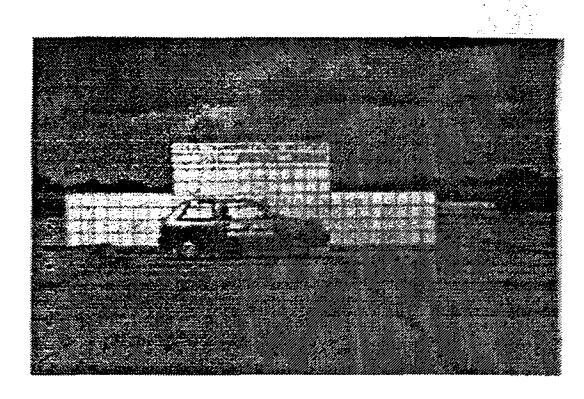
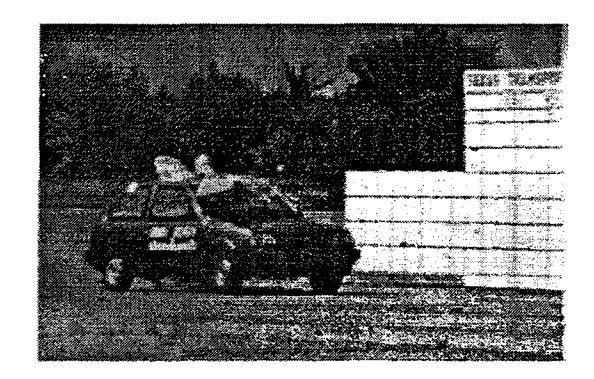
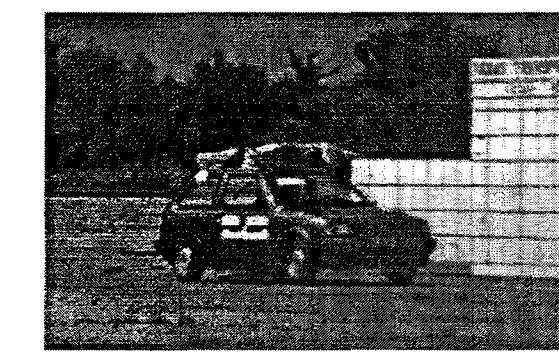
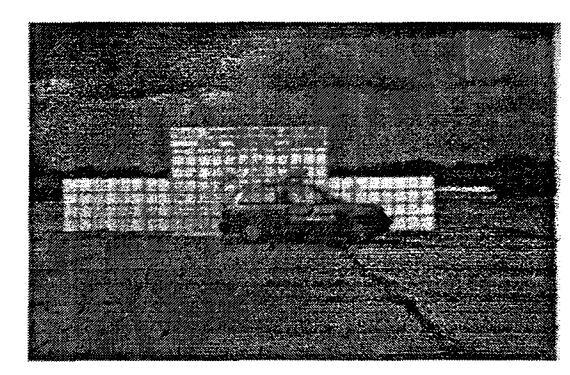
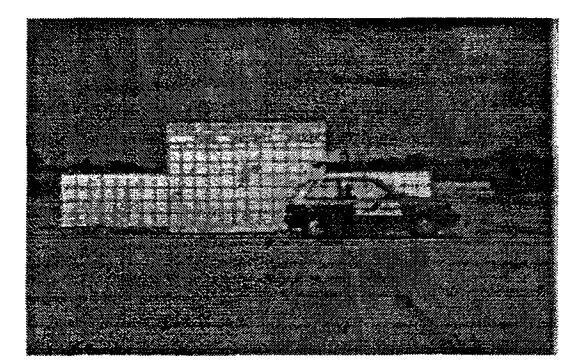
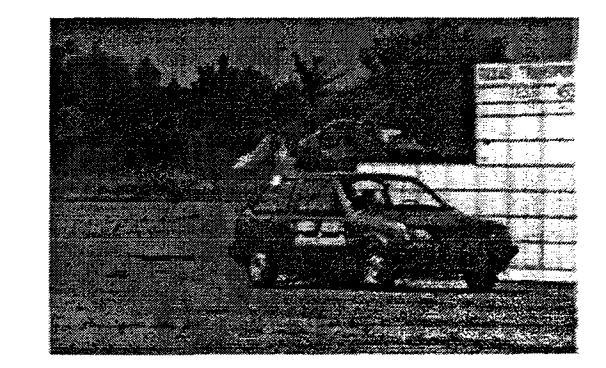
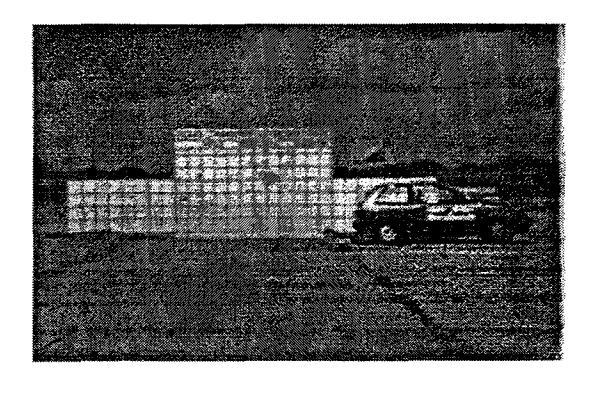
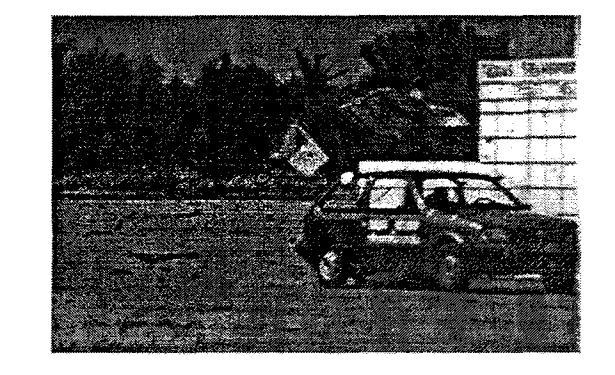
Figure 31. Sequential Photographs for Test No. 453790-1 (continued)

As the vehicle impacted the portable sign support, the upper portion of the sign separated from the base, and the plastic/fabric sign panel formed to the front of the vehicle. The plastic/fabric sign panel and reinforcement strips contacted the windshield at 50 msec and 69 msec, respectively. At 100 msec, the flags contacted the roof of the vehicle and separated from the sign panel. At 221 msec, the vehicle cleared the installation site traveling at a speed of 95.8 km/h. Prior to brake application, the vehicle was tracking straightforward. The vehicle subsequently came to rest 102 m down and 1.7 m to the right of the point of impact. Figure 31 shows sequential photographs of the test period.

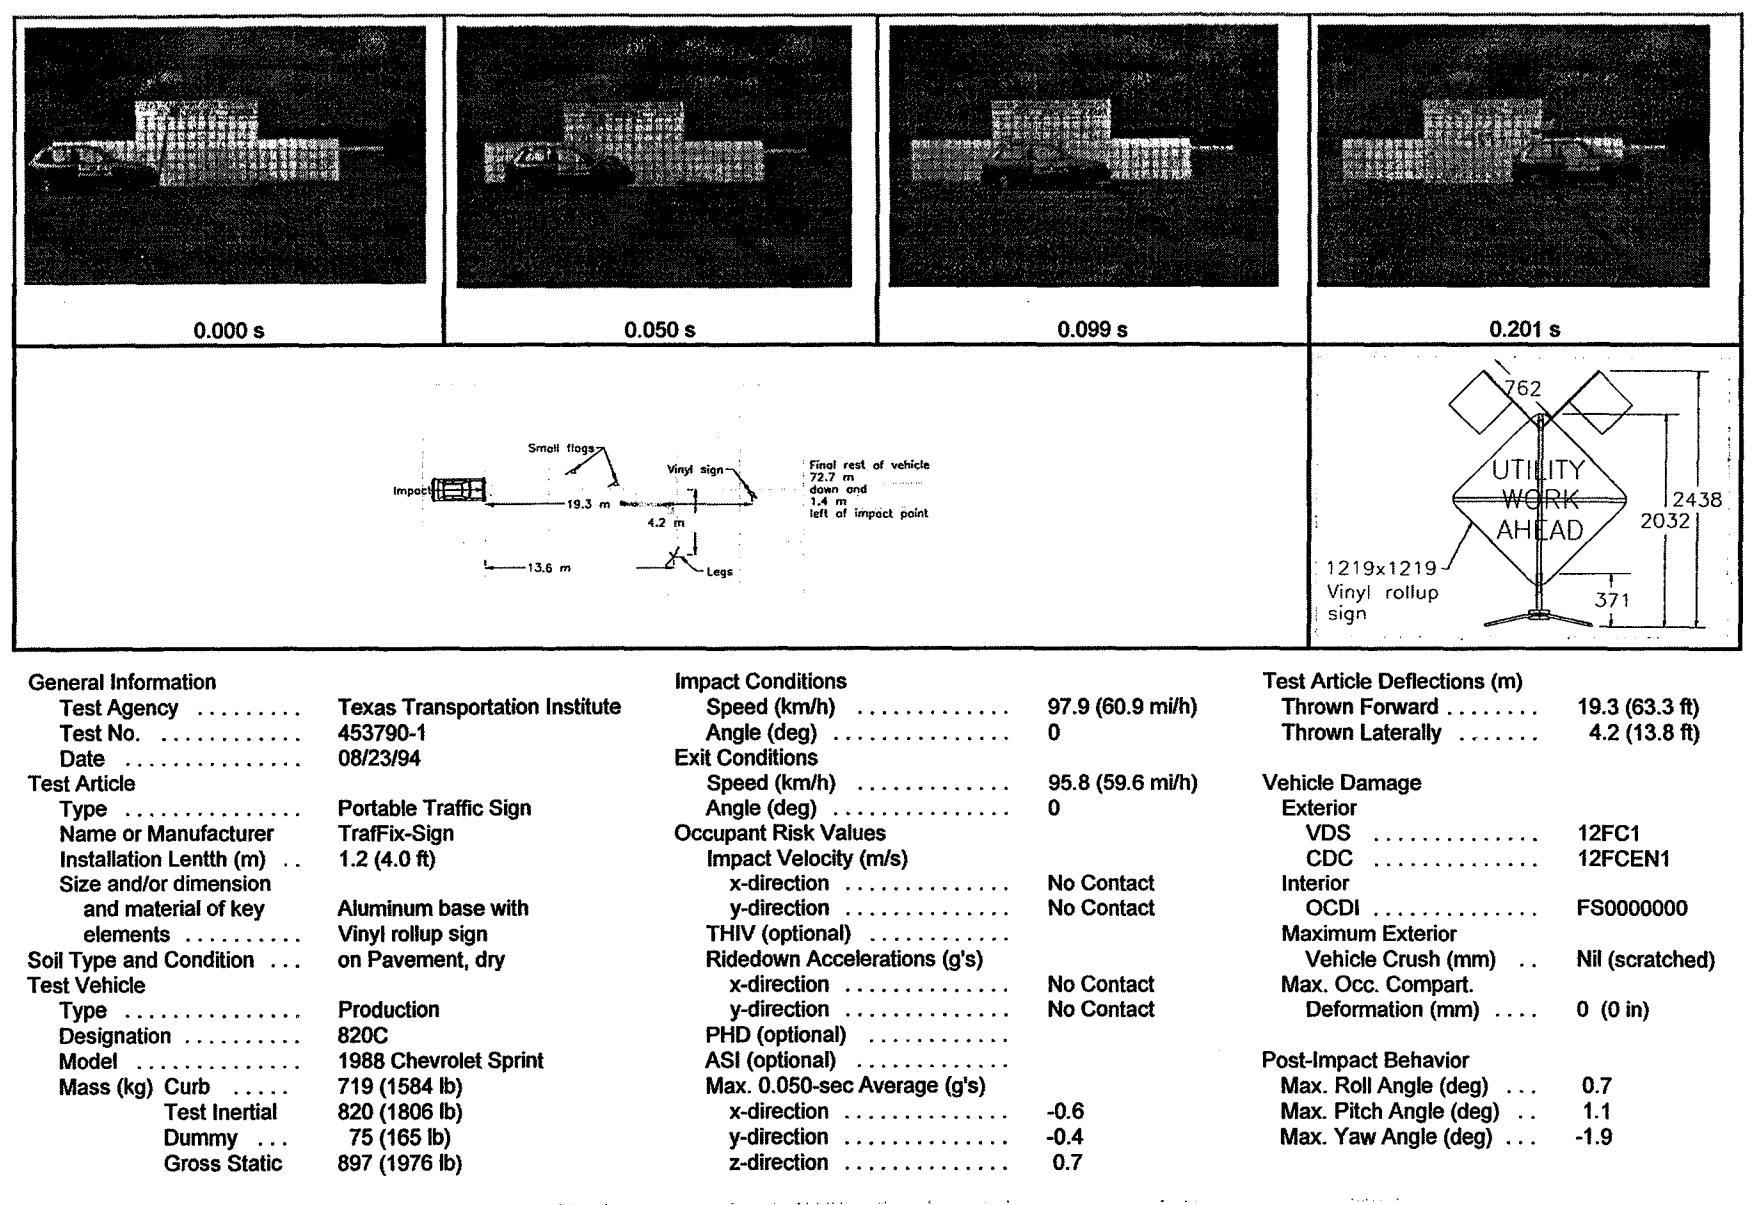
Figure 32. Summary of Results for Test No. 453790-1

Figure 32 presents a brief summary of the results of this test. The portable sign support shattered upon impact. Fragments of the plastic/fabric sign panel and the sign support made contact with the roof, but there was no penetration or intrusion into the occupant compartment. Debris from the sign was thrown along an area 5.5 m wide by 19.3 m long. The fragments were not large enough to pose potential hazard to oncoming traffic in adjacent lanes or to workers in the area. The vehicle sustained minor scratches to the hood and roof. There was no measurable crush to the exterior of the vehicle. There was no longitudinal or lateral occupant impact. The 50-msec average accelerations were -0.6 g in the longitudinal direction and -0.4 g in the lateral direction. The vehicle exited the immediate test site in a relatively smooth, stable manner and showed no potential for intrusion into adjacent traffic lanes.

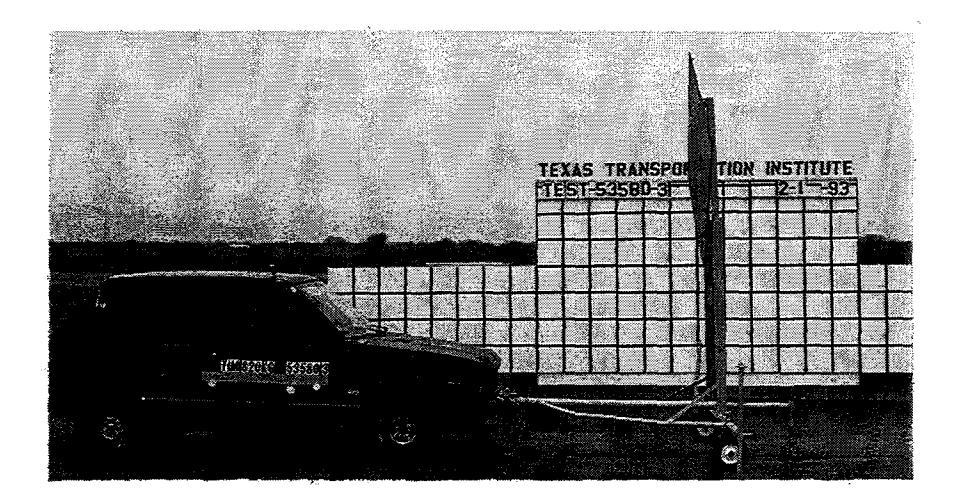
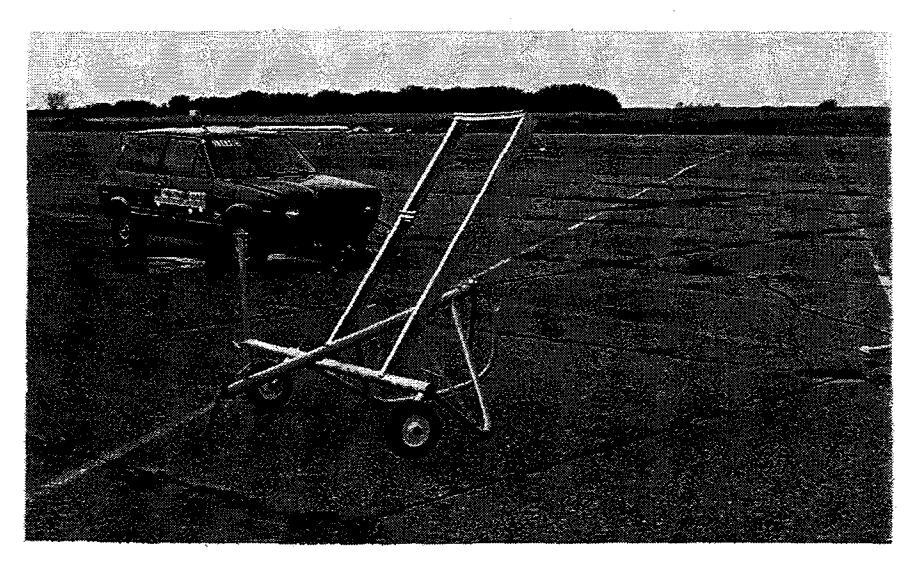
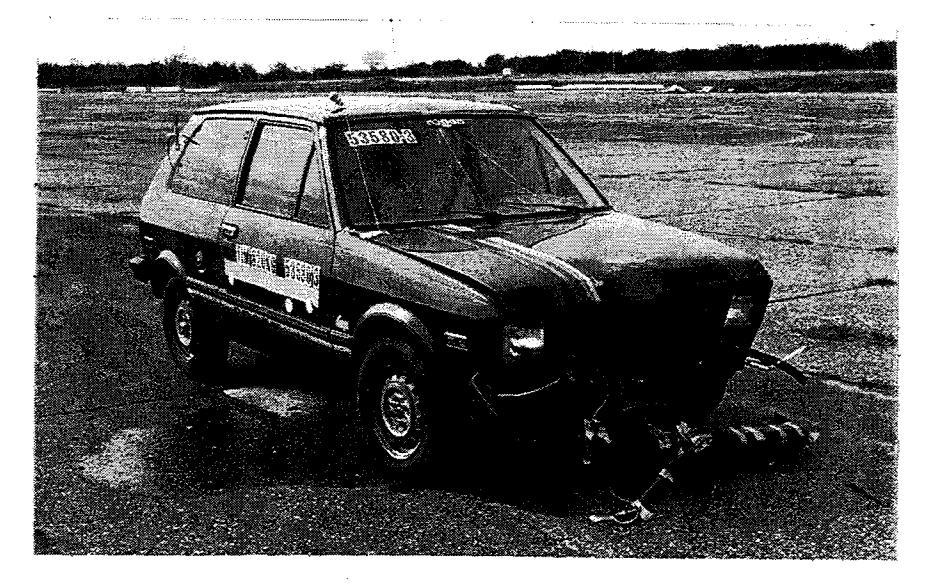
Figure 34. Vehicle and Sign Trailer for Test No. 453580-3

As Figure 34 shows, the sign panel and support separated from the trailer upon impact. The sign panel and upper support structure came to rest 2 m down and 4 m to the left side of the vehicle path. The sign support trailer came to rest 106 m down and 3 m to the right of the point of impact with a fragment 3.4 m west of the trailer. The trailer was deformed and some of the welds broken. As Figure 34 also shows, the vehicle sustained moderate damage to the front. The maximum crush at bumper height was 330 mm. The windshield was cracked starting at the edge of the roof near the center. There were also two dents in the roof, the deepest approximately 8 mm. There were dents and scratches on the hood and the bumper, and the grill and radiator were damaged.

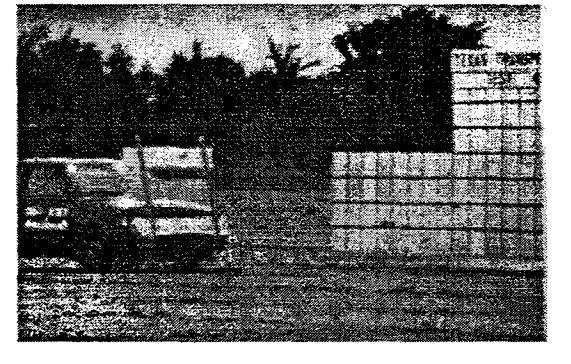
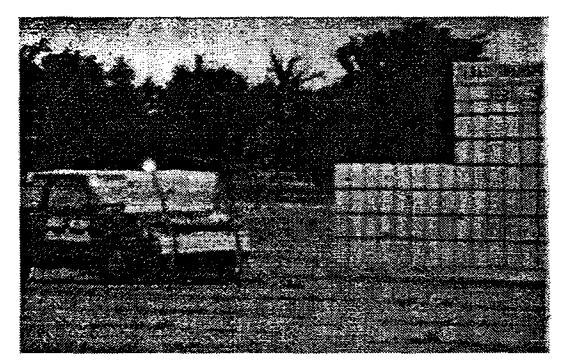
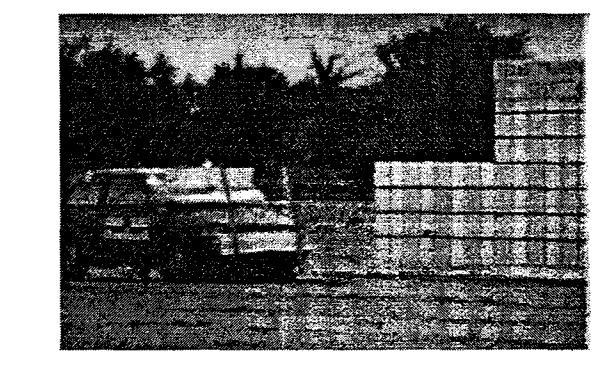
Figure 47. Sequential Photographs for Test No. 453790-3

As the vehicle impacted the vertical supports, the middle and upper plastic rail elements separated from the vertical supports. The lower plastic rail element and vertical supports deformed and wrapped around the front of the vehicle. Windshield contact by the middle plastic rail element occurred at 42 msec and with the upper rail element at 54 msec. The vehicle lost contact with the barricade at 69 msec, traveling at a speed of 95.2 km/h. Prior to brake application, the vehicle was tracking straightforward. The vehicle subsequently came to rest 91.7 m down and 7.9 m to the left of the point of impact. Figure 47 shows sequential photographs of the test period.

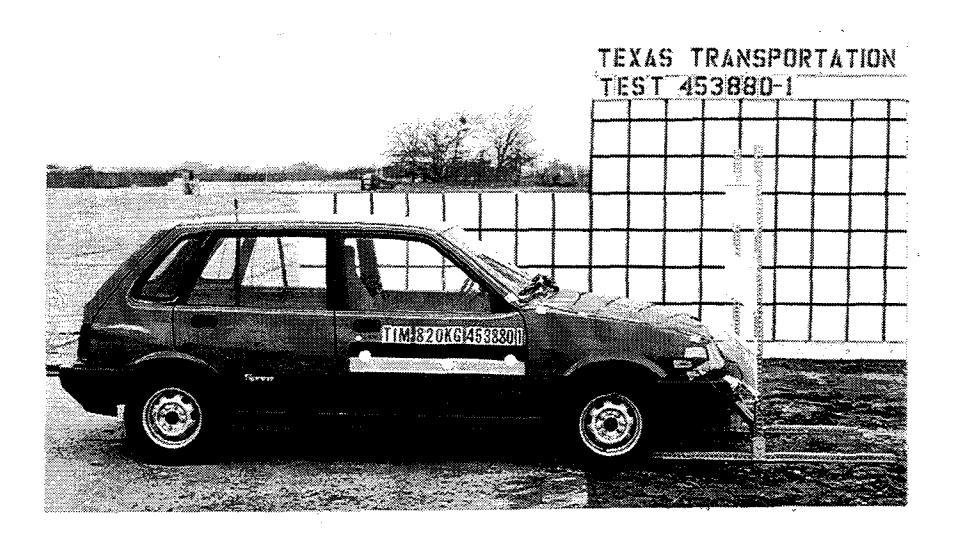
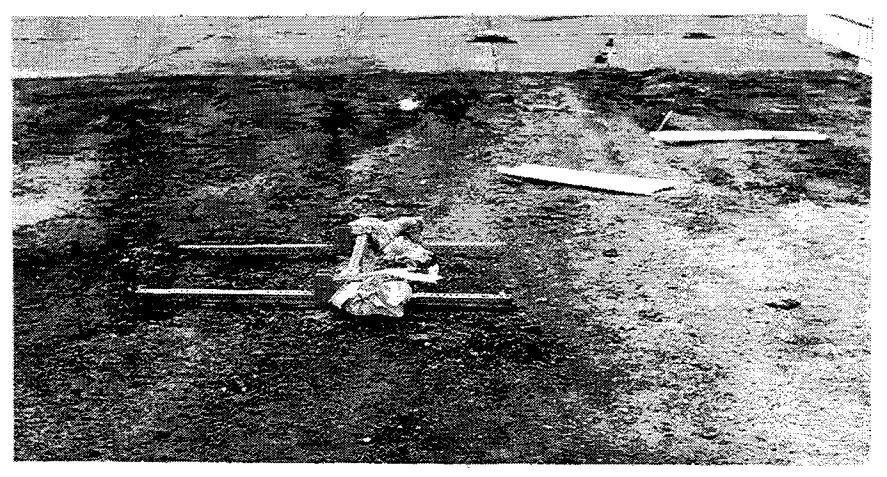
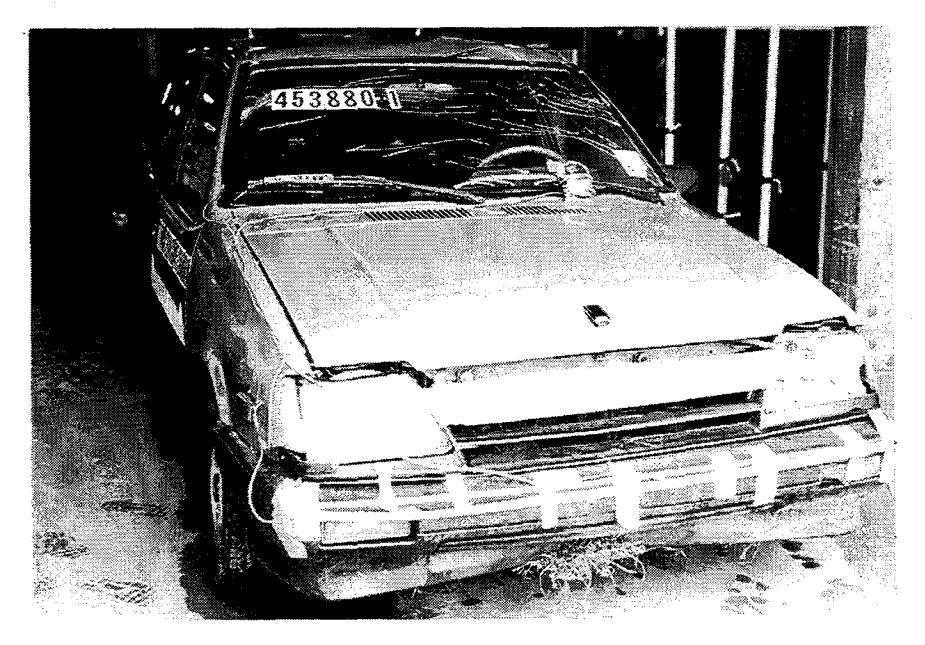
Figure 50. Vehicle and Barricade for Test No. 453880-1

As Figure 50 shows, the plastic rail elements separated from the barricade upon impact, and the barricade came apart subsequently. Debris and sand were strewn along the path of the vehicle in an area 12.6 m wide by 121 m long. Damage to the vehicle is also shown in Figure 50. There were three dents in the roof from impact with the plastic rail elements, and the windshield was cracked. A vertical support made a cut on the roof 15 mm deep and 55 mm long just above the windshield on the driver's side. There were scratches along the hood.

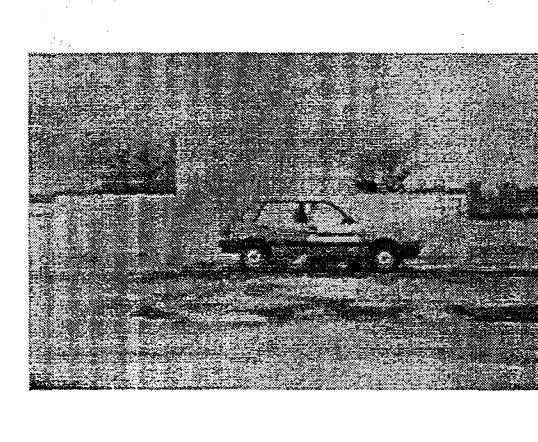
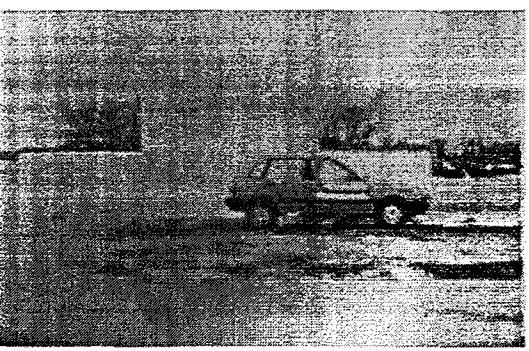
Figure 52. Summary of Results for Test No. 453880-1

Figure 52 presents a brief summary of the results of this test. The barricade came apart upon impact, and the broken segments contacted the hood, windshield, and roof of the vehicle. However, there was no penetration or intrusion into the occupant compartment. Sand and fragments of the barricade were scattered along an area 12.6 m wide by 121 m long. Most fragments were not large enough to pose potential hazard to oncoming traffic in adjacent lanes; however, the metal tubing from the vertical support could pose a hazard to workers in the area. The vehicle sustained minor damage to the hood and windshield, with a small cut in the roof. The longitudinal occupant impact velocity was 1.9 m/s and the highest 10-msec average ridedown acceleration was -2.7 g. The lateral occupant impact velocity was 1.0 m/s and the highest 10-msec average ridedown acceleration and -0.8 g in the lateral direction. The vehicle exited the immediate test site in a relatively smooth, stable manner and showed no potential for intrusion into adjacent traffic lanes.

In summary, the Type III barricade fabricated from perforated tubing with plastic rail elements tested with wet soil condition was judged to have met all evaluation criteria set forth in NCHRP Report 350.

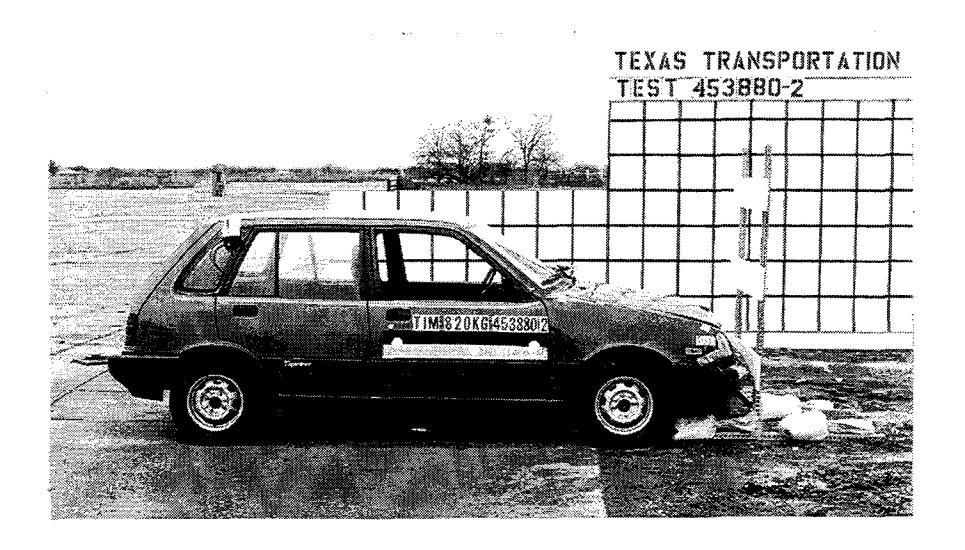
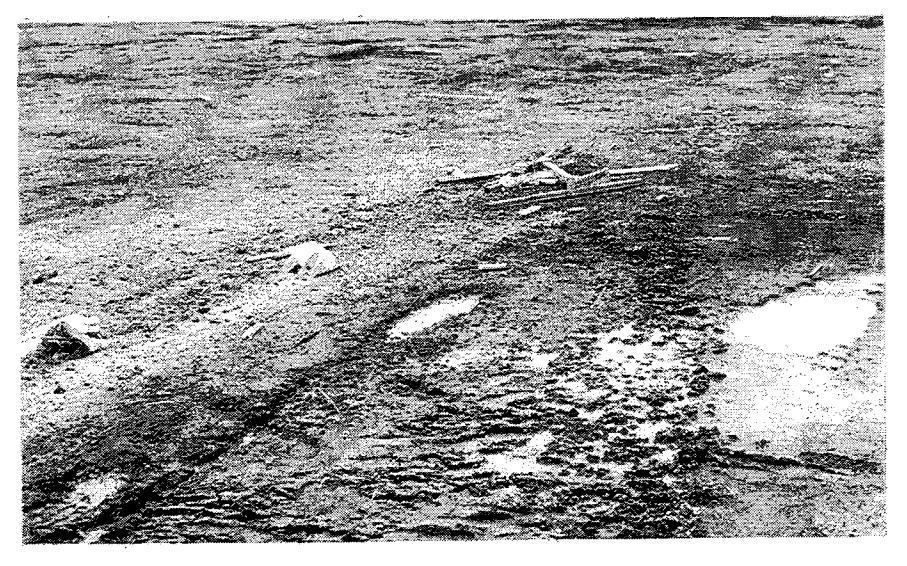
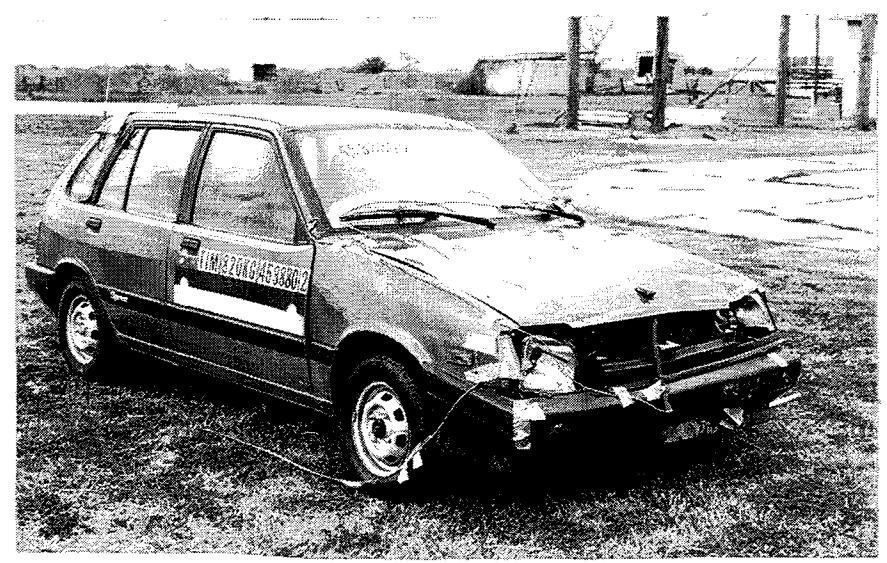
Figure 54. Vehicle and Barricade for Test No. 453880-2

As Figure 54 shows, the barricade shattered upon impact. Debris and sand were strewn along the path of the vehicle in an area 11 m wide by 46 m long. Figure 54 shows damage to the vehicle. There were dents and scratches along the bumper, grill, and hood, and the left rear tire was flat.

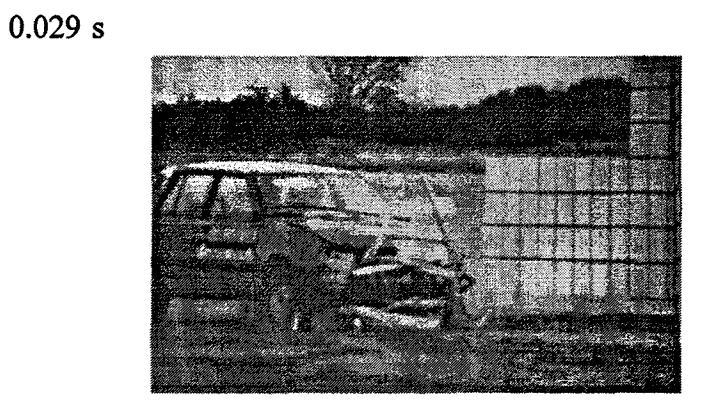
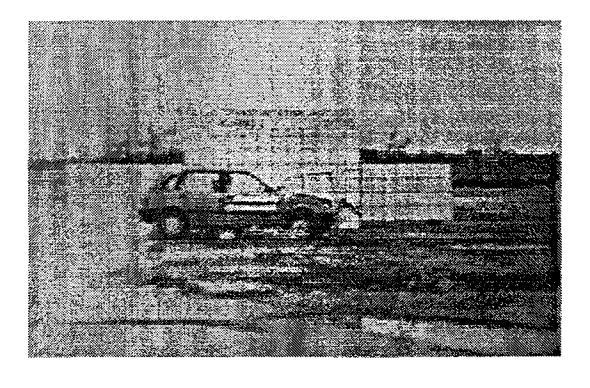
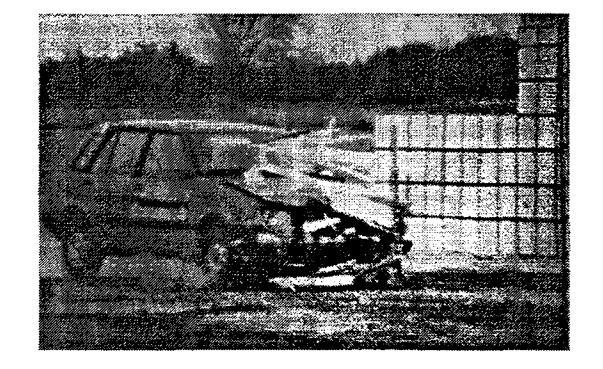
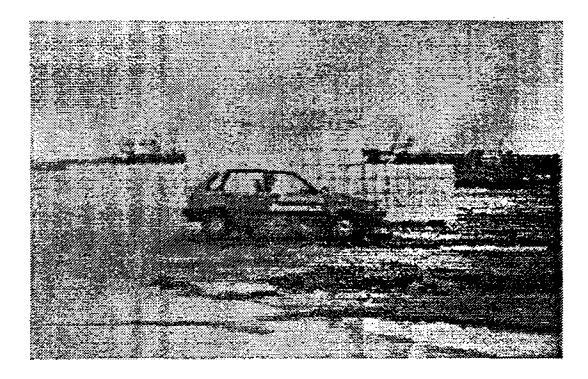
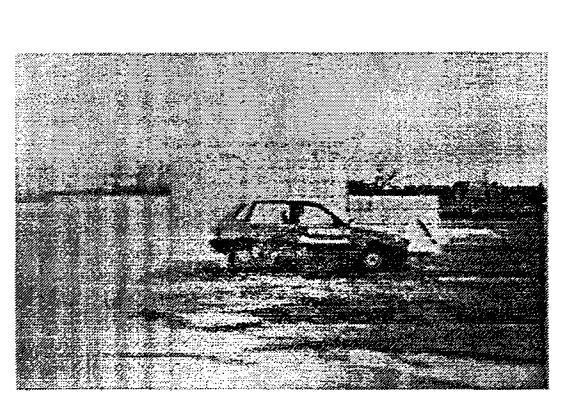
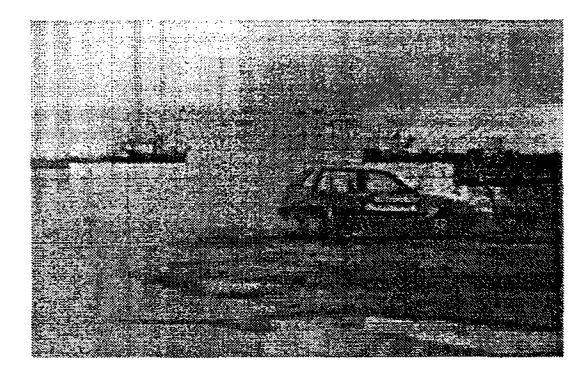
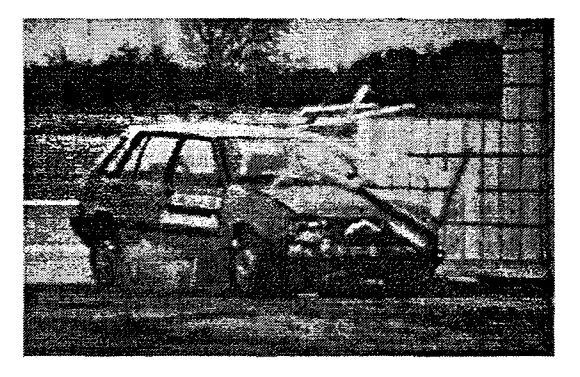
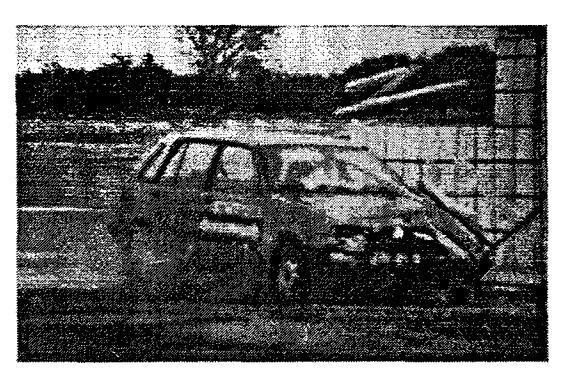
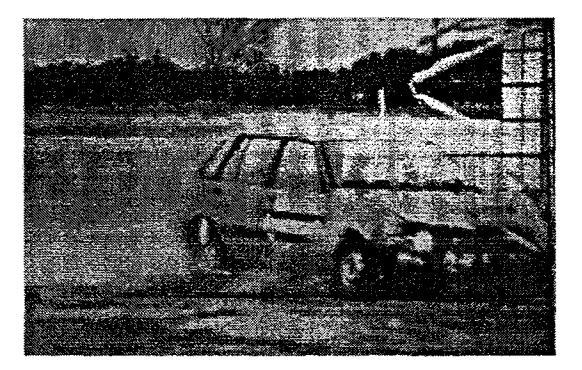
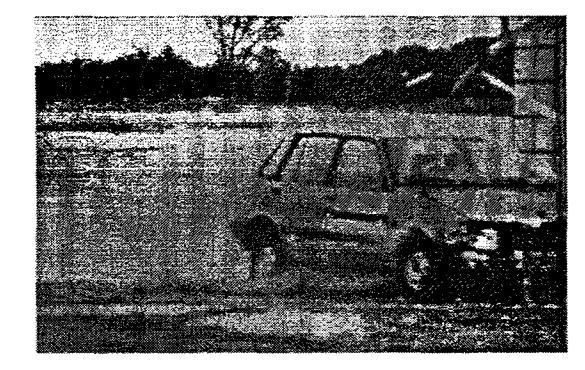
Figure 55. Sequential Photographs for Test No. 453880-2

at bumper height. The top wooden rail element contacted the hood of the vehicle at 38 msec. At 46 msec, the right vertical support separated from the rail element and became airborne while the vehicle was traveling at a speed of 93.4 km/h. The left vertical support rode along the front of the vehicle and lost contact with the vehicle at 176 msec as the vehicle had slowed to 92.5 km/h. Prior to brake application, the vehicle was tracking straight-forward. The vehicle subsequently came to rest 116 m down and 6.7 m left of the point of impact. Figure 55 shows sequential photographs of the test period.
