EVALUATION OF WORK ZONE BARRICADES AND TEMPORARY SIGN SUPPORTS

Report No. 5388-1F Research Study No. 585xxA3014 Research Study Title: Development of New Designs for Barricades and Sign Supports in Work Zones

> Sponsored by the Texas Department of Transportation

> > February 1996

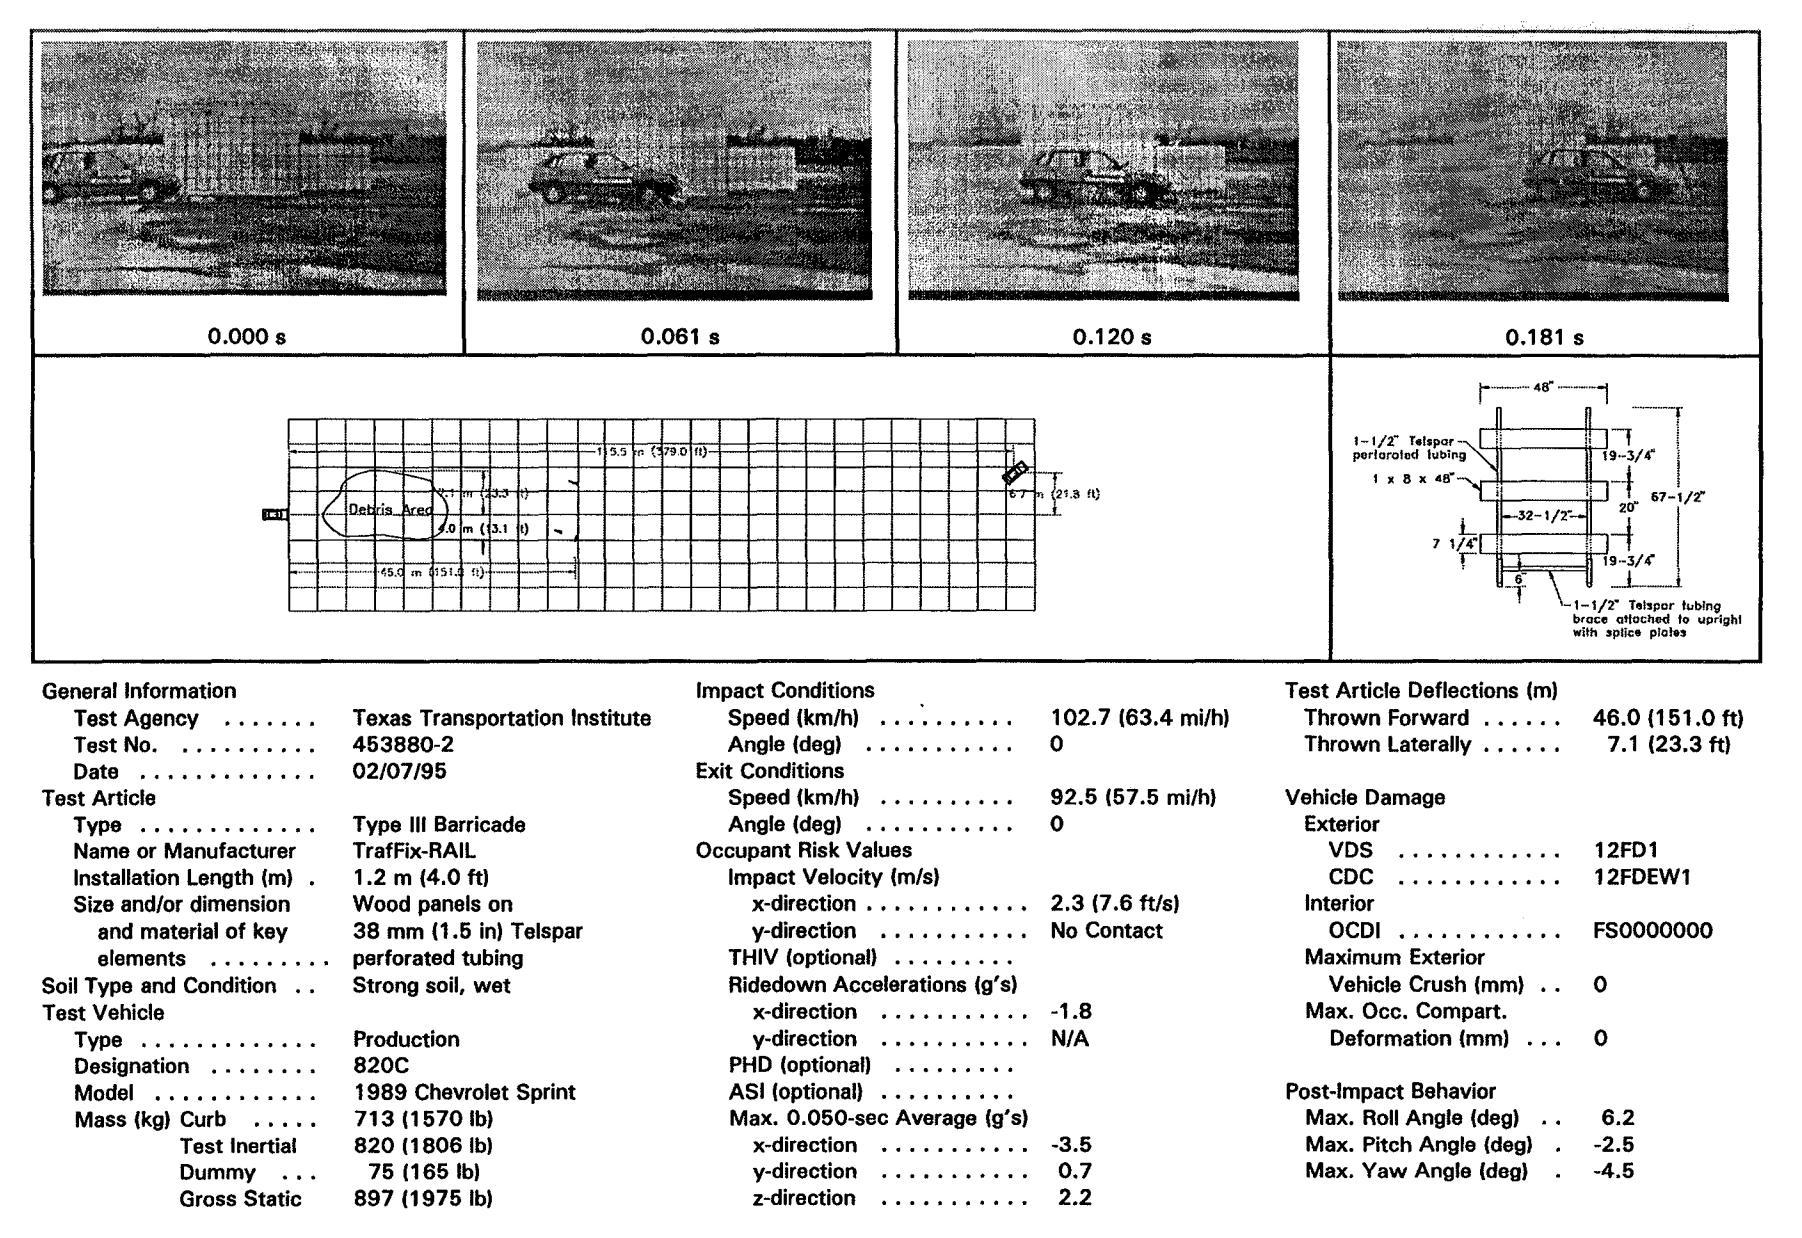
Figure 56. Summary of Results for Test No. 453880-2

A brief summary of the results of this test is presented in Figure 56. The barricade shattered upon impact and broken segments of the barricade made contact with the hood but did not penetrate the occupant compartment. Debris from the barricade was thrown along an area 11 m wide by 46 m long. Most fragments were not large enough to pose potential hazard to oncoming traffic in adjacent lanes. The fractured metal vertical supports could cause minor hazard to workers in the area. The vehicle sustained minor damage to the bumper, grill, and hood. There was no penetration or intrusion into the occupant compartment. The longitudinal occupant impact velocity was 2.3 m/s, and the highest 10-msec average ridedown acceleration was -1.8 g. There was no lateral occupant contact. The 50-msec average accelerations were -3.5 g in the longitudinal direction and 0.7 g in the lateral direction. The vehicle exited the immediate test site in a relatively smooth, stable manner and showed no potential for intrusion into adjacent traffic lanes.

In summary, the Type III barricade fabricated from perforated tubing with wooden rail elements tested with wet soil condition was also judged to have met all evaluation criteria set forth in NCHRP Report 350.

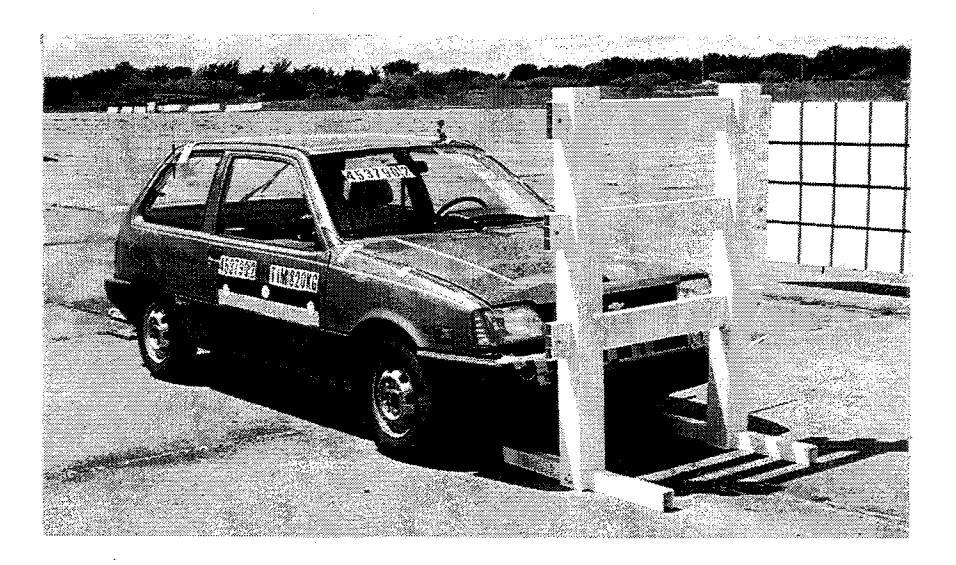
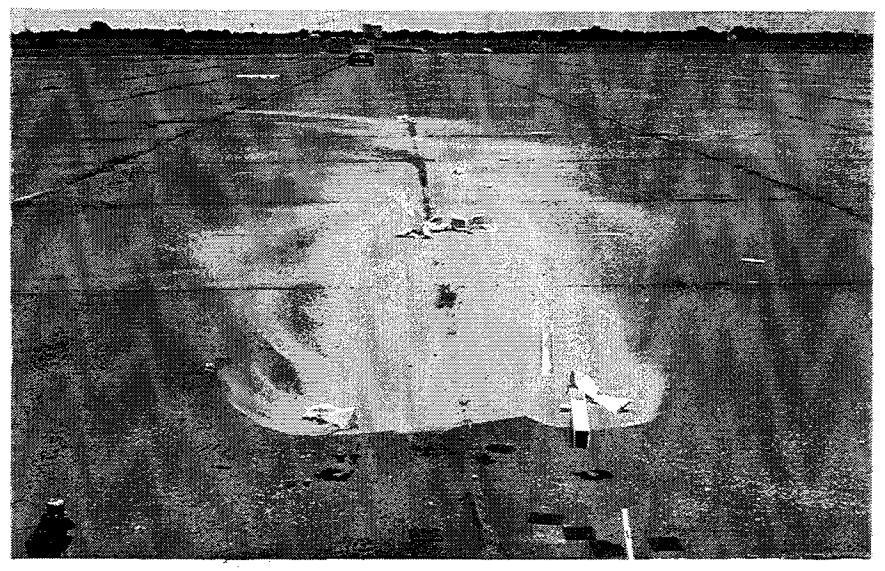
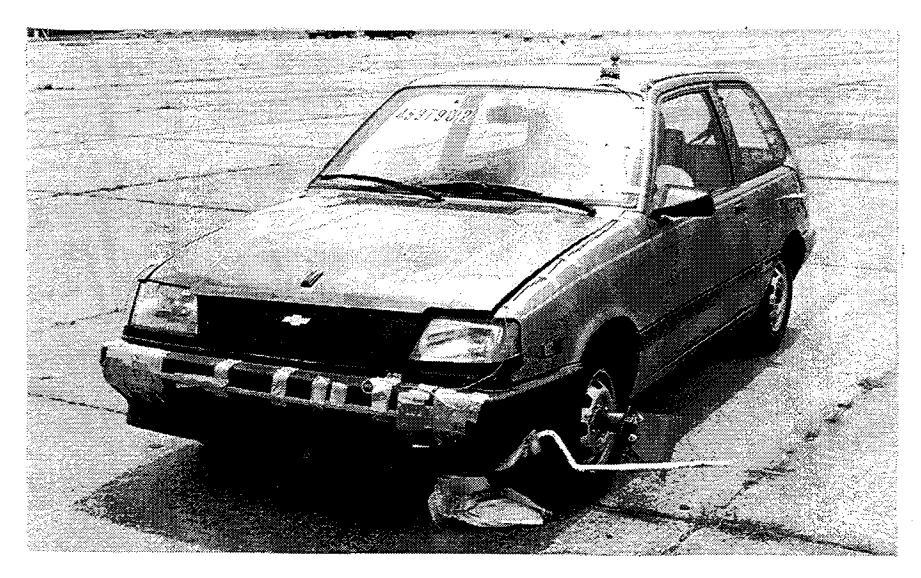
As Figure 58 shows, the barricade separated from the base upon impact. Debris and sand were strewn along the path of the vehicle in an area 6 m wide by 54 m long. Figure 58 also shows damage to the vehicle. The bumper was pushed up slightly, and the headlight on the driver's side was loose. The hood was dented on each corner, and there were three scratches along the hood.

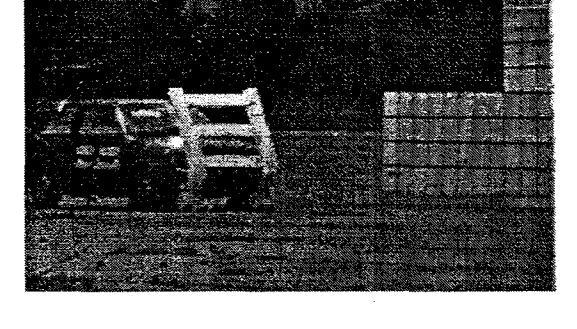
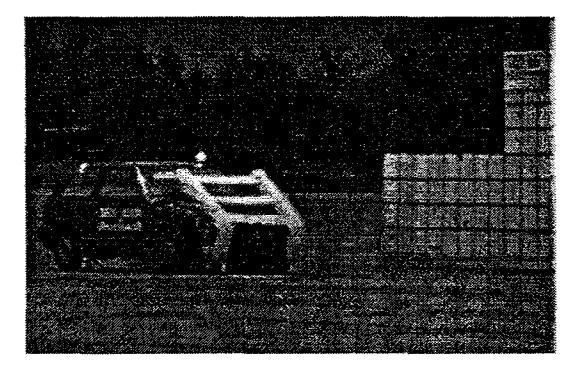
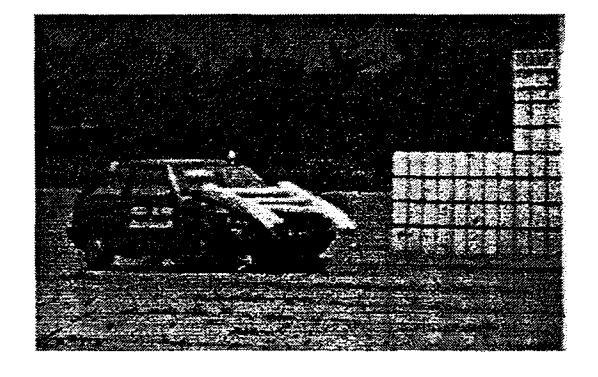
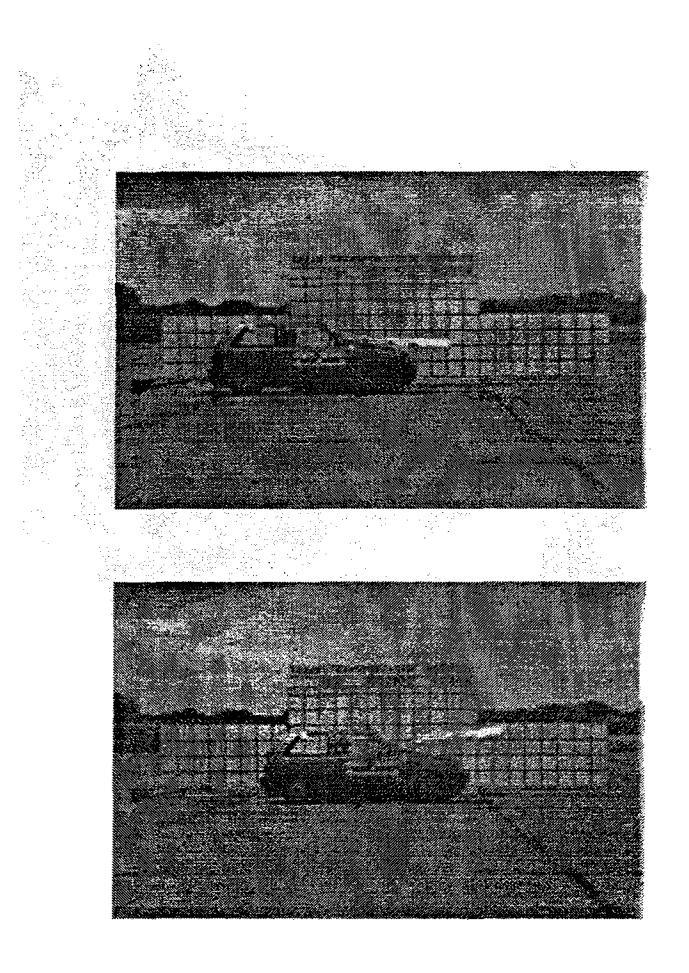
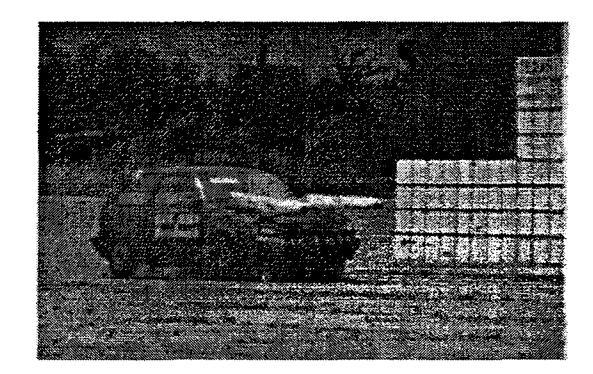
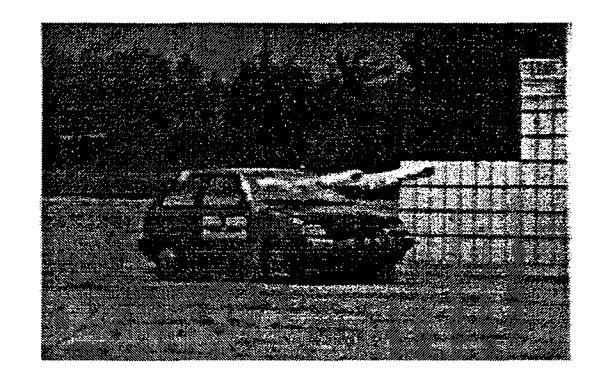
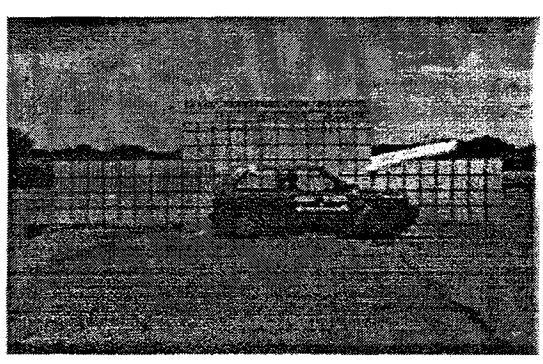
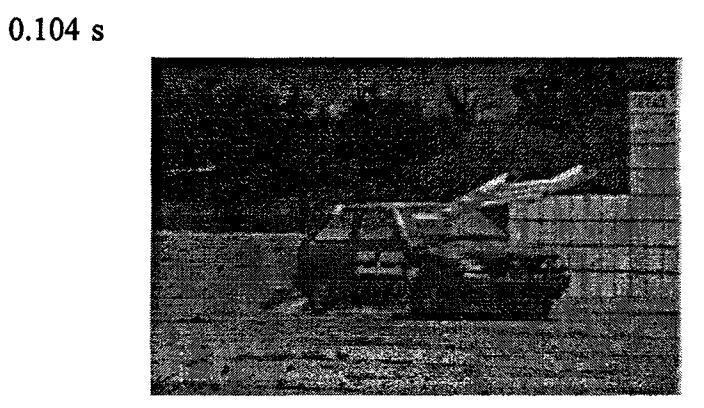
Figure 59. Sequential Photographs for Test No. 453790-2.

As the vehicle impacted the barricade, the vertical supports separated from the base as one unit and deformed to the front of the vehicle. At 57 msec, the barricade was in full contact with the hood of the vehicle and continued up and over the vehicle. The vehicle lost contact with the barricade at 69 msec, traveling at a speed of 96.3 km/h. Prior to brake application, the vehicle was tracking straightforward. The vehicle subsequently came to rest 85 m down and 2.6 m left of the point of impact. Figure 59 shows sequential photographs of the test period.

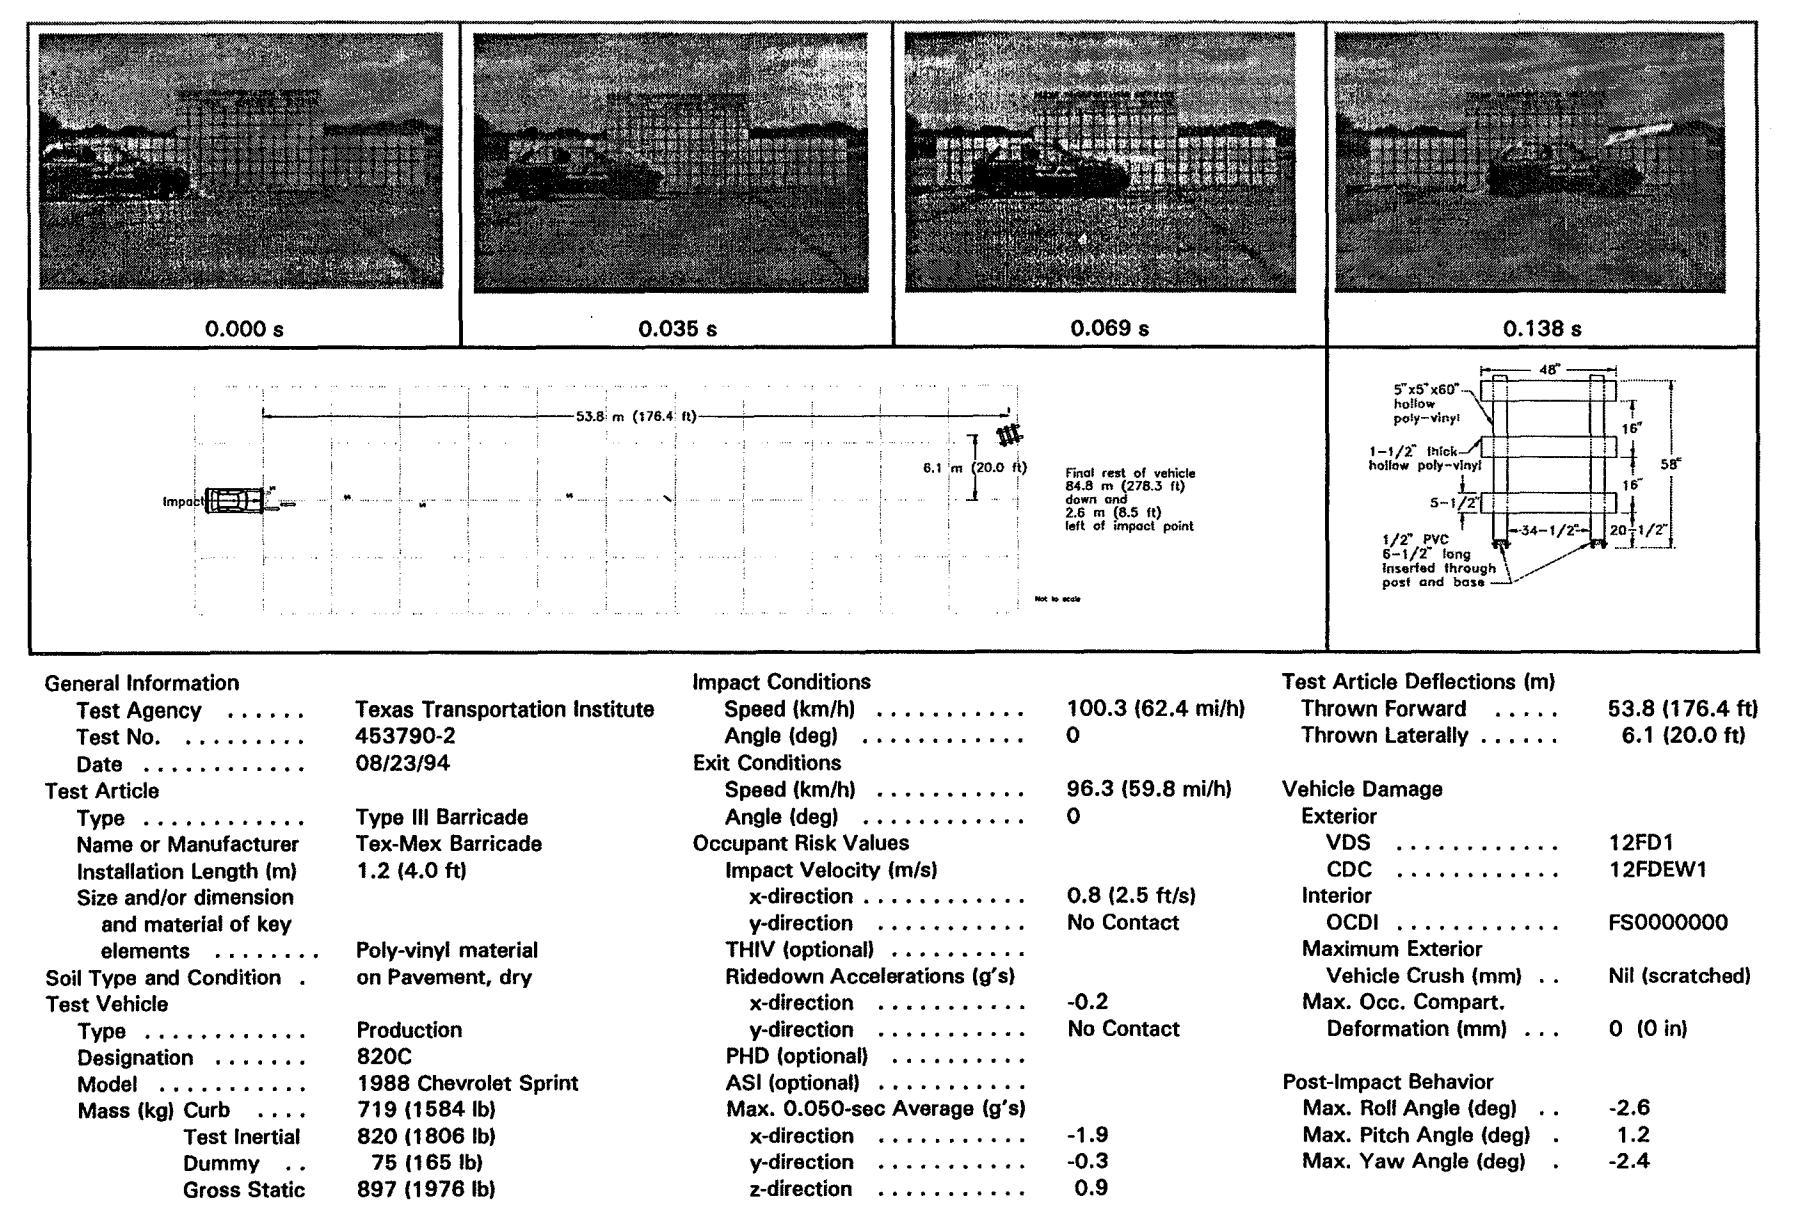
Figure 60. Summary of Results for Test No. 453790-2

A brief summary of the results of this test is presented in Figure 60. The vertical supports of the barricade separated from the base upon impact and made contact with the hood, but did not penetrate the occupant compartment. Debris from the barricade was thrown along an area 6 m wide by 54 m long. Most fragments were not large enough or heavy enough to pose potential hazard to oncoming traffic in adjacent lanes; however, the vertical supports may pose a slight hazard to workers in the area. The vehicle sustained minor damage to the bumper and hood. The longitudinal occupant impact velocity was 0.8 m/s, and the highest 10-msec average ridedown acceleration was -0.2 g. There was no lateral occupant contact. The 50-msec average accelerations were -1.9 g in the longitudinal direction and -0.3 g in the lateral direction. The vehicle exited the immediate test site in a relatively smooth, stable manner and showed no potential for intrusion into adjacent traffic lanes.

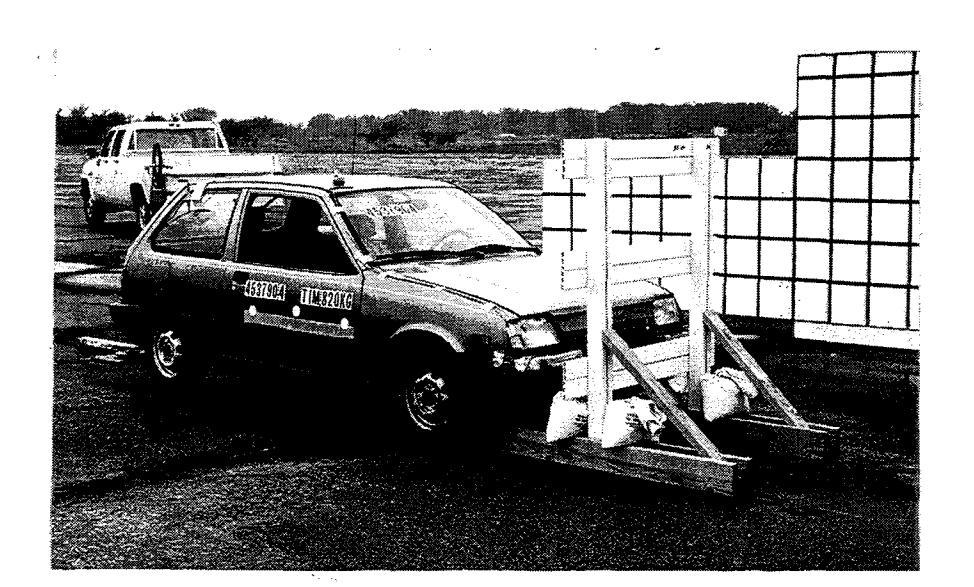
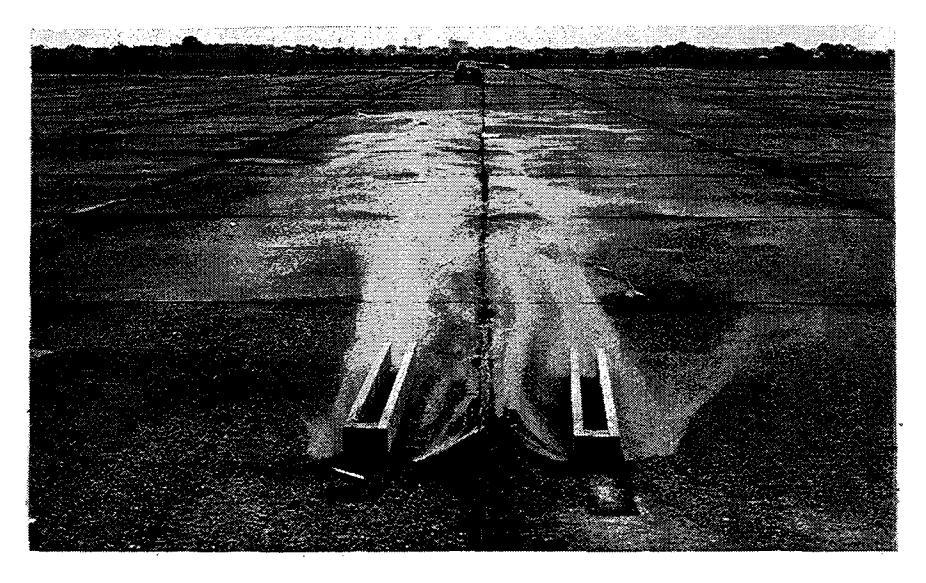
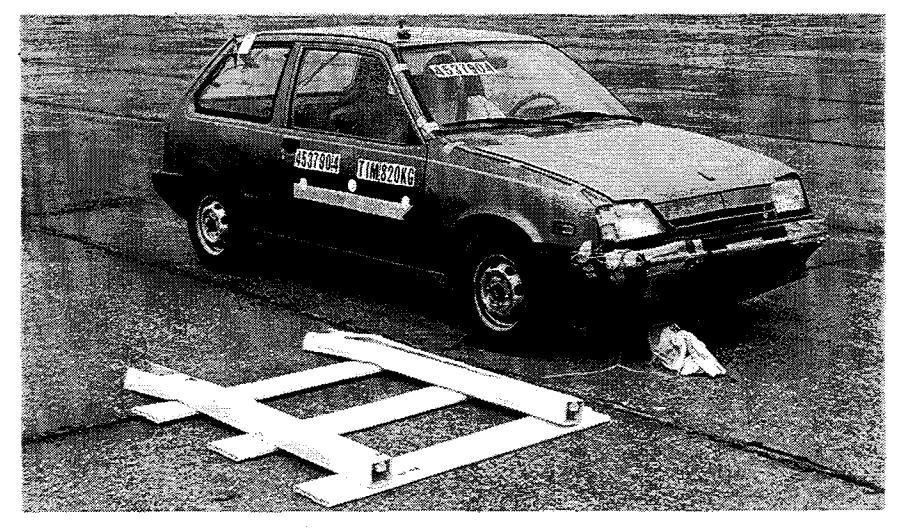
As Figure 62 shows, the hollow core recycled plastic vertical supports and rail elements separated from the wooden base upon impact. Debris and sand were strewn along the path of the vehicle in an area 17 m wide by 77 m long. Figure 62 also shows damage to the vehicle. The bumper and hood of the vehicle were scratched. No penetration or intrusion of the occupant compartment occurred. There was no measurable crush to the exterior of the vehicle.

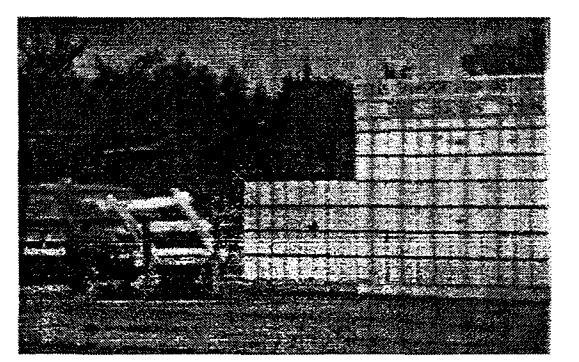
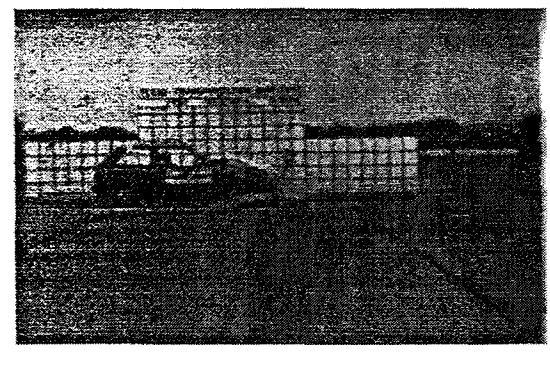
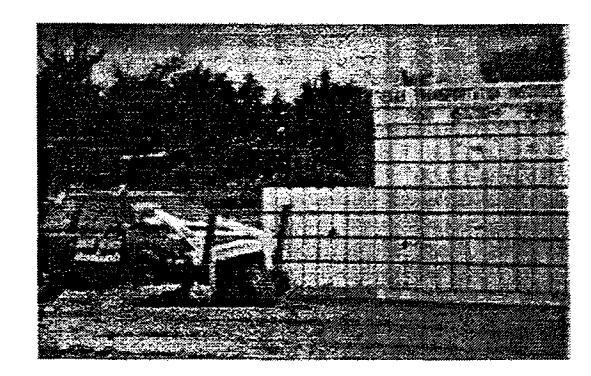
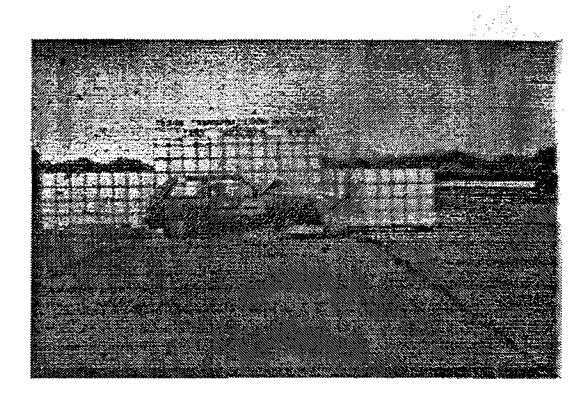
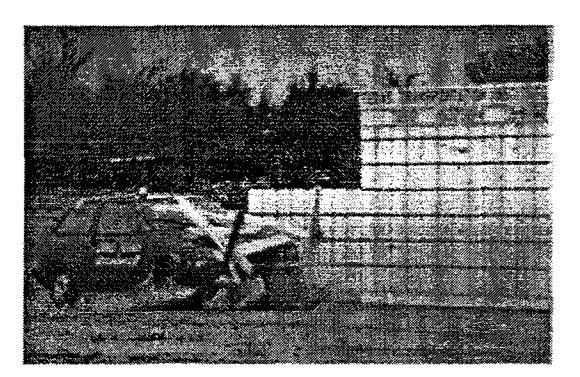
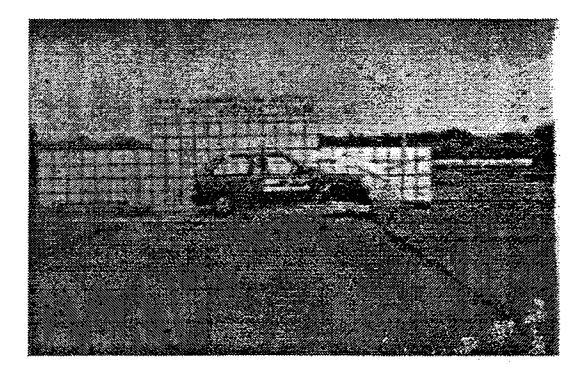
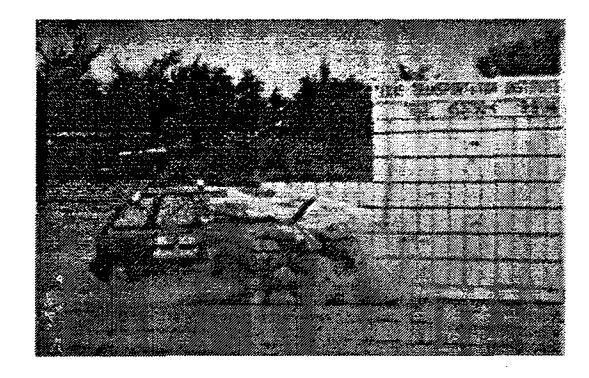
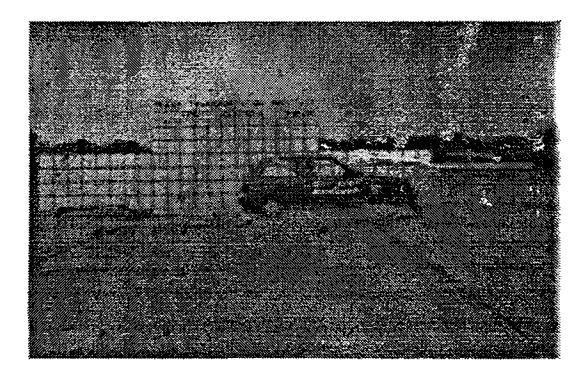
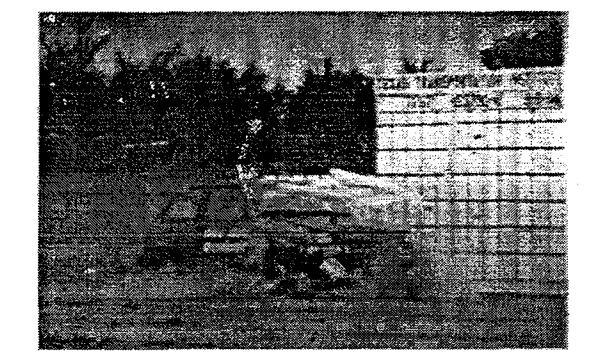
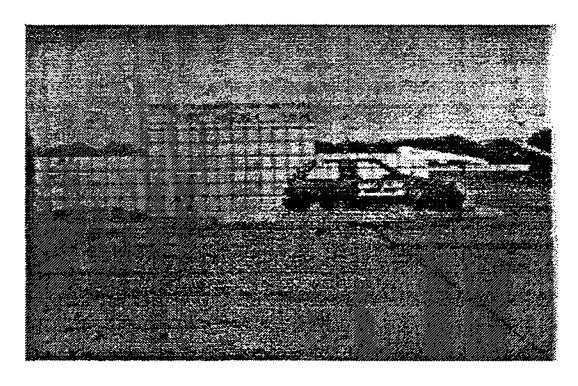
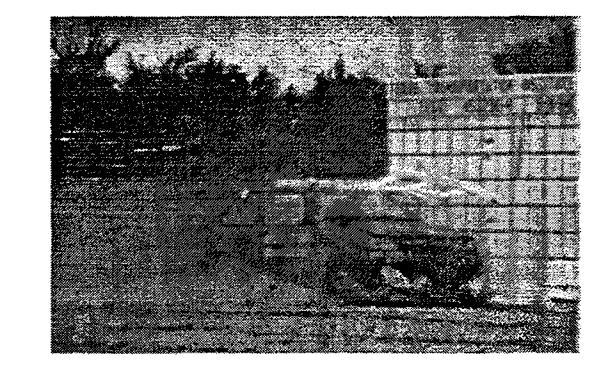
Figure 63. Sequential Photographs for Test No. 453790-4

At 10 msec after impact, the braces for the vertical supports broke away, and at 15 msec, the vertical supports and rail elements separated from the base as a single unit. The top of the vertical supports contacted the wipers in the windshield area at 47 msec. The vehicle lost contact with the barricade at 87 msec, traveling at a speed of 93.5 km/h. Prior to brake application, the vehicle was tracking straight-forward. The vehicle subsequently came to rest 76 m down and 1.5 m to the left of the point of impact. Figure 63 shows sequential photographs of the test period.

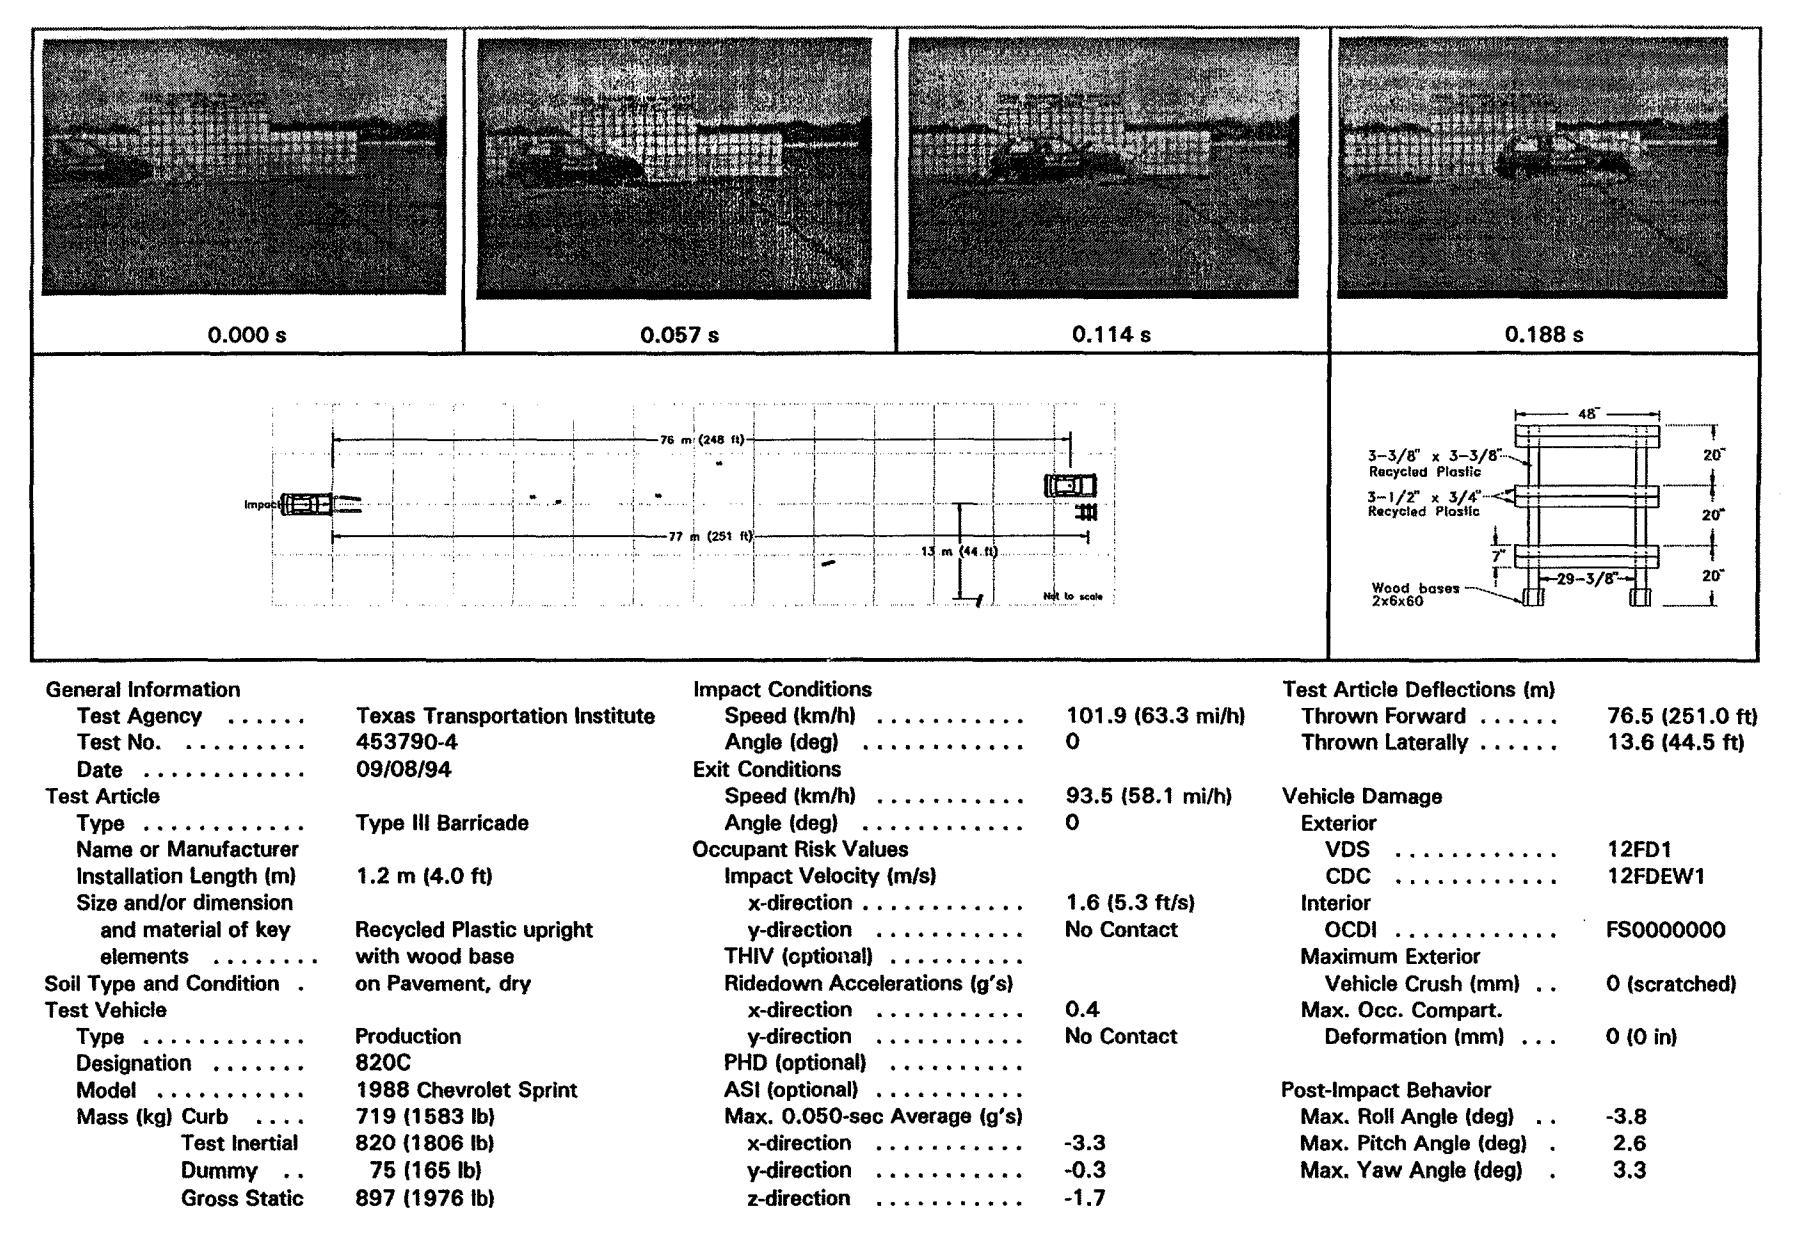
Figure 64. Summary of Results for Test No. 453790-4

Figure 64 presents a brief summary of the results of this test. The hollow core plastic vertical supports and rail elements separated from the wooden base and made contact with the

hood and windshield of the vehicle, but did not penetrate the occupant compartment. Debris from the barricade was thrown along an area 17 m wide by 77 m long. The plastic vertical supports and wooden braces rode along with the vehicle. The wooden base remained near the point of impact and most of the remaining fragments were not large enough to pose potential hazard to oncoming traffic in adjacent lanes or to workers in the area. Damage to the vehicle included scratches to the bumper and hood. The plastic vertical supports, which separated from the wooden base, contacted the windshield area, but there was no penetration or intrusion into the occupant compartment. The longitudinal occupant impact velocity was 1.6 m/s, and the highest 10-msec average ridedown acceleration was 0.4 g. There was no lateral occupant contact. The 50-msec average accelerations were -3.3 g in the longitudinal direction and -0.3 g in the lateral direction. The vehicle exited the immediate test site in a relatively smooth, stable manner and showed no potential for intrusion into adjacent traffic lanes.

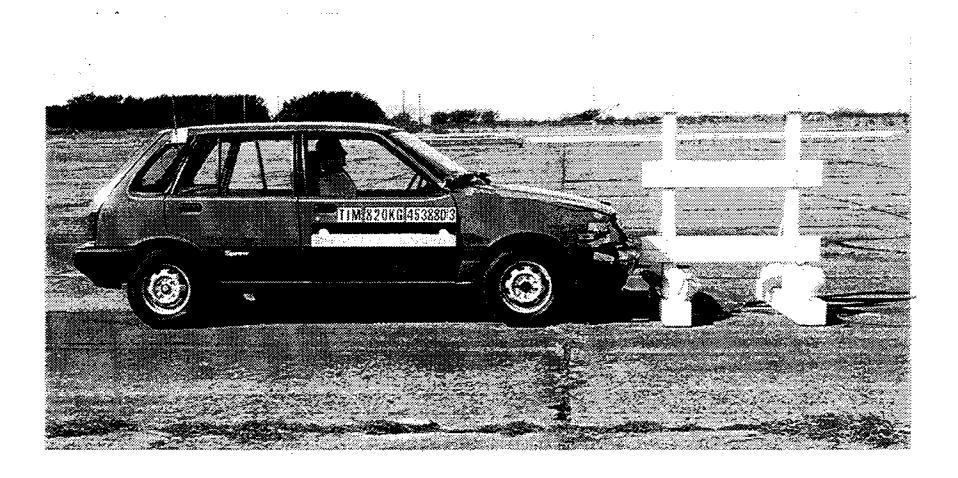
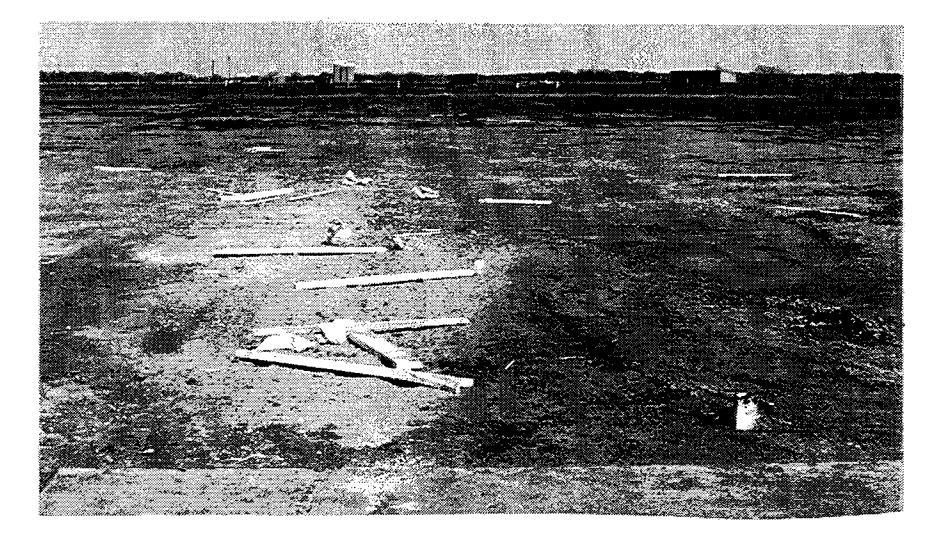
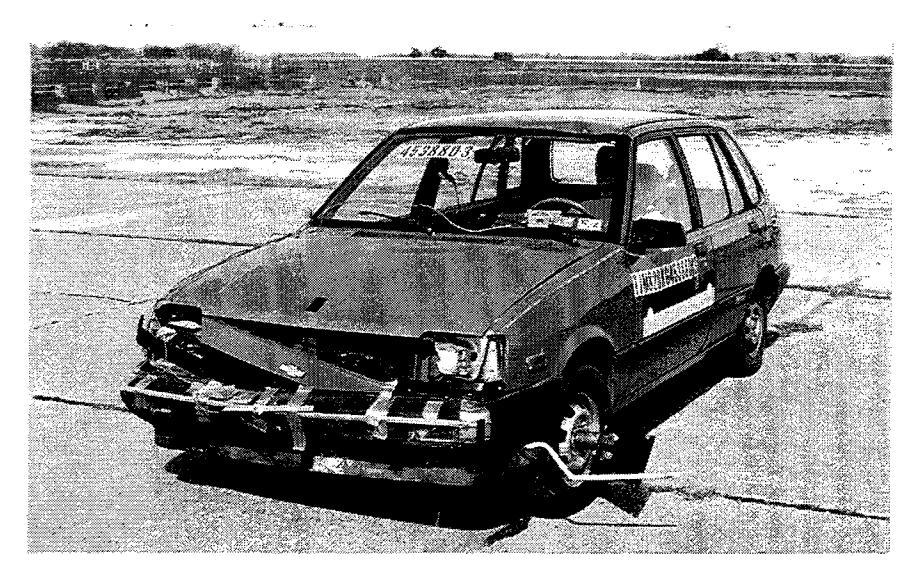
Figure 66. Vehicle and Barricade for Test No. 453880-3

As Figure 66 shows, the hollow core recycled plastic vertical supports and rail elements separated from the base fabricated from solid recycled plastic upon impact and subsequently shattered. Debris and sand were strewn along the path of the vehicle in an area 9.9 m wide by

48 m long. Figure 66 shows damage to the vehicle. The damage to the vehicle included the bumper, grill, and scratches on the hood. The right rear tire was flat.

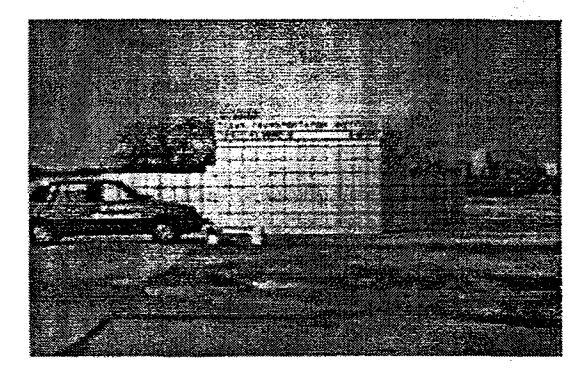
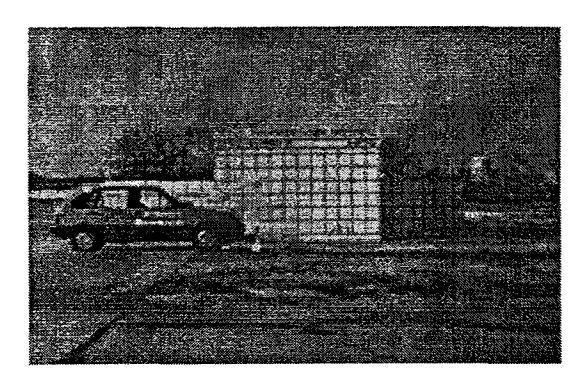
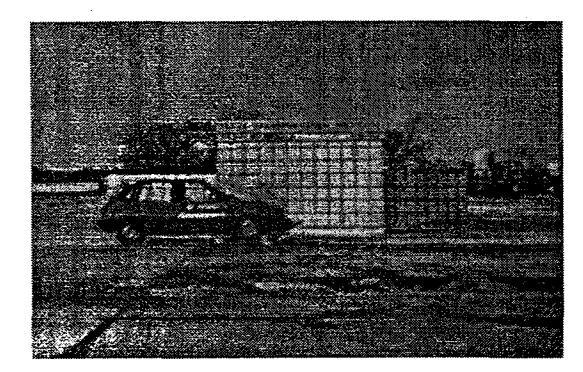
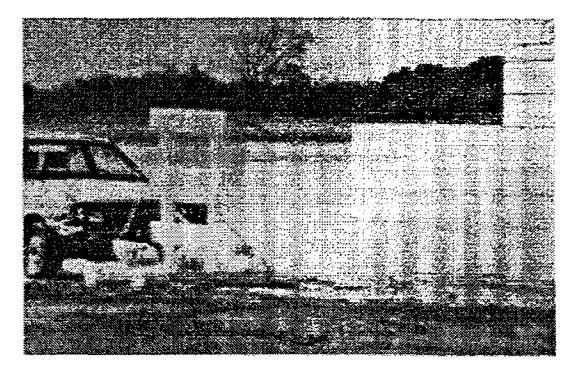
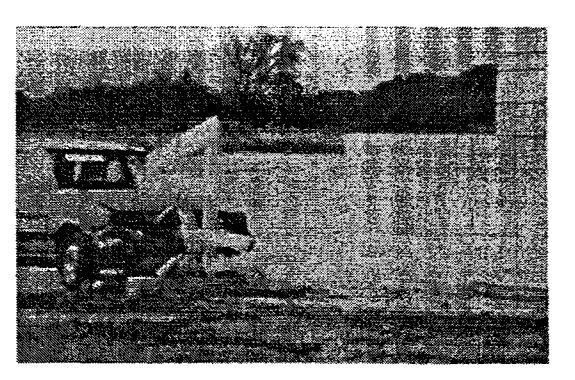
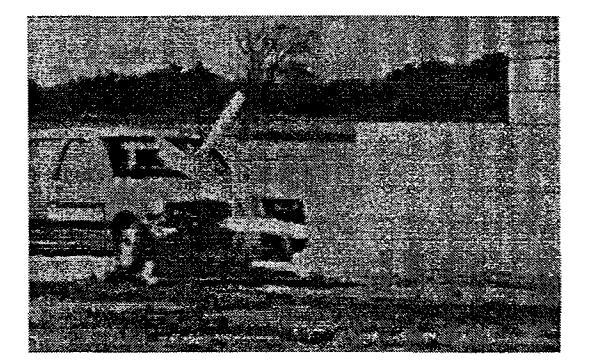
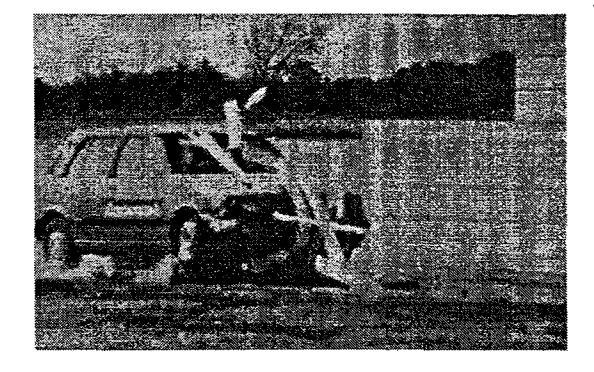
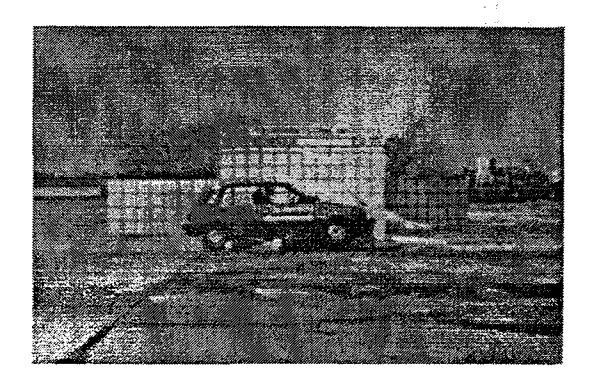
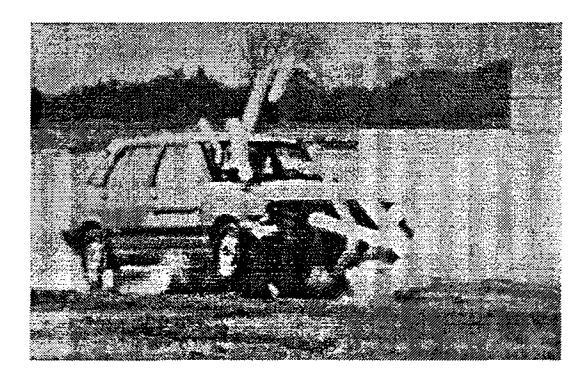
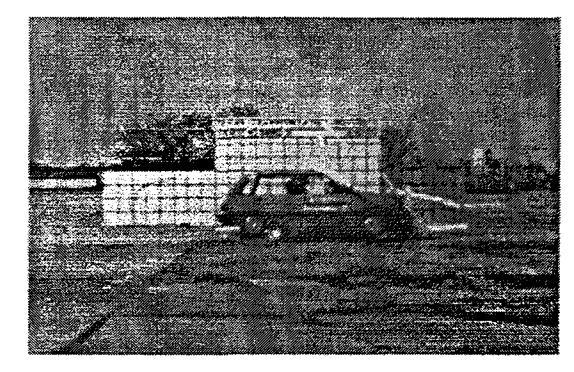
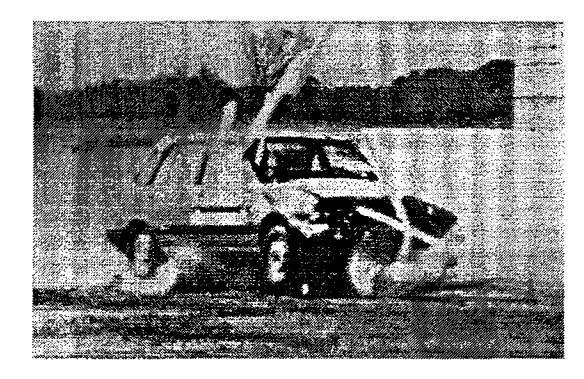
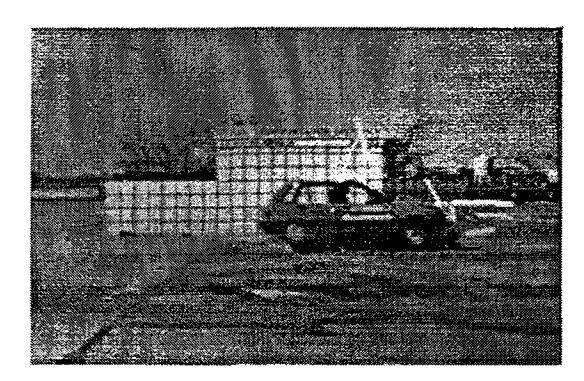
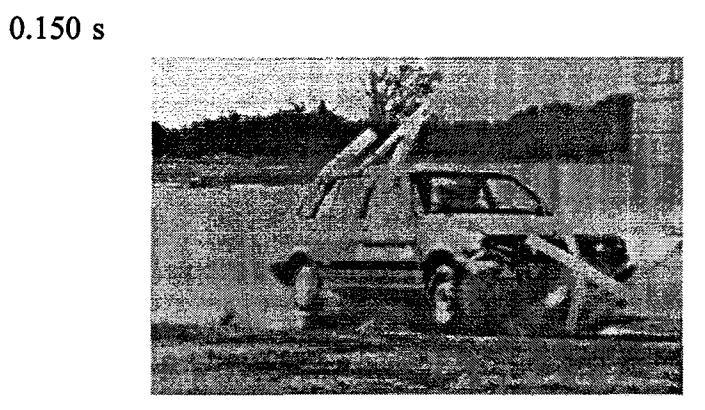
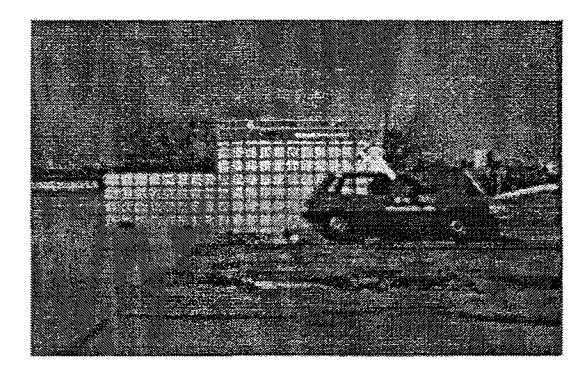
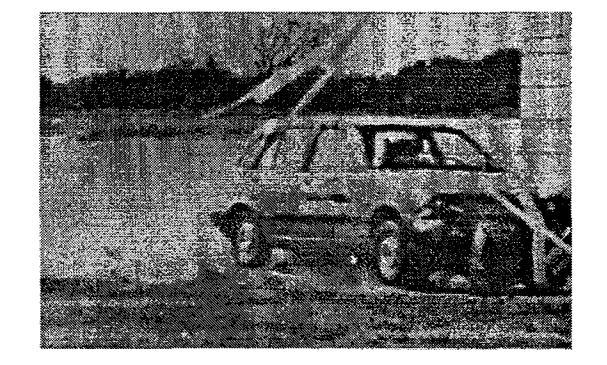
Figure 67. Sequential Photographs for Test No. 453880-3

At 6 msec after impact, the lower rail element separated from the right vertical support. The vehicle contacted the left vertical support at 10 msec. At 15 msec, the middle rail element separated from the left vertical support, and the top rail element twisted. The lower edge of the middle rail element contacted the hood of the vehicle at 19 msec. The vehicle contacted the right vertical support at 39 msec, and the top rail element contacted the hood. At 41 msec, the middle rail elements contacted the windshield with no resulting damage. Shortly thereafter, the rail elements separated from the right vertical support, and the debris rode along with the vehicle. At 221 msec, the vehicle cleared the test site traveling at a speed of 95.4 km/h. Prior to brake application, the vehicle was tracking straightforward. The vehicle subsequently came to rest 114 m down and 1.8 m to the right of the point of impact. Figure 67 shows sequential photographs of the test period.
