EVALUATION OF WORK ZONE BARRICADES AND TEMPORARY SIGN SUPPORTS

Report No. 5388-1F Research Study No. 585xxA3014 Research Study Title: Development of New Designs for Barricades and Sign Supports in Work Zones

> Sponsored by the Texas Department of Transportation

> > February 1996

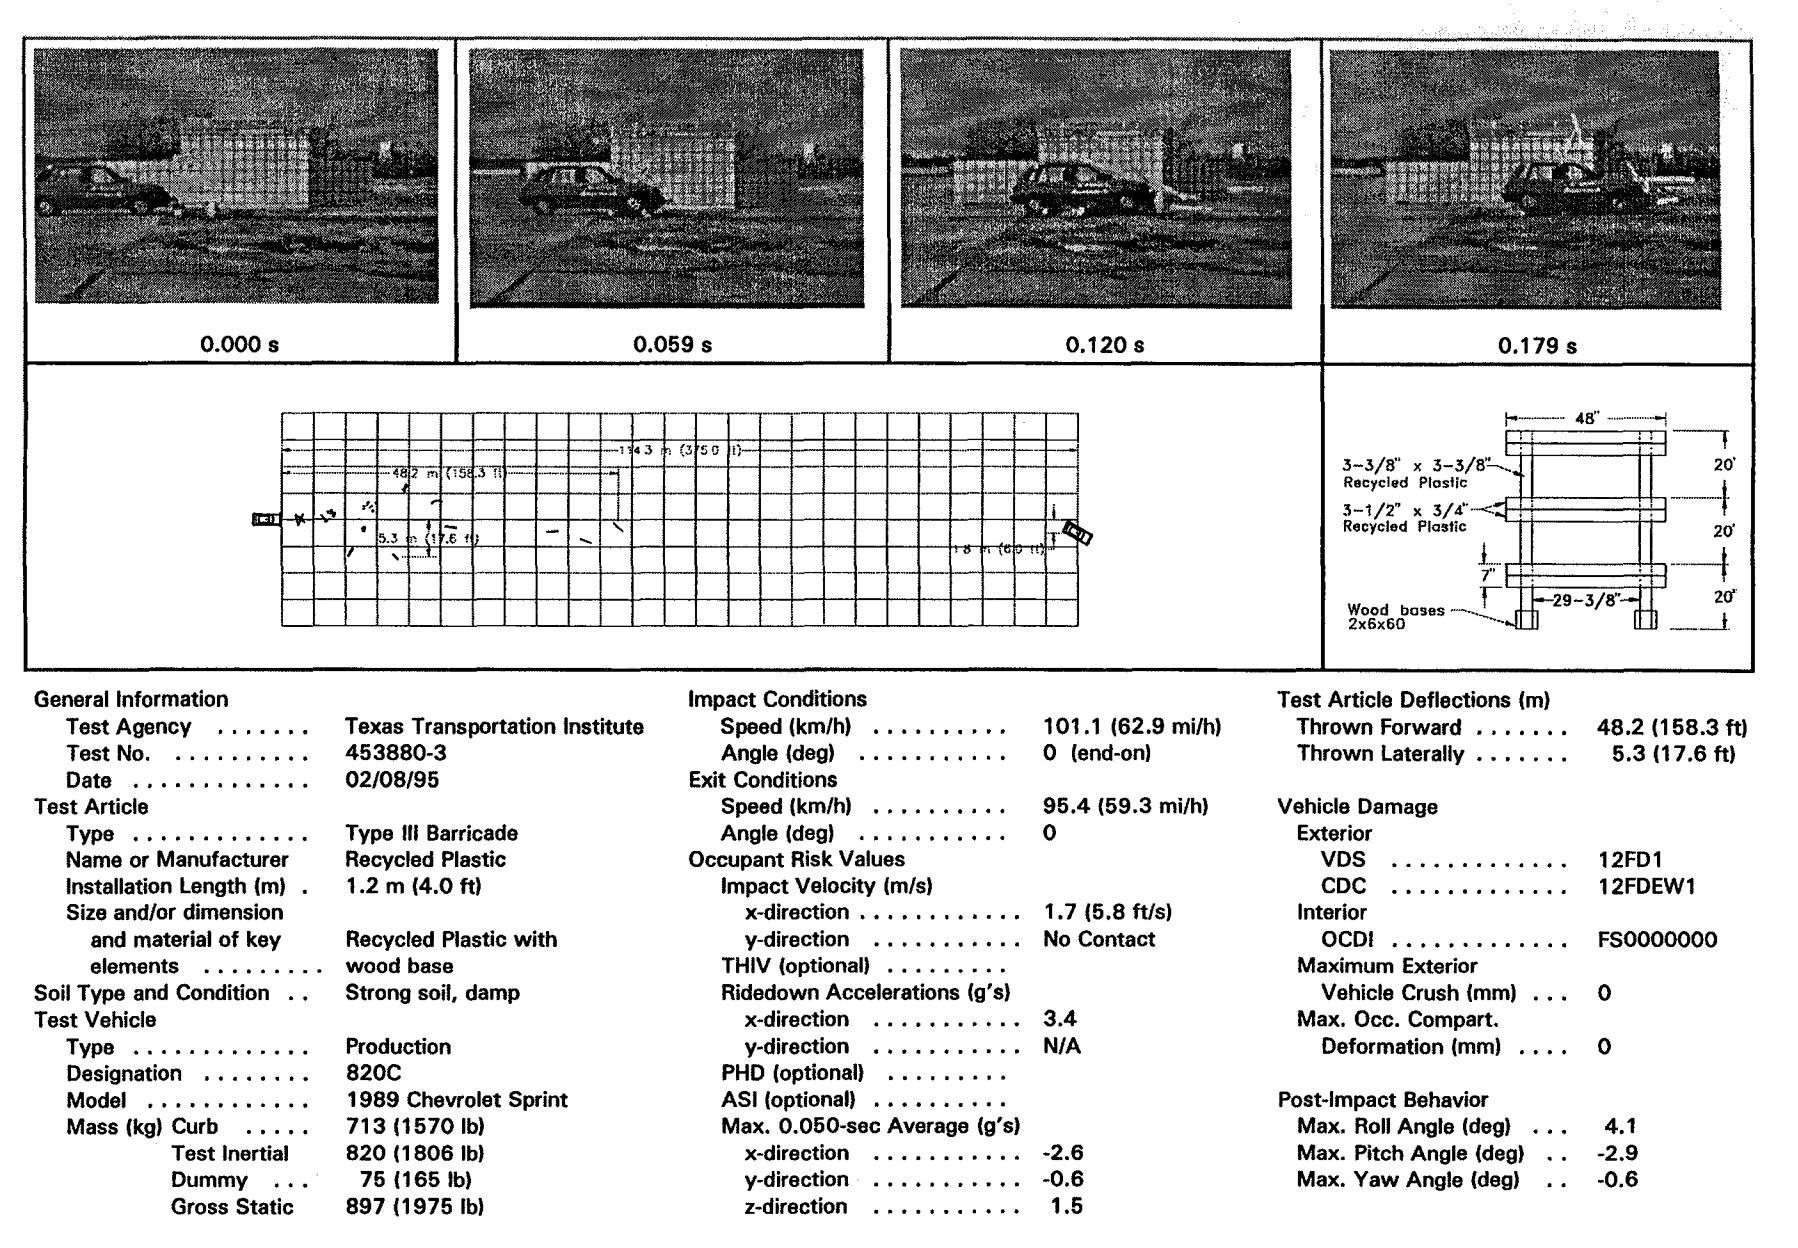
Figure 68. Summary of Results for Test No. 453880-3

A brief summary of the results of this test is presented in Figure 68. The hollow core recycled plastic vertical supports and rail elements separated from the solid recycled plastic base upon impact. The broken segments made contact with the hood and the windshield, but did not penetrate the occupant compartment. Sand and fragments of the barricade were scattered along an area 9.9 m wide by 48 m long. Most fragments were not large enough to pose potential hazard to oncoming traffic in adjacent lanes or to workers in the area. The vehicle sustained minor damage to the bumper, grill and hood. The longitudinal occupant impact velocity was 1.7 m/s and the highest 10-msec average ridedown acceleration was 3.4 g. There was no lateral occupant contact. The 50-msec average accelerations were -2.6 g in the longitudinal direction and -0.6 g in the lateral direction. The vehicle exited the immediate test site in a relatively smooth, stable manner and showed no potential for intrusion into adjacent traffic lanes.

In summary, the Type III barricade fabricated from hollow core recycled plastic material with a base constructed of solid recycled plastic material tested with wet soil condition was also judged to have met all evaluation criteria set forth in NCHRP Report 350.

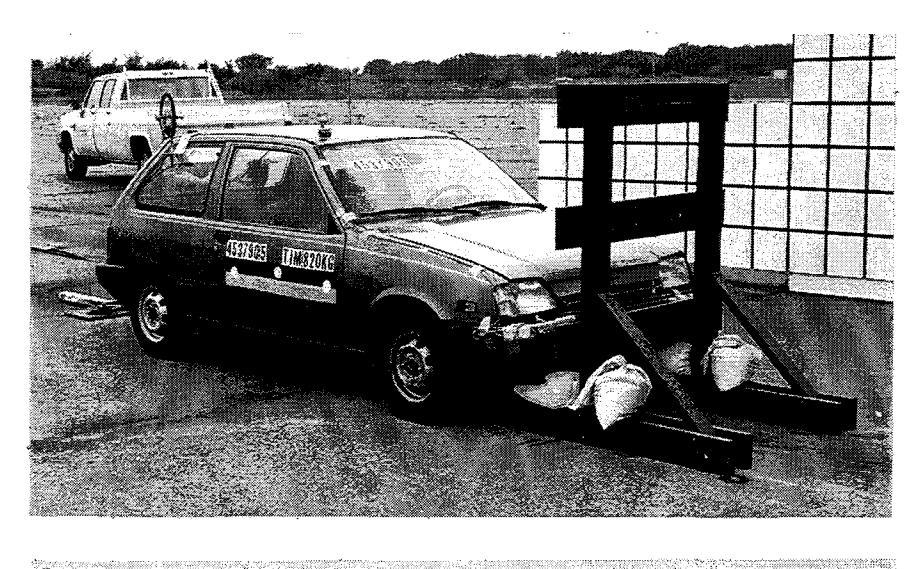
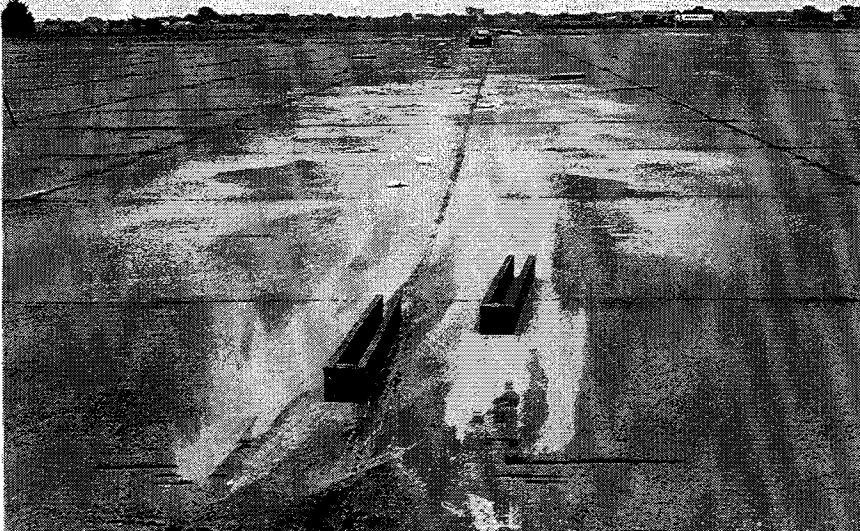
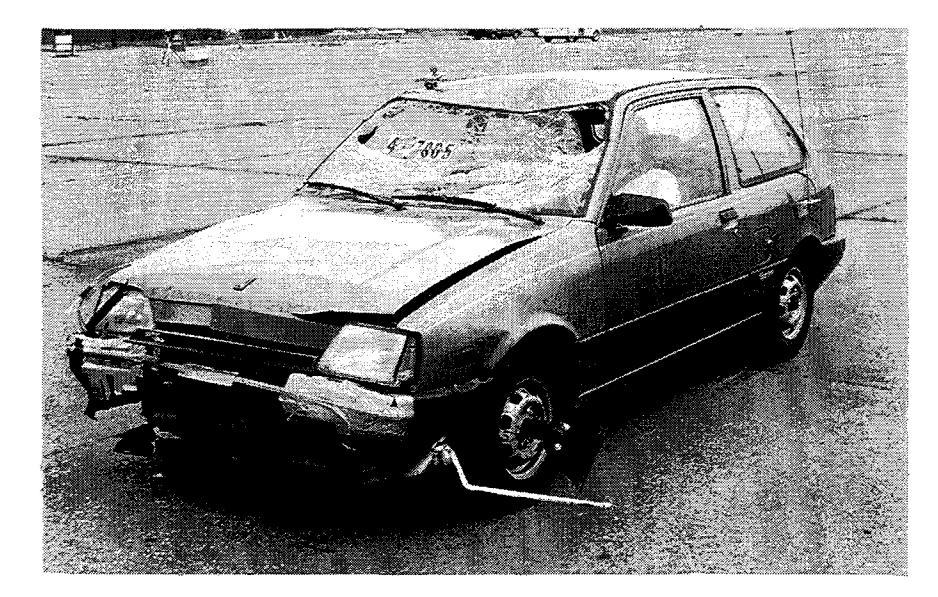
As Figure 70 shows, the solid recycled plastic barricade shattered upon impact. Debris and sand were strewn along the path of the vehicle in an area 14.5 m wide by 63 m long. Figure 70 also shows damage to the vehicle. The bumper, grill, and hood of the vehicle were dented and scratched. The left side A-post was dented, the windshield was broken, and the roof was dented. Maximum exterior crush to the front of the vehicle at bumper height was 80 mm. Maximum intrusion into the occupant compartment (measured from high-speed film) was 259 mm near the head area of the driver. The maximum residual deformation into the occupant compartment was 61 mm.

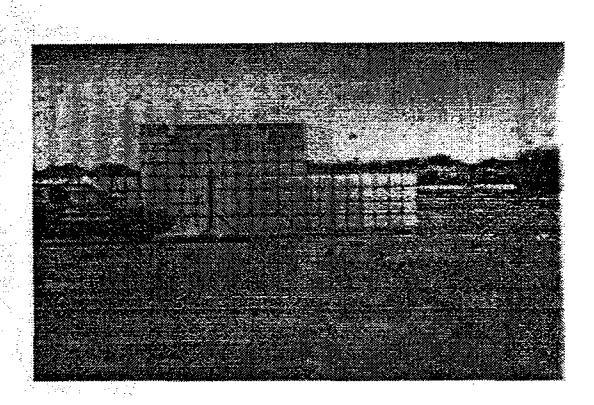
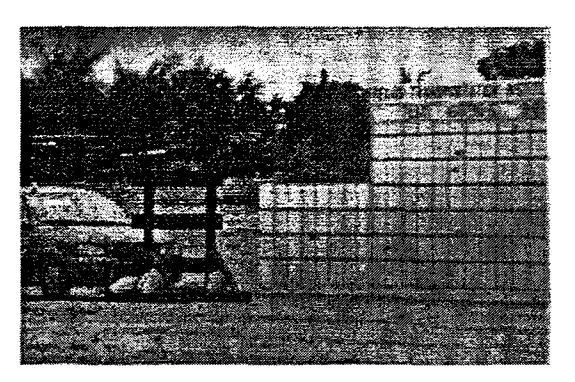
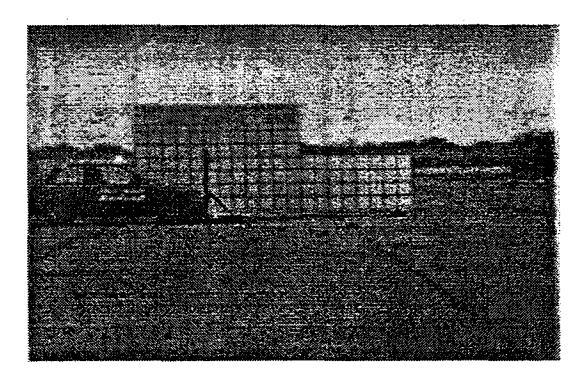
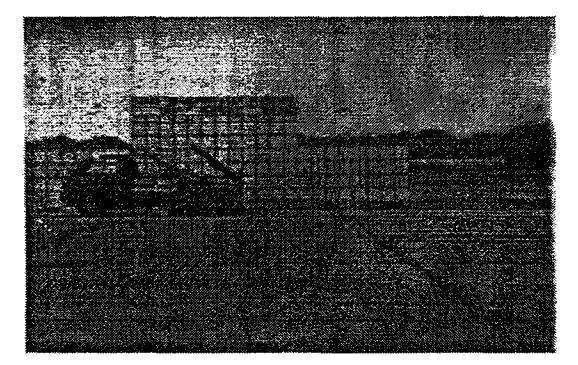
At 5 msec after impact, the barricade shattered. At 47 msec, the fractured vertical support impacted and penetrated the windshield. The segment then went up over the vehicle and touched the roof. The vehicle lost contact with the barricade at 176 msec, traveling at a speed of 93.6 km/h. Prior to brake application, the vehicle was tracking straightforward. The vehicle subsequently came to rest 93 m down and 1.2 m to the left of the point of impact. Figure 71 shows sequential photographs of the test period.

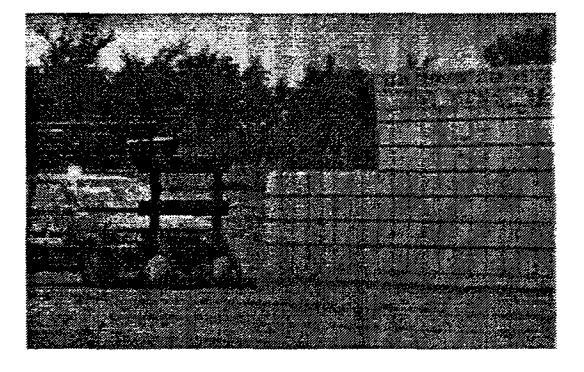
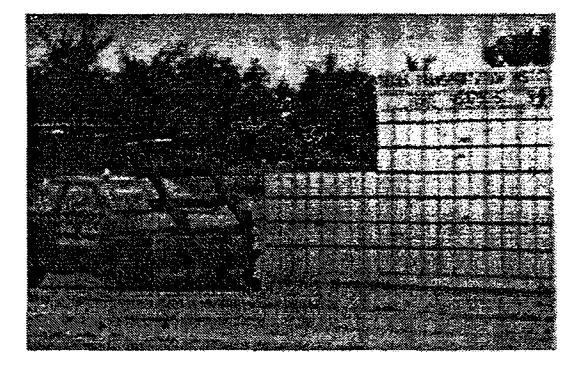
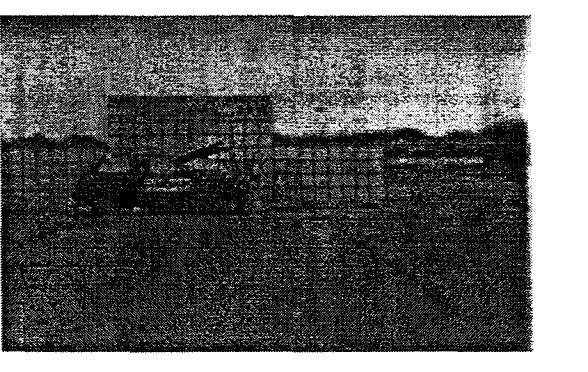
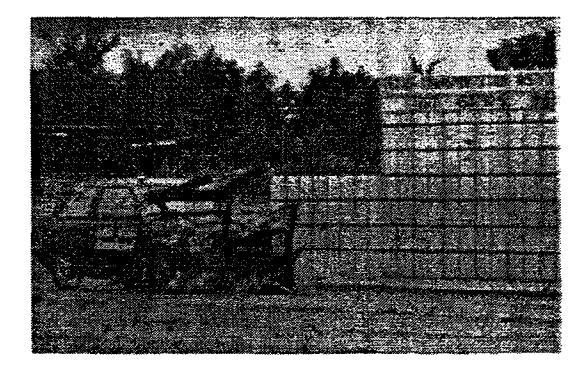
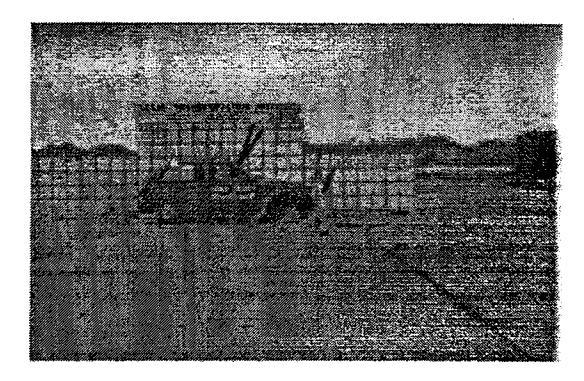
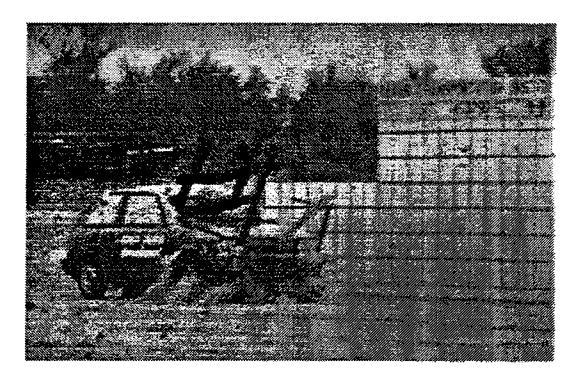
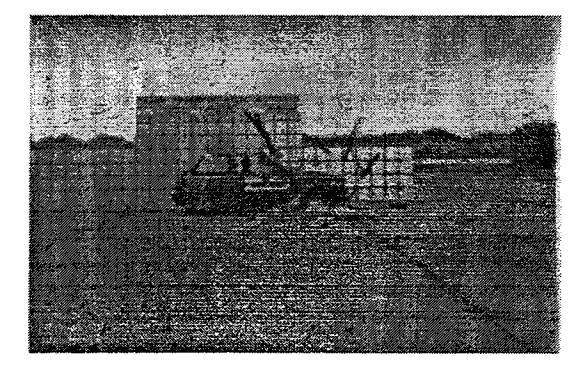
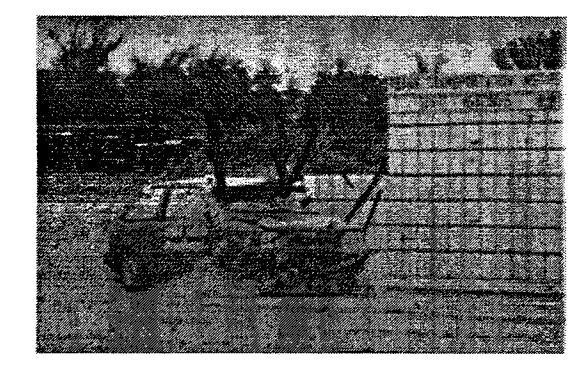
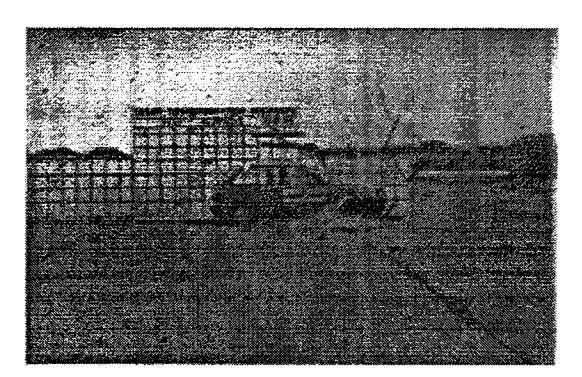
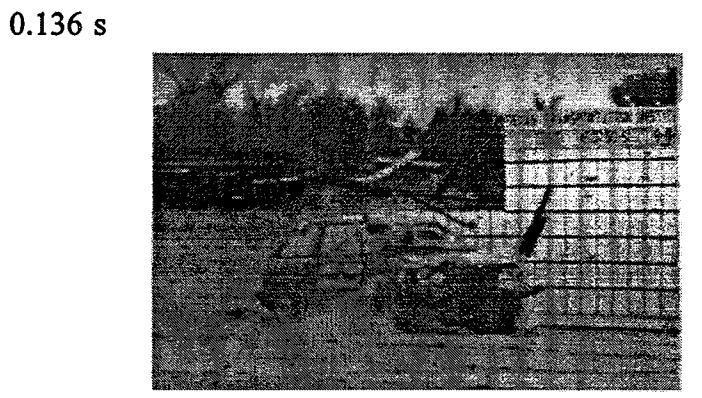
Figure 71. Sequential Photographs for Test No. 453790-5

Figure 72 presents a brief summary of the results of this test. The barricade shattered upon impact. A segment of the vertical support made contact with the windshield and penetrated into the occupant compartment. Maximum intrusion into the occupant compartment was 259 mm near the driver's head area. Debris from the barricade was thrown along an area 14.5 m wide by 63 m long. Most of the fragments were not large enough to pose potential hazard to oncoming traffic in adjacent lanes or to workers in the area. Damage to the vehicle included dents and scratches to the bumper and hood and penetration to the windshield area. The longitudinal occupant impact velocity was 2.0 m/s and the highest 10-msec average ridedown acceleration was 0.4 g. Lateral occupant impact velocity was 0.6 m/s, and the highest 10-msec average ridedown acceleration acceleration was 0.5 g. The 50-msec average accelerations were -3.9 g in the longitudinal direction and -0.4 g in the lateral direction. The vehicle exited the immediate test site in a relatively smooth, stable manner and showed no potential for intrusion into adjacent traffic lanes.

In summary, the performance of the Type III barricade fabricated from solid recycled plastic material was judged to be unsatisfactory due to penetration of the windshield and the occupant compartment by a segment of the fractured vertical support.

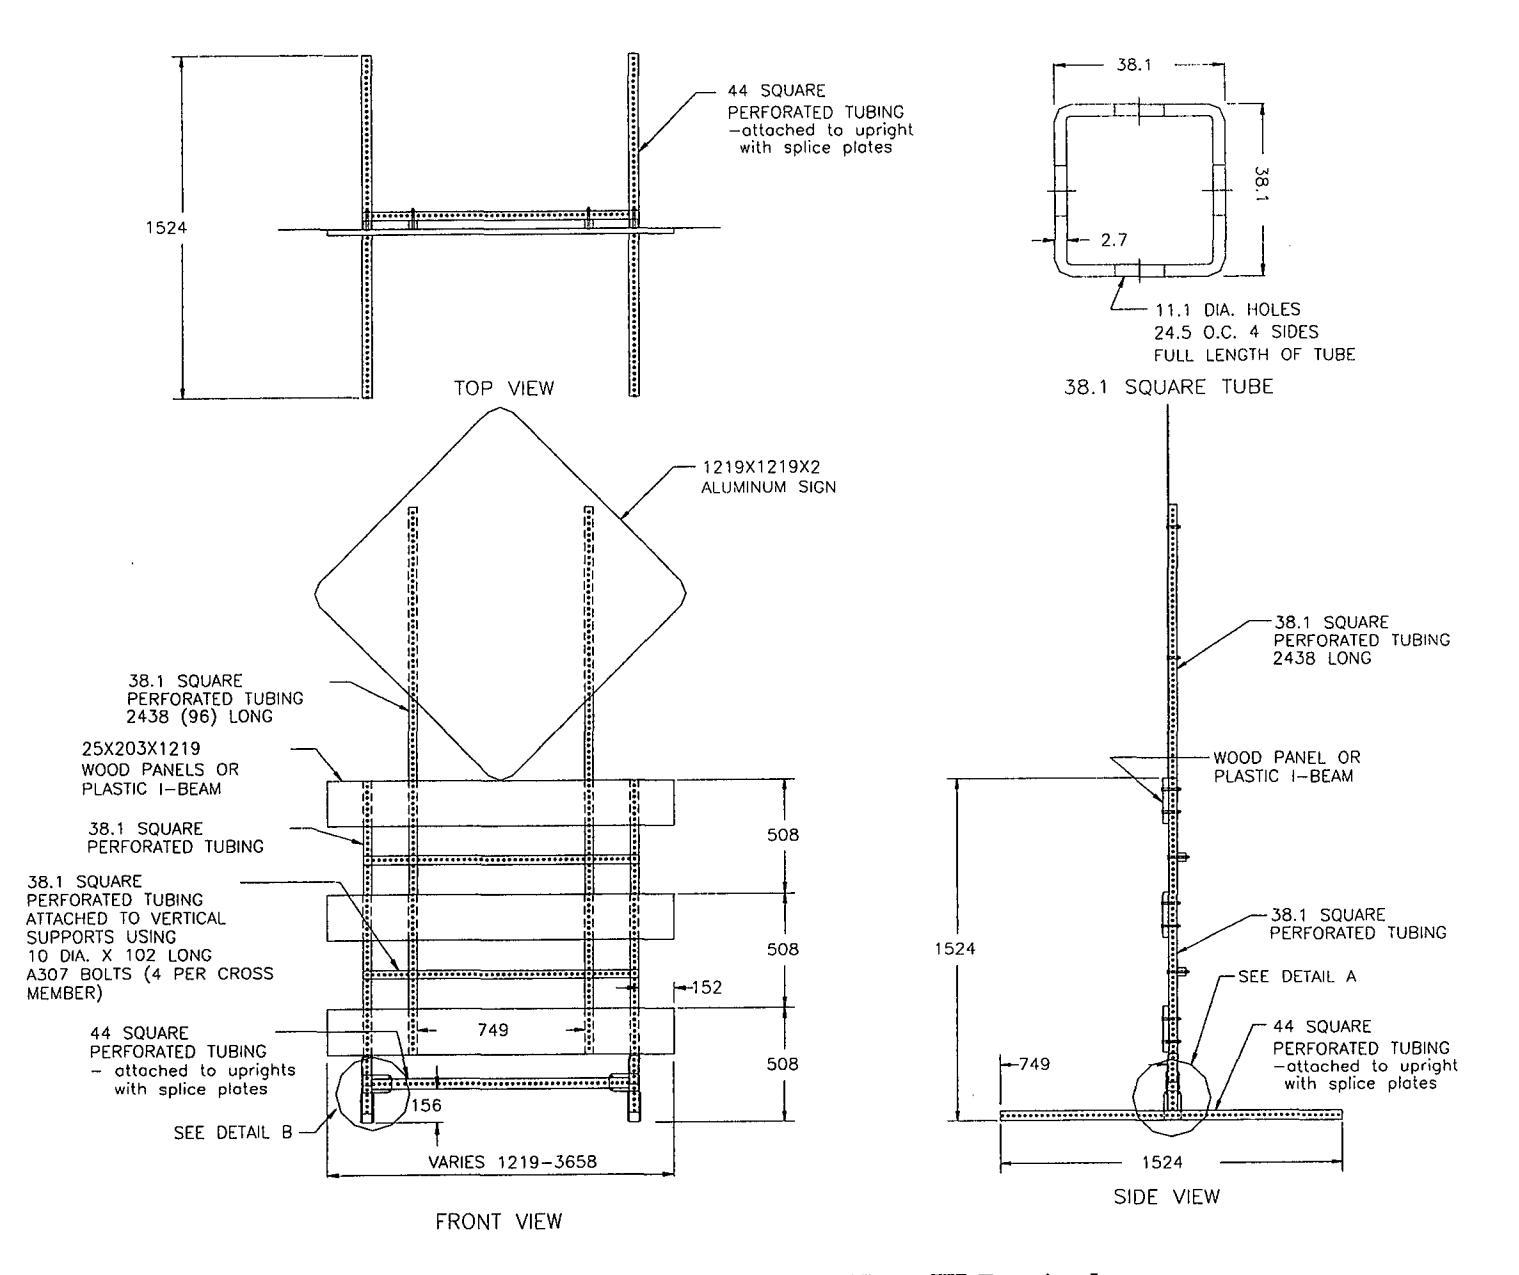
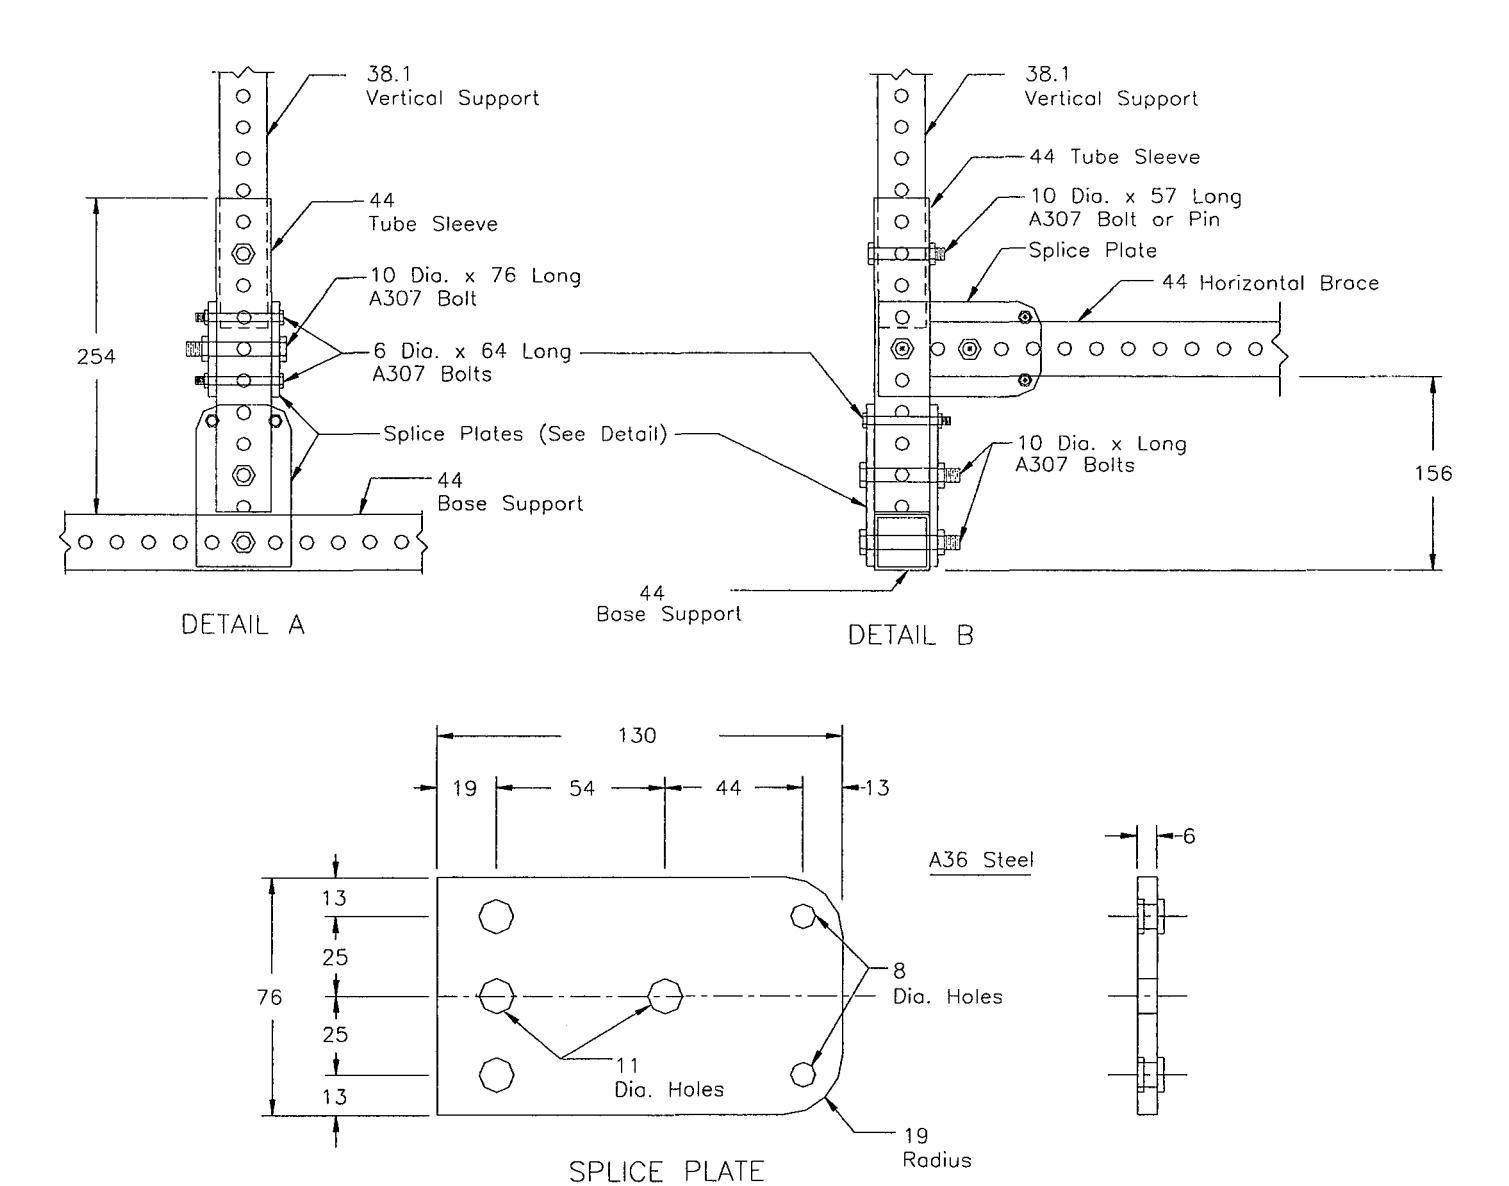
Figure 74. Perforated Steel Tube Type III Barricade with Sign Panel Attached to Perforated Tube Cross Members

The crash test with the second sign attachment alternative (test no. 453880-7) was successful. However, the fractured vertical supports, the rail elements and the sign panel stayed as a single unit and was thrown forward by the impacting vehicle, raising concern that this may pose a hazard to adjacent traffic and workers in the area. After consultation with TxDOT, it was decided that this sign attachment mechanism is not desirable and should not be considered for implementation.

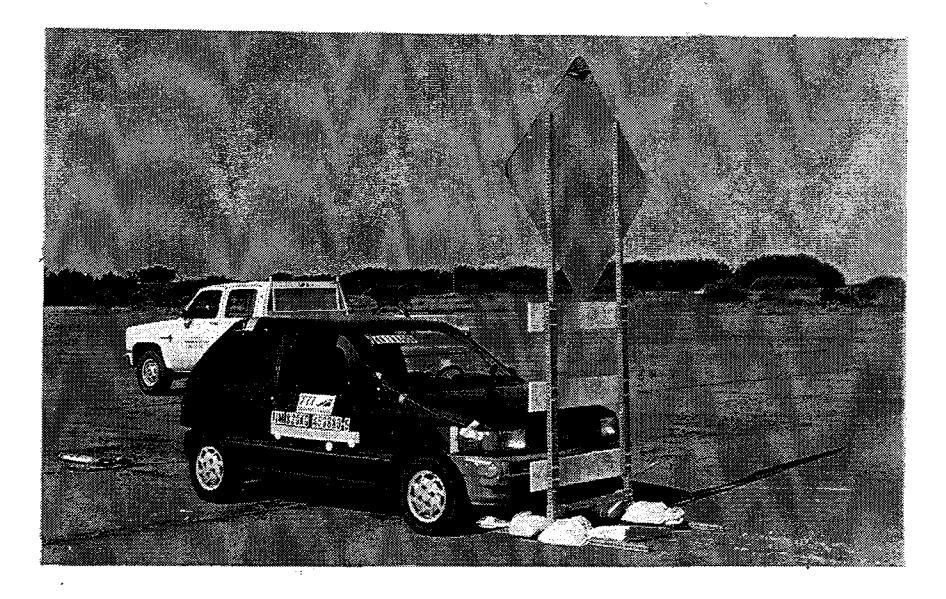
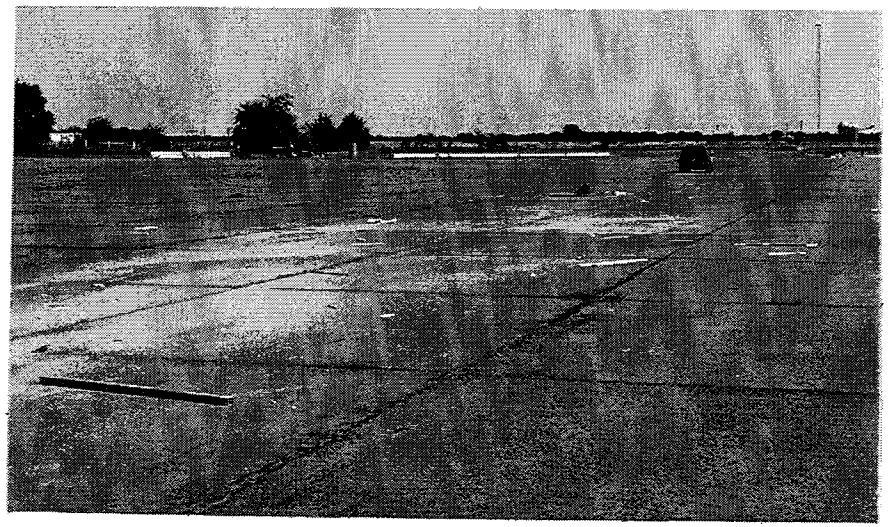
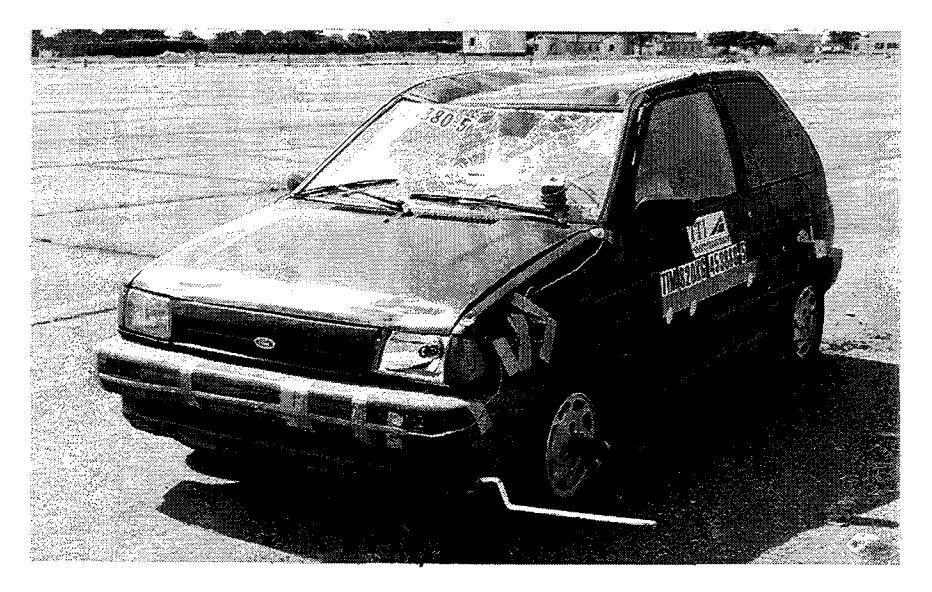
Figure 77. Vehicle and Barricade for Test No. 453880-5

As Figure 77 shows, the barricade and the sign attachment shattered upon impact. Debris and sand were strewn along the path of the vehicle in an area 14.6 m wide and 90.5 m long. Figure 77 also shows damage to the vehicle. There was damage to the hood, roof, and left headlight, but the damage was limited to minor scrapes. The windshield was shattered and deformed into the occupant compartment 51 mm.

Figure 79 presents a brief summary of the results of this test. The barricade and sign panel attachment mechanism shattered upon impact. The bottom corner of the sign panel contacted and shattered the windshield and deformed the windshield into the occupant compartment by 51 mm,

but did not penetrate the occupant compartment. Debris from the barricade was thrown along an area 14.6 m wide and 90.5 m long. Most fragments were not large enough to pose potential hazard to oncoming traffic in adjacent lanes or to construction workers in the area. The vehicle sustained minor damage and a shattered windshield. The longitudinal occupant impact velocity was 2.3 m/s, and the highest 10-msec average ridedown acceleration was 0.3 g. There was no contact in the lateral direction. The 50-msec average accelerations were -3.8 g in the longitudinal direction and 1.7 g in the lateral direction. The vehicle exited the immediate test site in a relatively smooth, stable manner and showed no potential for intrusion into adjacent traffic lanes. This crash test was judged to be unsatisfactory due to shattering and deformation of the windshield from contact with the bottom corner of the sign panel. The bending or folding of the bottom corner of the sign panel could potentially be prevented by either providing additional vertical bracing behind the sign panel or lowering the mounting height of the sign panel and bolting the bottom corner of the aluminum panel to the top wooden rail element. With either of these modifications, it is the opinion of the researchers that this sign attachment design would perform satisfactorily for a 1.52-m mounting height in accordance with the guidelines set forth in NCHRP Report 350. Also, based on the results of this test, as well as the test of the skid mounted sign support (Test No. 453360-3), it is the opinion of the researchers that the tested design (shown in Figure 76) will perform satisfactorily for a 2.13-m mounting height without modification. The 2.13-m mounting height should prevent contact of the sign blank with the windshield, thus eliminating the potential hazard associated with the bending or folding of the bottom of the sign panel during impact.

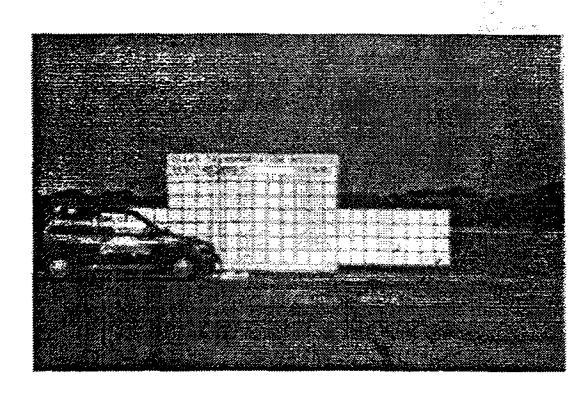
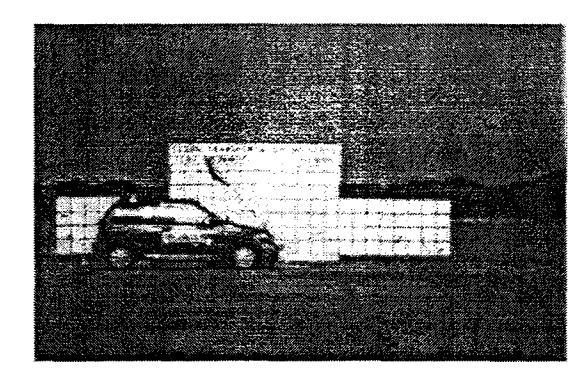
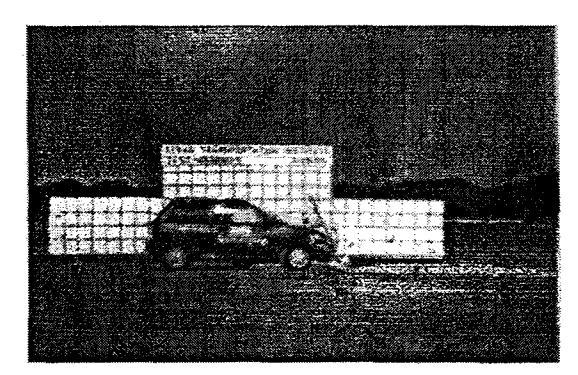
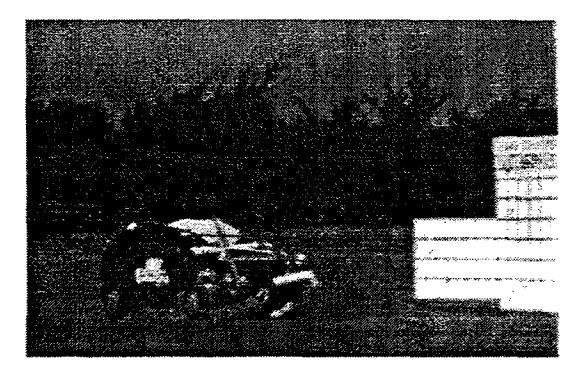
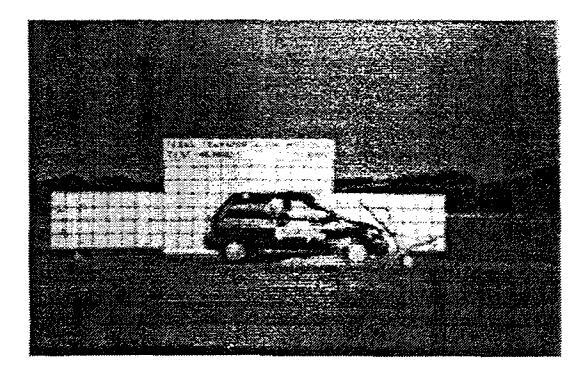
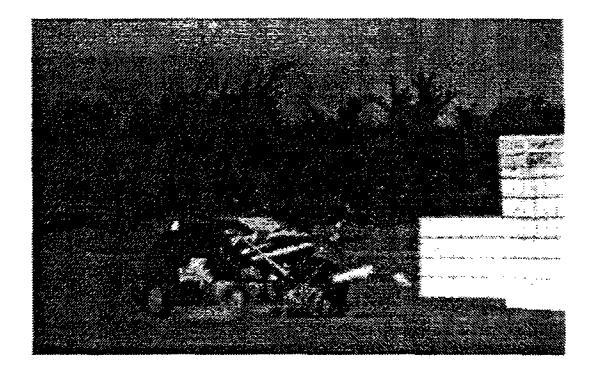
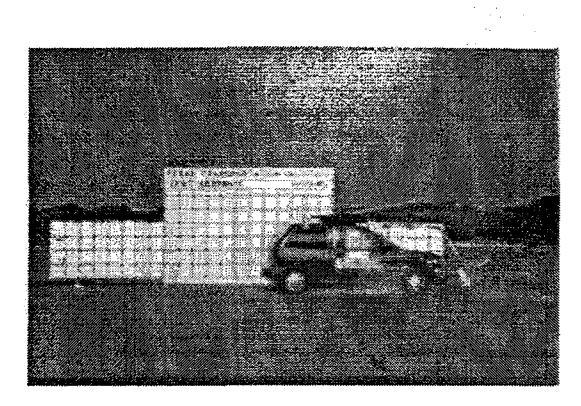
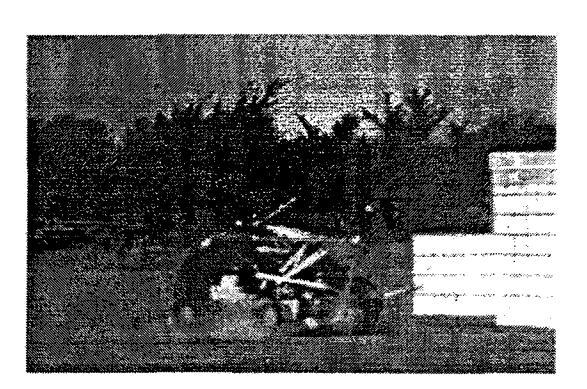
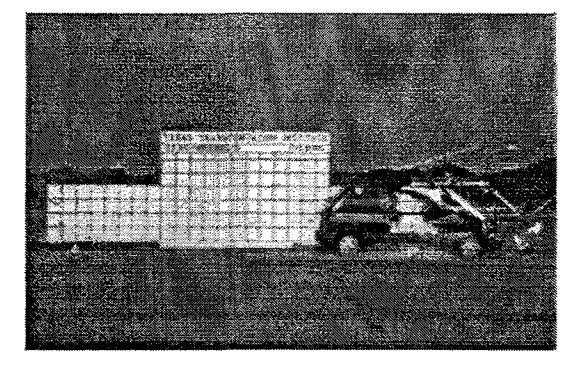
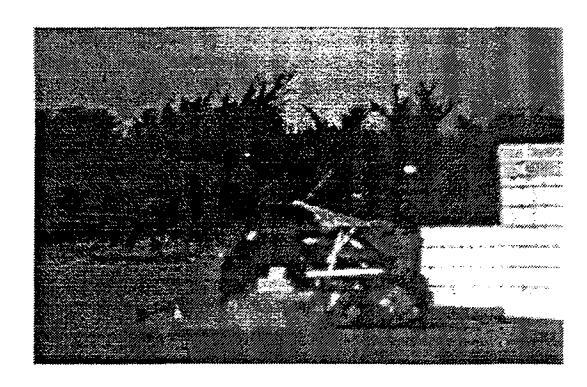
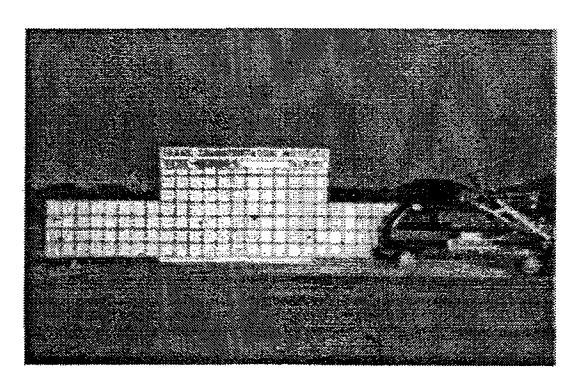
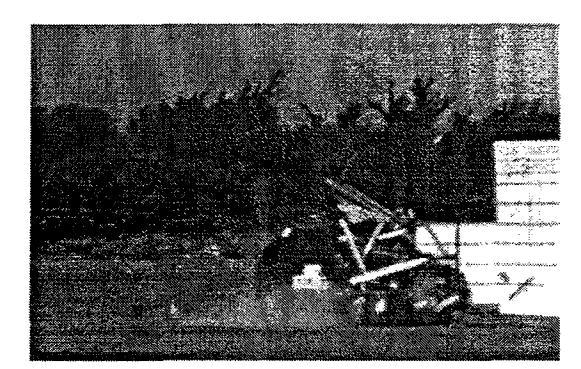
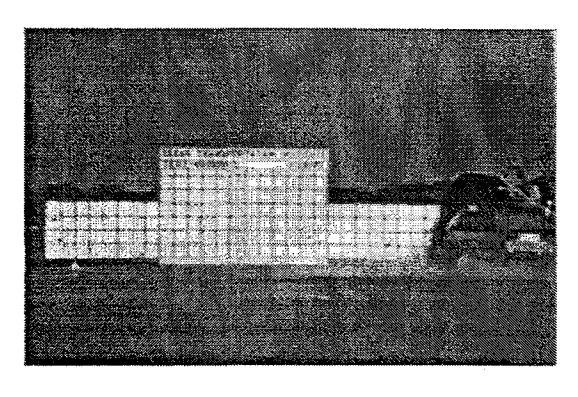
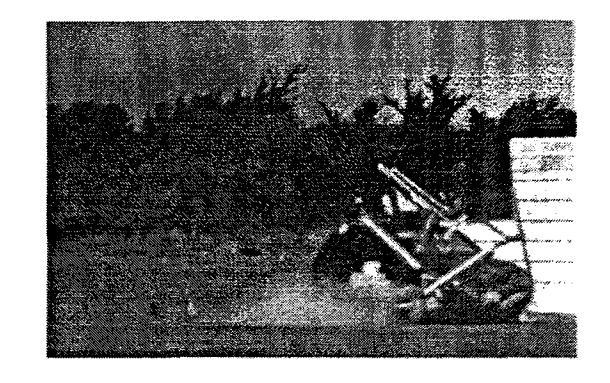
Figure 78. Sequential Photographs for Test No. 453880-5

As the vehicle impacted the barricade, the bottom rail element began to break and the vertical supports for the barricade began to bend. At 11 msec, the top and center rail elements began to break. At 24 msec, the right vertical support for the sign panel started to separate from the barricade. The right vertical support for the sign panel cleared the bumper and hood at 39 msec, and the left vertical supports for the sign panel and the barricade began to rise at 48 msec. The top of the sign panel contacted the roof at 71 msec. The bottom of the sign panel folded forward and subsequently contacted and penetrated the windshield at 97 msec. At 103 msec, the supports lost contact with the vehicle as it traveled at 86.9 km/h; however, the sign panel remained in contact with the roof. The left vertical support for the sign panel began to separate from the left vertical support of the barricade at 116 msec. At 258 msec, the right vertical support for the barricade began to separate from the base. Prior to brake application, the vehicle was tracking straightforward. The vehicle subsequently came to rest 78 m down and 3.2 m to the right of the point of impact. Figure 78 shows sequential photographs of the test period.

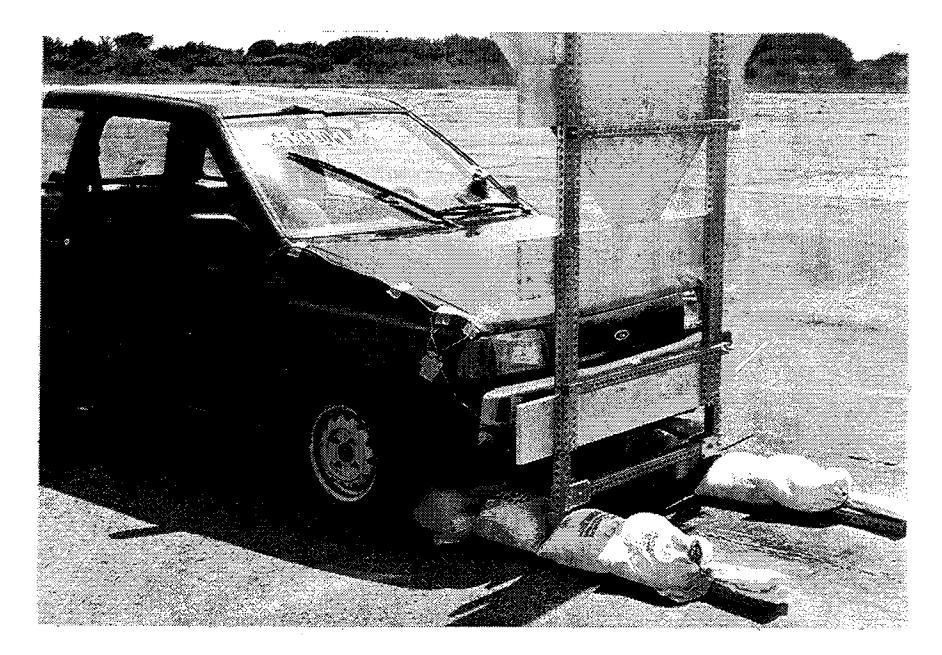
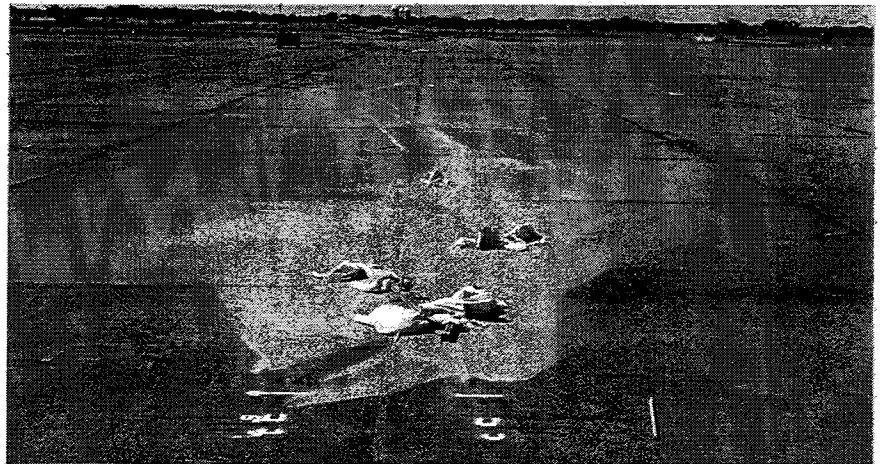
Figure 81. Vehicle and Barricade for Test No. 453880-7

As Figure 81 shows, the vertical supports and the sign attachment separated from the barricade upon impact. Debris and sand were strewn along the path of the vehicle in an area 15.2 m wide and 87.8 m long. Damage to the vehicle is also shown in Figure 81. Maximum crush to the front exterior of the vehicle was not measurable (scrapes only). There was damage to the hood and roof. The windshield was shattered, and the roof was deformed 41mm into the occupant compartment.

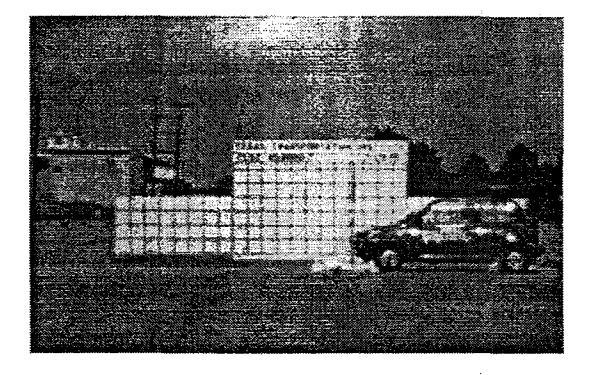
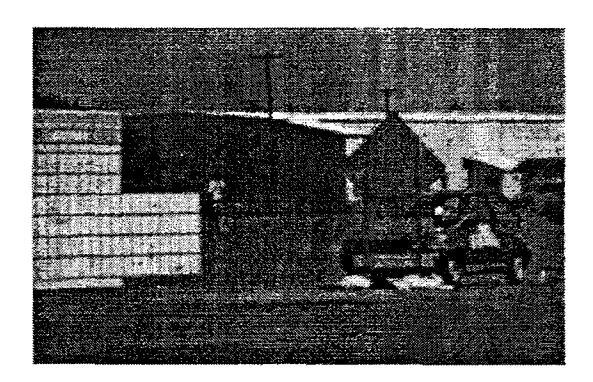
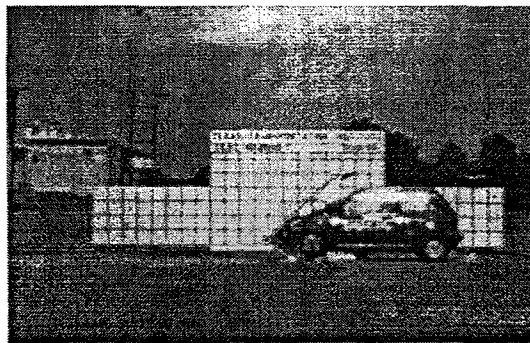
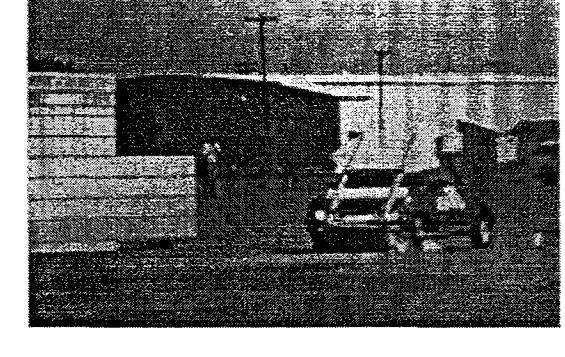
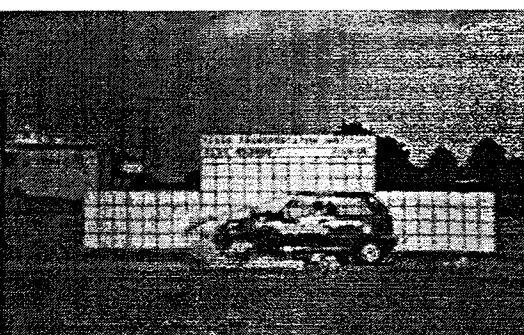
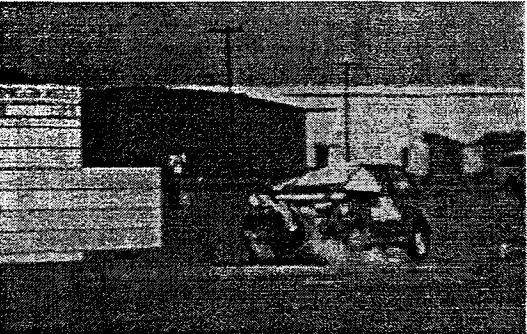
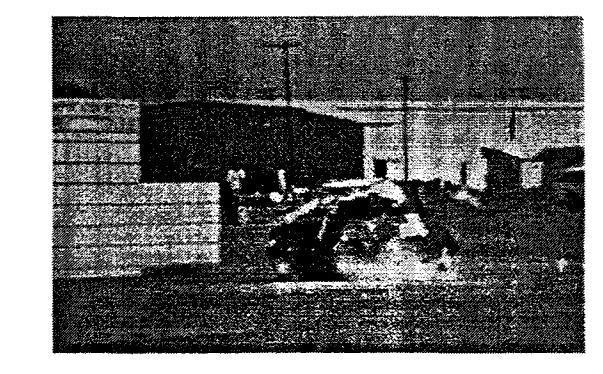
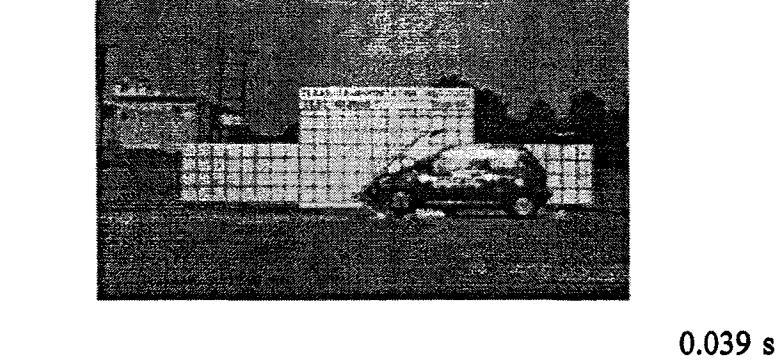
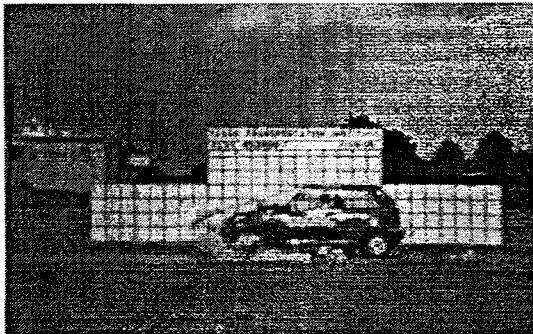
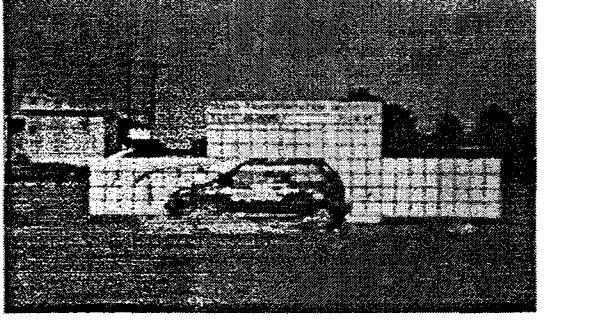
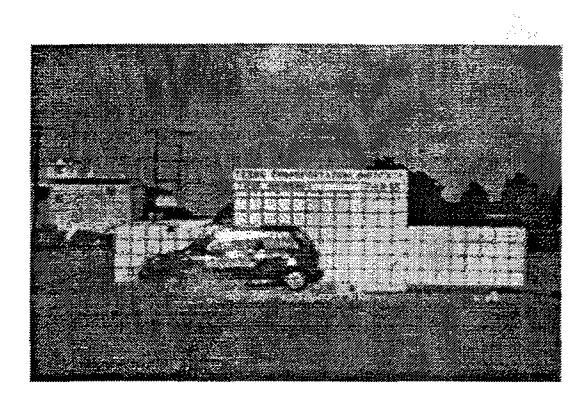
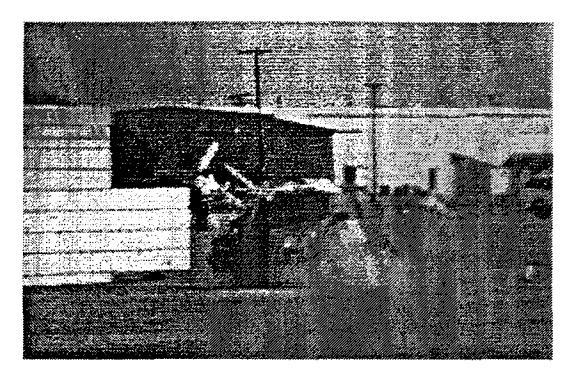
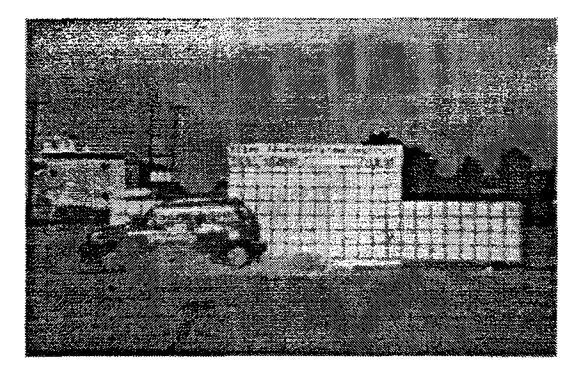
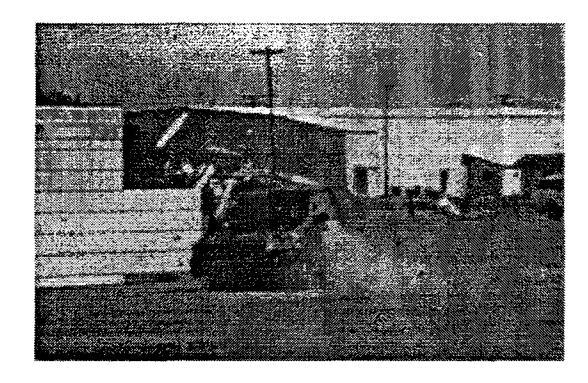
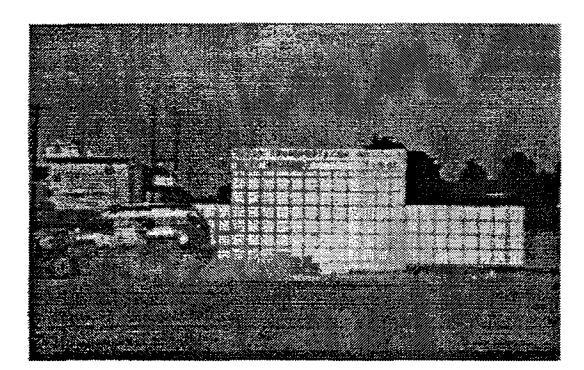
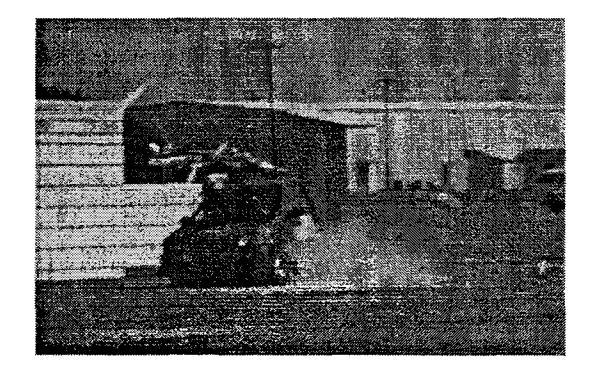
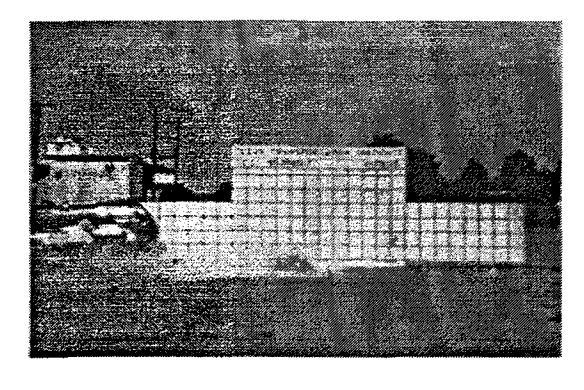
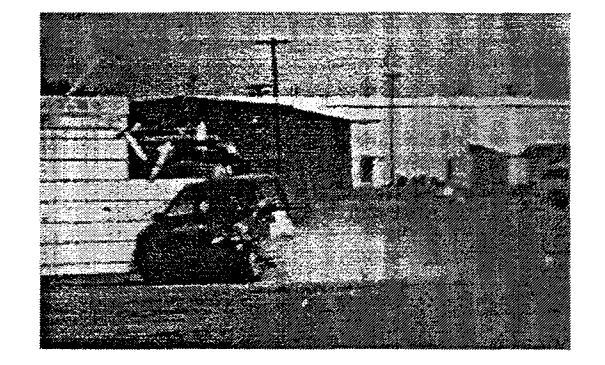
Figure 82. Sequential Photographs for Test No. 453880-7

As the vehicle impacted the barricade, the bottom panel began to break, and the vertical supports began to bend. At 39 msec, the bottom of the sign panel contacted the hood near the windshield. The supports lost contact with the bumper at 47 msec, and the sign panel contacted the windshield at 56 msec. At 130 msec, the sign panel lost contact with the windshield as the vehicle was traveling at 87.0 km/h, and the panel continued to travel in front of the vehicle. Prior to brake application, the vehicle was tracking straightforward. The vehicle subsequently came to rest 91 m down and 9.1 m to the right of the point of impact. Figure 82 shows sequential photographs of the test period.
