EVALUATION OF WORK ZONE BARRICADES AND TEMPORARY SIGN SUPPORTS

Report No. 5388-1F Research Study No. 585xxA3014 Research Study Title: Development of New Designs for Barricades and Sign Supports in Work Zones

> Sponsored by the Texas Department of Transportation

> > February 1996

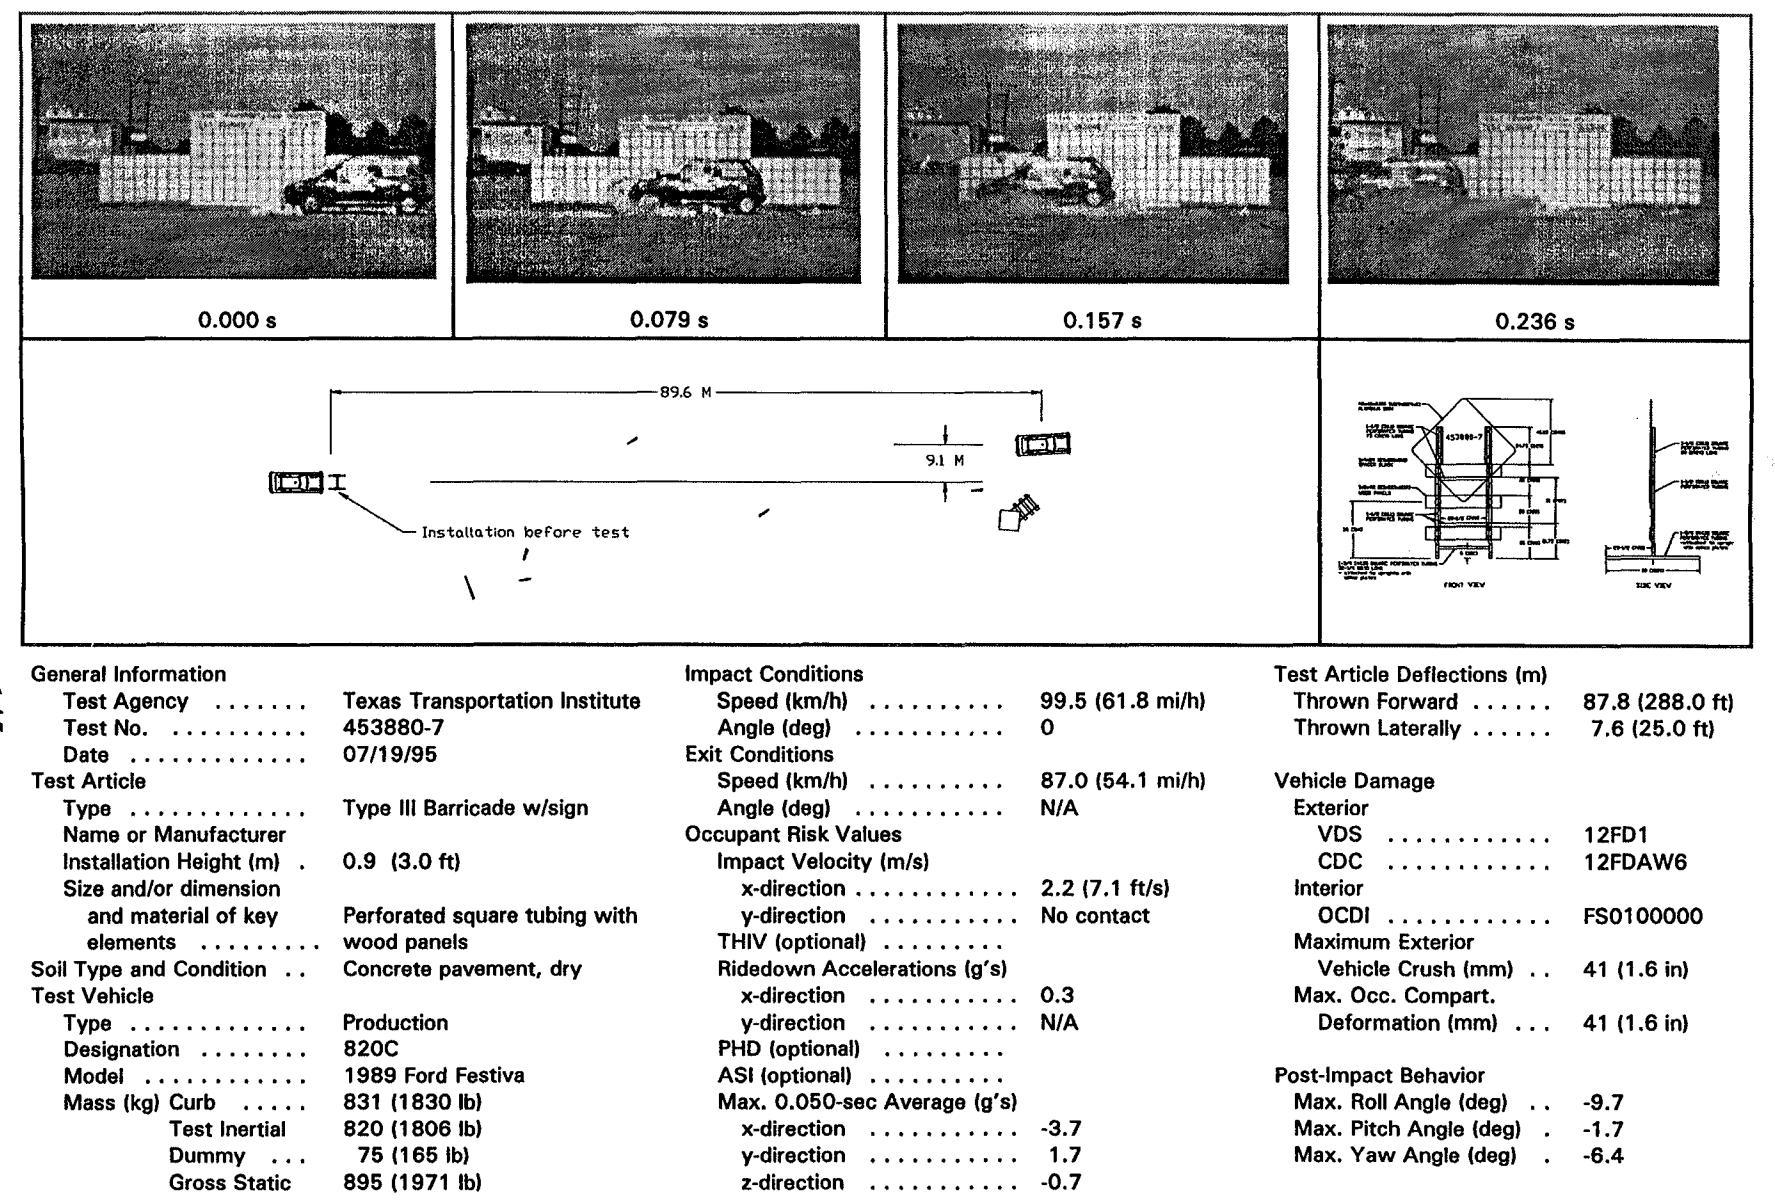
Figure 83. Summary of Results for Test No. 453880-7

Figure 83 presents a brief summary of the results of this test. The vertical supports and the sign panel attachment separated from the barricade upon impact. Broken segments of the barricade made contact with the hood and shattered the windshield and deformed the roof into the occupant compartment by 41 mm, but there was no penetration into the occupant compartment. Debris from the barricade was thrown along an area 15.2 m wide and 87.8 m long. The barricade vertical supports and the sign panel attachment were carried forward by the vehicle as a single unit, and it could pose potential hazard to oncoming traffic in adjacent lanes or to workers in the area, although it remained mostly in the path of the vehicle. The vehicle sustained minor damage to the hood and roof; however, the windshield was shattered. Crush to the center front bumper was not measurable. The longitudinal occupant impact velocity was 2.2 m/s, and the highest 10-msec average ridedown acceleration was 0.3 g. There was no contact in the lateral direction. The 50-msec average accelerations were -3.7 g in the longitudinal direction and 1.7 g in the lateral direction. The vehicle exited the immediate test site in a relatively smooth, stable manner and showed no potential for intrusion into adjacent traffic lanes. This crash test was judged to be successful; however, due to the potential hazard associated with the barricade vertical supports and sign panel attachment being carried forward as a single unit by the impacting vehicle, this sign panel attachment mechanism is not recommended for implementation.

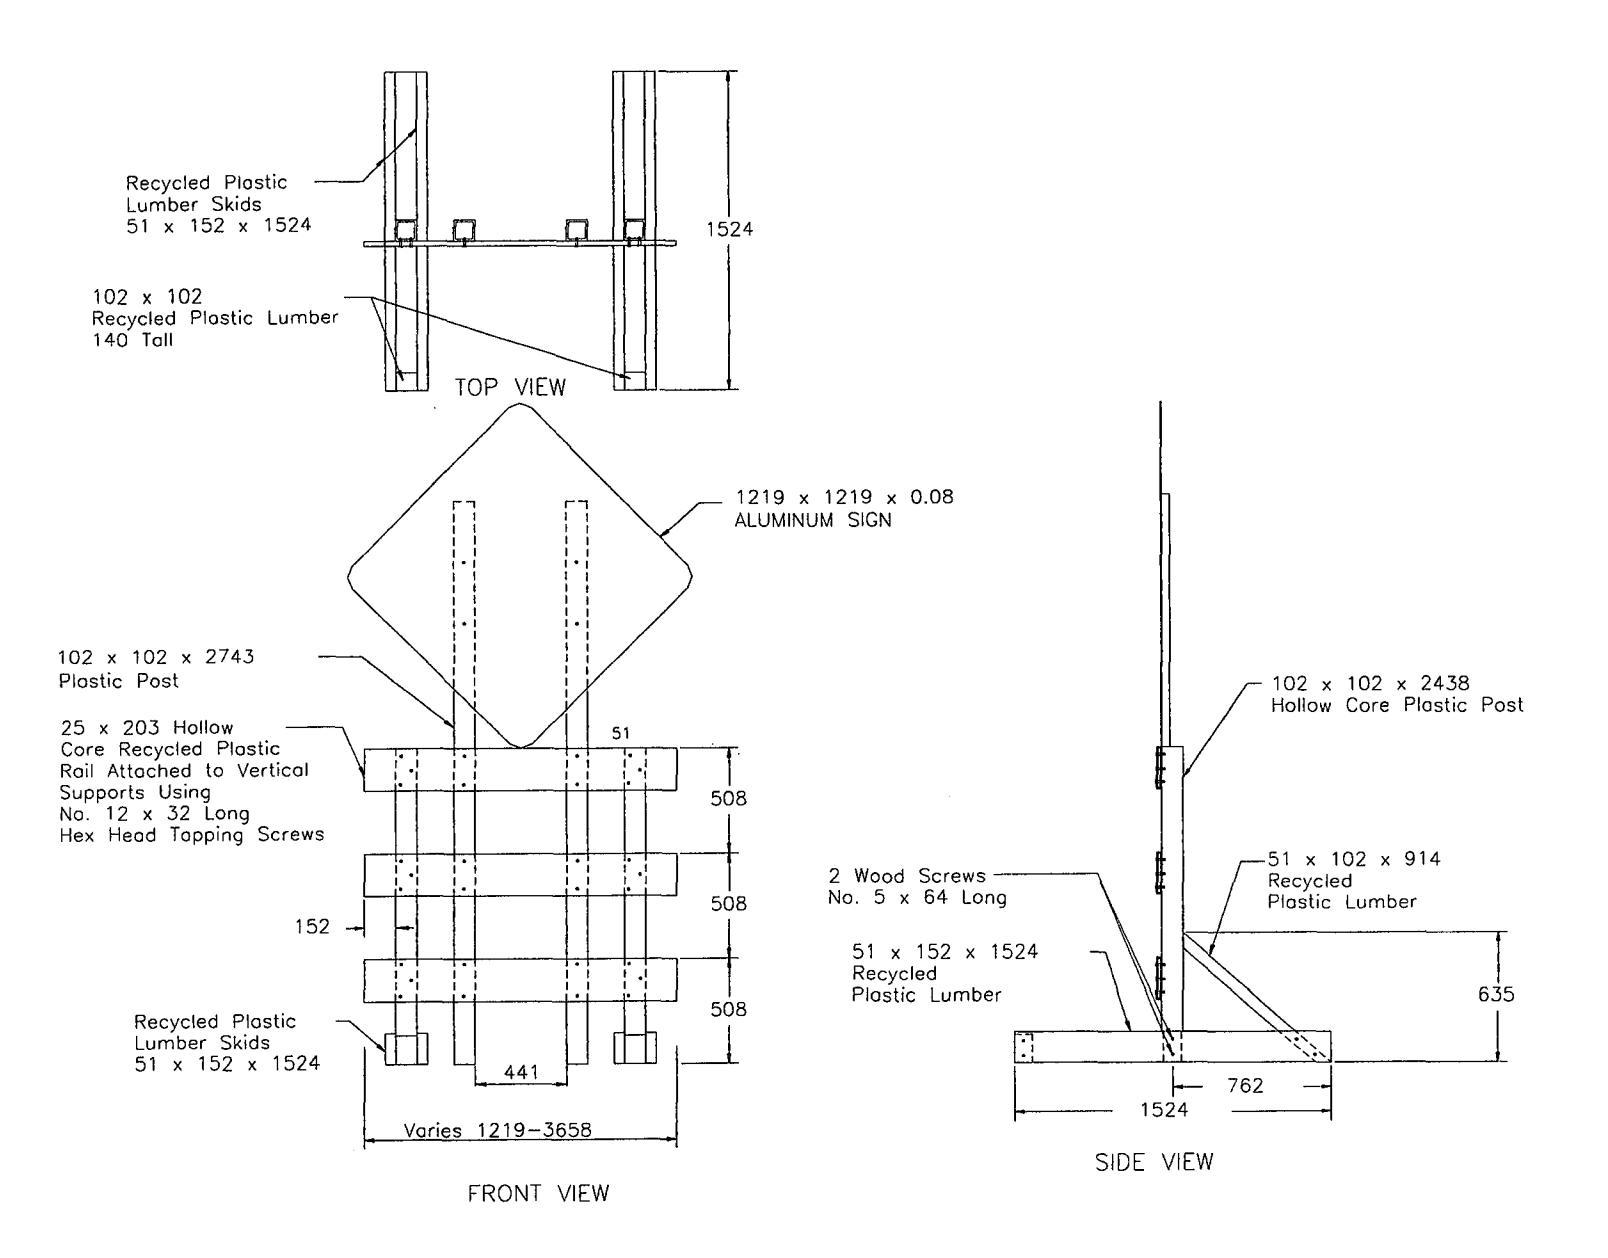
Figure 84. Schematic of Type III Barricade Fabricated from Hollow Core Recycled Plastic Material with Solid Recycled Base and Sign Panel (Test No. 453880-6)

It was observed in the high-speed film that the bottom corner of the aluminum sign panel bent and folded in a manner similar to that observed in a previous test with the perforated tubing using the same 1.52-m mounting height (test no. 453880-5). Therefore, although no intrusion into the occupant compartment was observed in this test, it is the opinion of the researchers that the potential for the corner of the sign panel shattering and penetrating the windshield should be addressed. As with the perforated tubing design, two options are available for eliminating this behavior:

The simpler and more economical of the two modifications is to lower the mounting height by 51 mm and to attach it to the horizontal cross member, as shown in Figure 84. In the opinion of the researchers, modification of the existing hollow core recycled plastic barricade design is not necessary for a 2.13-m mounting height, since the sign panel should not contact the windshield of the impacting vehicle.

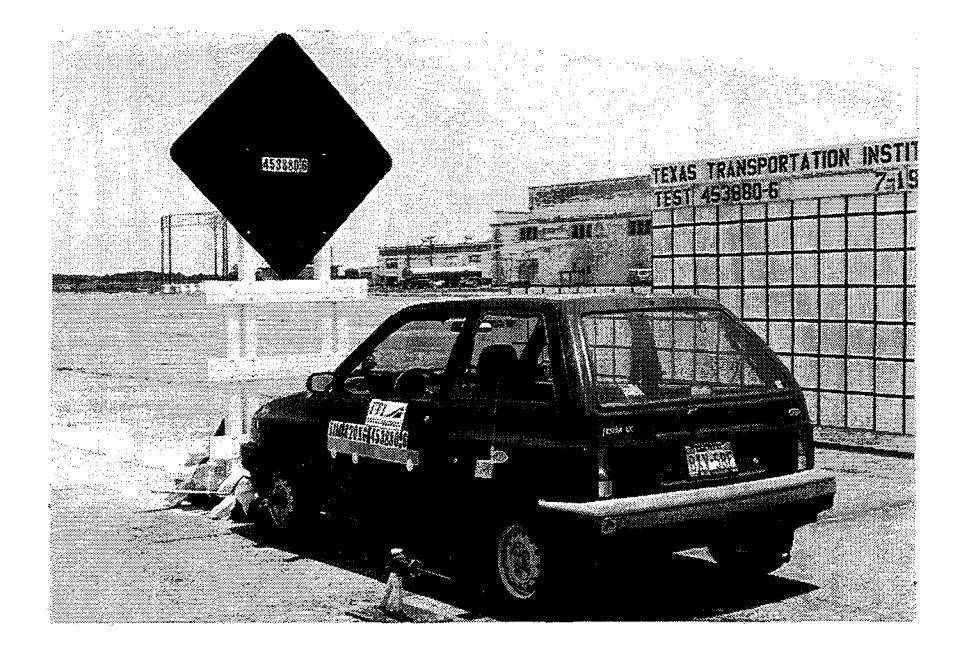
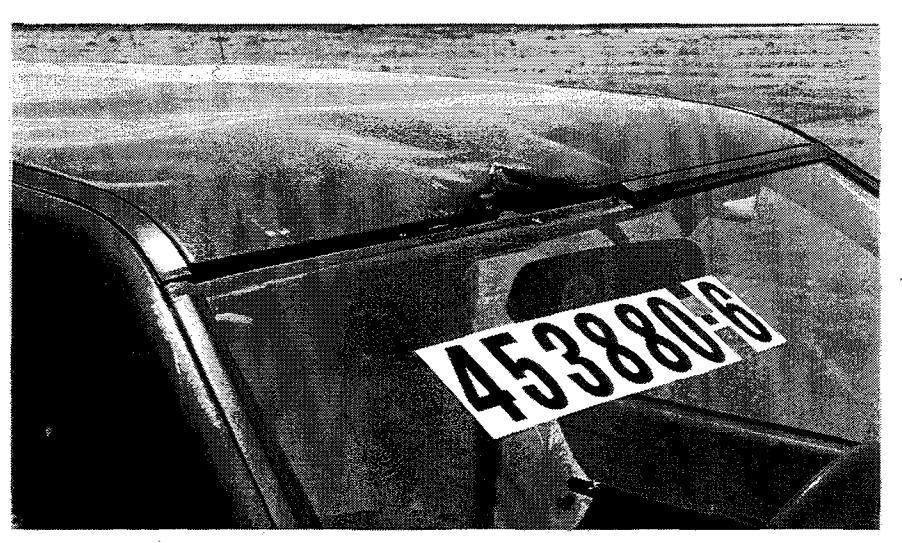
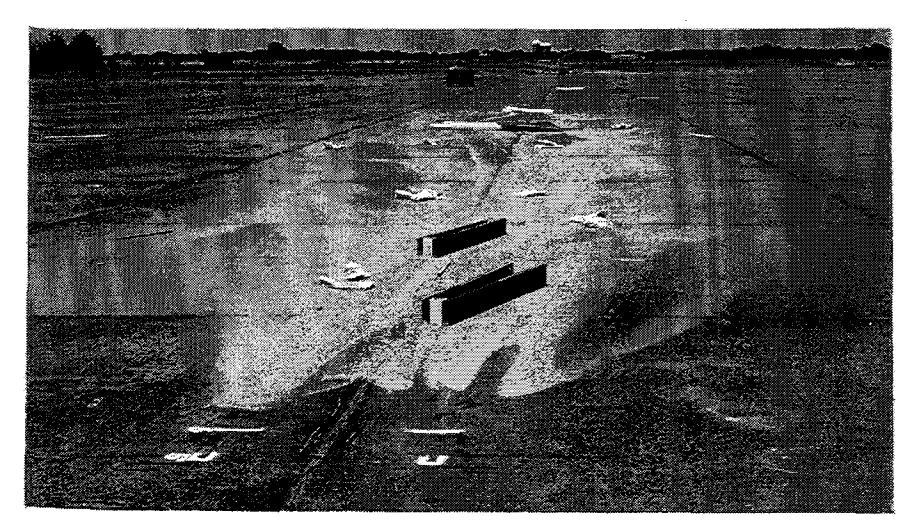
Figure 85. Vehicle and Barricade for Test No. 453880-6

As Figure 85 shows, the barricade shattered upon impact. Debris and sand were strewn along the path of the vehicle in an area 13.0 m wide and 83.2 m long. Figure 85 shows damage to the vehicle. Maximum crush to the exterior of the vehicle was 70 mm on the passenger side just above the windshield. There was scrapes on the hood and roof. There was no deformation or intrusion into the occupant compartment.

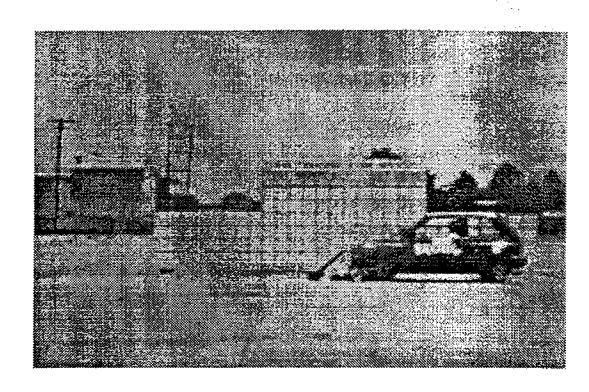
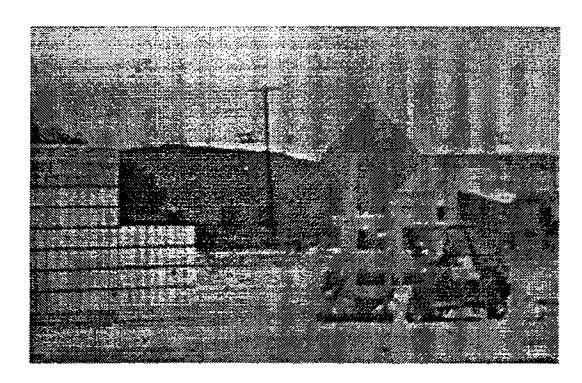
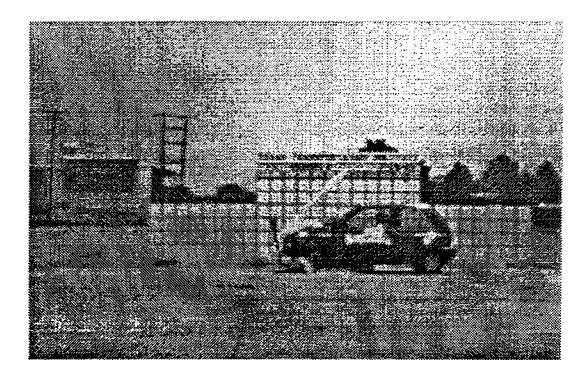
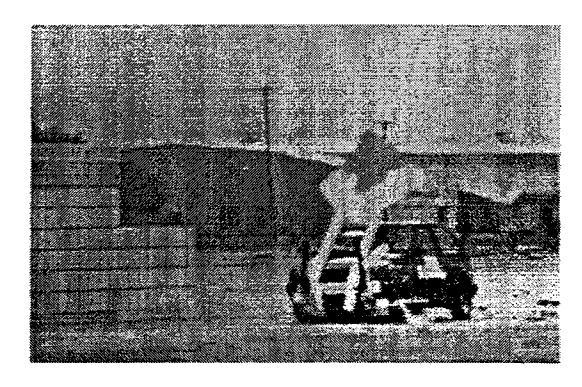
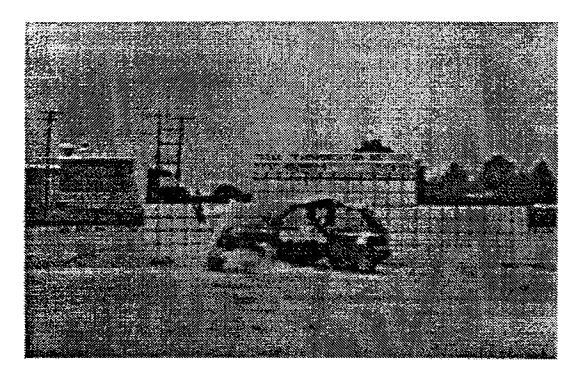
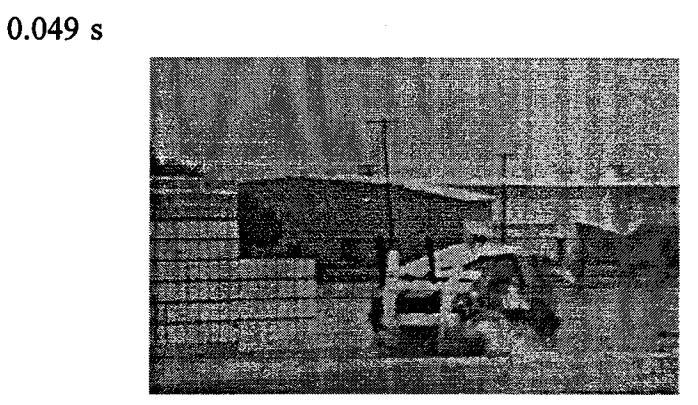
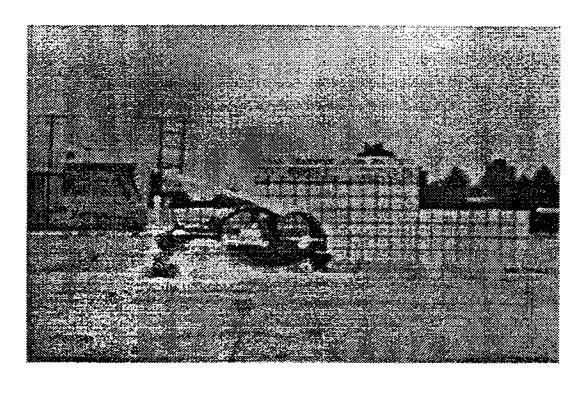
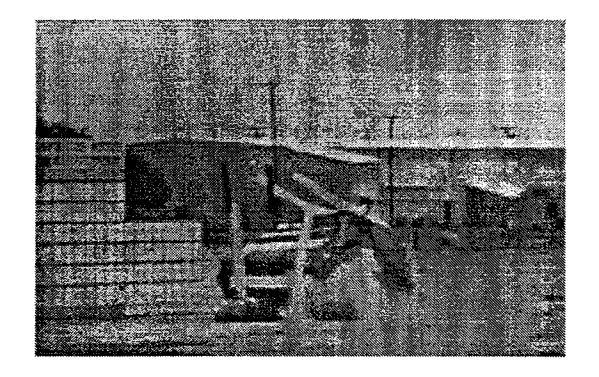
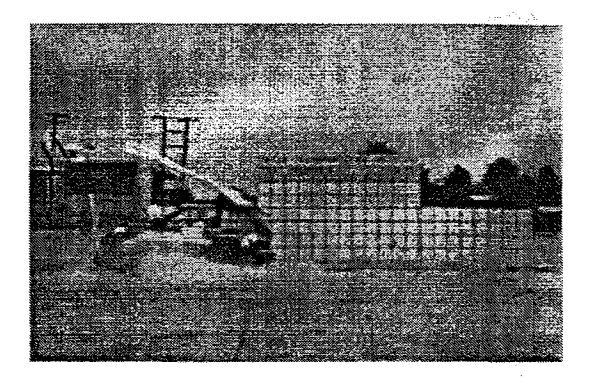
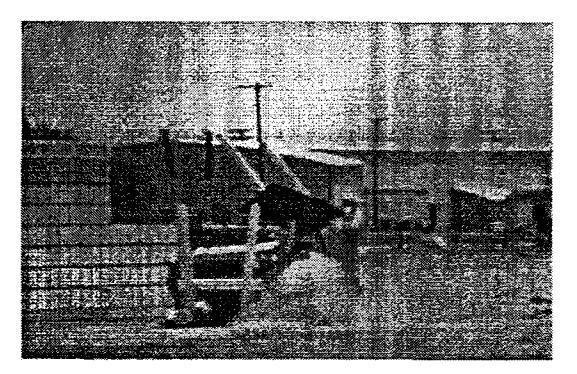
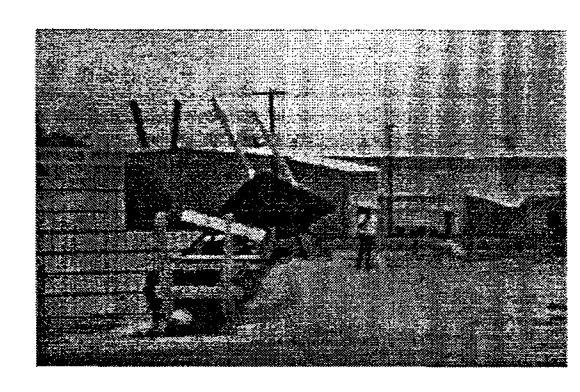
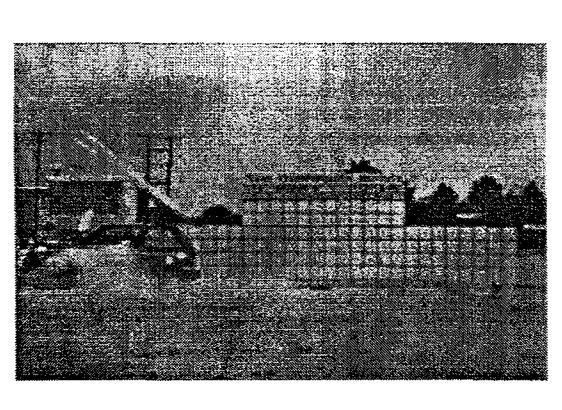
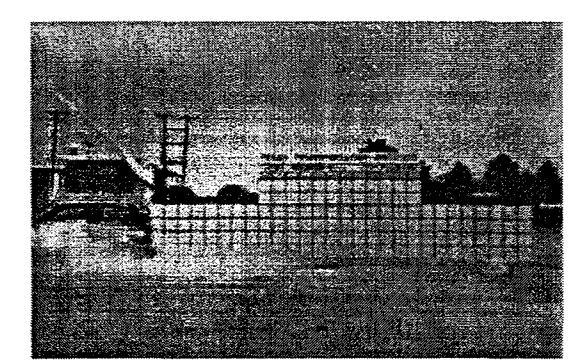
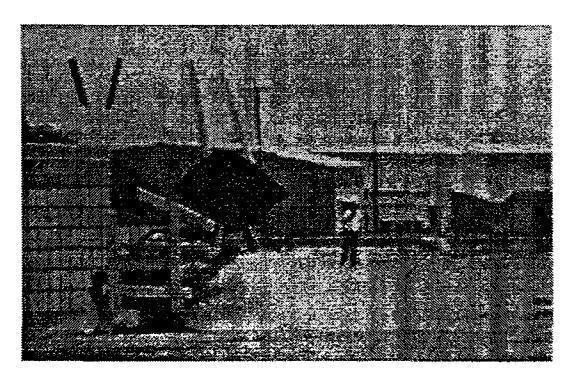
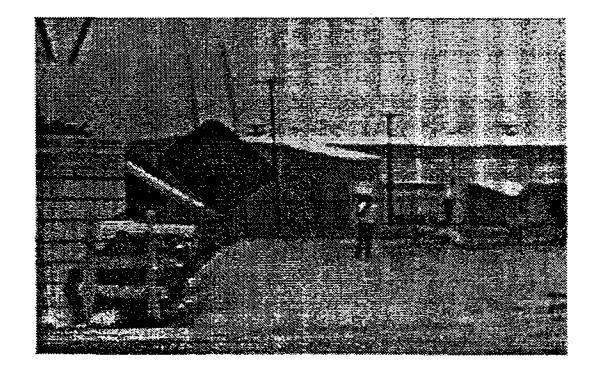
Figure 86. Sequential Photographs for Test No. 453880-6

As the vehicle impacted the barricade, the base began to separate from the vertical supports, and at 34 msec, the vertical supports slapped the hood. At 49 msec, the vertical supports began to pitch up, and at 89 msec, the sign panel contacted the windshield. The braces separated from the supports at 101 msec. At 126 msec, the sign panel contacted the roof, and the vertical supports for the sign panel separated from those for the barricade. The braces

separated from the base at 152 msec. The vehicle lost contact with the barricade at 199 msec, traveling at a speed of 87.2 km/h. Prior to brake application, the vehicle was tracking straightforward. The vehicle subsequently came to rest 80 m down and 5.7 m to the right of the point of impact. Figure 86 shows sequential photographs of the test period.
