# **Evaluation of Bridge Decks Using Non-Destructive Evaluation (NDE) at Near Highway Speeds for Effective Asset Management – Implementation for Routine Inspection (Phase III)**

**Element Level Condition State Assessment,  
Comparison to Traditional Methods, and Cost and  
Time Comparison Analysis mini reports**

October 09, 2018

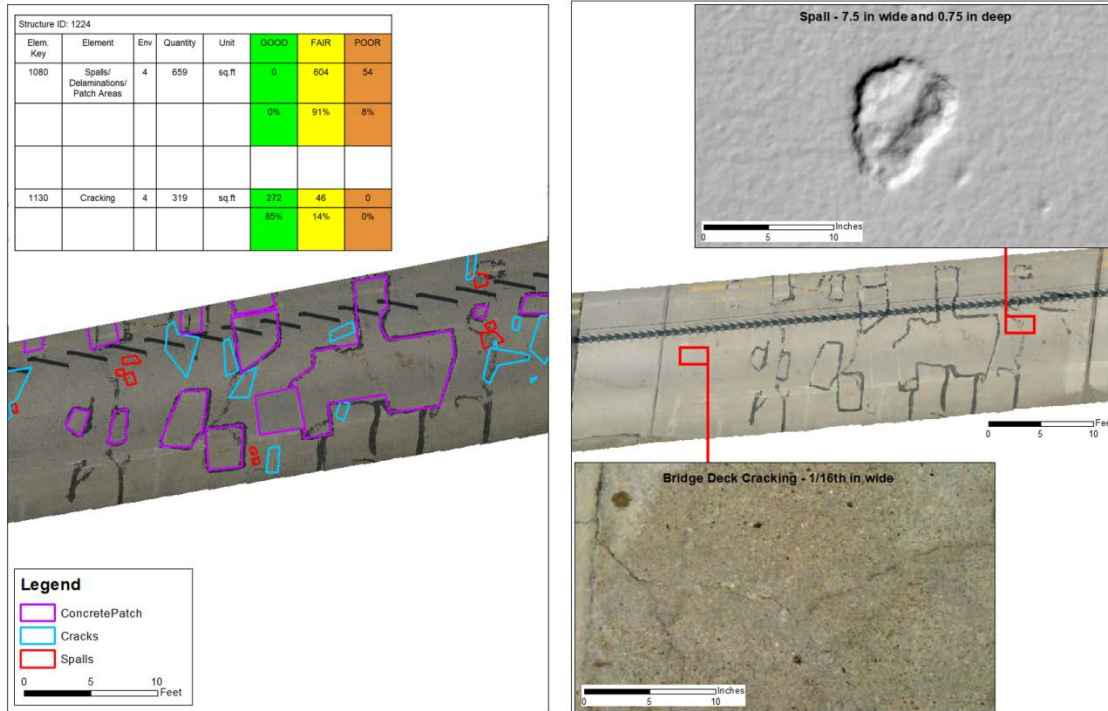
**Figure 14. An example of the high resolution image mosaic and DEM resulting from 3DBOS (Right). The left side of the figure shows the results of the defect digitizing of the image mosaic along with the resulting element level condition state table.**

The data collected for 3DOBS was processed into high resolution mosaicked images of bridges decks (~ 1/64<sup>th</sup> in) and a high resolution DEM (~ 1/16<sup>th</sup> in) which can be used for detailed assessments similar to a bridge scoping (Figure 14). This is a significant advantage for inspectors to track defect changes over time for asset management as objective measurements can be taken of cracks, spall, and patching. Another advantage is not having to close lanes on the bridge to collect this data which reduces the impact to motorists.
