MASH TEST 3-11 EVALUATION OF MODIFIED TxDOT ROUND WOOD POST GUARDRAIL SYSTEM

Test Report 0-6968-R4

Report 0-6968-R4
Project 0-6968

Project Title: Roadside Safety Device Analysis, Testing, and Evaluation Program

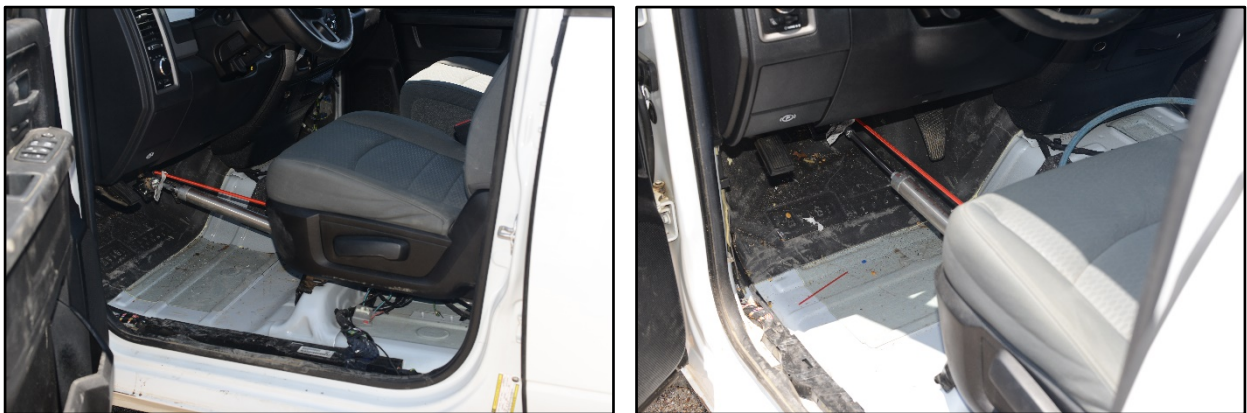
Figure 5.4 shows the damage sustained by the vehicle. The front bumper, hood, grill, left headlight, left front fender, left front tire and rim, left front lower A-arm, and left front door were damaged. Maximum exterior crush to the vehicle was 11.0 inches in the horizontal at bumper height. No measurable occupant compartment deformation occurred. Figure 5.5 shows the interior of the vehicle.

Before Test

After Test

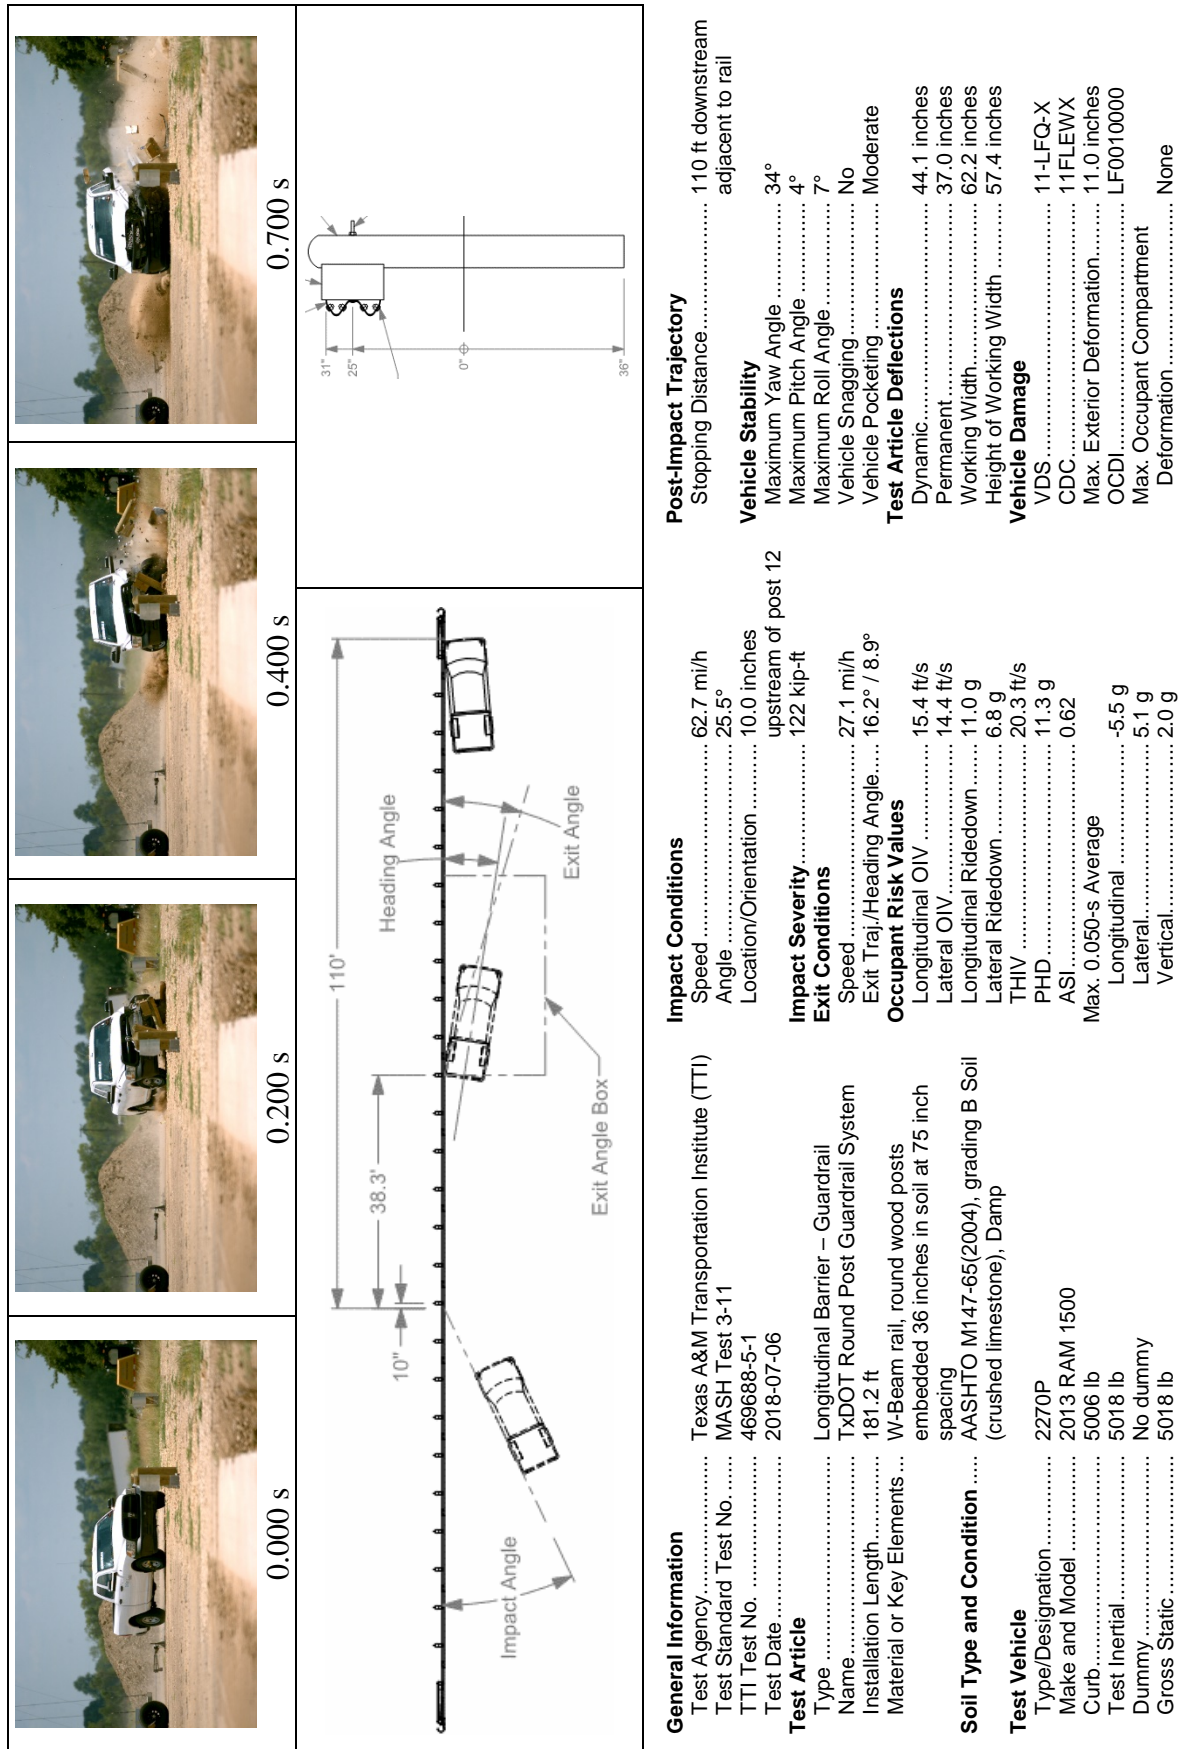
Figure 5.6. Summary of Results for MASH Test 3-11 on 31-inch Tall TxDOT Round Post Guardrail System.

Occupant Risk Factor	Value		Time
Occupant Impact Velocity (OIV) Longitudinal Lateral	m/s	ft/s	at 0.1540 seconds on left side of interior
	4.7	15.4	
	-4.4	-14.4	
Occupant Ridedown Accelerations (G's) Longitudinal Lateral			
	-11		(0.5048–0.5148 seconds)
	6.8		(0.2480–0.2580 seconds)
Theoretical Head Impact Velocity (THIV)	km/h	mi/h	at 0.1466 seconds on left side of interior
	22.2	13.8	
	m/s	ft/s	
	6.2	20.3	
Post Head Deceleration (PHD) (G's)	11.3		(0.5050–0.5150 seconds)
Acceleration Severity Index (ASI)	0.6		(0.2579–0.3079 seconds)
Maximum 50-ms Moving Average (G's) Longitudinal Lateral Vertical			
	-5.5		(0.4653–0.5153 seconds)
	5.1		(0.2340–0.2840 seconds)
	2		(0.2767–0.3267 seconds)
Maximum Roll, Pitch, and Yaw Angles Roll Pitch Yaw	Degrees		
	7.4		(0.2920 seconds)
	4.3		(0.8174 seconds)
	33.9		(1.0510 seconds)
