**POST-WINTER EVALUATION REPORT**

**Detectable Warning Devices (Truncated Domes) for use by the Visually Impaired**

Location: Great Falls, 6<sup>th</sup> St. N. W.

Project No.: STPU 5201(11)

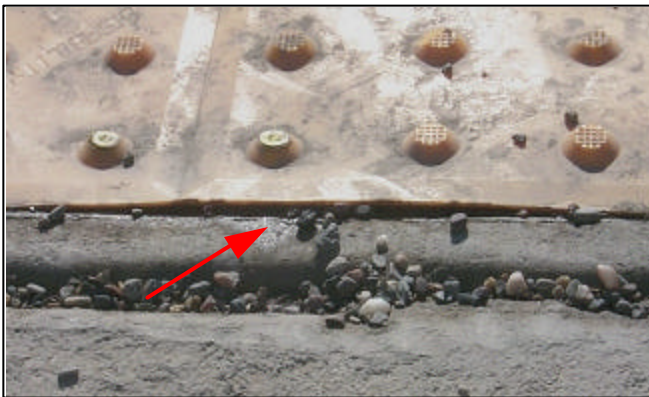
This treatment performed poorly since construction. Substantial amounts of domes have been sheared off through use of a shovel or blade apparatus when removing snow. The edges within the treatment and perimeter are beginning to loose adhesion. The setting pins are breaking off.

**Installation 2:** Close-ups of sheared domes and example image of edges losing adhesion.

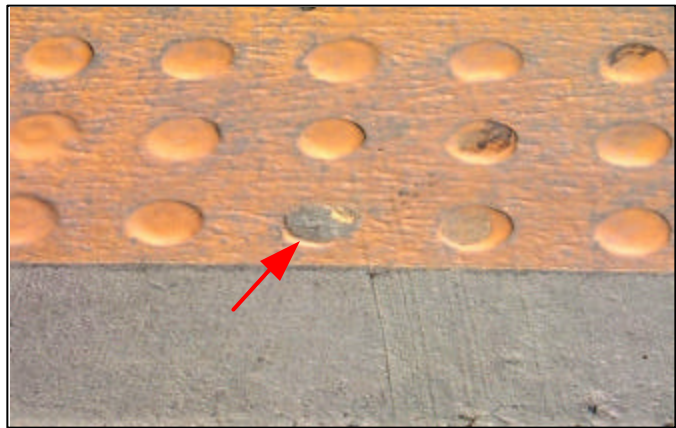
All installations were in fair condition at the time of inspection. Treatment 4A displayed no deterioration. Treatment 4B & 4C have cracked at the mortar sidewalk joint. Treatment 4C has lost one dome.

**Installation 4C:** Close-ups of cracked mortar joint and dome loss.
