Technical Assistance Report 18-04TA-P

**Submerged Road Characteristics and Distresses  
on LA 493, Natchitoches Parish, State Project Number H.011071**

Kevin Gaspard, P.E.  
Zhongjie Zhang, Ph.D., P.E.

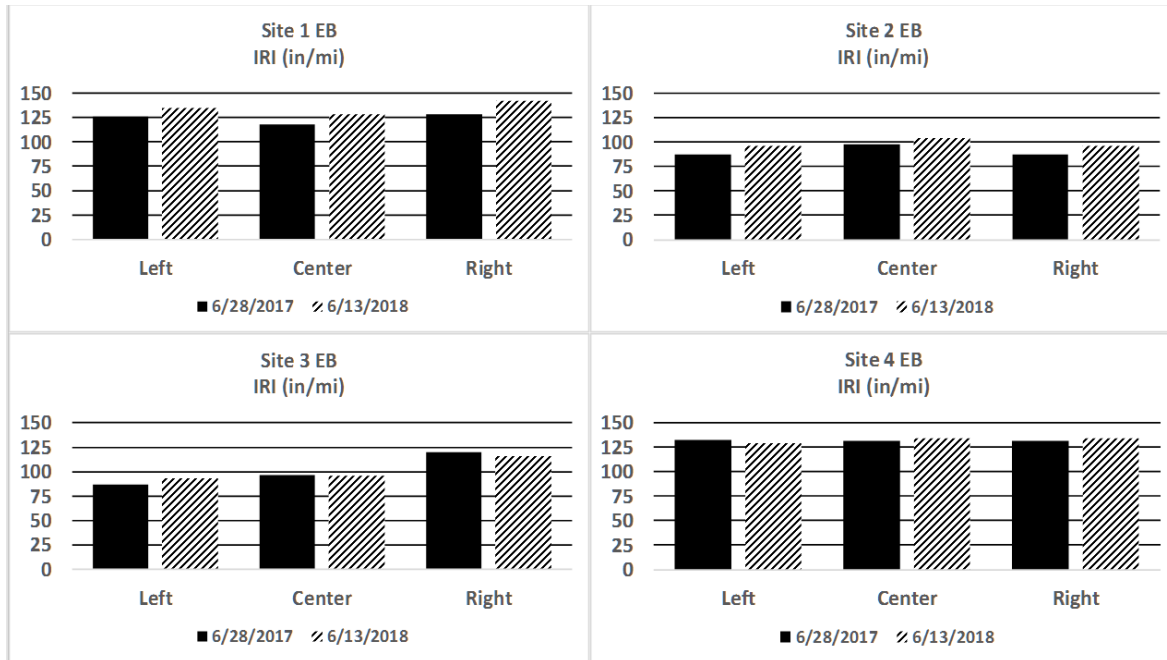
**Figure 26**  
**EB IRI for Sites 1 to 4**

The IRI measurements for the six sites are presented in Figures 26 and 27. Regarding the EB direction assessment, there was only approximately 300 ft. on roadway available for the vehicle to begin its assessment. Because of that, the profile data may not represent the conditions of the roadway surface for Site 1. The profile measurements on the remaining sites (2-6) should not have been affected. IRI values for all sites exceeded 75 on the June 2017 collection date indicating that the roadway is rougher than it should be for the amount of time that it has been in service.

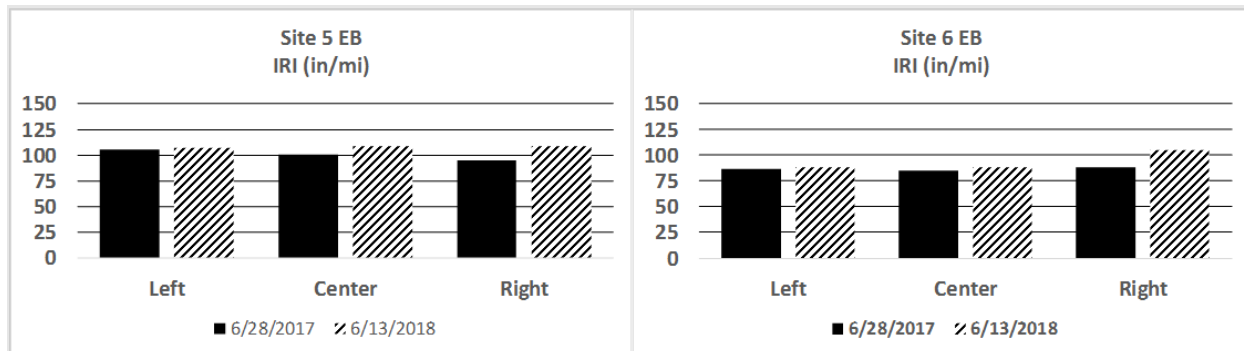
**Figure 27**  
**EB IRI for Sites 5 to 6**

Site 5 IRI values for the LWP were higher than both the CLP and RWP for the June 2017 collection date. On the June 2018 collection date the CLP IRI values were higher than the LWP and RWP. The IRI for the RWP value increased more than the CLP and LWP for the June 2018 collection date. The IRI values for the June 2018 collection date were larger than the June 2017 collection date.

For Site 6, the IRI values for the LWP and RWP were higher than the CLP for the June 2017 collection date. On the June 2018 collection date, the LWP and CLP had similar IRI values and both were less than the RWP. The IRI values for the June 2018 collection date were larger than the June 2017 collection date.

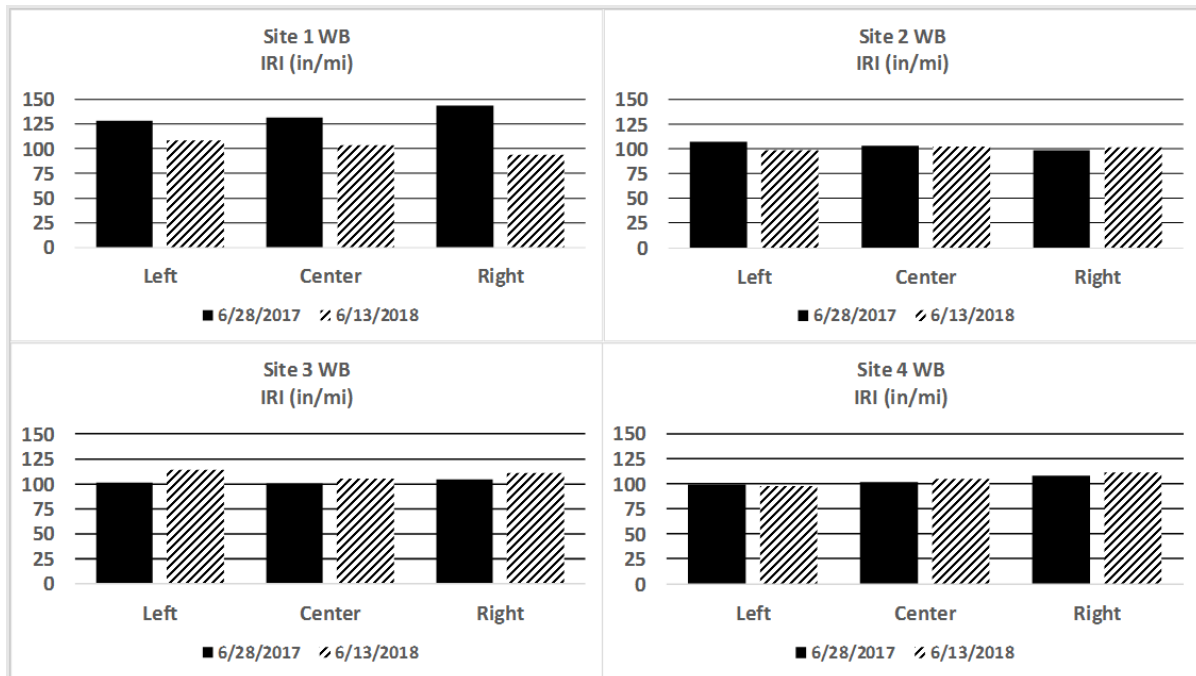
**Figure 28**  
**WB IRI for Sites 1 to 4**

The IRI measurements for the six sites are presented in Figures 28 and 29. Similar to the EB direction, IRI values for all sites exceeded 75 on the June 2017 collection date indicating that the roadway is rougher than it should be for the amount of time that it has been in service. On some sections the IRI decreased between June 2018 and June 2017 collection dates. This is an unusual event and may be due to profile changes, but the reason for this is unknown.

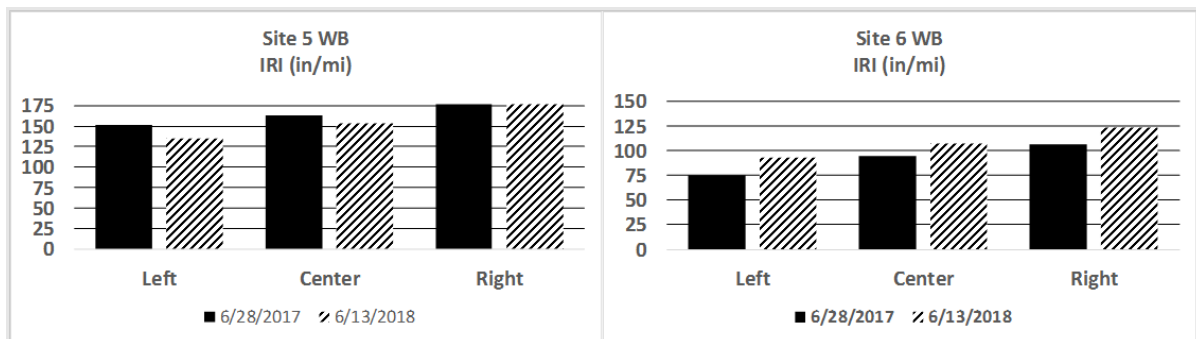
**Figure 29**  
**WB IRI for Sites 5 to 6**

The IRI values at Site 5 were much higher than the other sites. The IRI values for the RWP was higher than the CLP and both were higher than the LWP on the June 2017 collection date. There was a similar trend on the June 2018 collection date. The IRI value for the RWP on the June 2018 collection date was similar to the June 2017 date. The CLP and LWP IRI values decreased between the June 2018 and June 2017 collection date.

On Site 6, the IRI value on the RWP was greater than the CLP and both were greater than the LWP on the June 2017 collection date. The trend was similar in the June 2018 collection date and all the IRI values increased.

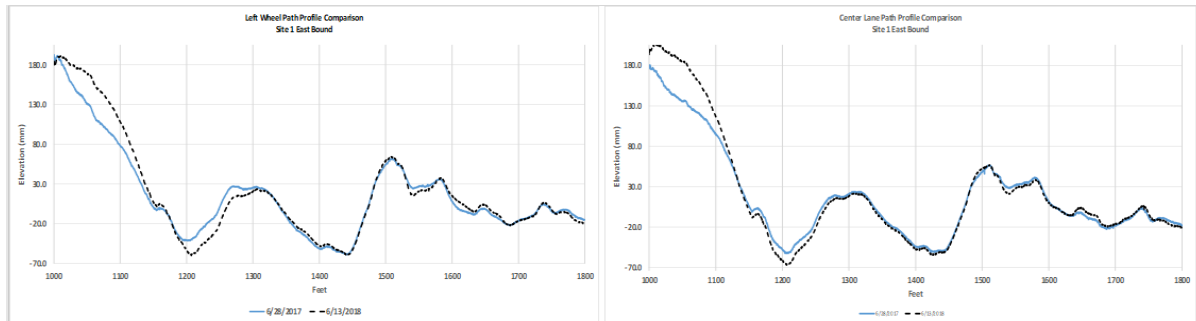
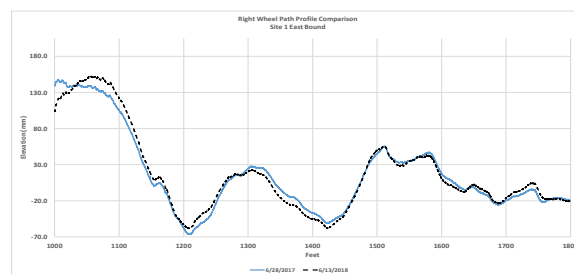
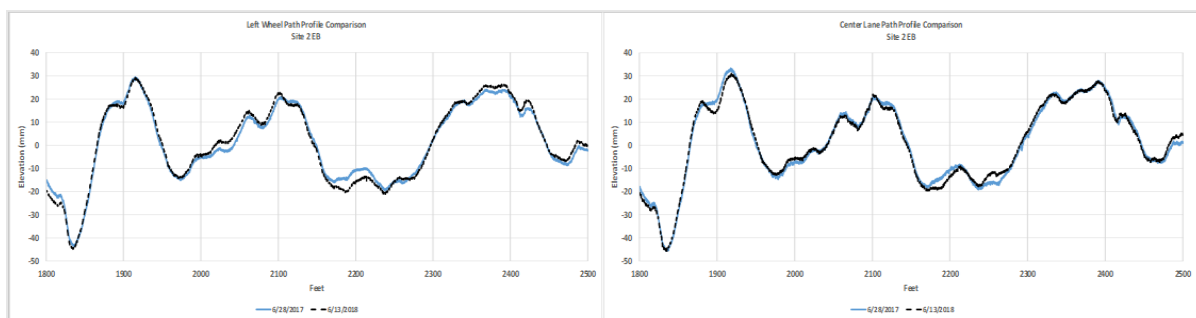
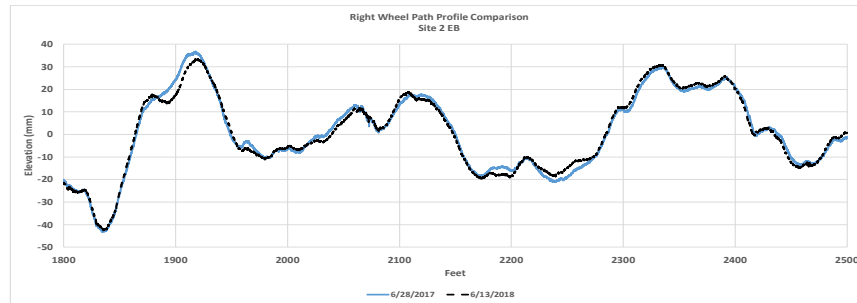
Figures 30 to 33 presents the longitudinal profiles for the LWP, CLP, and RWP for Sites 1 and 2 for the EB roadway. The remainder of longitudinal profile figures for both the EB and WB roadway are located in Appendix 3. The longitudinal profiles for the June 2017 and June 2018 collection dates are presented in the Figures. Examining the Figures indicates that there were changes in the profile at the two collection dates. While it is typical for the profiles to change over time due to traffic loading, it is important to keep in mind that no traffic was on the roadways during the three submergence events of January 2016 to March 2016, February 2017 to

April 2017, and July 2017 to August 2017. It is probable that the changes in profile shapes were primarily due to volumetric changes in the subgrade.
