# RAILROAD ACCIDENT REPORT

## HAZARDOUS MATERIALS RAILROAD ACCIDENT

### IN THE ALTON AND SOUTHERN GATEWAY YARD

REPORT NUMBER: NTSB-RAR-73-1

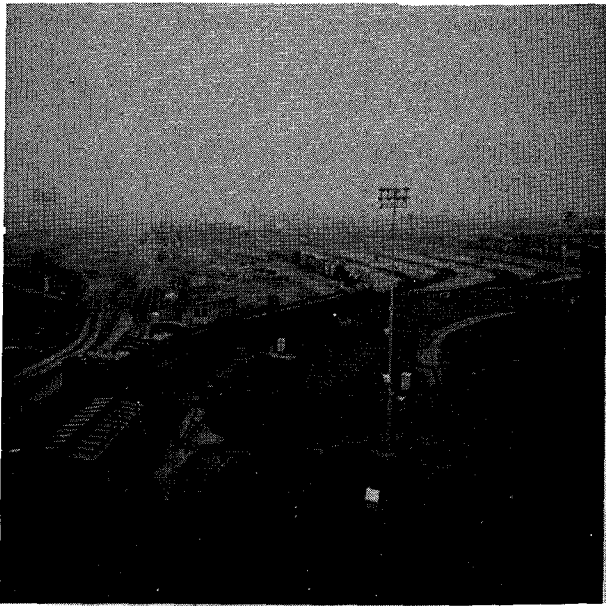
**Figure 2. Gateway Yard (picture taken from crest hump tower.)**

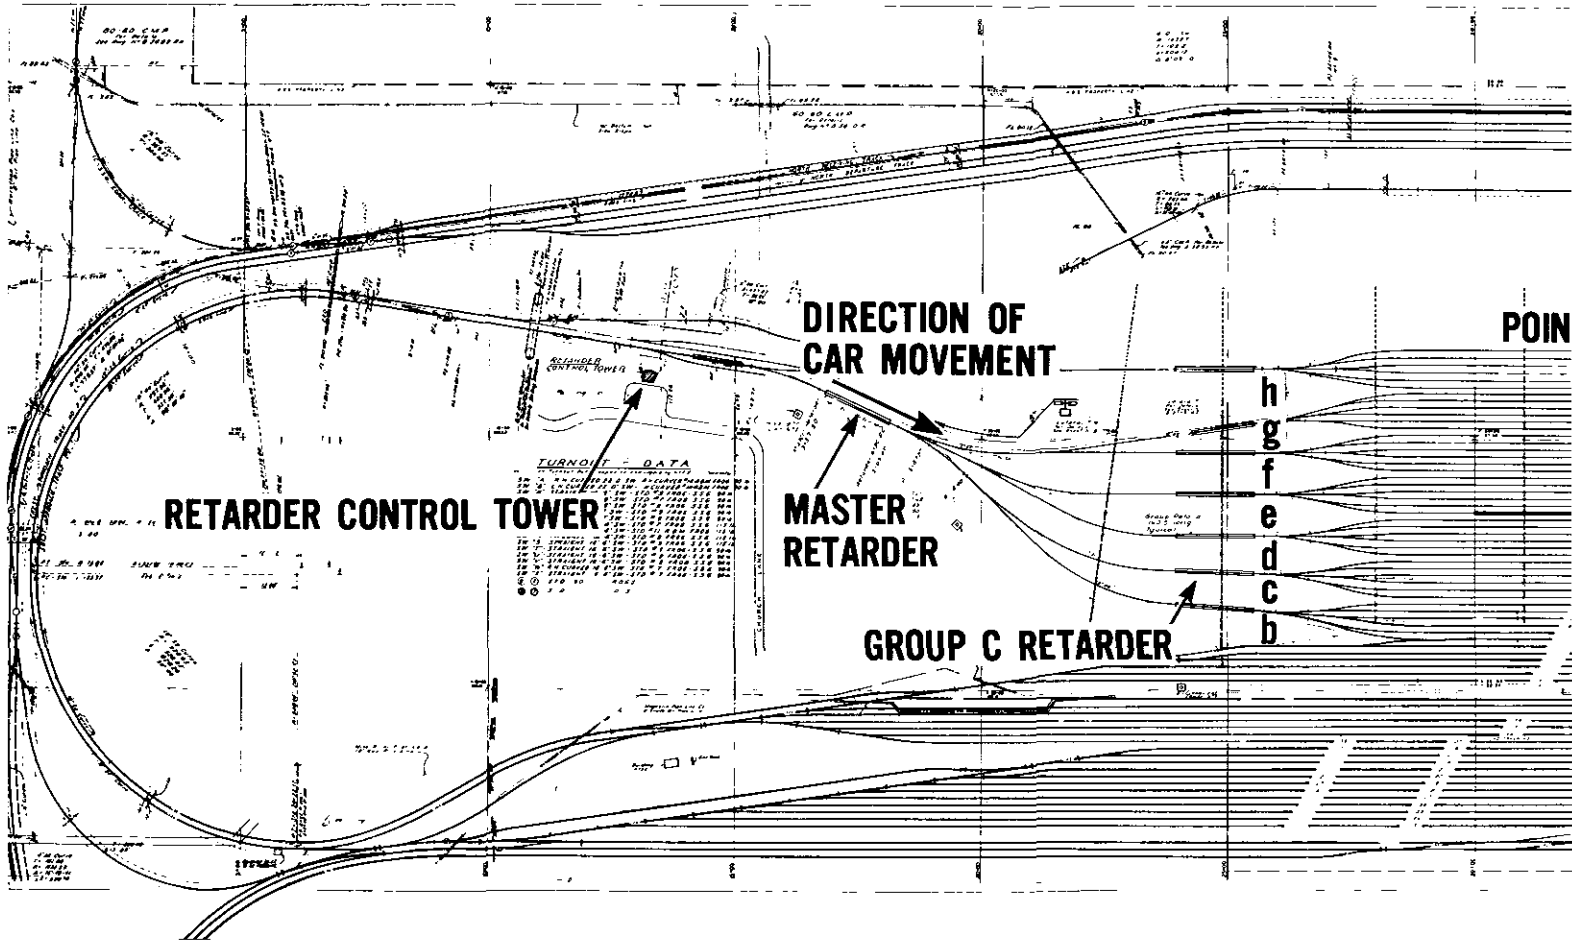
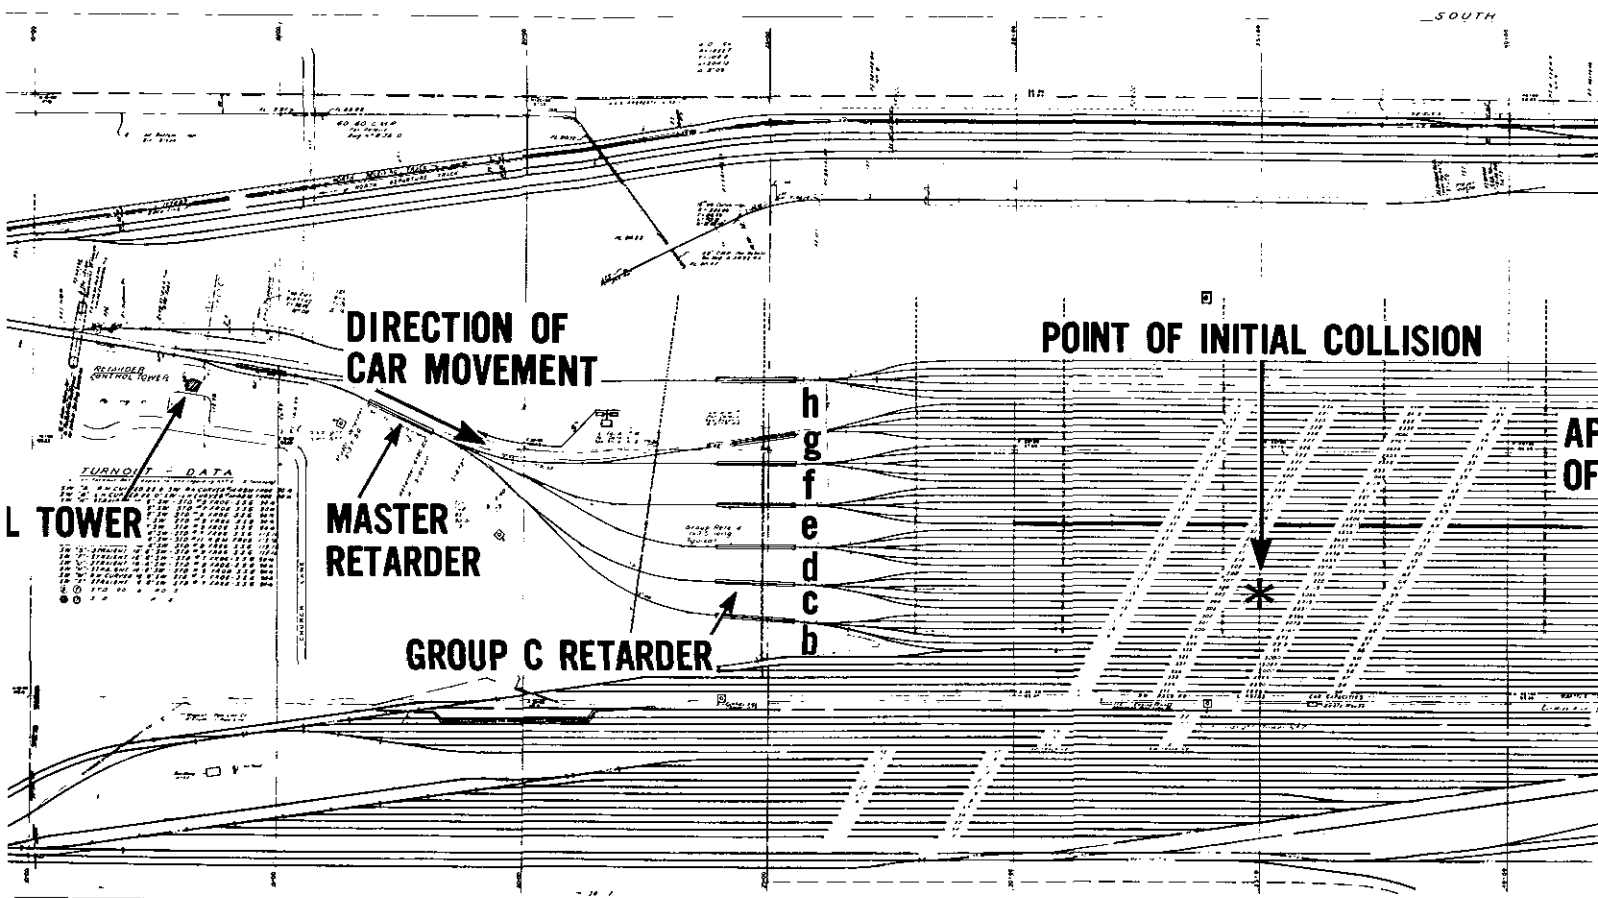
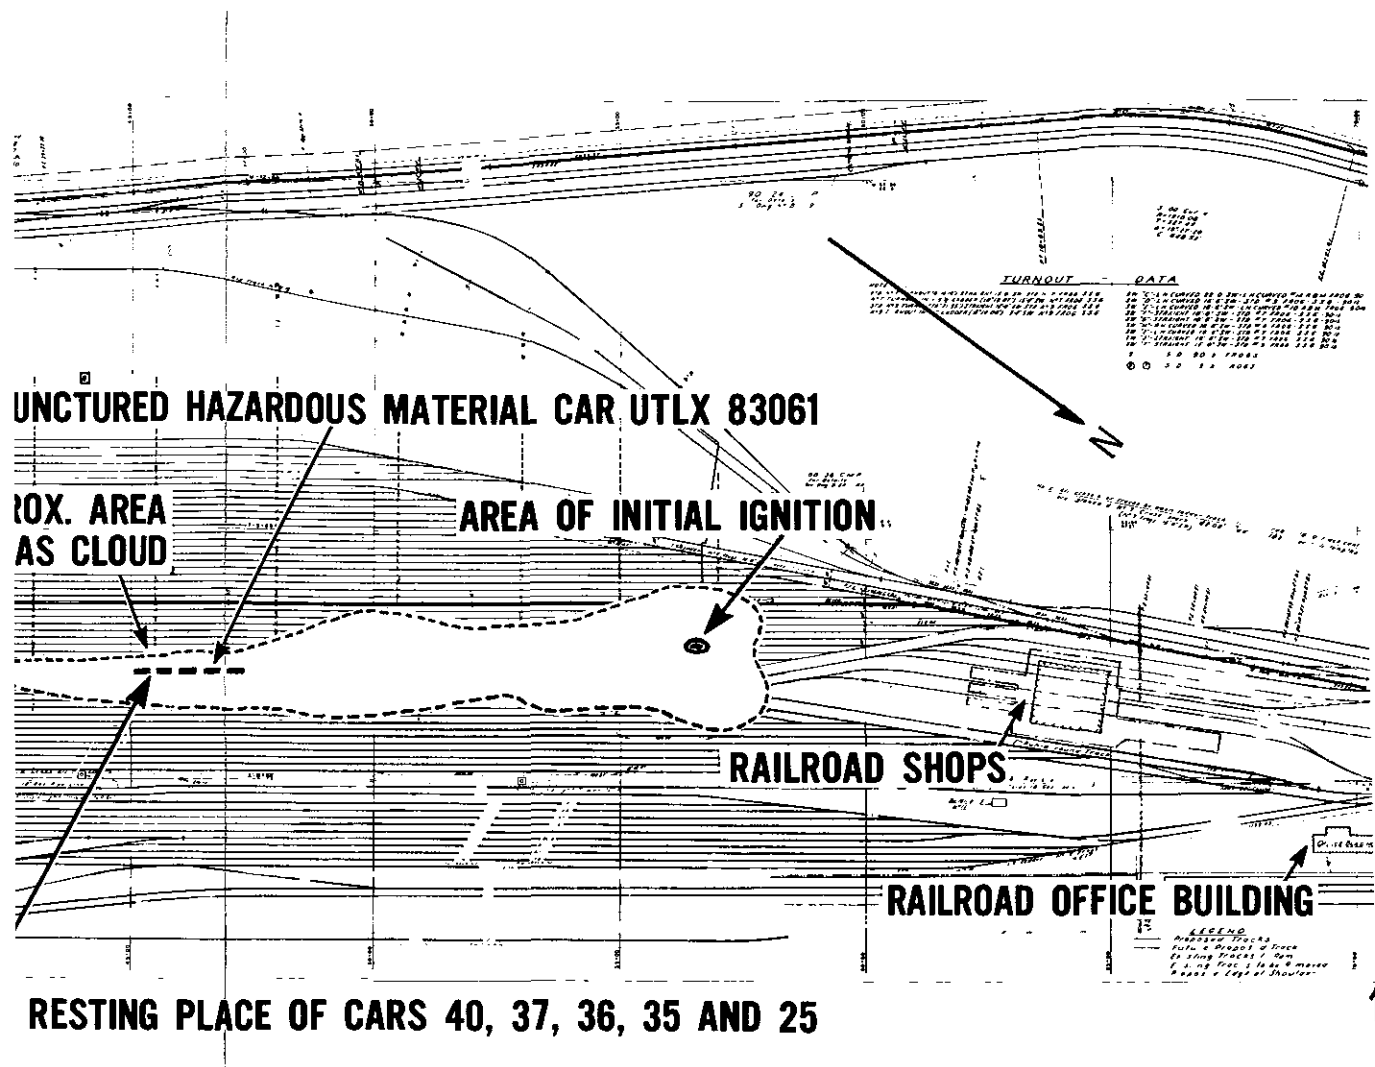
Figure 3. Plan of Alton & Southern Gateway Yard.

Classification of the 44-car cut began at 6:02 a.m. The first 24 cars were humped without any unusual occurrence. The 25th car, L&N 131571, an empty hopper, was humped without incident en route to track No. 15. The car, however, stopped about 1,000 feet beyond the group retarder, or about 1,300 feet short of its planned coupling point with other cars on the track. (See Figure 3.) Cars 26 through 34 were humped as programmed and routed to other classification tracks.
