NATIONAL TRANSPORTATION SAFETY BOARD

RAILROAD ACCIDENT REPORT

HEAD-END COLLISION OF
AMTRAK PASSENGER TRAIN NO. 74
AND CONRAIL TRAIN OPSE-7
DOBBS FERRY, NEW YORK
NOVEMBER 7, 1980

NTSB-RAR-81-4

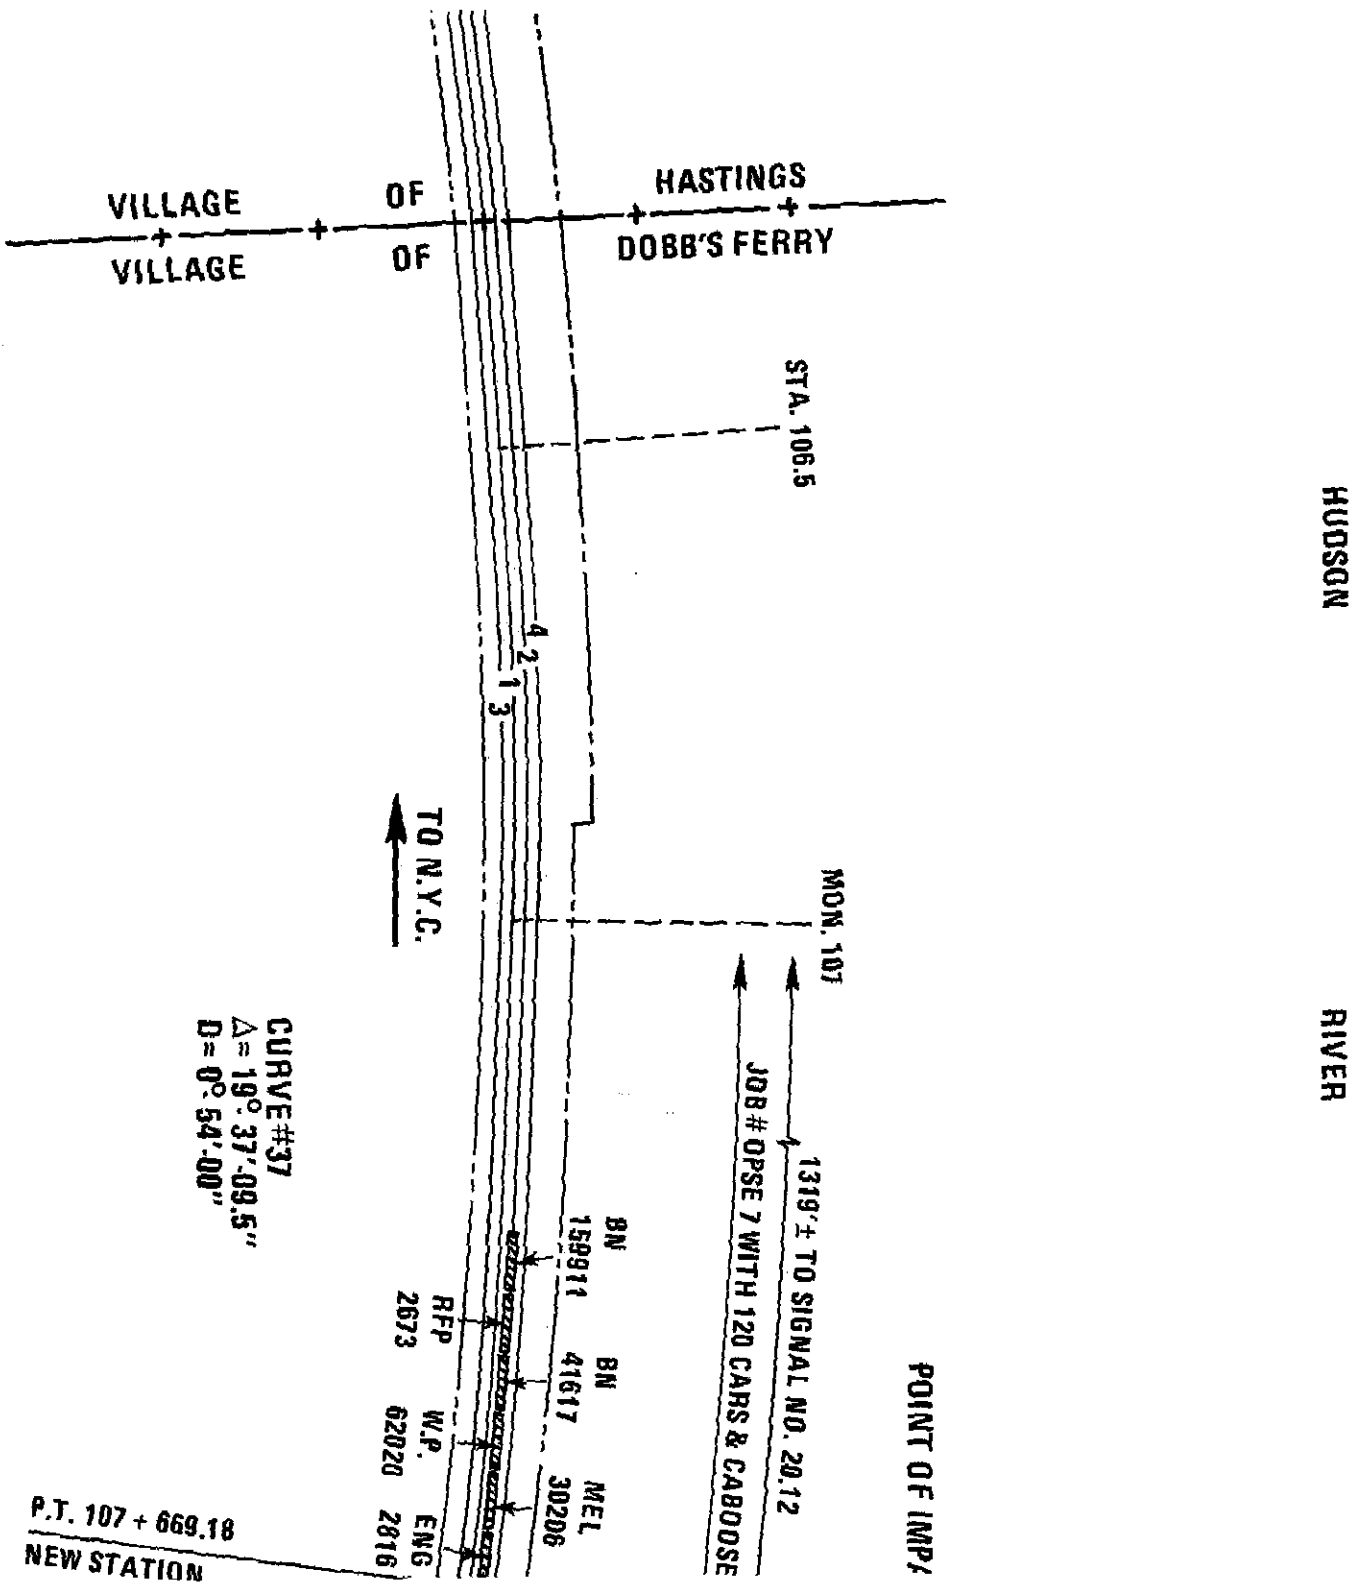
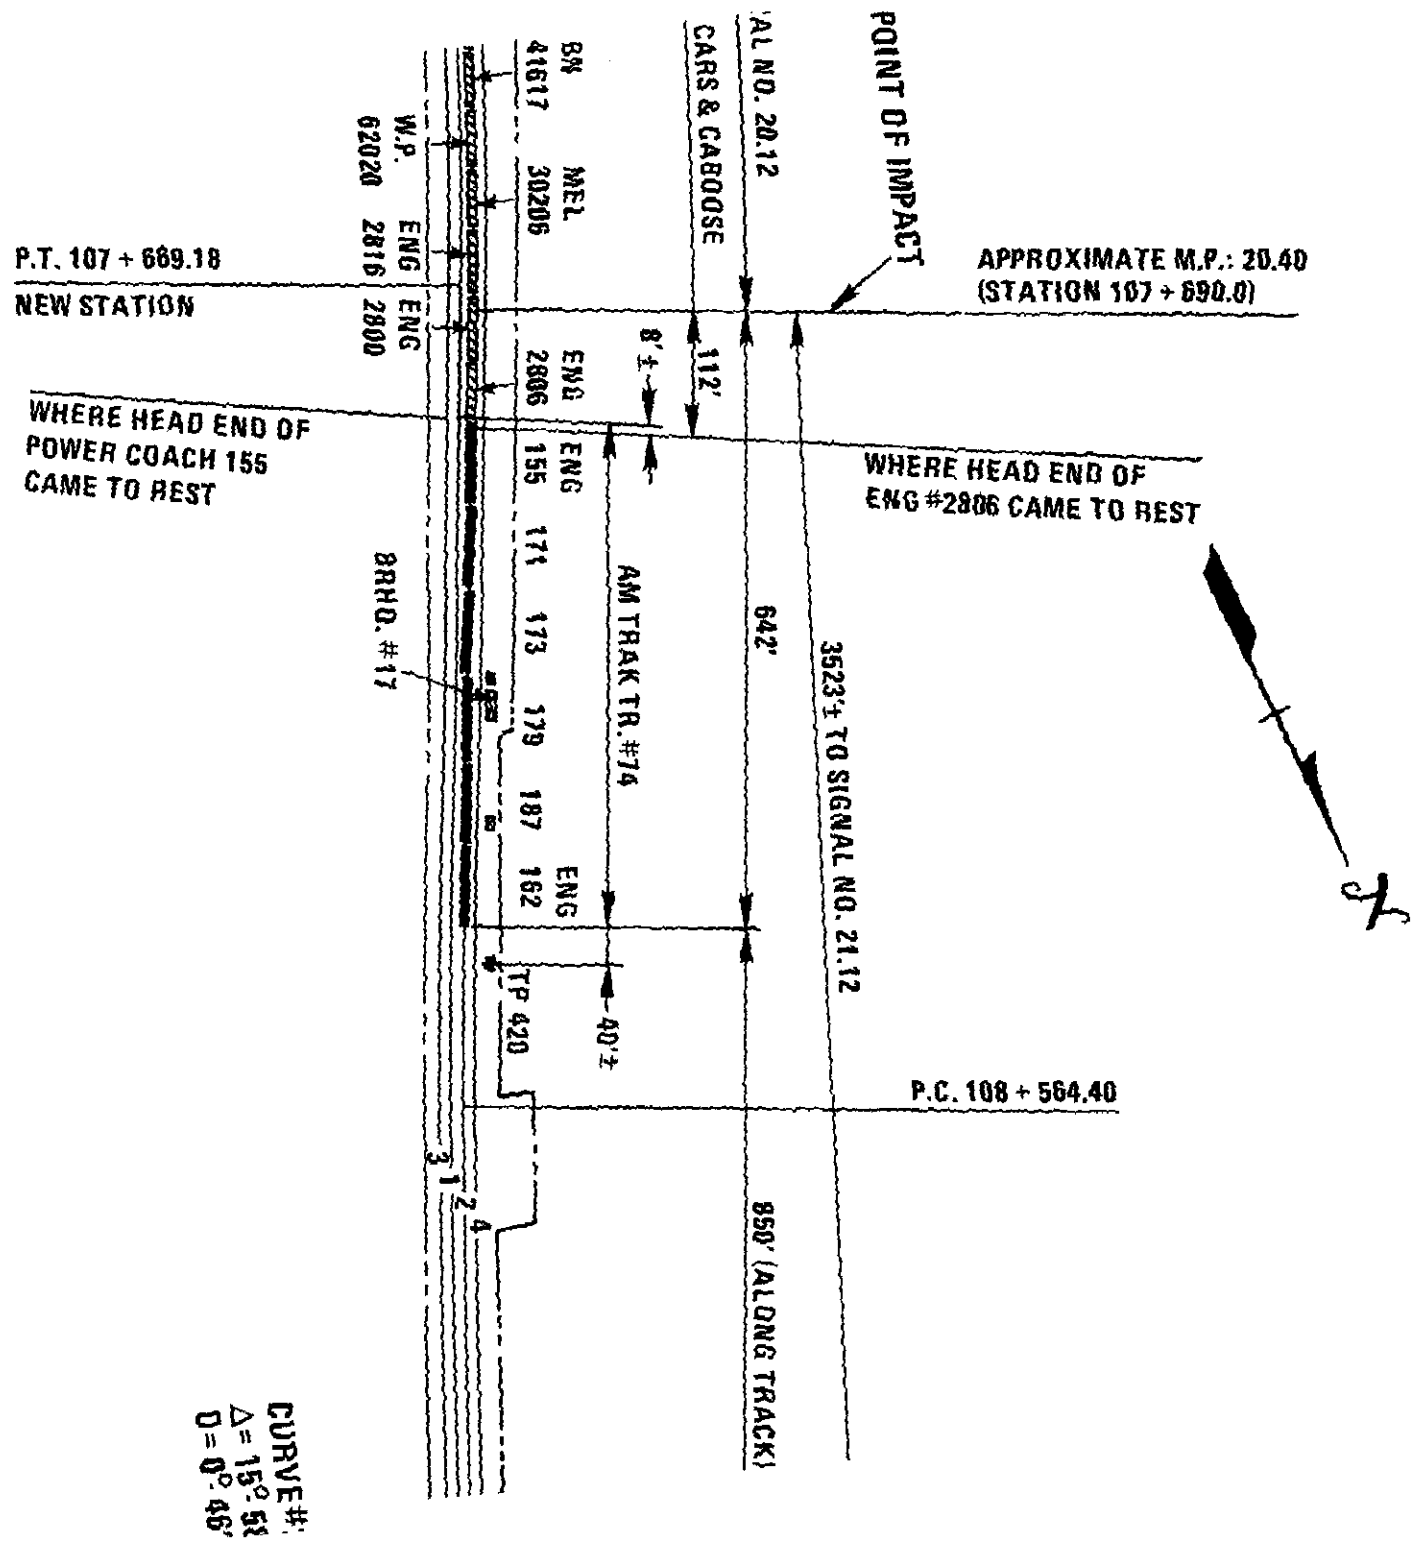
Figure 3. -- DOBBS FERRY ACCI

Moments later, OPSE-7 collided with standing train No. 74 at about 10 mph. The impact derailed the lead unit of OPSE-7 and pushed train No. 74 rearward about 112 feet, derailling the lead power car (see figure 2) and the following three passenger cars. (See figure 3.) Electrical power to the four tracks was shut off after a crewmember boarded the cab of the rear power car and used the radio to request that the power be shut off because of the collision and because passengers were getting onto the tracks. An employee of a restaurant adjacent to the accident site immediately called the Dobbs Ferry Police Department. Within 3 minutes after the accident, emergency forces began to arrive at the accident site.

Track damage was confined to the area of the collision and the 112 feet No. 74 was pushed rearward. The third rail equipment 4/ was also damaged when the second car of train No. 74 derailed and came to rest against it.

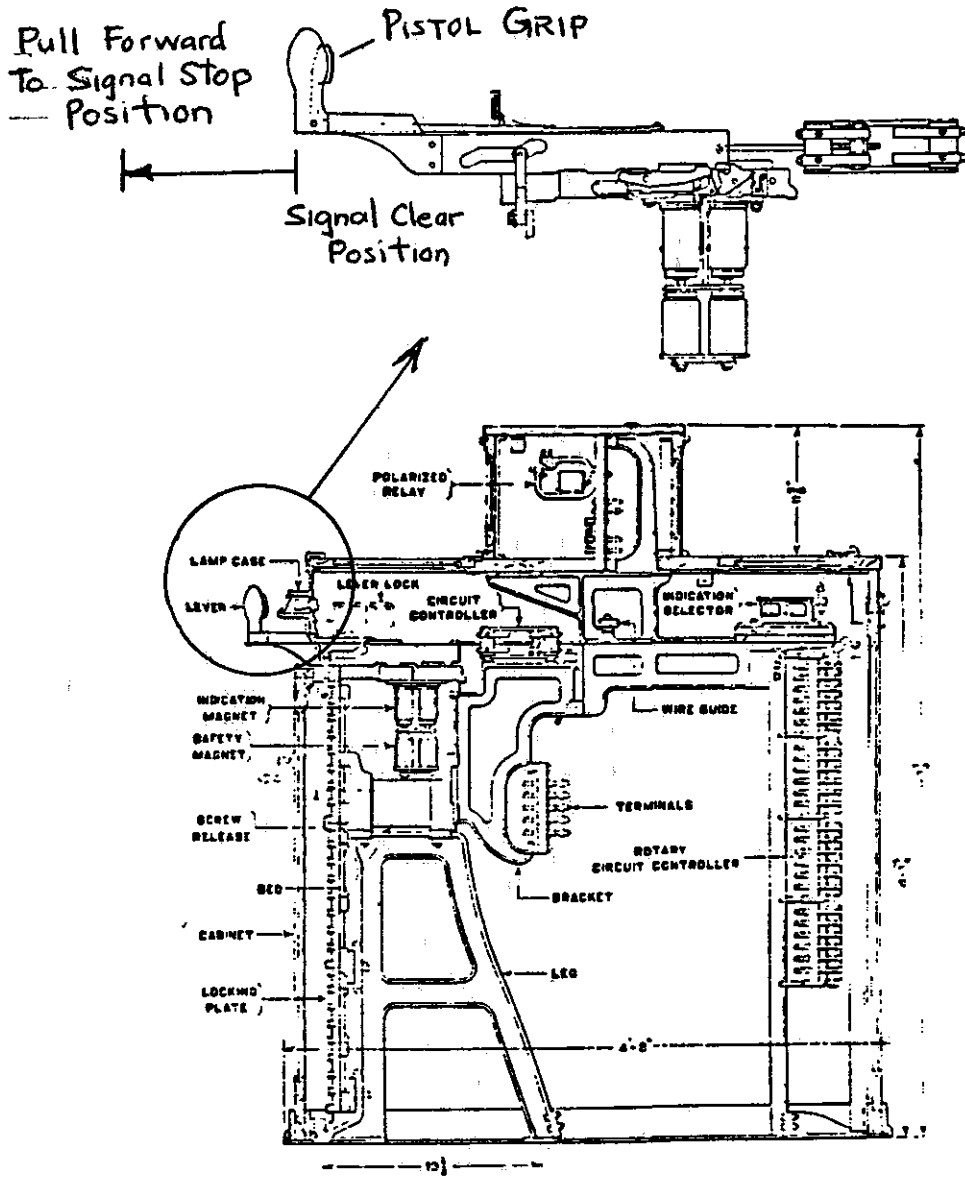
Figure 6.-- Unit lever-type machine.

The OW interlocking tower has a unit lever-type machine. (See figure 6.) The machine is equipped with 56 hand-operated levers: 33 levers control 34 signals; 19 levers control 20 switches, 3 levers control 4 electric locks, and there is 1 spare lever. The levers are a pistol grip-type which can only be moved by depressing the trigger in the handle. (See figure 6.) The blocking devices are metal boxes with opened ends.
