NATIONAL TRANSPORTATION SAFETY BOARD

RAILROAD ACCIDENT REPORT

FIRE ONBOARD AMTRAK PASSENGER TRAIN
TRAIN NO. 11, COAST STARLIGHT
GIBSON, CALIFORNIA
JUNE 23, 1982

NTSB / RAR-83 / 03

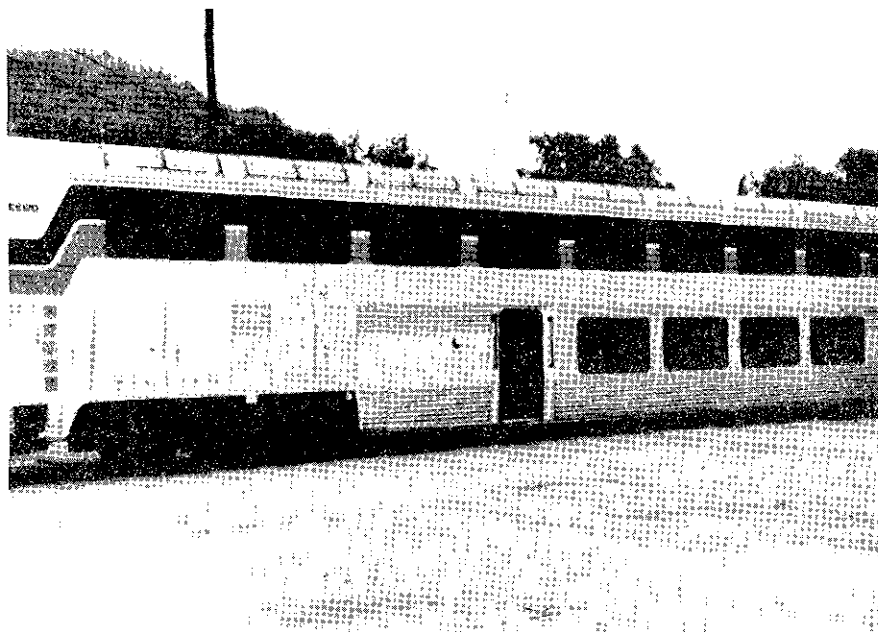
Figure 1.--Amtrak superliner sleeping car.

When the 1130 car attendant and the rear brakeman became aware that a handicapped passenger was still in bedroom A on the upper level of the 1131 car, they climbed up the rear of the car to the upper level and attempted to enter the car through the upper level end door to rescue the passenger. The end car door, which was also the end of the train, had been locked with a key to prevent its opening by passengers. The rear brakeman could not open the door until he had been provided with a coach key. When the door was opened, volumes of thick black smoke immediately emptied through the door, thus, preventing their entry into the car. They discovered later that because the cars were oriented in the train such that the deluxe bedrooms were adjacent to each other, the handicapped passenger had to be reached from the front end of the car. (See figure 1.)

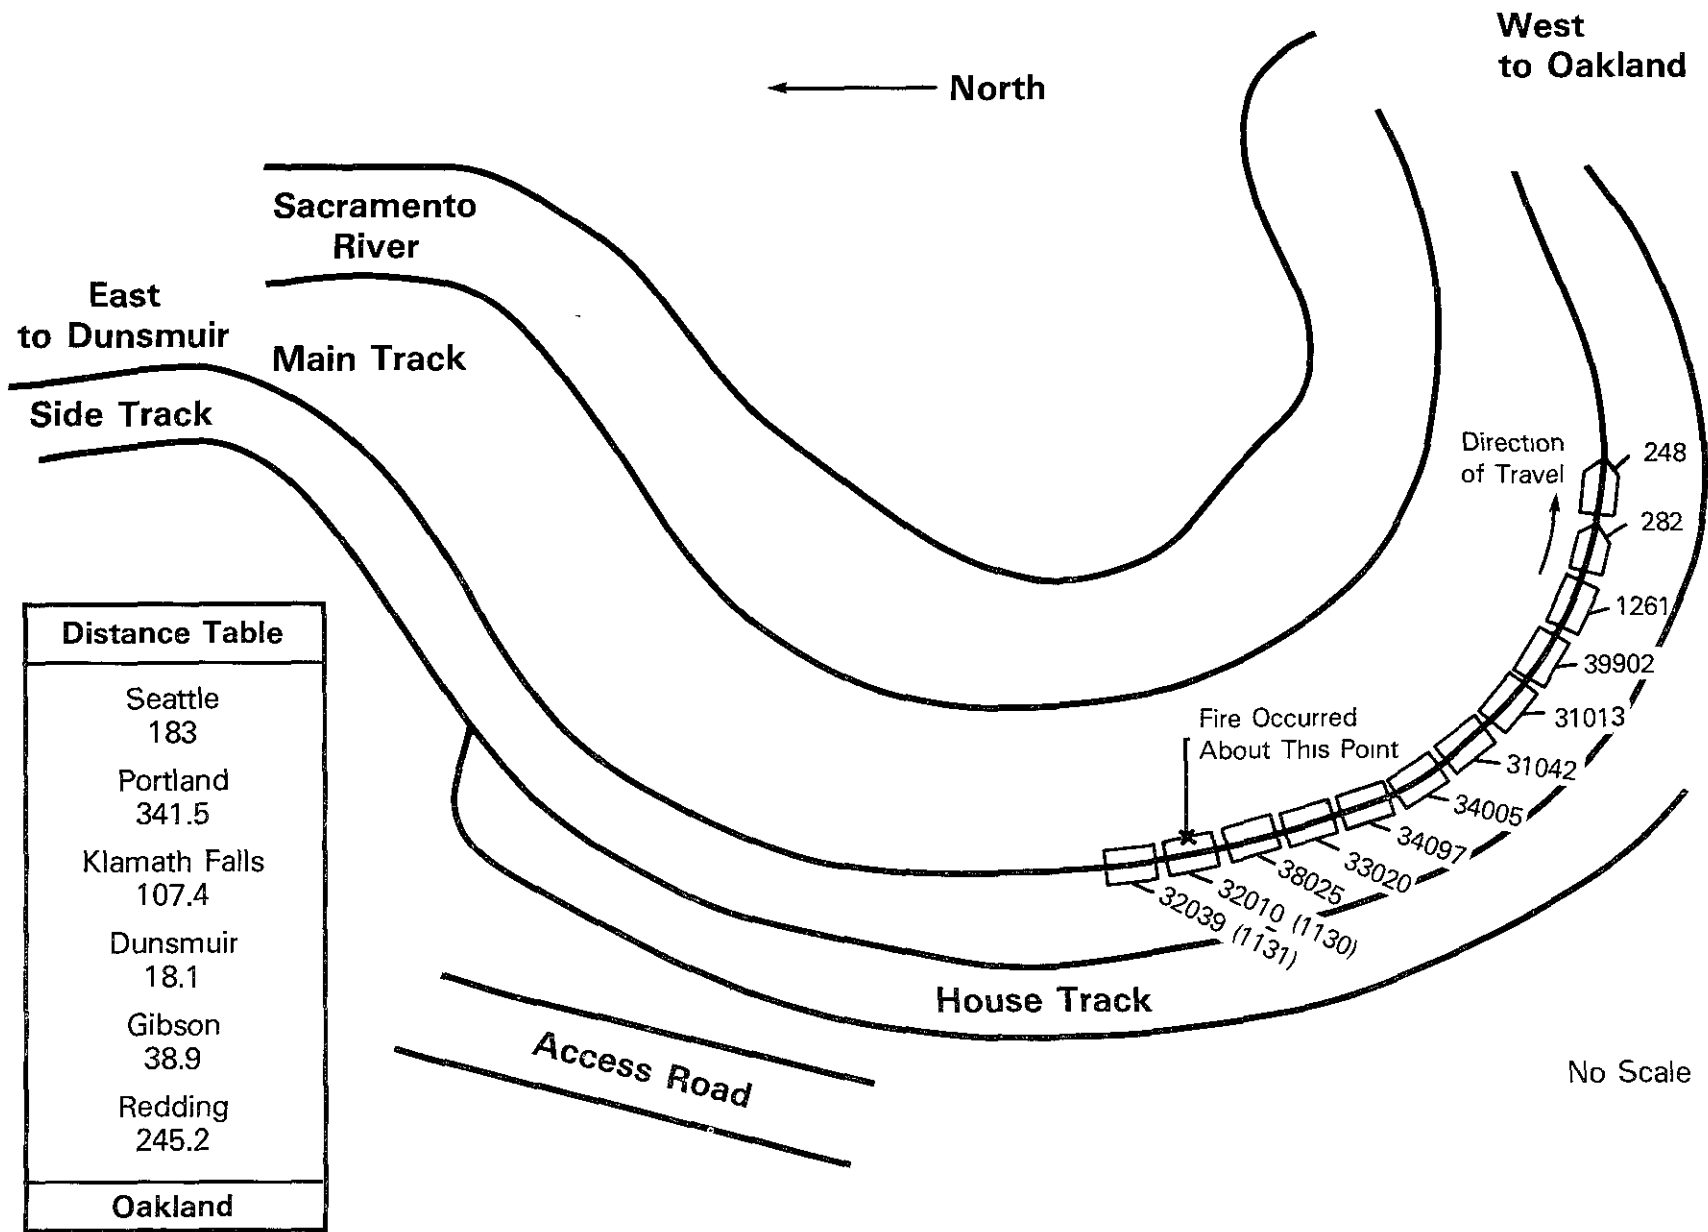
Figure 3.--Plan view of accident site.

The engineer said that he and the fireman looked northward at the train, which was standing in a left-hand curve in the direction of travel. (See figures 3 and 4.) They could see a yellowish light in the upper part of the 1130 car that was unlike the normal light reflected from a rail passenger car. When the engineer became aware of the magnitude of the fire, he radioed the dispatcher to send emergency fire assistance. Later, the conductor instructed him over the radio to make the moves required to separate the two rear cars in the train. The engineer said that he assigned the locomotive fireman the task of shutting off the electrical power to the train before the cars were uncoupled. The
