# NATIONAL TRANSPORTATION SAFETY BOARD

## RAILROAD ACCIDENT REPORT

DERAILMENT OF AMTRAK TRAIN NO. 4  
THE SOUTHWEST LIMITED  
ON THE ATCHISON, TOPEKA  
AND SANTA FE RAILWAY COMPANY  
LAWRENCE, KANSAS  
OCTOBER 2, 1979

NTSB-RAR-80-4

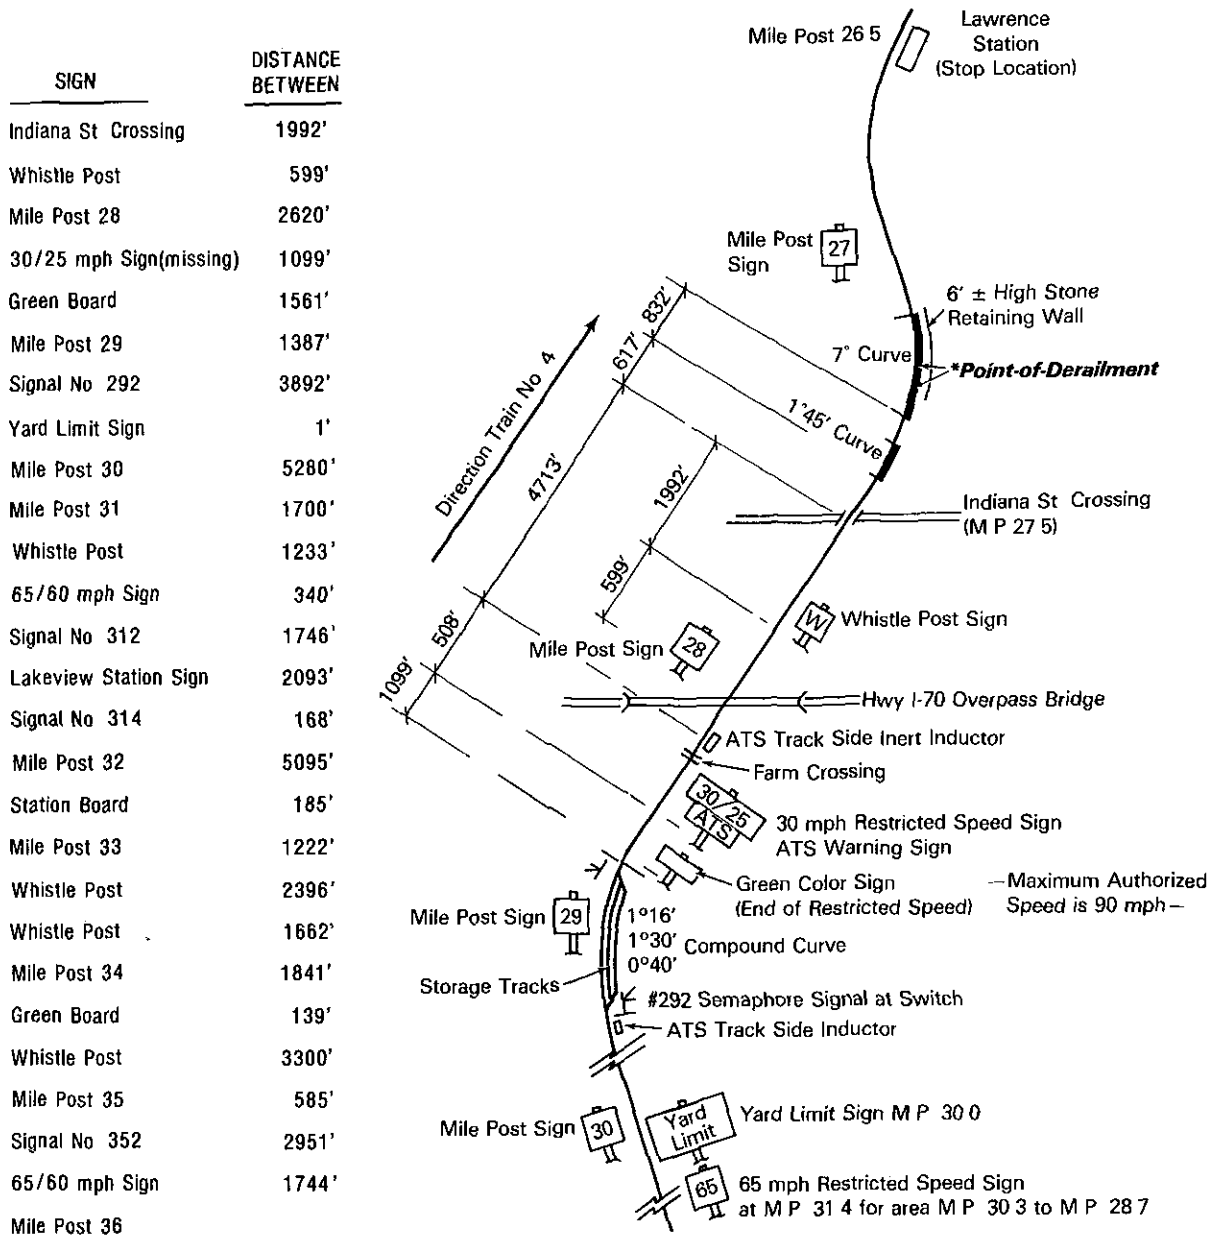
Figure 2.--Plan view of track and signs approaching derailment site.

The locomotive derailed near the middle of a 7°, 526-ft curve to the left (See figure 2.) The lead locomotive unit slid on its side and hit a 6-ft-high concrete retaining wall on the outside of the curve. The other locomotive units tipped on their right sides and stopped adjacent to the wall, 500 ft east of the point of the derailment. (See figure 3.) The two baggage cars jackknifed across the track, and the lead one turned onto its side. The following dormitory car separated from the baggage cars and continued tangentially over the wall, stopping next to a residence adjacent to the railroad property. The next four coaches and a diner followed, remained upright, and stopped somewhat in line. The ninth car, a sleeping car, separated from and struck the rear of the diner. Two Amtrak employees inside the diner were killed. (See figure 4.) The sleeping car continued forward about 100 ft along the left side of the diner before stopping. The following three sleeping cars jackknifed across the track and turned onto their sides. The next five coaches, including a second diner, remained upright, leaning, and in-line; they stopped on the inside of the curve adjacent to the track. The last car, a sleeper, stopped on the track and did not derail. In all, 3 locomotive units and 17 cars derailed.
