# NATIONAL TRANSPORTATION SAFETY BOARD

## RAILROAD ACCIDENT REPORT

**TRAIN ACCIDENT INVOLVING  
AMTRAK PASSENGER TRAIN NO. 225  
AND AMTRAK WORK EXTRA NO. 4934  
LINDEN, NEW JERSEY  
JULY 9, 1980**

**NTSB-RAR-80-12**

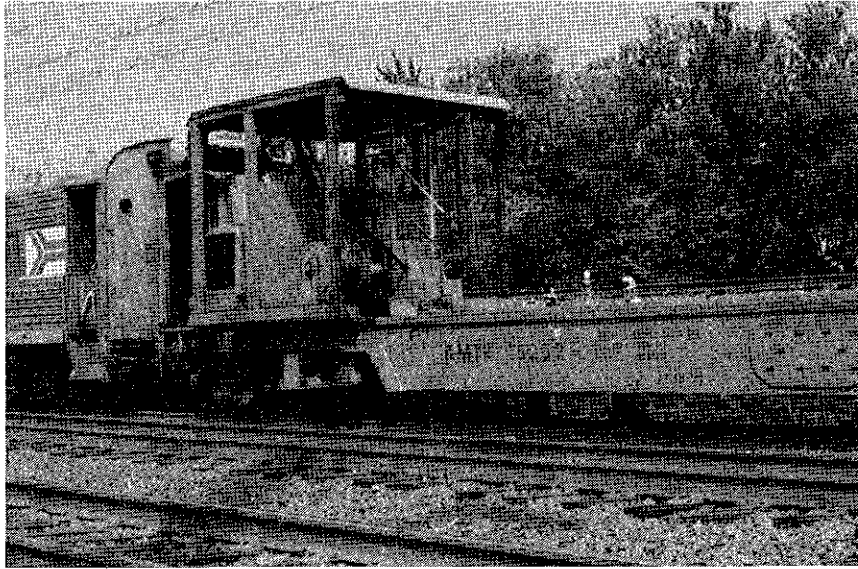
He assigned a foreman who had previous knowledge of the operation to the first threader car, which is used to pull the rails from the train. (See figure 1.) At the third threader car, which is used in a step down operation to lower the rails to the ground level, he assigned a foreman and four trackmen who had not previously worked on a CWR train. Their job was to attach the ends of each successive rail together during the unloading process. He assigned an assistant track foreman, who had previously worked on CWR trains, and two trackmen to the anchor car, the flat car near the middle of the train to which the rail is secured against longitudinal movement while the train is in transit. Their job was to remove the anchors that secured the rails to the car. At the rear railcar of the train, he assigned the track foreman and a truckdriver to remove the buffer rails <sup>2/</sup> from the ends of the CWR. (See figure 2.) Buffer rails are attached to CWR with standard joint bars. <sup>3/</sup> The track foreman had not worked a CWR train of this type, and as he and the other employees removed the joint bars, they allowed the buffer rails to drop to the next level of rails and eventually to the car floor. During the 2 days of unloading, the track supervisor was located in the area of the threader step down car and did not go to the rear flatcar where the buffer rails were being removed.

Figure 1.—View of threader car.

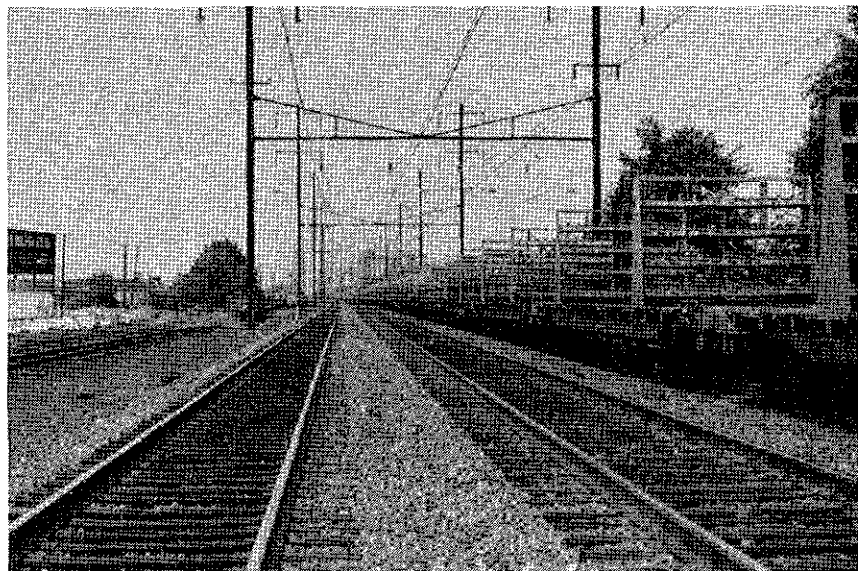
Figure 2.—Arrangement of railcars in CWR train.
