PB94-916301
NTSB/RAR-94/01

RAILROAD-MARINE ACCIDENT REPORT

DERAILMENT OF AMTRAK TRAIN NO. 2
ON THE CSXT BIG BAYOU CANOT BRIDGE
NEAR MOBILE, ALABAMA
SEPTEMBER 22, 1993

Adopted: September 19, 1994
Notation 6167B

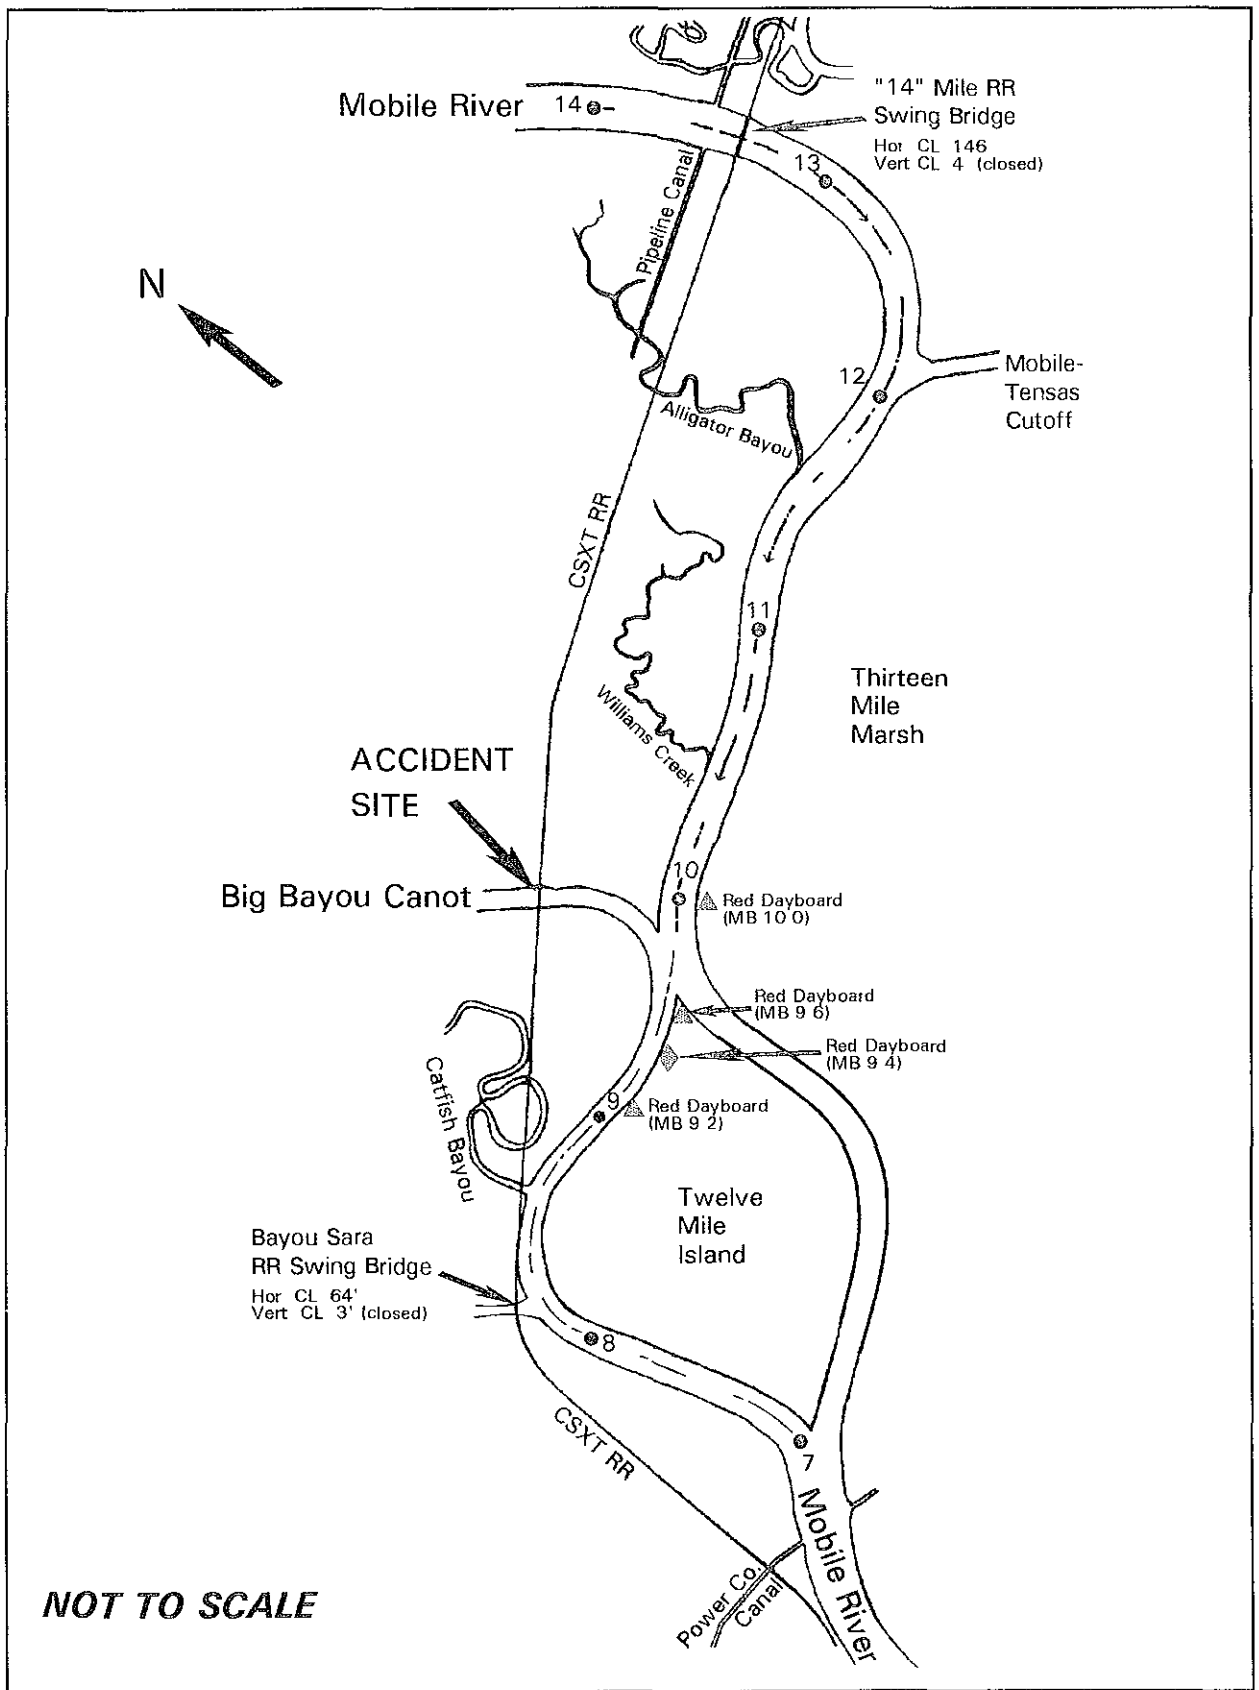
Figure 2.--Mobile River chart.

He stated that visibility was good³ and recalled learning from marine radio conversations shortly before he departed that conditions were foggy north of his position. He could see the THOMAS B. McCABE's stern lights until that vessel rounded a bend in the Mobile River at Bayou Sara (about mile 8.2). The MAUVILLA's position at the time, according to the pilot, was near the south end of Twelve Mile Island (mile 7), and he recalled visibility beginning to become "hazy" there (see figure 2).

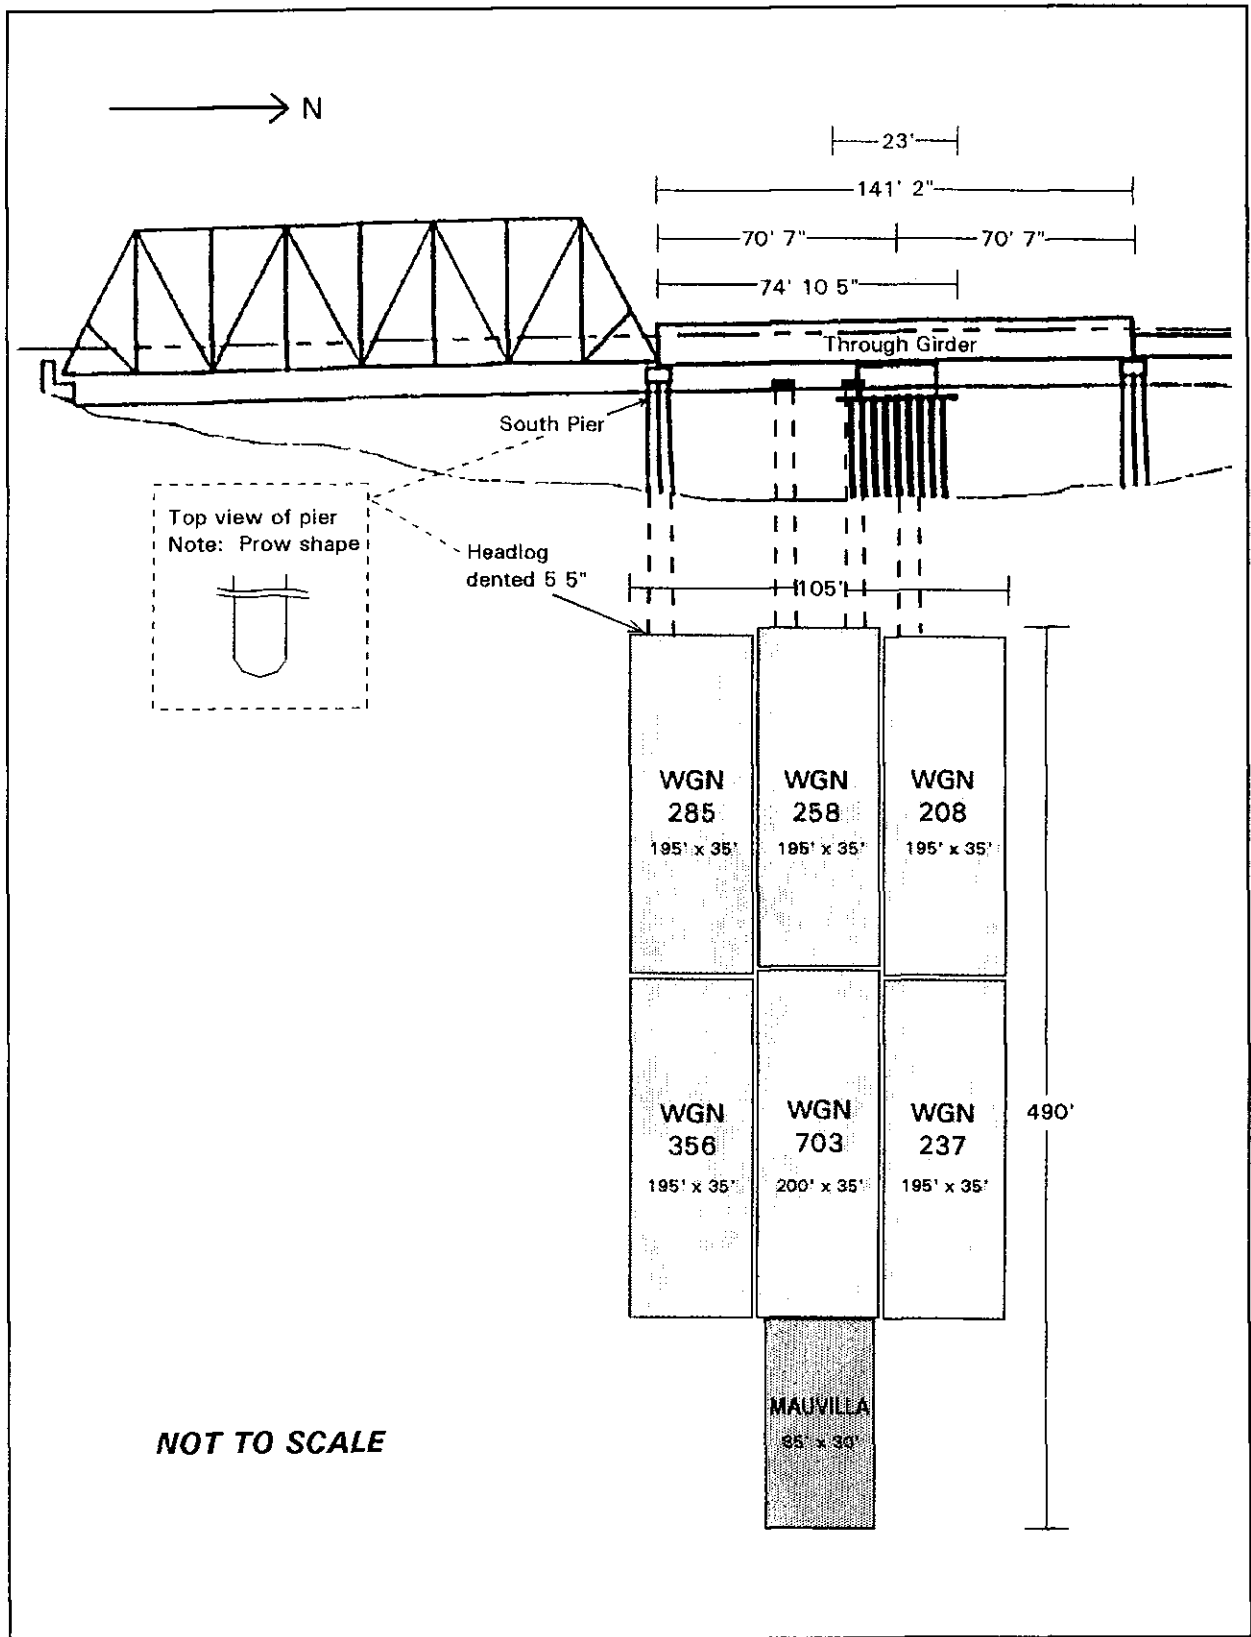
Figure 4.--MAUVILLA tow configuration and Big Bayou Canot bridge.

was drydocked at W&GN's yard on September 27, 1993, for a hull survey. The marine investigative group noted no apparent damage to the hull, rudders, or propellers. Inspection revealed no evidence of a wire or other item having been wrapped around the propellers or rudders. The lead port (WGN 285) and starboard (WGN 208) barges (see figure 8) were slightly dented where they struck the bridge's concrete piers, and the center lead barge (WGN 258) had six marks on its headlog where it struck the vertical stiffeners on the bridge span (see figure 4). The other three barges were undamaged.

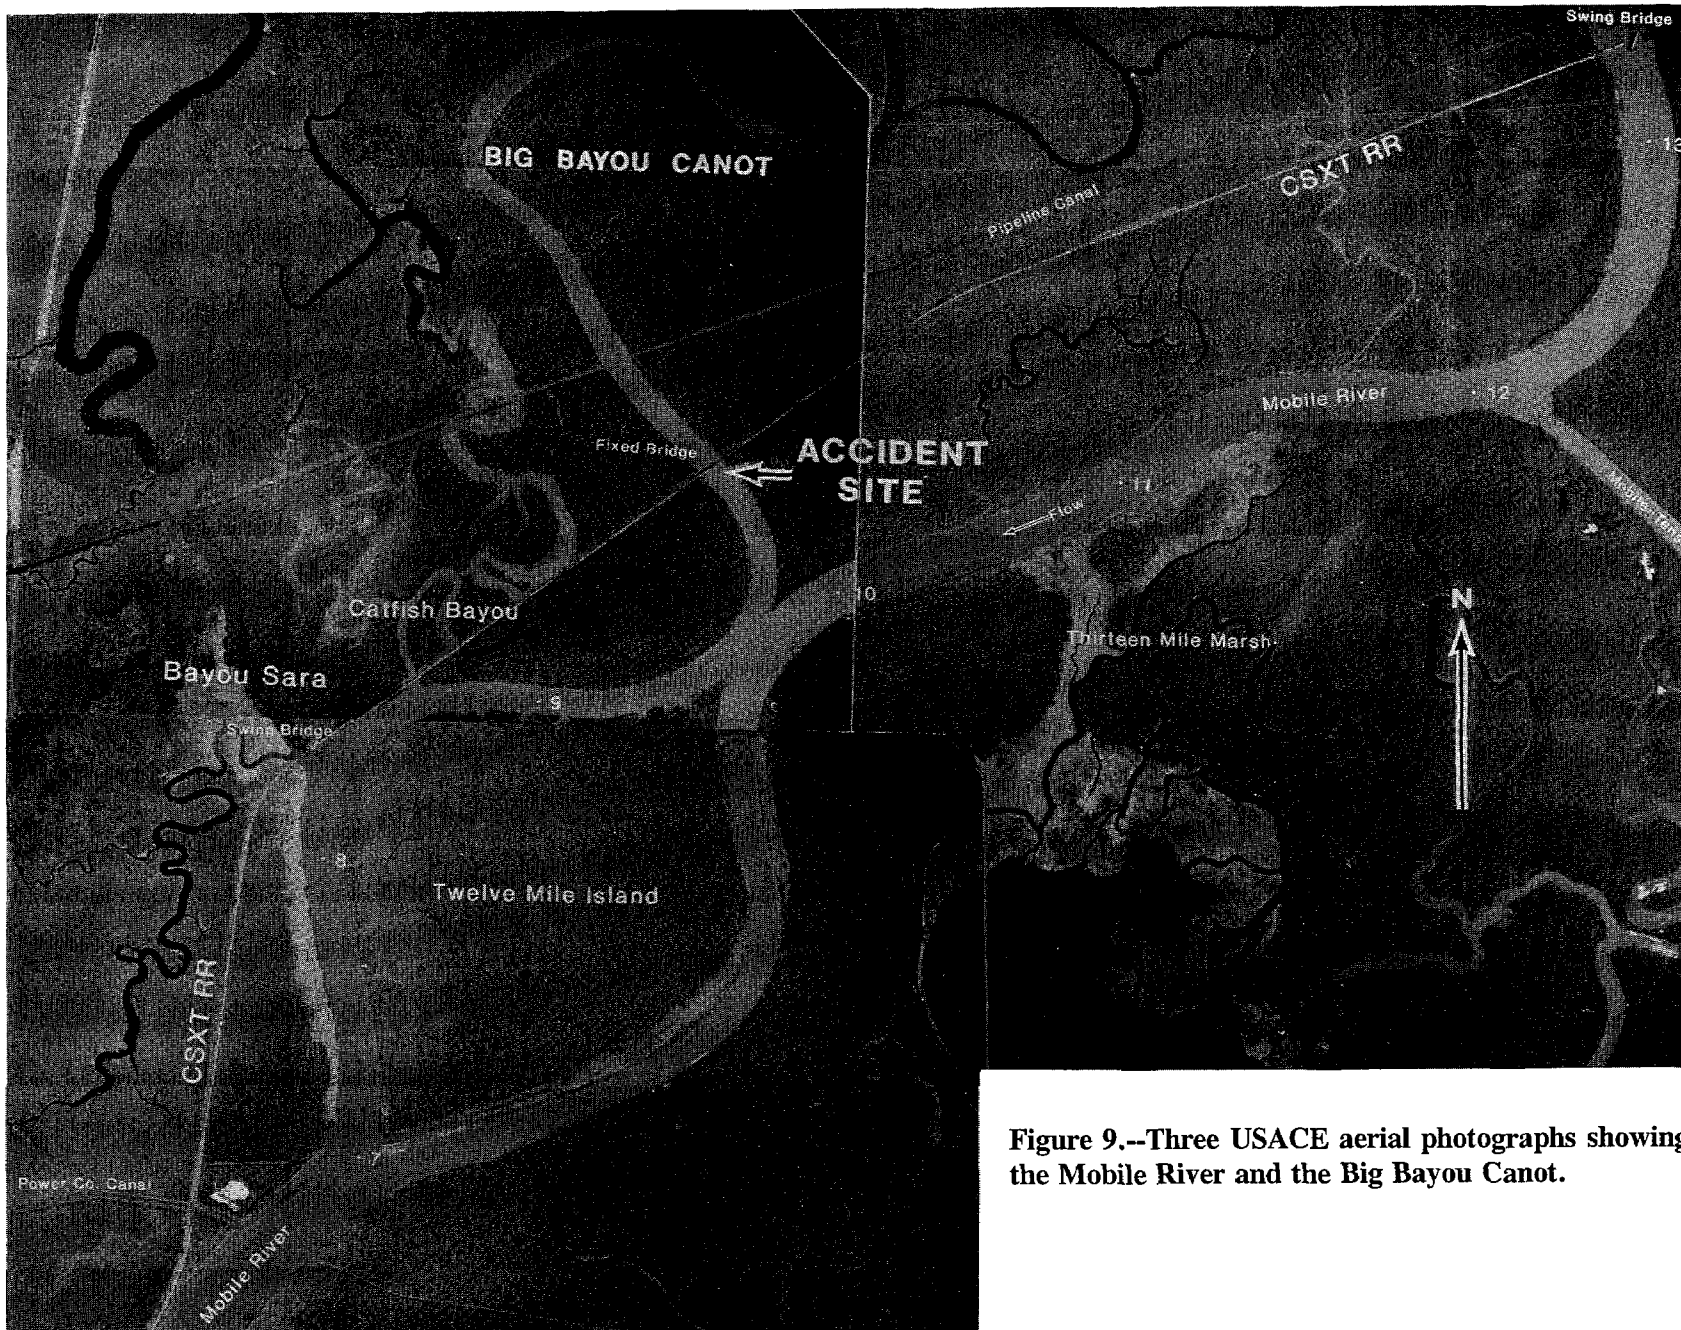
Figure 9.--Three USACE aerial photographs showing the Mobile River and the Big Bayou Canot.

To continue upriver and avoid entering the Big Bayou Canot, a tow following the river curvature must stop its leftward movement (see figure 9). When the shorelines are visible, cues are available to guide an operator through the intersection. When the shorelines are obscured, an operator needs radar information to stay on the intended courses. He or she has to correlate the radar information with chart information or memory of the waterway's geography to determine the tow's location and choose the proper waterway.

Heading upriver about mile 9.1, the Mobile River begins curving to the left and spans an arc of about 95 degrees to the entrance of Big Bayou Canot, a distance of about 0.8 mile. Although the pilot said he did not see the intersection of the two waterways on the radar, it should have appeared on the radarscope about the time the tow passed mile 9.1 and should have remained there even after the MAUVILLA entered Big Bayou Canot if the radar was set to the 1/2-mile scale. Even if the radar was set to the 1/4-mile scale, the triangular point of land marking the north end of the intersection should have appeared on the radar shortly after the tow entered the intersection.
