RAILROAD ACCIDENT REPORT

DERAILMENT OF
AMTRAK TRAIN NO. 820
(THE CRESCENT)
ON SOUTHERN RAILWAY SYSTEM TRACK
ROCKFISH, VIRGINIA
APRIL 3, 1983

NTSB/RAR-83/10

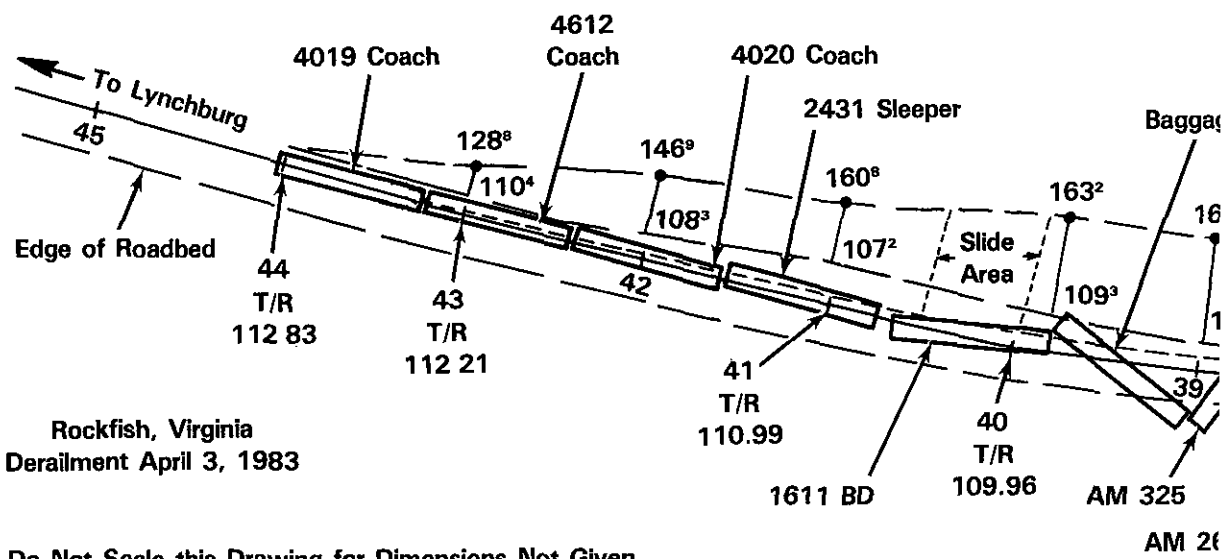
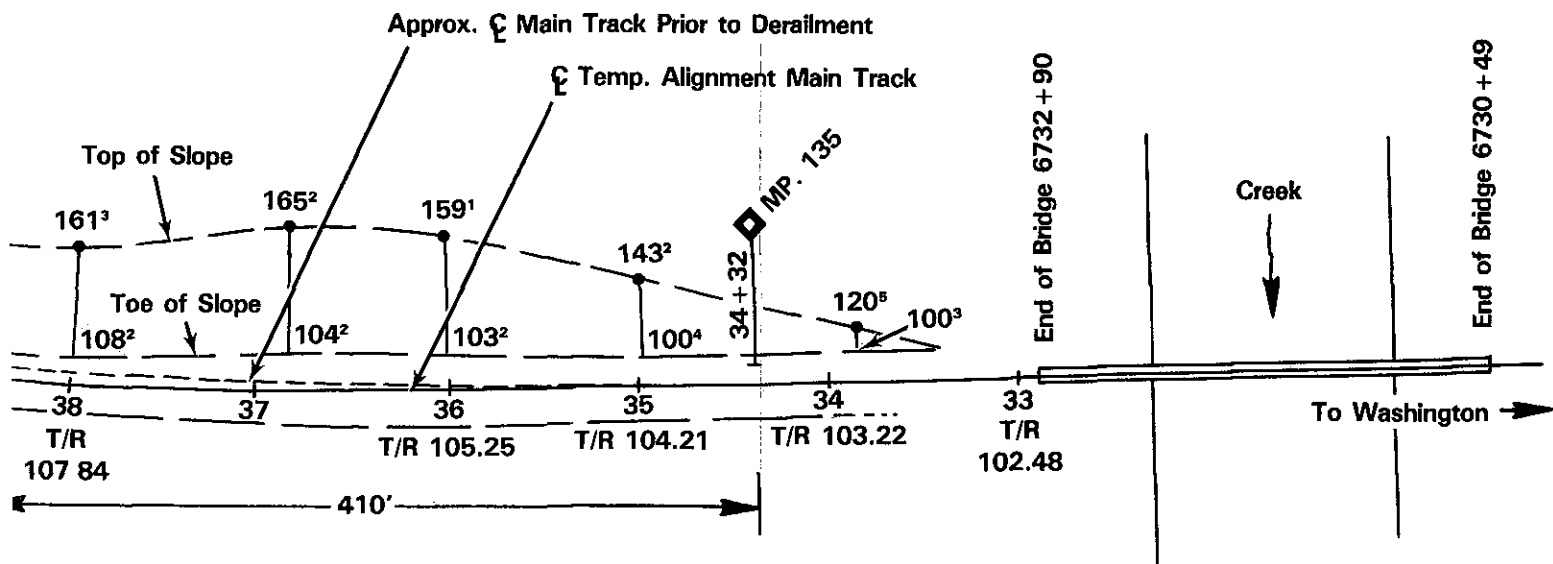
Plan view of accident site.

The west slope of the cut rises from zero feet near the end of the railroad bridge near MP 135 to 56 feet (measured from the top of the rail) over a distance of 200 feet. (See figure 3.) The highest point of the slope is 61 feet. In the slide area, the slope rose about 55 feet with a 1 1/2 to 1 slope at the north end of the slide area. About 10 feet of the slope was displaced in the landslide. The amount of earth movement was estimated to be about 150 to 200 tons, or 100 cubic yards. (See figure 4.) The earth covered the west rail to a depth of about 6 feet and covered the east rail to a depth of about 2 feet.
