RAILROAD ACCIDENT REPORT

DERAILMENT OF AMTRAK TRAIN NO. 1
WHILE OPERATING ON THE
ILLINOIS CENTRAL RAILROAD NEAR
SALEM, ILLINOIS

June 10, 1971

REPORT NUMBER. NTSB-RAR-72-5

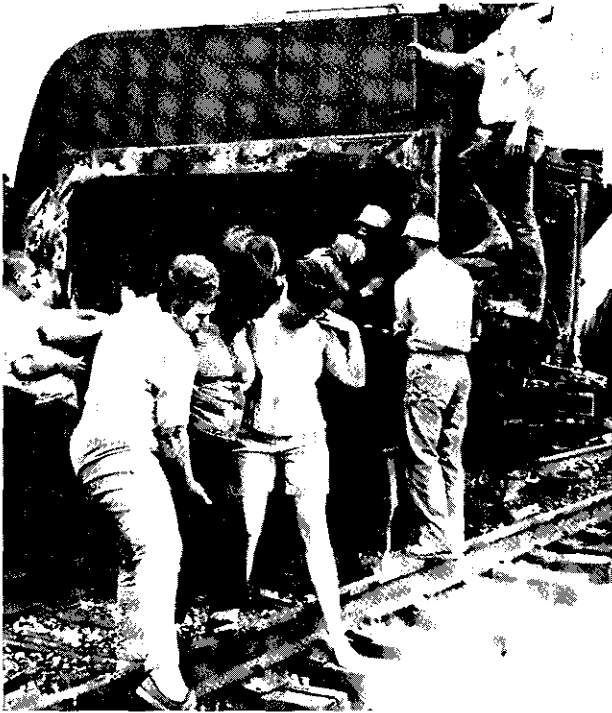
a Injured passengers being helped out the end of the car and down to the ground after having climbed over partitions and through the 2-foot high tunnels over or under the rest rooms

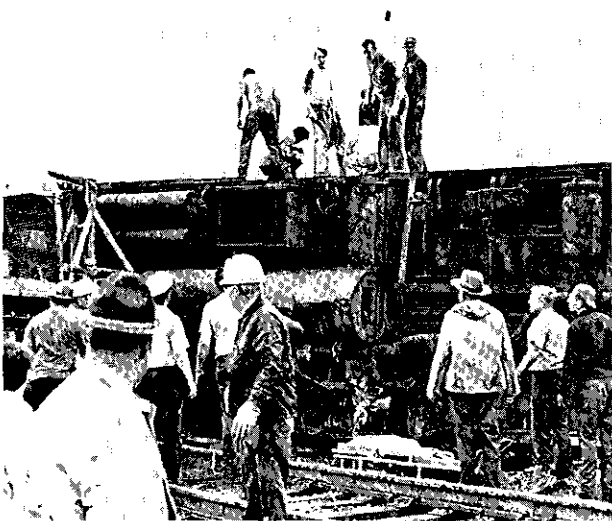
b Some were rescued by being lifted up through windows by means of ropes

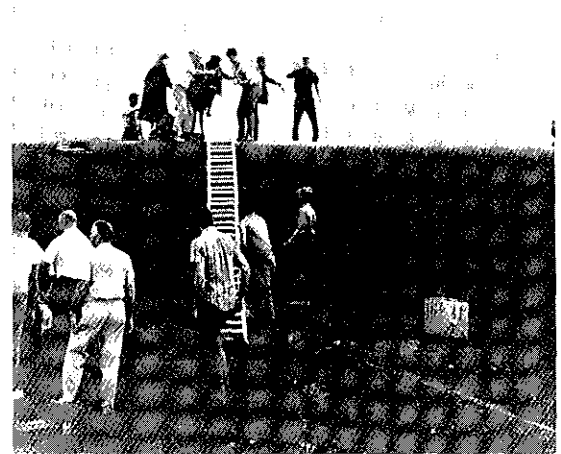
c Other rescue workers brought ladders to assist passengers to the ground after they climbed up the seats and out the windows

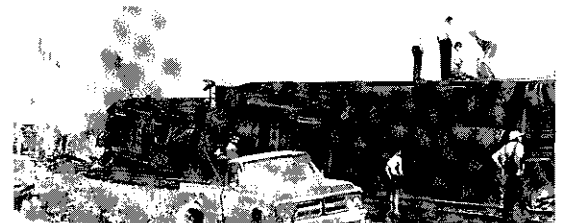
Figure 14

The bending of the roofs downwards caused the metal ceiling to separate, producing sharp edges in three of the overturned cars.⁸ (See Figure 13.) The deformation of the superstructure of the cars not only caused injuries but made rescue of the passengers extremely difficult. The passageways at the ends of the cars were either blocked or difficult to use, and with no emergency exits, the passengers had to wait until the rescue personnel could break windows on the top sides and provide ladders for climbing out. (See Figure 14.)

d View of rescue workers lowering a ladder through a window they have knocked out to rescue passengers
