NATIONAL
TRANSPORTATION
SAFETY
BOARD

RAILROAD ACCIDENT REPORT

AMTRAK TRAIN 87 DERAILMENT
AFTER COLLIDING WITH INTERMODAL TRAILER
FROM CSXT TRAIN 176
SELMA, NORTH CAROLINA
MAY 16, 1994

Adopted: March 21, 1995
Notation 6420A

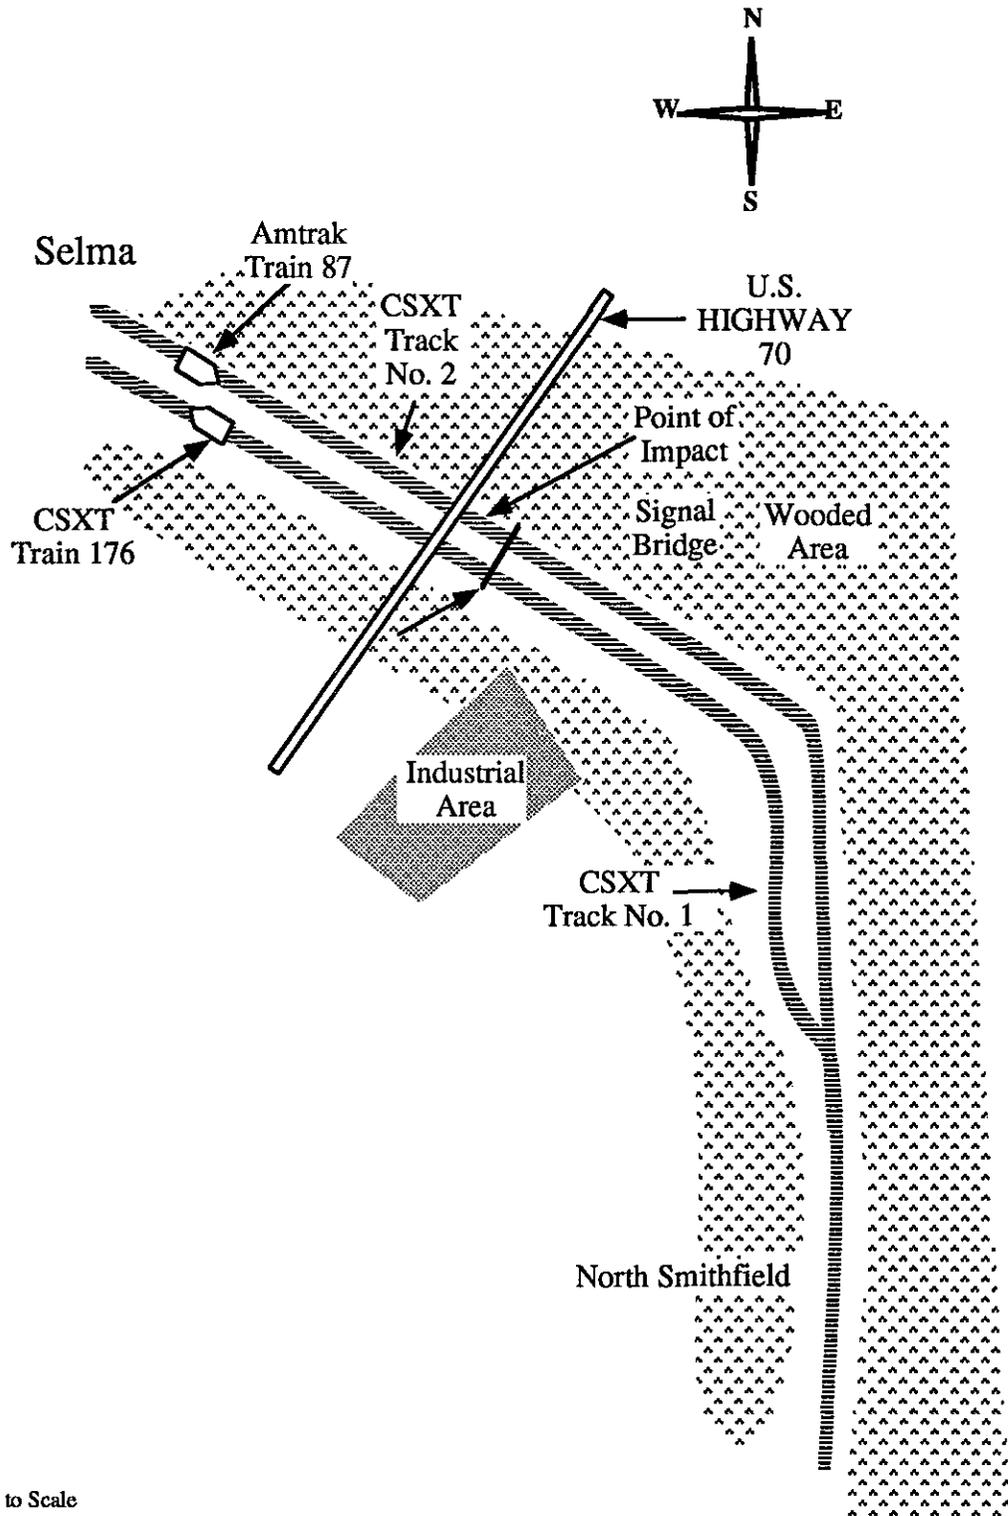
Figure 2. -- Track split from single (main track) to double (tracks 1 and 2).

The CSXT 176 engineer stated that the wayside signal at North Smithfield, North Carolina, where the track splits from single to double, had indicated that the freight train would be routed onto track 1. CSXT 176 proceeded northward from the main track onto track 1 between North Smithfield and Selma. (See figure 2) The CSXT 176 crew received a clear signal indication⁵ at the MP A164 4 signal as they saw Amtrak train 87 approach their location. Both the engineer and the conductor on CSXT 176 said they inspected southbound Amtrak train 87 passing on track 2. Once the passenger train had passed the lead unit on CSXT 176, the conductor radioed Amtrak train 87 and said the passenger train "looked good." Seconds later CSXT 176 went into unplanned emergency braking.

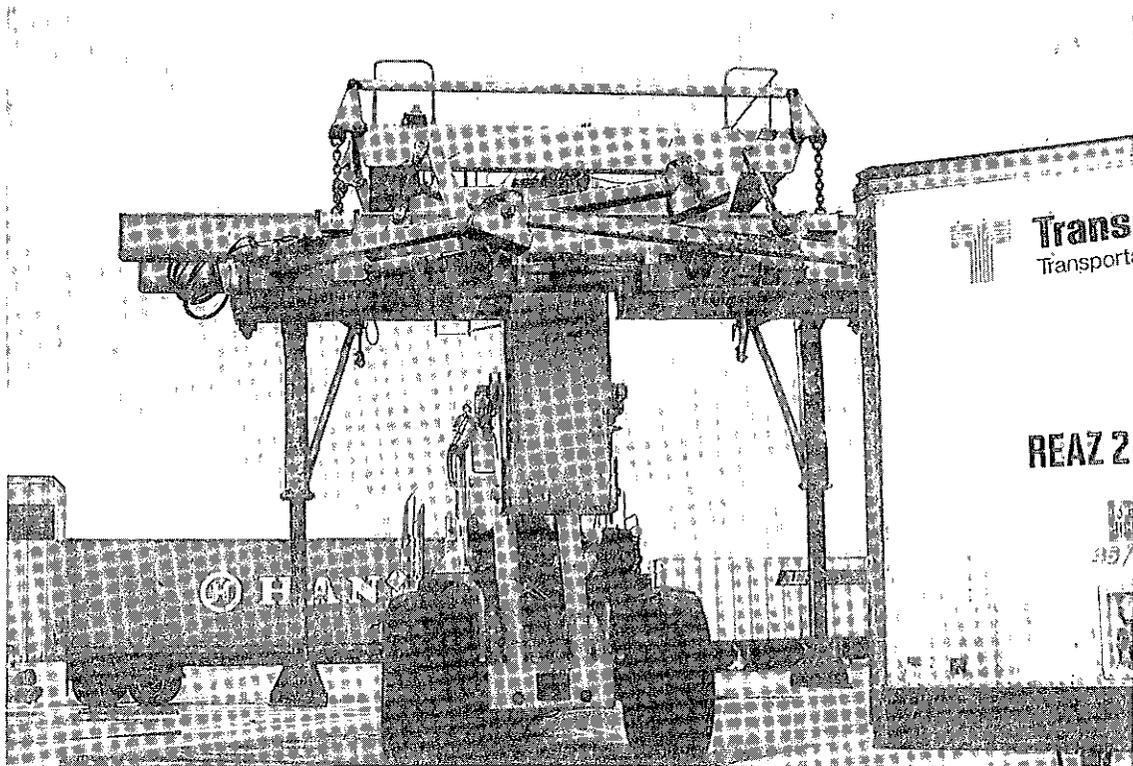
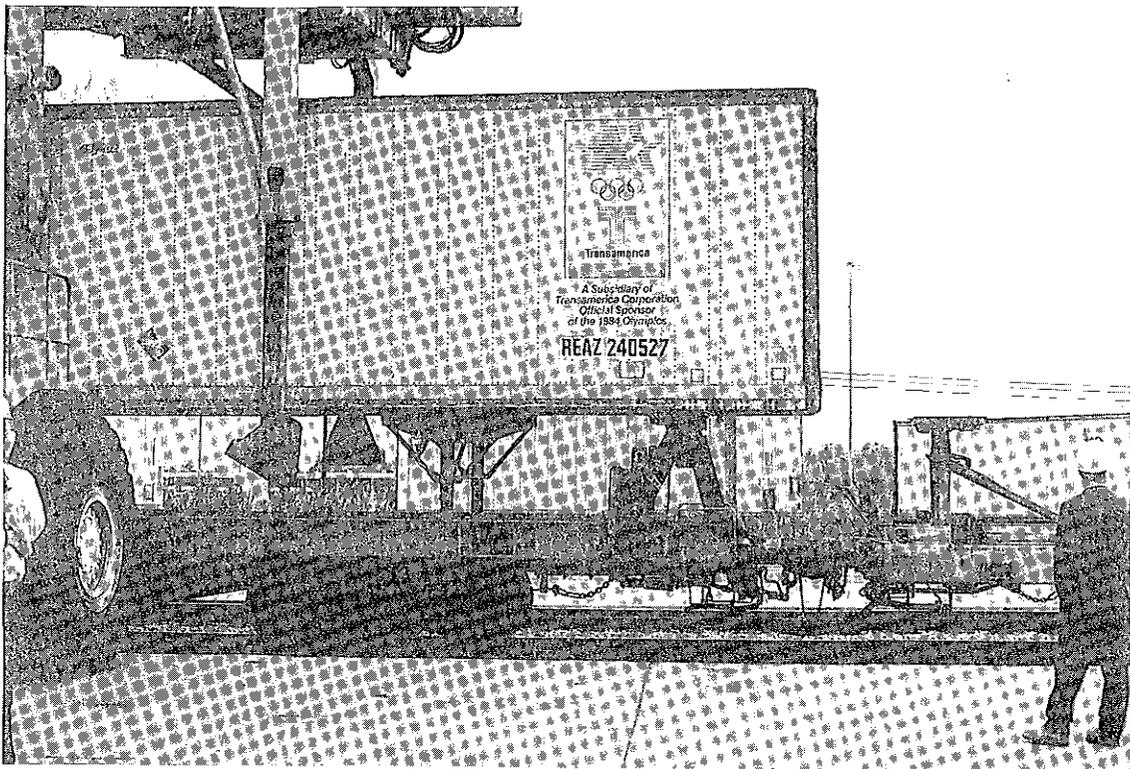
Figure 4. -- Trailer being loaded on flat car.

The packer operates a large, modified, hydraulic forklift, which is used to side-load trailers onto or off the railroad flat cars, he follows the hand signal directions of a groundman The rubber-tired hydraulic loader has a special attaching device for intermodal trailers It has two fixed and two folding legs that hang down on either side of a trailer, and the protruding feet at the end of each leg extend under the bottom side of the trailer for lifting (See figure 4)

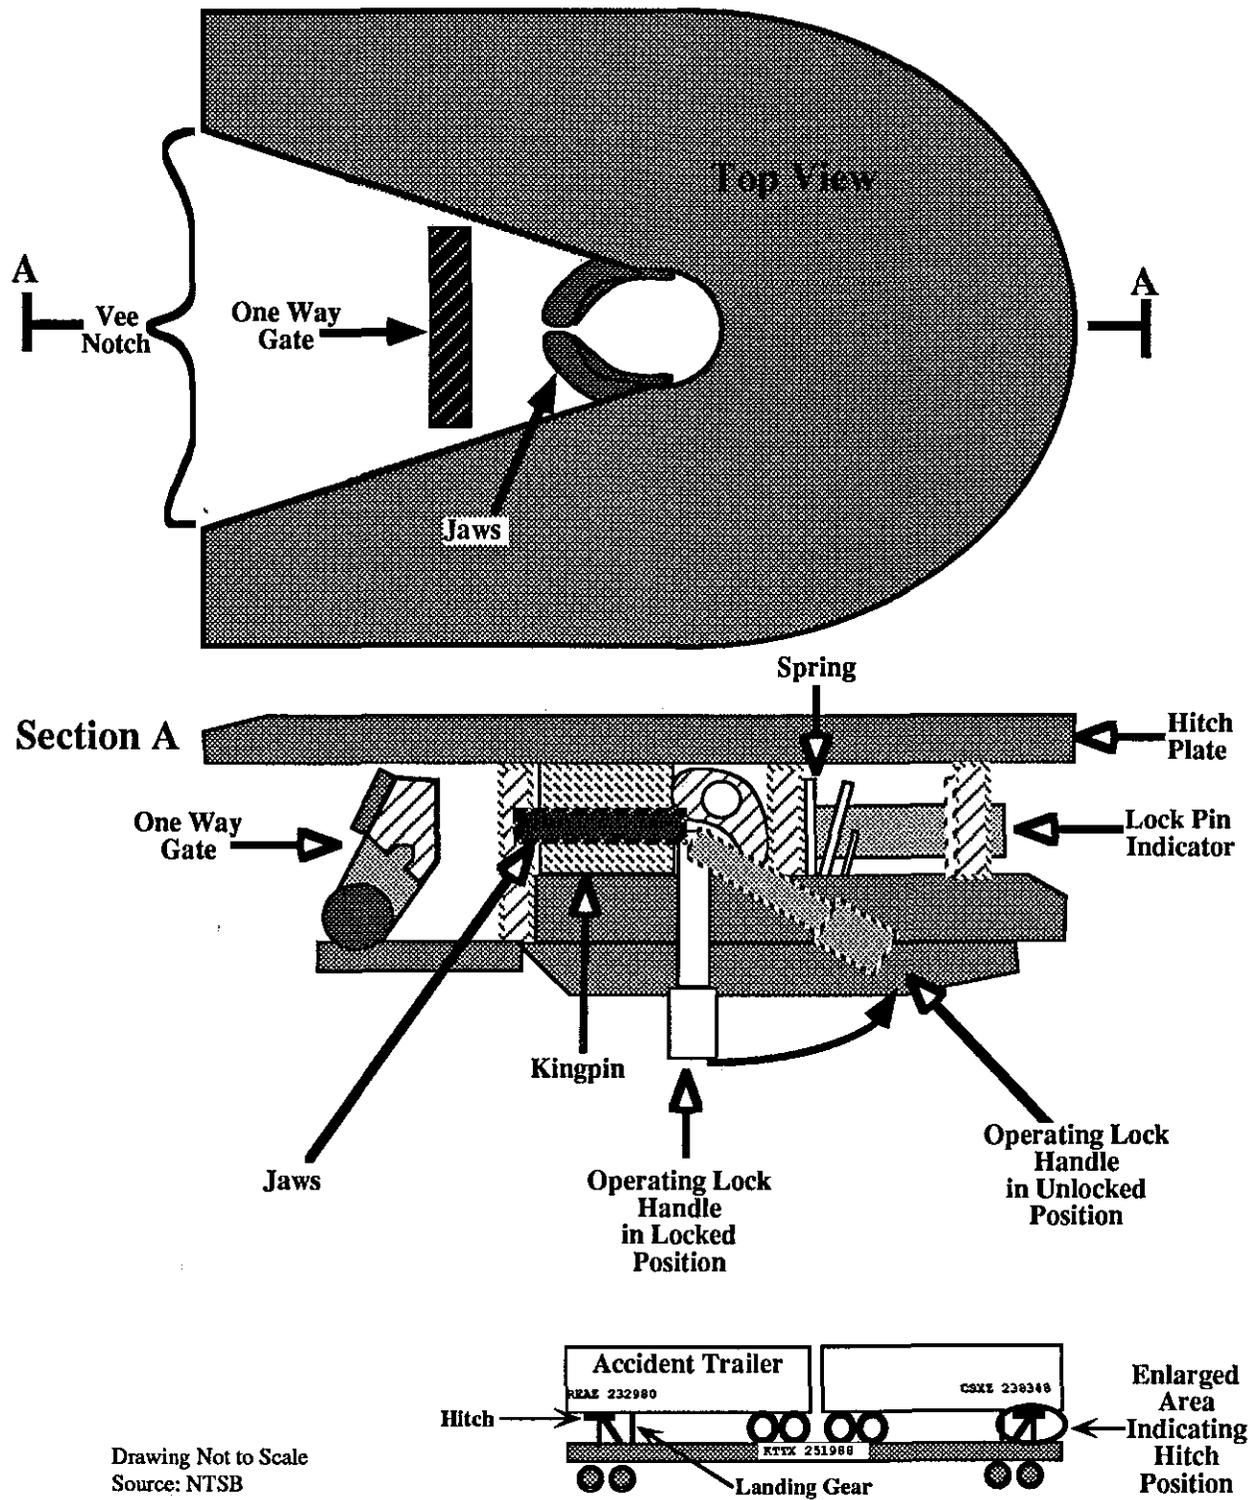
Figure 5. -- Intermodal trailer type III hitch and kingpin.

Three basic hitch designs,¹⁶ which includes type III, are found in intermodal trailer service. Type II and type III hitch heads have the same basic major parts that include a slotted top plate, a one-way gate at the entrance to the slot, a locking device within the slot, and operating or unlocking handles on each side (See figure 5)

movement of the kingpin horizontally into but not out of the slot, is a redundant safety feature to ensure a kingpin does not slide forward beyond the hitch should the locking mechanism fail. The hitch is designed that should a kingpin not be moved completely rearward into the locking jaws during loading, the one-way gate will remain depressed and, thus, not prevent the kingpin from moving out of the hitch.
