RAILROAD ACCIDENT REPORT

DERAILMENT OF
AMTRAK PASSENGER TRAIN NO. 21
ON THE ILLINOIS CENTRAL GULF RAILROAD
SPRINGFIELD, ILLINOIS
OCTOBER 30, 1980

NTSB-RAR-81-5

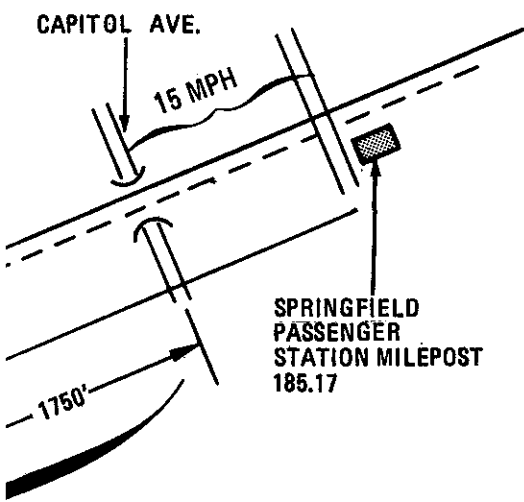
APPENDIX G

NATIONAL TRANSPORTATION SAFETY BOARD
 ACCIDENT SITE AND TRACK DIAGRAM, ALTON DISTRICT
 ILLINOIS CENTRAL GULF RAILROAD - SPRINGFIELD TO H
 DERAILMENT OF AMTRAK NO.21 - OCTOBER 30, 1980
 SCALE: 1-INCH = 1,000 FEET
 TIMETABLE SPEED RESTRICTIONS FOR PASSENGER TRAIN
