NATIONAL TRANSPORTATION SAFETY BOARD

RAILROAD ACCIDENT REPORT

DERAILMENT OF
AMTRAK TRAIN NO. 21 (THE EAGLE)
ON THE MISSOURI PACIFIC RAILROAD
WOODLAWN, TEXAS
NOVEMBER 12, 1983

NTSB/RAR-85/01.

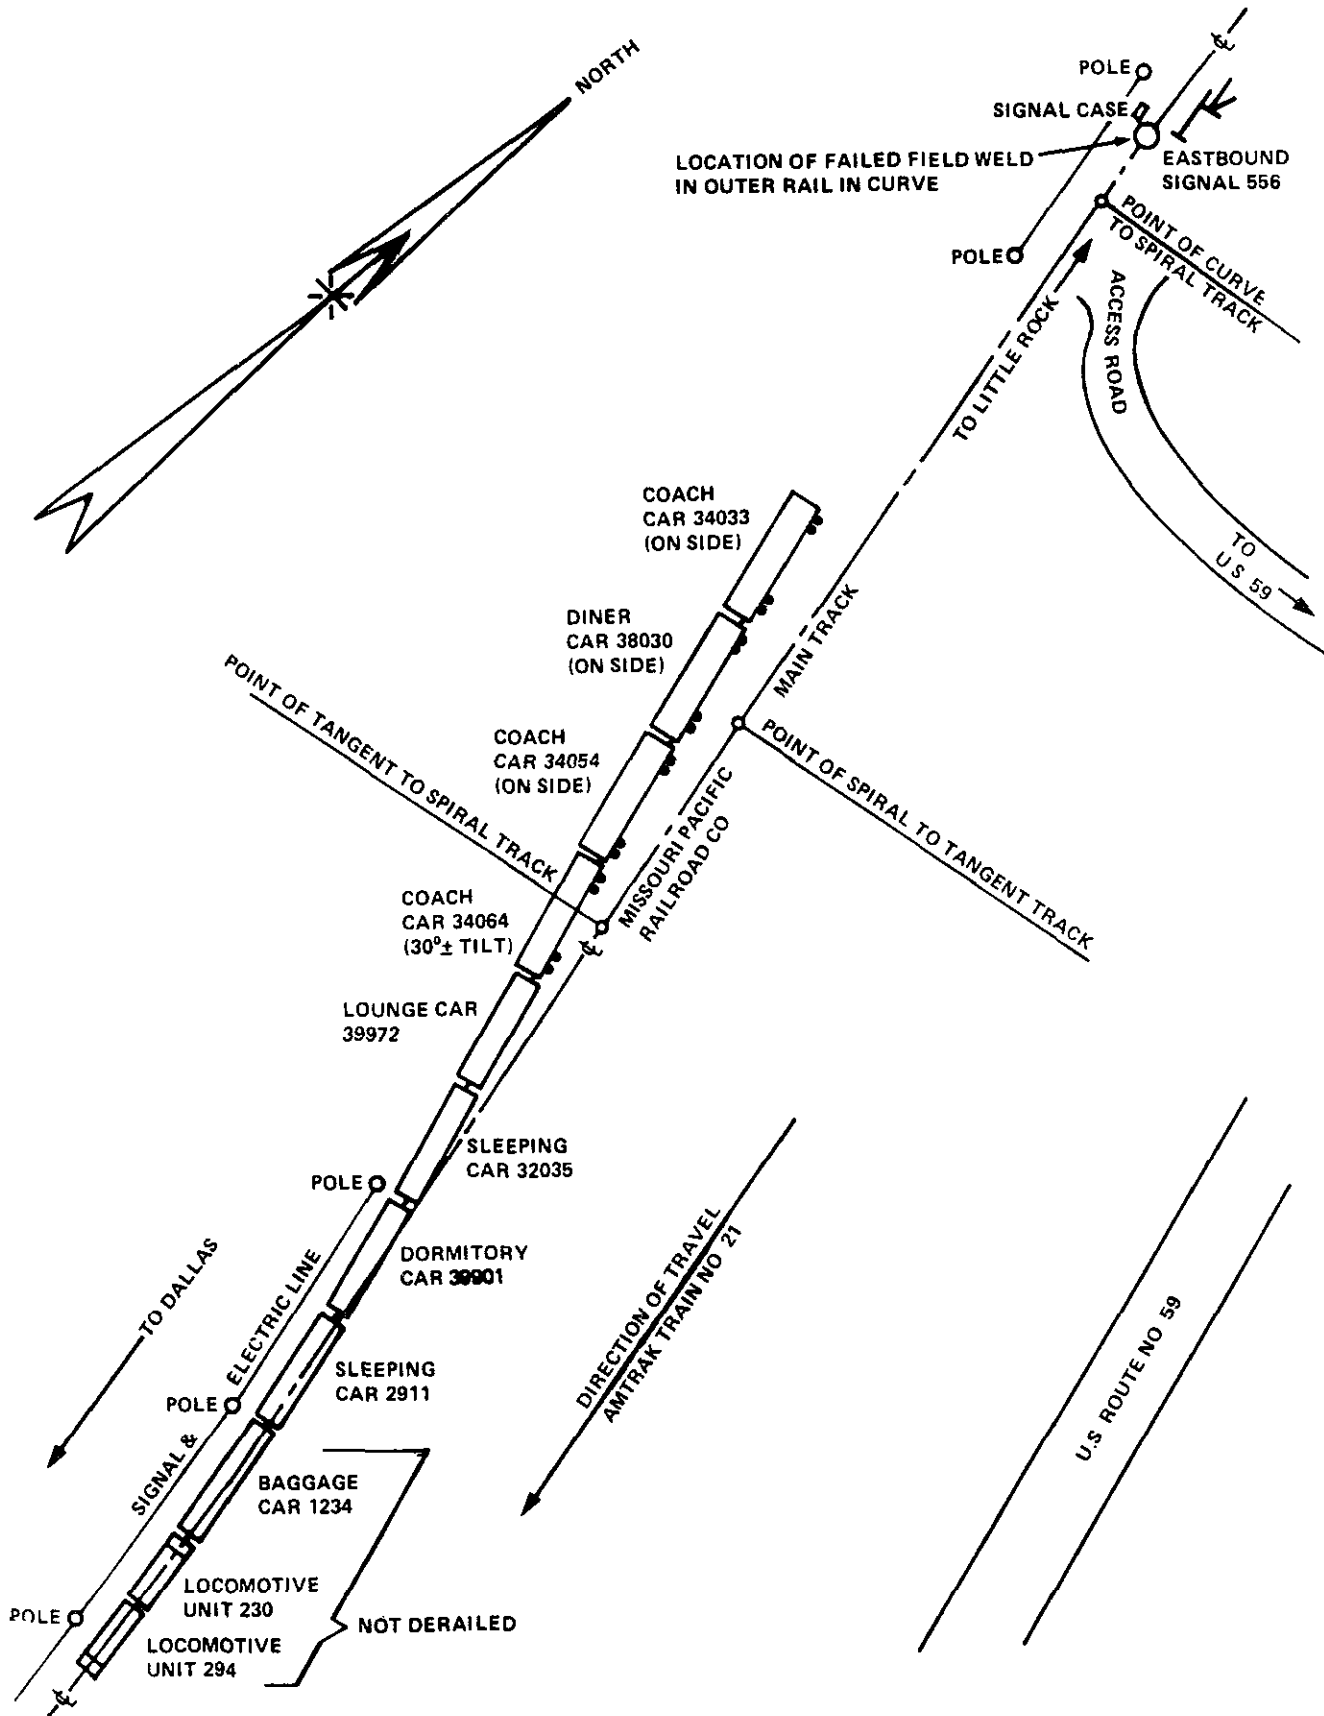
Figure 2.--Plan view of accident site.

Initial onsite examination of the chrome-vanadium alloy rail indicated the presence of a small crack in the web of the rail at a discontinuity in the torch-cut face near where the alloy rail was bolted to the south end of the standard-carbon insert. The break appeared to extend from that discontinuity through the web a distance of about 6 feet. Within the next 34 feet approximately, the rail was broken into between 50 and 100 pieces of various size.

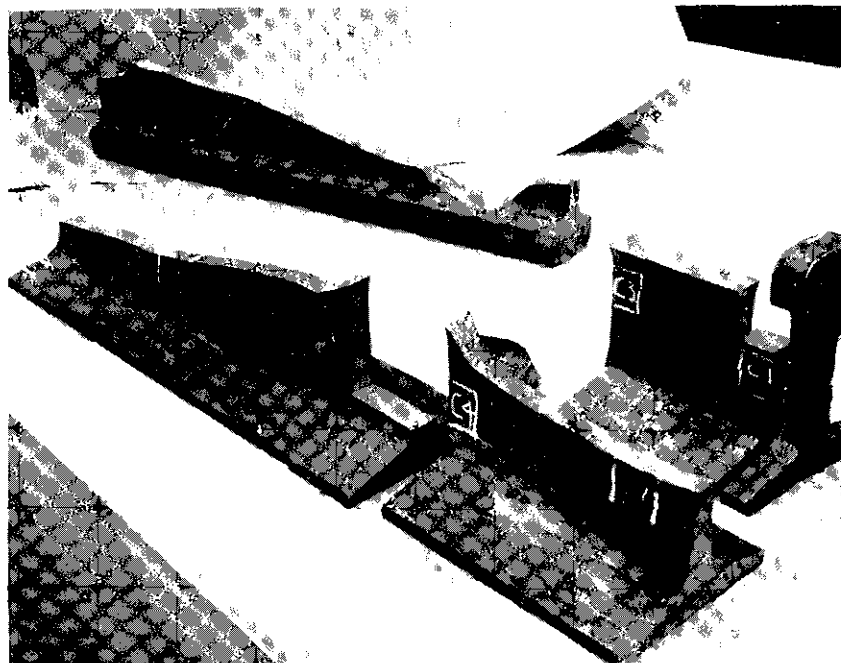
Figure 1. Location of test specimens in rail.
(a) view showing the location of hardness, tensile, impact, and chemistry (general) specimens,
(b) location of specimens used for hydrogen analysis.

In a letter dated April 9, 1984, the National Transportation Safety Board (NTSB) requested the National Bureau of Standards Fracture and Deformation Division to perform tensile tests, Charpy V-notch impact tests, Brinell hardness tests, and a chemical analysis, including hydrogen, on a high strength rail involved in the derailment of Amtrak Train Number 21. Specimen type, location, orientation, and designation was done by Mr. J. Wildey of the NTSB. The tensile and hardness survey specimens were taken from the railhead. The Charpy and chemistry specimens were taken from the web plate. The locations in the rail from which the specimens were taken are shown in Figure 1.
