RAILROAD ACCIDENT REPORT

REAR-END COLLISION OF
AMTRAK/MASSACHUSETTS BAY
TRANSPORTATION AUTHORITY COMMUTER TRAINS,
BOSTON, MASSACHUSETTS,
NOVEMBER 12, 1987

NTSB/RAR-88/05

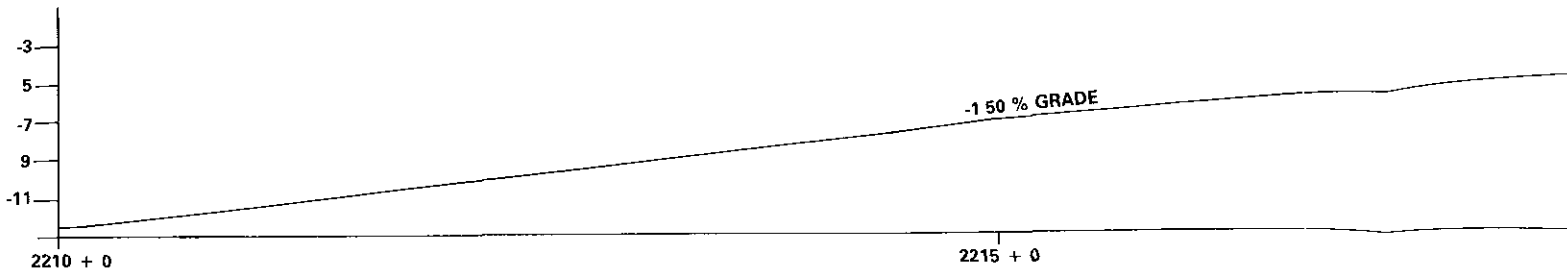
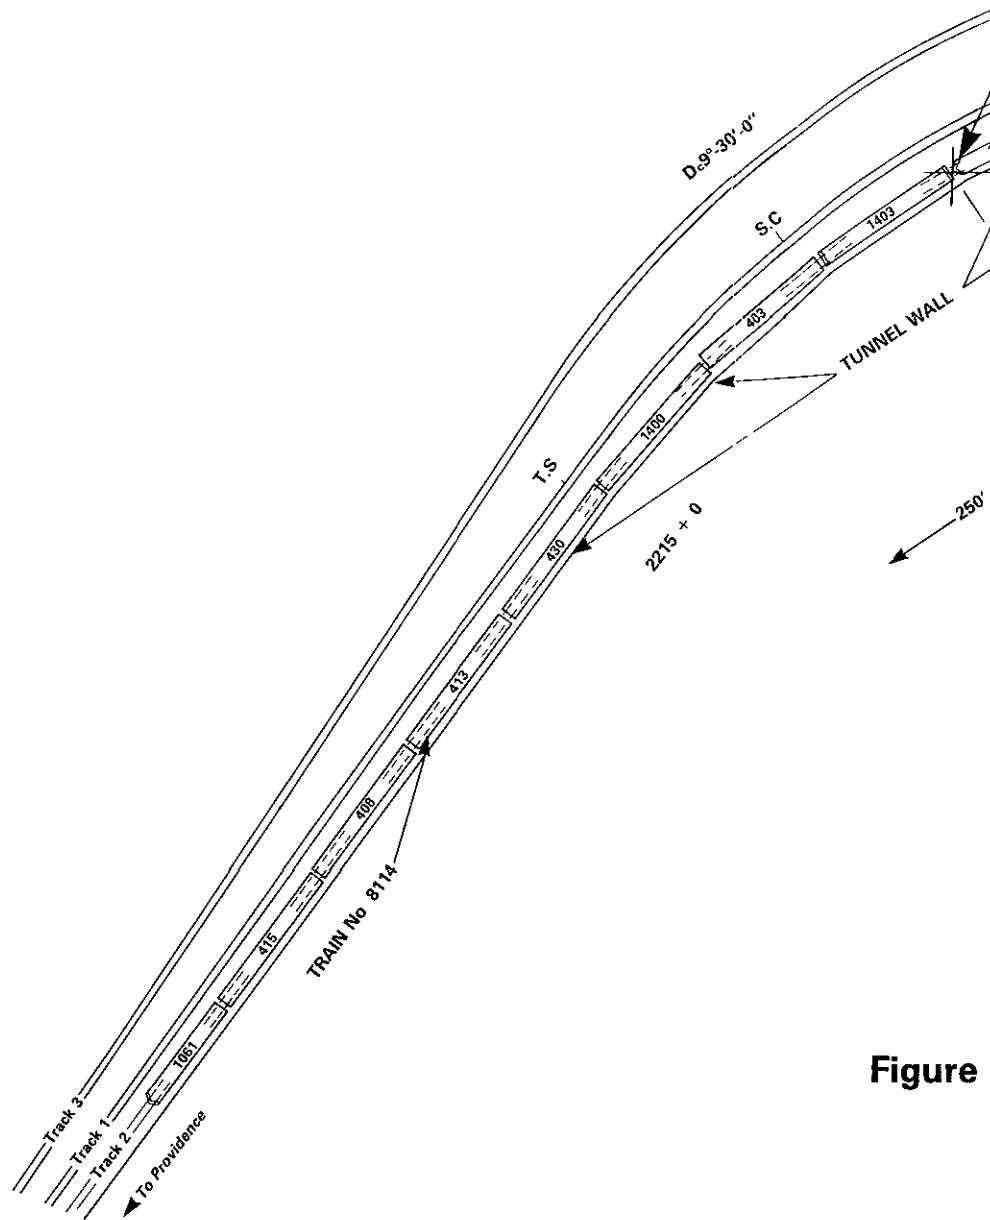
Figure :

The engineer said that as train 8110 rounded the curve approaching the Back Bay station platform, he observed train 8910 stopped at the platform. (See figure 2.) Because only about two car lengths of platform space remained behind train 8910, the engineer of train 8110 stopped his train short of the platform to prevent any passengers from detraining. Train 8110's engineer then radioed train 8910's engineer to request that train 8910 pull forward. After train 8910's engineer complied with that request, train 8110's engineer pulled his train forward so that the head 3 1/2 cars were stopped adjacent to the station platform.
