NATIONAL TRANSPORTATION SAFETY BOARD

RAILROAD ACCIDENT REPORT

ATCHISON, TOPEKA AND
SANTA FE RAILWAY COMPANY (ATSF)
FREIGHT TRAINS ATSF 818 AND ATSF 891
ON THE ATSF RAILWAY
CORONA, CALIFORNIA
NOVEMBER 7, 1990

ADOPTED: July 23, 1991
NOTATION: 5413A

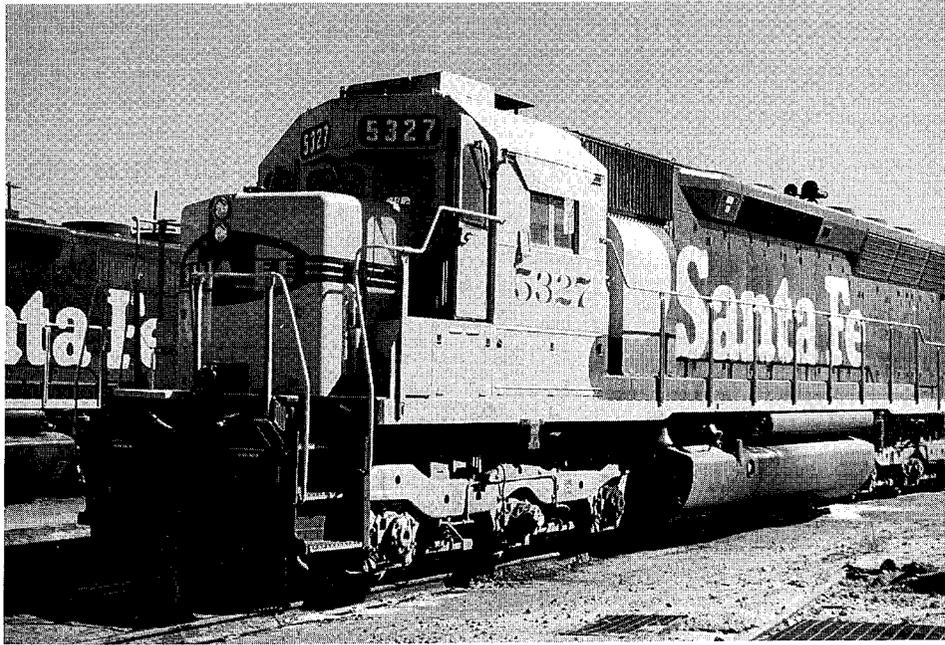
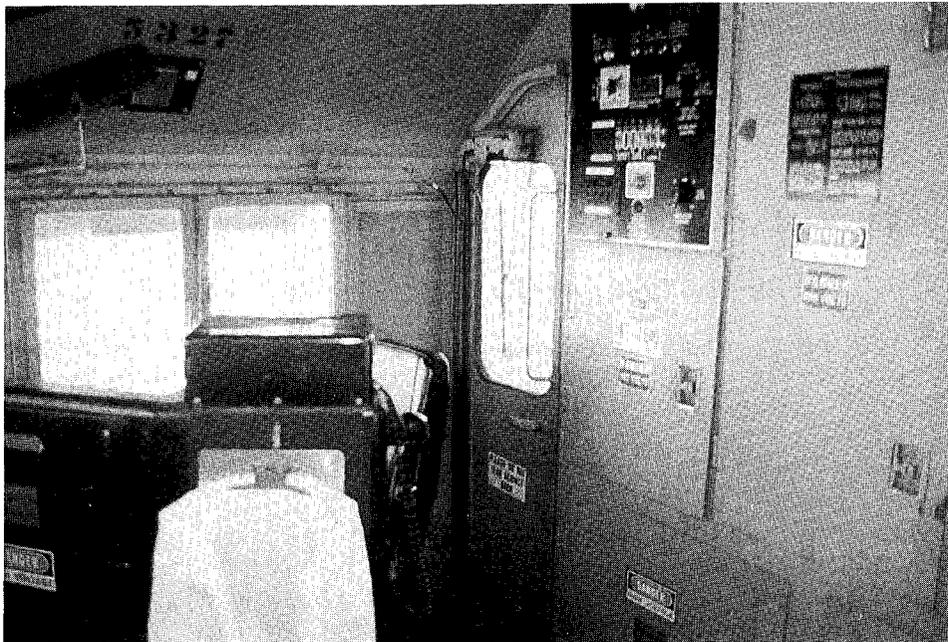
Figure 2.--SD-45 locomotive.
Top: General Motors Electro-Motive Division.
Bottom: Engineer's control stand.

The SD 45 locomotive had 11-gauge (or 0.125) mild steel in its nose section. The collision posts on the SD-45 were 59 inches high on the left and 54 inches high on the right. Both posts were made of mild steel with a specified minimum yield strength of 27,000 pounds per square inch (psi). See figure 2 for a photograph of an SD-45 locomotive.

The SD-45 was equipped with a two-piece center horizontal windshield and a right front vertical windshield. Each side of the control compartment had two operable slide-type side windows. One rear fixed vertical observation window was at the left rear of the control compartment.

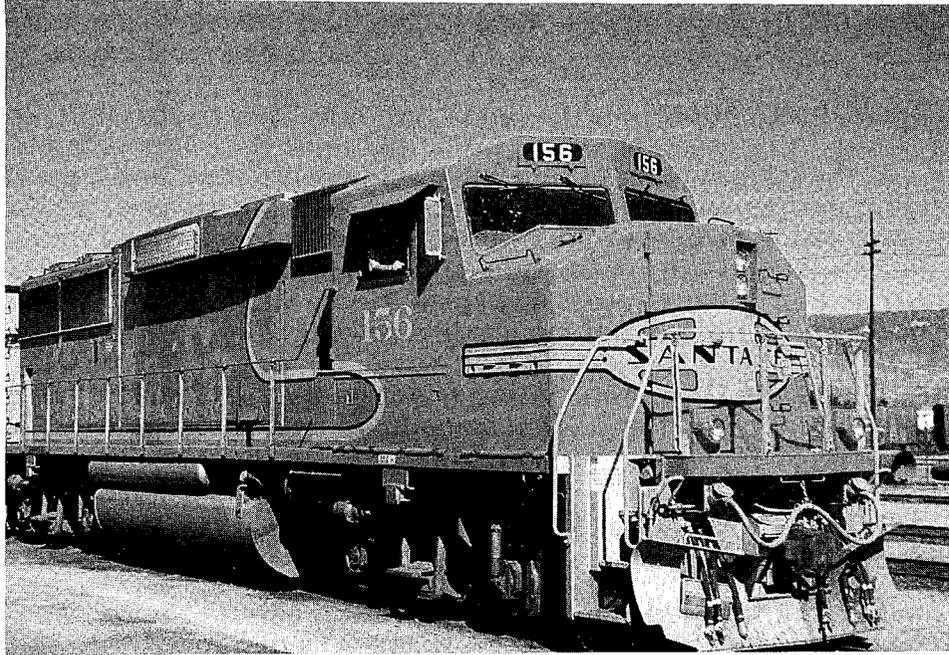
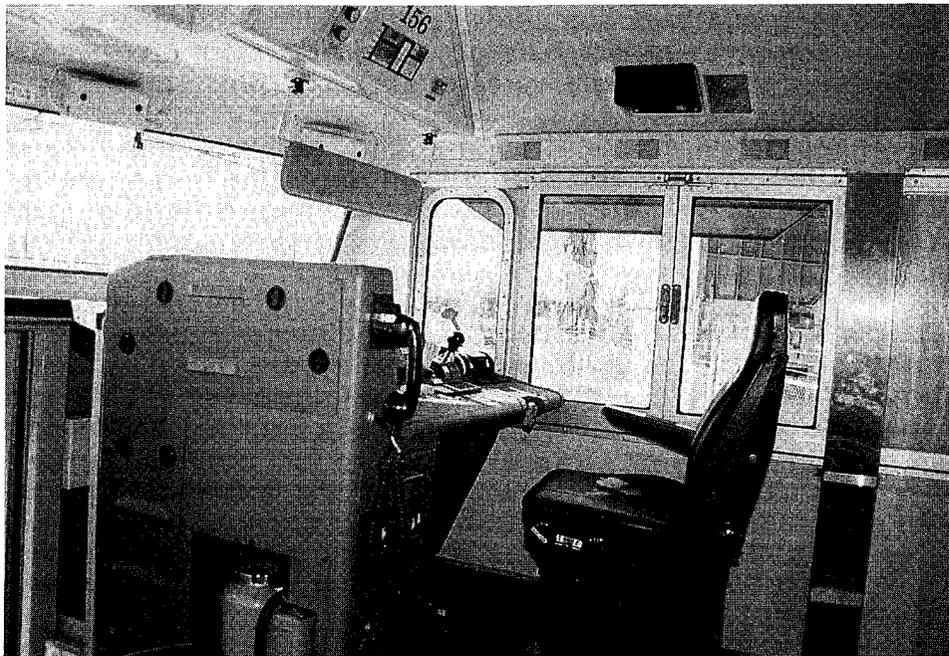
Figure 3.--GP-60M.
Top: General Motors Electro-Motive Division.
Bottom: Engineer's console.

ATSF 891--Train 891's locomotive consist had ATSF 137 (EMD-GP 60M), ATSF 147 (EMD-GP 60M), and ATSF 152 (EMD-GP 60M). The control compartments of the first and second locomotives faced east, while the control compartment of the third locomotive faced west. Figure 3 is a photograph of a GP-60M locomotive. The train had 47 rail cars, all of which were flat cars carrying either highway trailers or containers.

The forward entrance of the GP-60M was a heavy metal windowless door on the right side of the front wall. The exterior door led to a small vestibule in which an interior door led up two steps to the control compartment. The rear-entrance door, which had a fixed upper vertical window, was at the right rear of the control compartment, or behind the engineer's seat. The door led out to the right-side walkway, which ran alongside the engine compartment. Figure 3 also illustrates the interior of the GP-60M control compartment.

The control compartment had a two-piece windshield, two operable sliding side windows (one on each side), and a fixed left-rear window. The rear wall had an electrical cabinet.

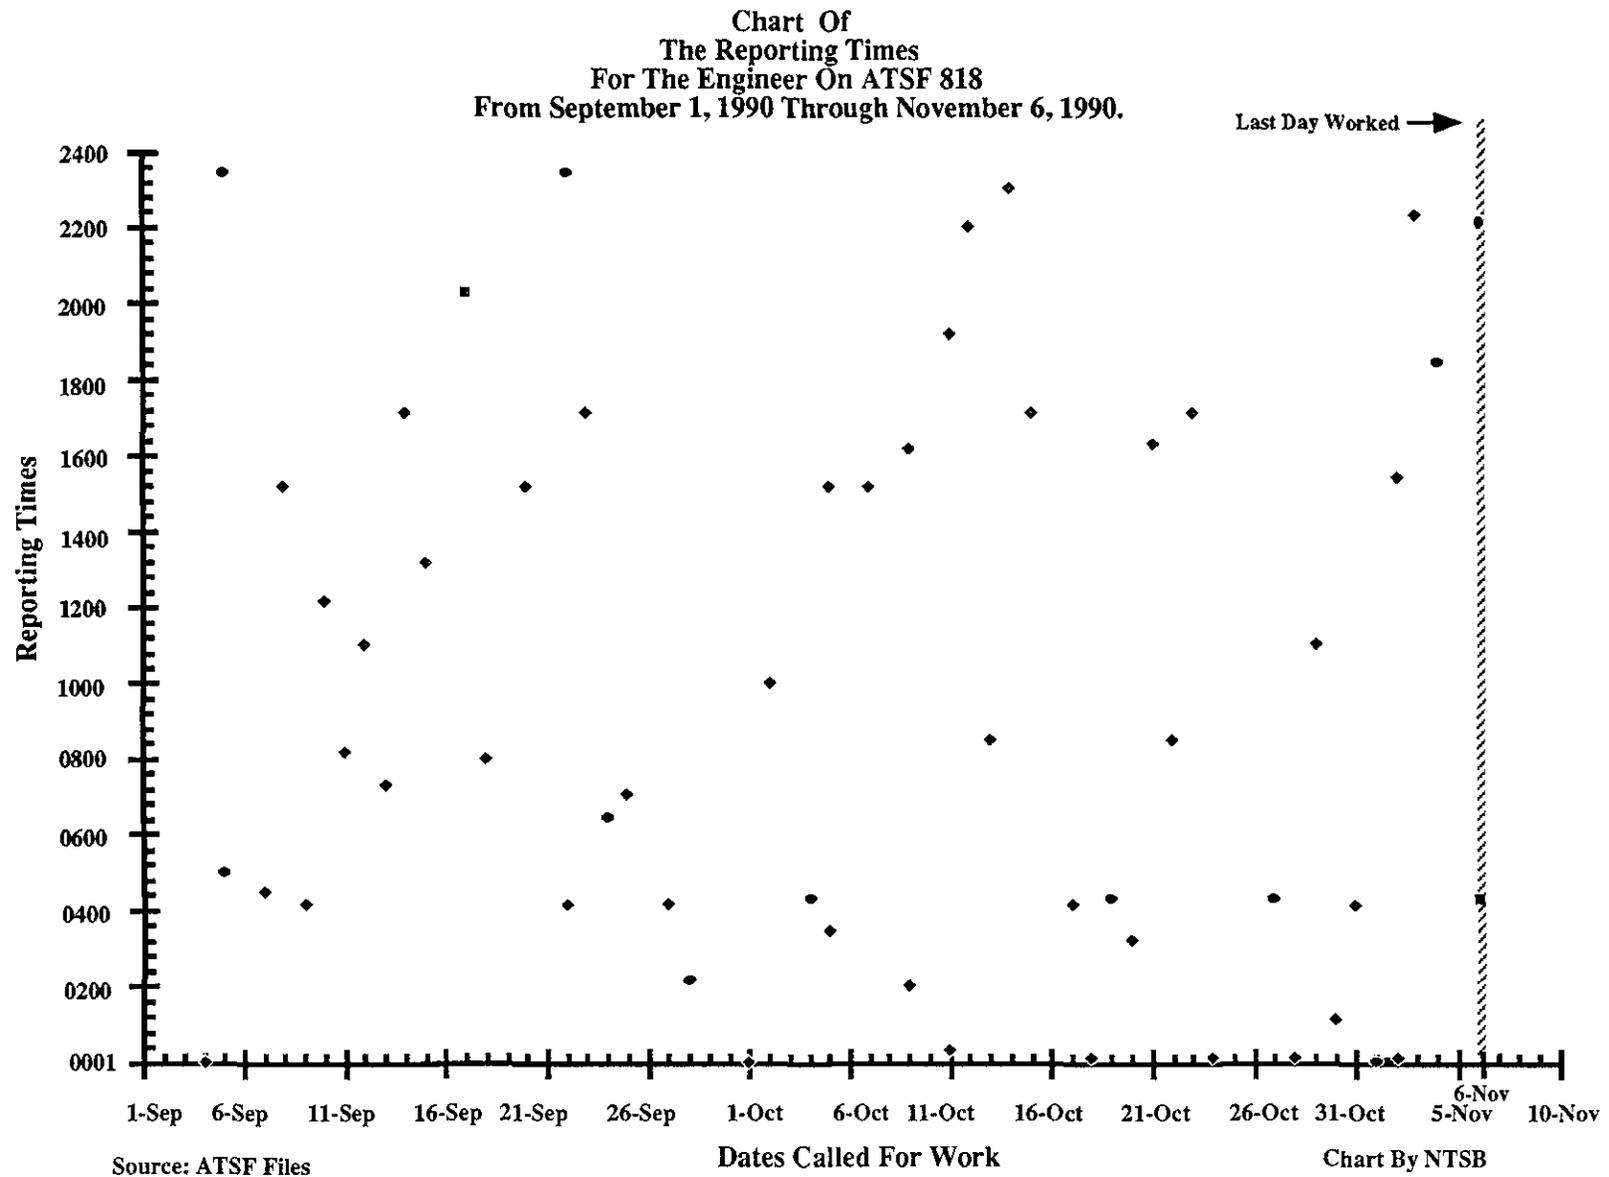
Figure 4.-- Reporting times for the engineer of train 818 from September through November 1990.

In the 64 days from September 5 through November 7, he worked 47 calendar days. His tours included 3 in yard service and 53 in road service;¹⁶ of the 56 tours, 7 were deadheaded. On seven occasions, he had two tours of duty that started on the same calendar day. (See figure 4.)

Figure 4 illustrates the variation in his reporting time during the 64 days before the accident On April 1, 1989, Hobart yard became the home terminal for operating personnel, including the engineer of train 818, whose home terminal had been San Bernardino He continued to live in the San Bernardino area; his commuting time increased from 10 or 15 minutes to, depending on the traffic, 1 1/2 to 2 1/2 hours.¹⁸

On 25 occasions he reported to work 8 hours or more later than he had on the previous day, meaning that he changed shifts 46 percent of the time. Figure 4 summarizes this information.
