PB90-917007  
NTSB/RHR-90/01

## RAILROAD/HIGHWAY ACCIDENT REPORT

COLLISION OF AMTRAK PASSENGER TRAIN NO. 708  
ON ATCHISON, TOPEKA AND SANTA FE RAILWAY  
WITH TAB WAREHOUSE AND DISTRIBUTION CO.  
TRACTOR-SEMITRAILER  
STOCKTON, CALIFORNIA  
DECEMBER 19, 1989

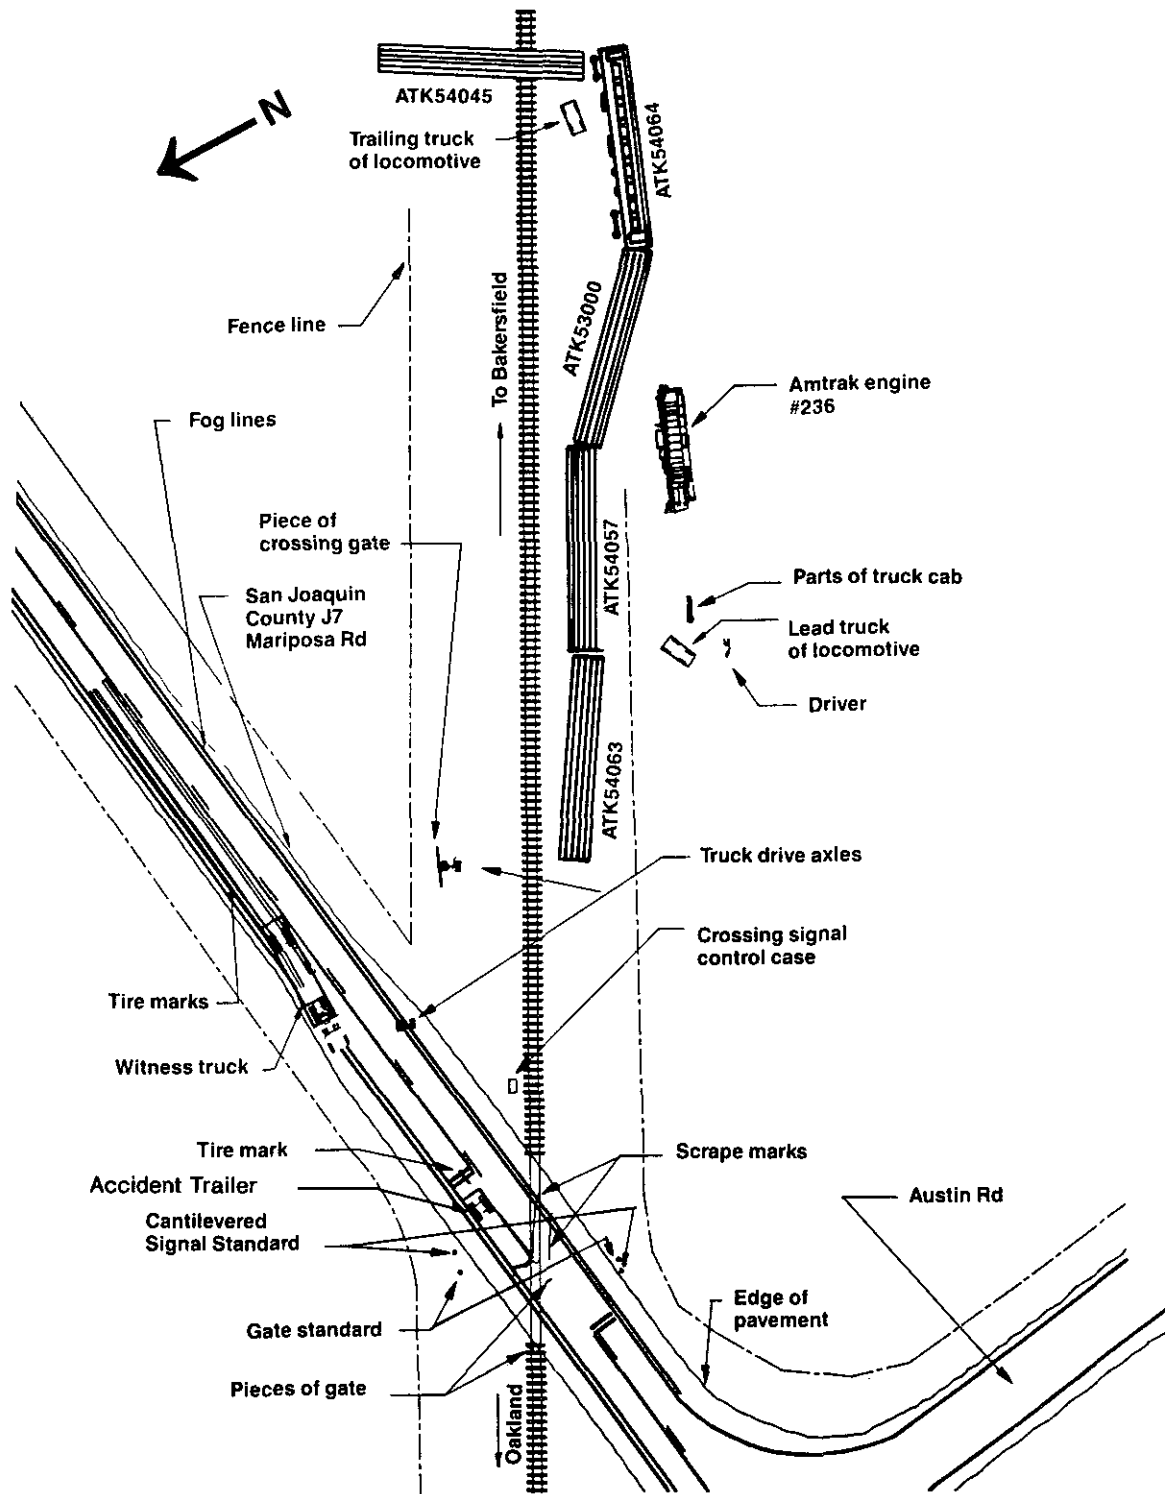
Figure 2--Diagram of crossing/derailment site.

The collision derailed the locomotive and all five passenger cars. A fire ensued after the train collided with the truck. The accident truck left tire marks about 6 feet long about 50 feet from the crossing. The train came to rest about 480 feet east of the crossing. The engineer, fireman, and truckdriver were killed in the collision and fire. The body of the engineer was found on the ground adjacent to the locomotive, and the body of the fireman was found in the locomotive cab. The tractor and the front section of the semitrailer were destroyed and scattered about the crossing area. The body of the truckdriver was found about 250 feet east of the crossing.

Damages--In the derailment the locomotive unit (#236) separated from the passenger cars and turned 180 degrees coming to rest on the fireman (left) side in a trackside ditch. (See figure 2.) The cab compartment and nose of the locomotive suffered collision damage. The roof of the cab was displaced downward so that the top of the windshield opening was just above hood level. Both windshield halves and side glass had been displaced from their original position. The interior sustained extensive fire damage both in the cab and engine room compartments. The fire damaged all gauges, control valves, and relays, as well as consuming the Barco speed recorder paper tape. The trucks separated from the locomotive in the derailment resulting in extensive damage to the truck frames, bearings, and traction motors. (See figure 3.)
