INVESTIGATION NO. 2597
THE ATCHISON, TOPEKA & SANTA FE RAILWAY COMPANY
REPORT IN RE ACCIDENT
NEAR CALZONA, CALIF., ON
JUNE 25, 1942

Accident near Calzona, Calif., on June 25, 1942, caused by
a bridge being burned out.

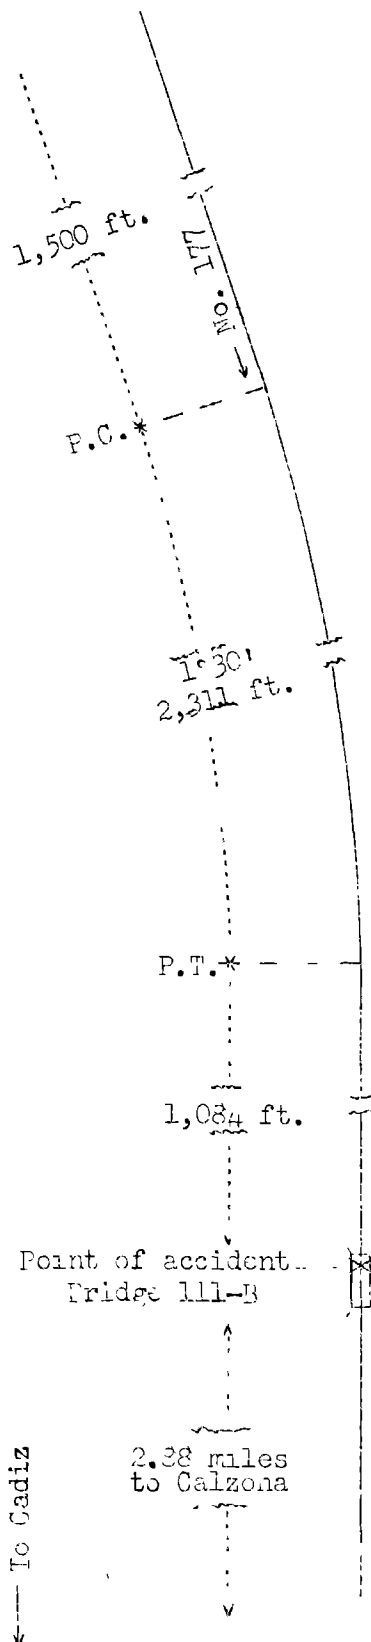
Inv-2597
Atchison, Topeka & Santa Fe Railway
Calzona, Calif.
June 25, 1942

- o Parker, Ariz.
1.5 mi.
- o Larp, Calif.
3.92 mi.
- X Point of accident
2.88 mi.
- o Calzona
76.4 mi.
- o Cadiz, Calif.
