RAILROAD ACCIDENT INVESTIGATION

Report No 4007

THE ATCHISON, TOPEKA AND SANTA FE RAILWAY COMPANY

April 5, 1964

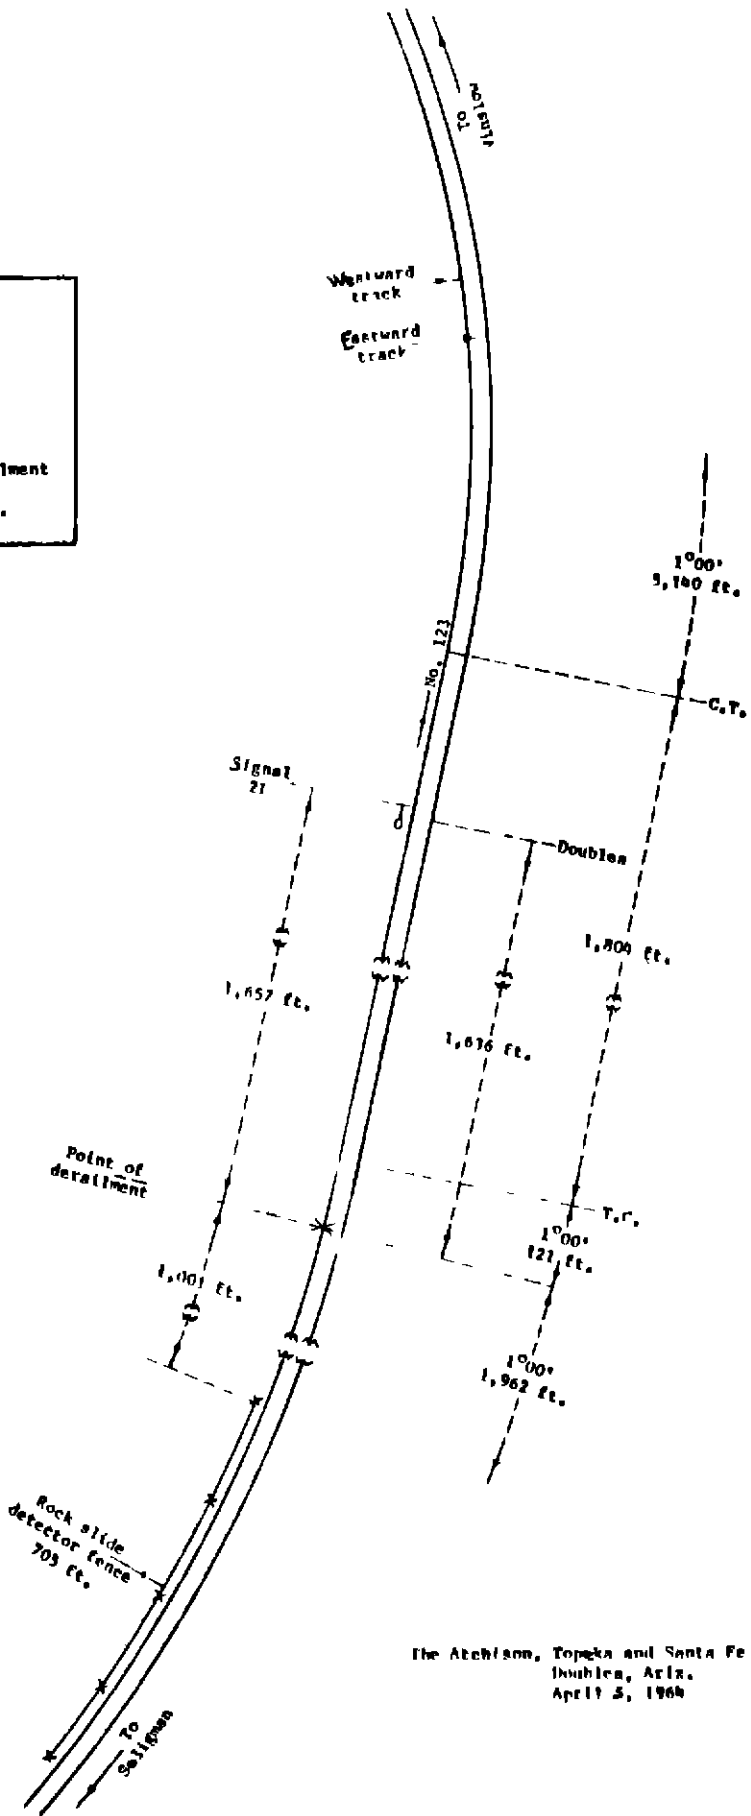
The Atchison, Topeka and Santa Fe Railway
 Double, Ariz.
 April 5, 1964

- Winslow, Ariz. 58.7 mi.
- Flagstaff 30.4 mi.
- Williams Jct. 20.5 mi.
- Double 0.3 mi.
- ✕ Point of derailment 33.4 mi.
- Saligman, Ariz.
