INVESTIGATION NO. 2847

THE ATLANTIC COAST LINE RAILROAD COMPANY

REPORT IN RE ACCIDENT

NEAR HORTENSE, GA., ON

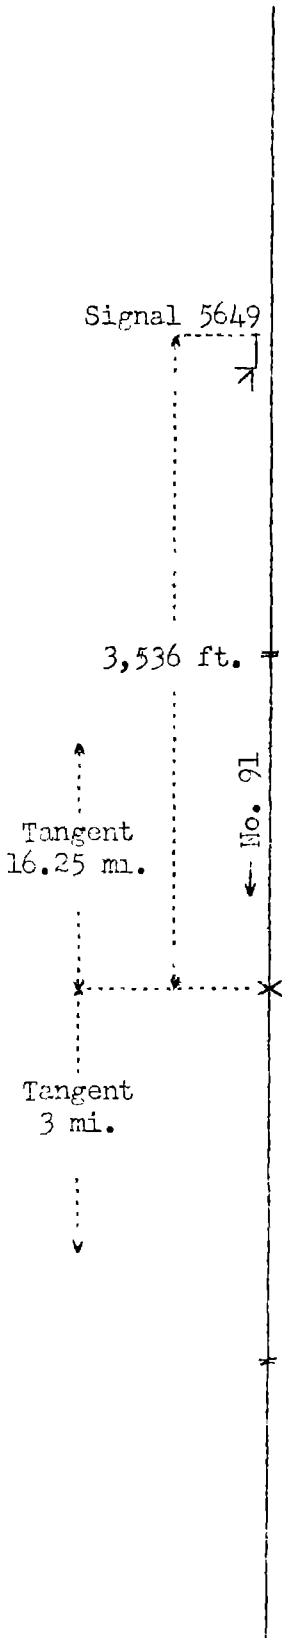
Sketch showing location of transverse fissure

After the accident a broken rail was found on the east side of the track. The rail was broken in many pieces, 10 of which were recovered. The pieces were scattered throughout a considerable distance south of the point of derailment. The first break occurred between two ties at a point about 12 inches south of the receiving end of the rail. Through the head of the rail the break was practically flush with the south ends of the angle bars, but through the base it was about 1 inch south of the south ends of the angle bars. Through the web of the rail the break was north of the bond-wire connection. This piece of rail, the rail to which it was attached, and several rails from each side of the track were displaced from their normal locations as a result of the derailment. At the first break there was a transverse fissure which covered 70 percent of the cross-sectional area of the head of the rail and had progressed very close to the outer surface. The battered condition of the rail at the south end of this break indicated that this failure had occurred some time prior to the accident. Wheel marks on the north end of the rail at another break, which was 5 feet 4-1/2 inches south of the first break, indicated that the derailment occurred between these fractures. The other fractures appeared to have occurred during the derailment.

It is found that this accident was caused by a broken rail, as a result of the presence of a transverse fissure.
