INVESTIGATION NO. 2751
THE ATLANTIC COAST LINE RAILROAD COMPANY
REPORT IN RE ACCIDENT
NEAR RENNERT, N. C., ON
DECEMBER 16, 1943

Railroad: Atlantic Coast Line
Date: December 16, 1943
Location: Rennert, N. C.
Kind of accident: Side collision
Trains involved: Passenger : Passenger
Train numbers: 91 : 8
Engine numbers: Diesel-electric : Diesel-electric
units 515-753-514 : units 506-503-500
Consist: 18 cars : 16 cars
Estimated speed: Standing : 80 m. p. h.
Operation: Timetable, train orders and
automatic block-signal and
automatic train-stop system
Track: Double; tangent; 0.42 percent
descending grade northward
Weather: Clear
Time: About 1:30 a. m.
Casualties: 72 killed; 187 injured
Cause: Failure to provide adequate
protection for derailed cars
which fouled adjacent main track

Accident near Rennert, N. C., on December 16, 1943, caused
by failure to provide adequate protection for derailed
cars which fouled adjacent main track.

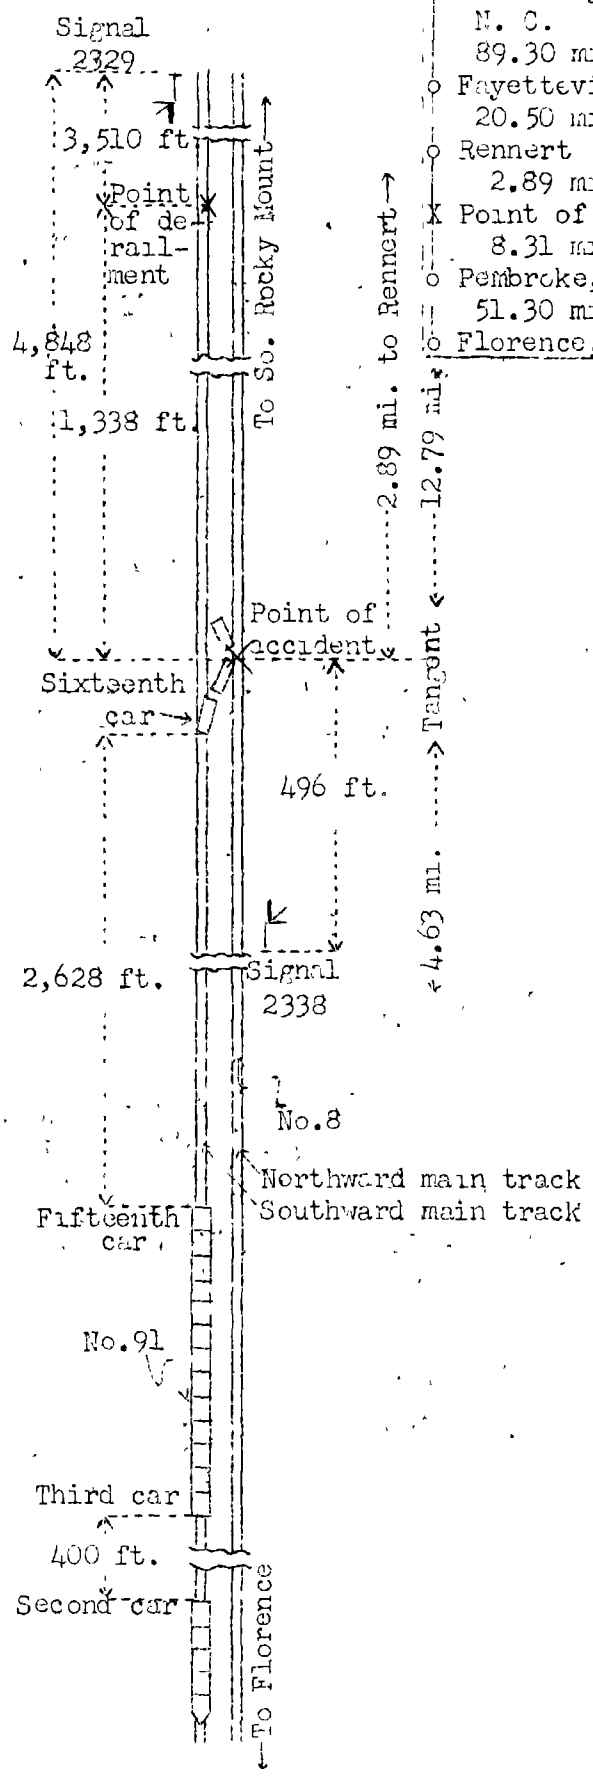
Inv. No. 2751
 Atlantic Coast Line Railroad
 Rennert, N. C.
 December 16, 1943

Sketch showing locations of fractures and transverse fissures in portion of rail recovered

After the accident a broken rail was found on the east side of the southward main track. The rail was broken into many pieces, 64 of which were recovered. The pieces were scattered throughout a distance of about 400 feet south of the point of derailment. The first break occurred between two ties at a point 5 feet 10-11/16 inches south of the receiving end of the rail. This piece of rail remained in normal position. At the first break there was a transverse fissure covering about 15 percent of the cross-sectional area of the head of the rail. At the second and third breaks, which occurred at points 7 feet 6-3/8 inches and 10 feet 2-1/8 inches south of the receiving end, there were transverse fissures covering, respectively, 1-1/2 percent and 15 percent of the cross-sectional area of the head. None of these fissures had progressed to the outer surface. Wheel marks on the rail at the south end of the third broken section indicated that the derailment occurred at that point. The other breaks in the rail appeared to have resulted during the derailment. Since the first automatic signal north of the broken rail displayed proceed and no abnormal condition of the track was felt when the front portion of No. 91 passed the point where the derailment occurred, it is apparent that the rail broke under the train. The track involved was last inspected by the section foreman from his motor-car on December 13, 1943, and no defective condition was found. A detector car was last operated over the track in this vicinity on October 17, 1943.
