REPORT NO. 3335
THE BALTIMORE AND OHIO RAILROAD COMPANY
IN RE ACCIDENT
NEAR EATON, W. VA., ON
JUNE 30, 1950

Date: June 30, 1950

Kind of accident: Derailment

Accident near Eaton, W. Va., on June 30, 1950, caused by a
broken rail.

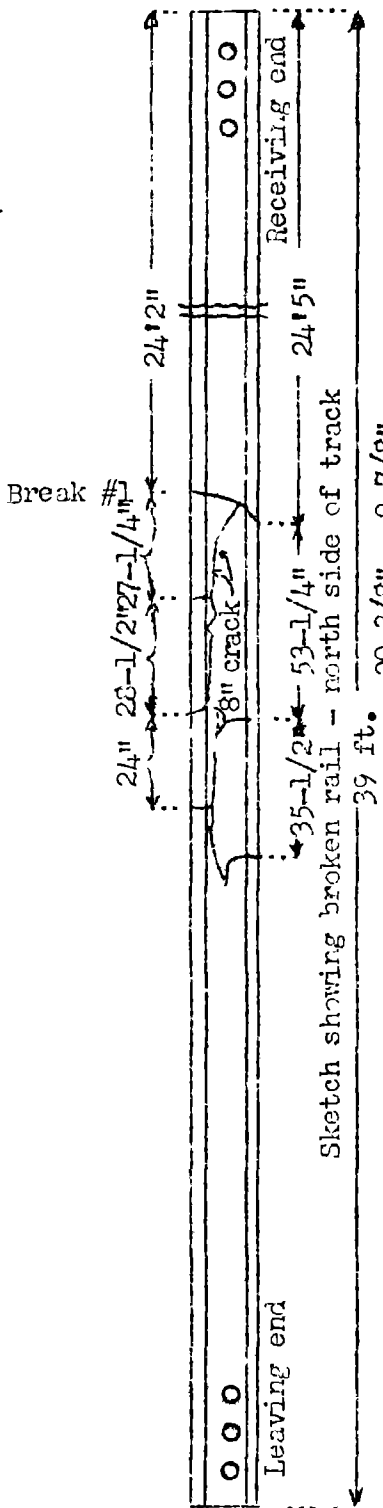
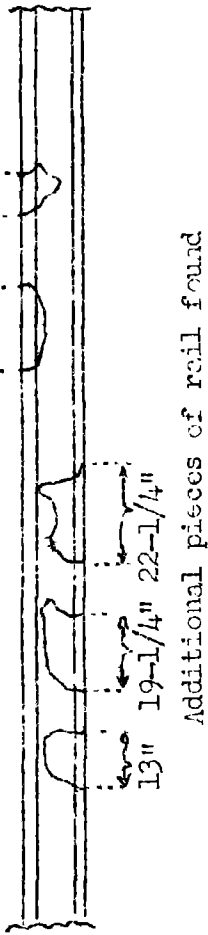
Additional pieces of rail found

After the accident occurred a broken rail was found on the north or high side of the curve. This rail was broken into many pieces, eleven of which, measuring from 9-7/8 inches to 53-1/4 inches in length, were recovered. The most easterly break occurred at a point 24 feet 2 inches west of the receiving end of the rail. Westward from this break, the rail was broken horizontally through the web a distance of 27-1/4 inches and then vertically through the head. Between points 12 inches and 20 inches west of the most easterly break, the adjacent surfaces of the horizontal break were worn smooth. This condition indicates that a break 8 inches long had existed for some time prior to the accident. All of the other breaks were new and apparently occurred as a result of the derailment. This rail was manufactured by the Illinois Steel Company in September, 1943, and was laid in the track the same year. The heat number was not legible.
