INVESTIGATION NO. 3229  
THE BALTIMORE AND OHIO RAILROAD COMPANY  
REPORT IN RE ACCIDENT  
AT SYKESVILLE, MD., ON  
JANUARY 22, 1949

Accident at Sykesville, Md., on January 22, 1949, caused  
by the overturning of a rail.

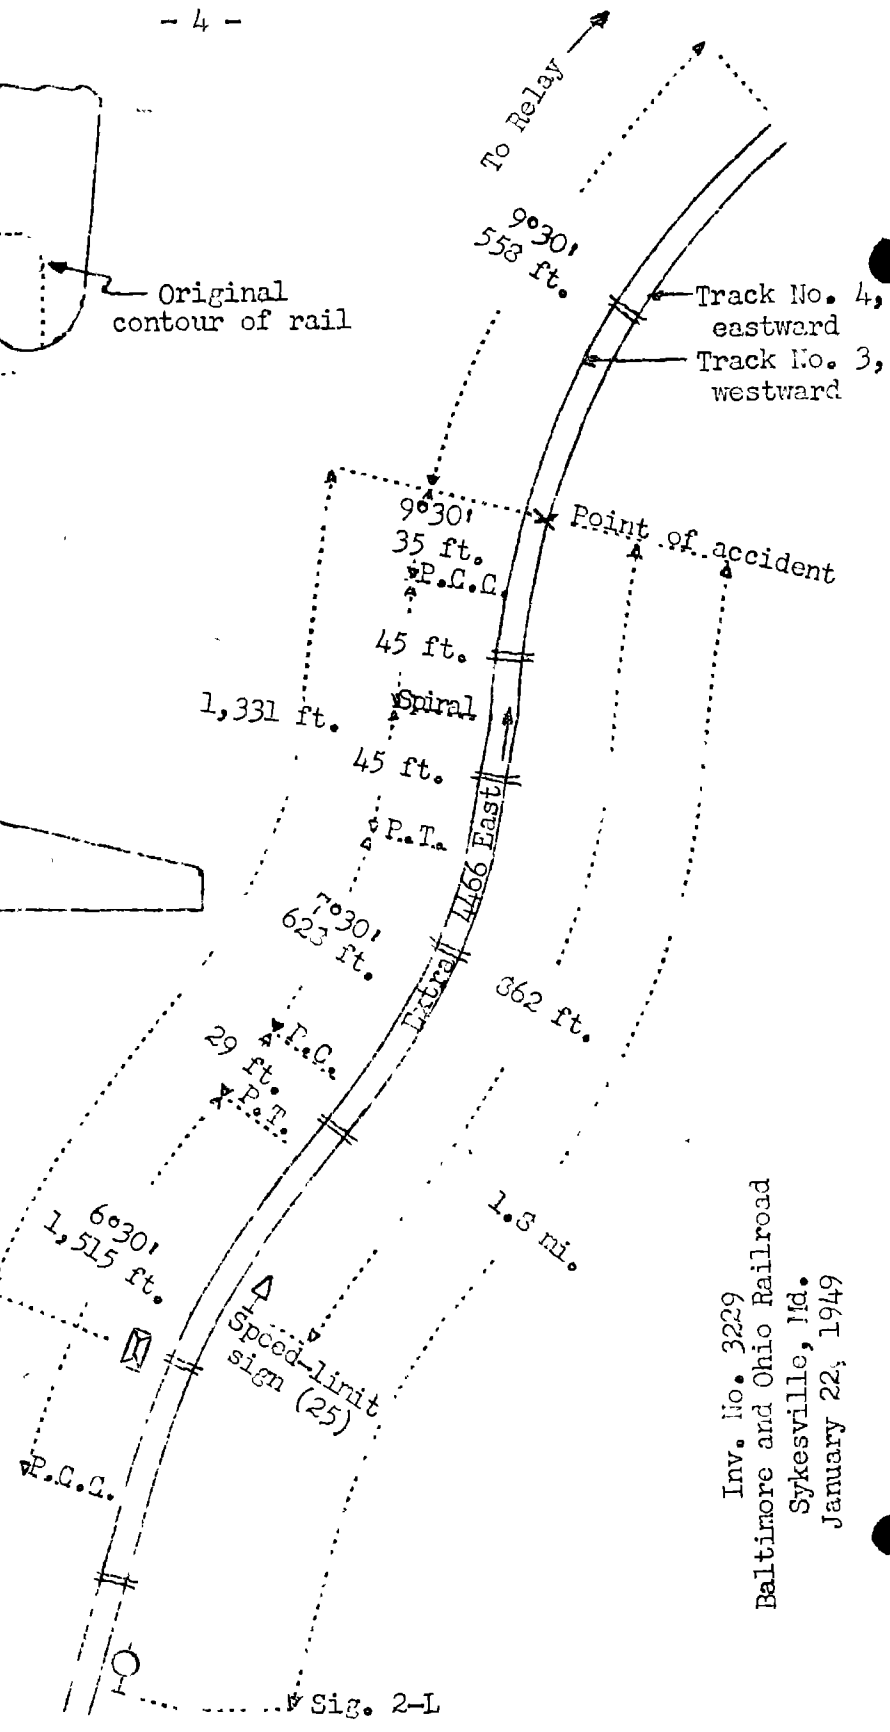
Inv. No. 3229  
 Baltimore and Ohio Railroad  
 Sykesville, Md.  
 January 22, 1949

Location of Accident and Method of Operation
