# **RAILROAD ACCIDENT REPORT**

HEAD-ON COLLISION AND DERAILMENT OF BURLINGTON NORTHERN FREIGHT TRAIN WITH UNION PACIFIC FREIGHT TRAIN KELSO, WASHINGTON NOVEMBER 11, 1993

Adopted: November 15, 1994 Notation 6247A

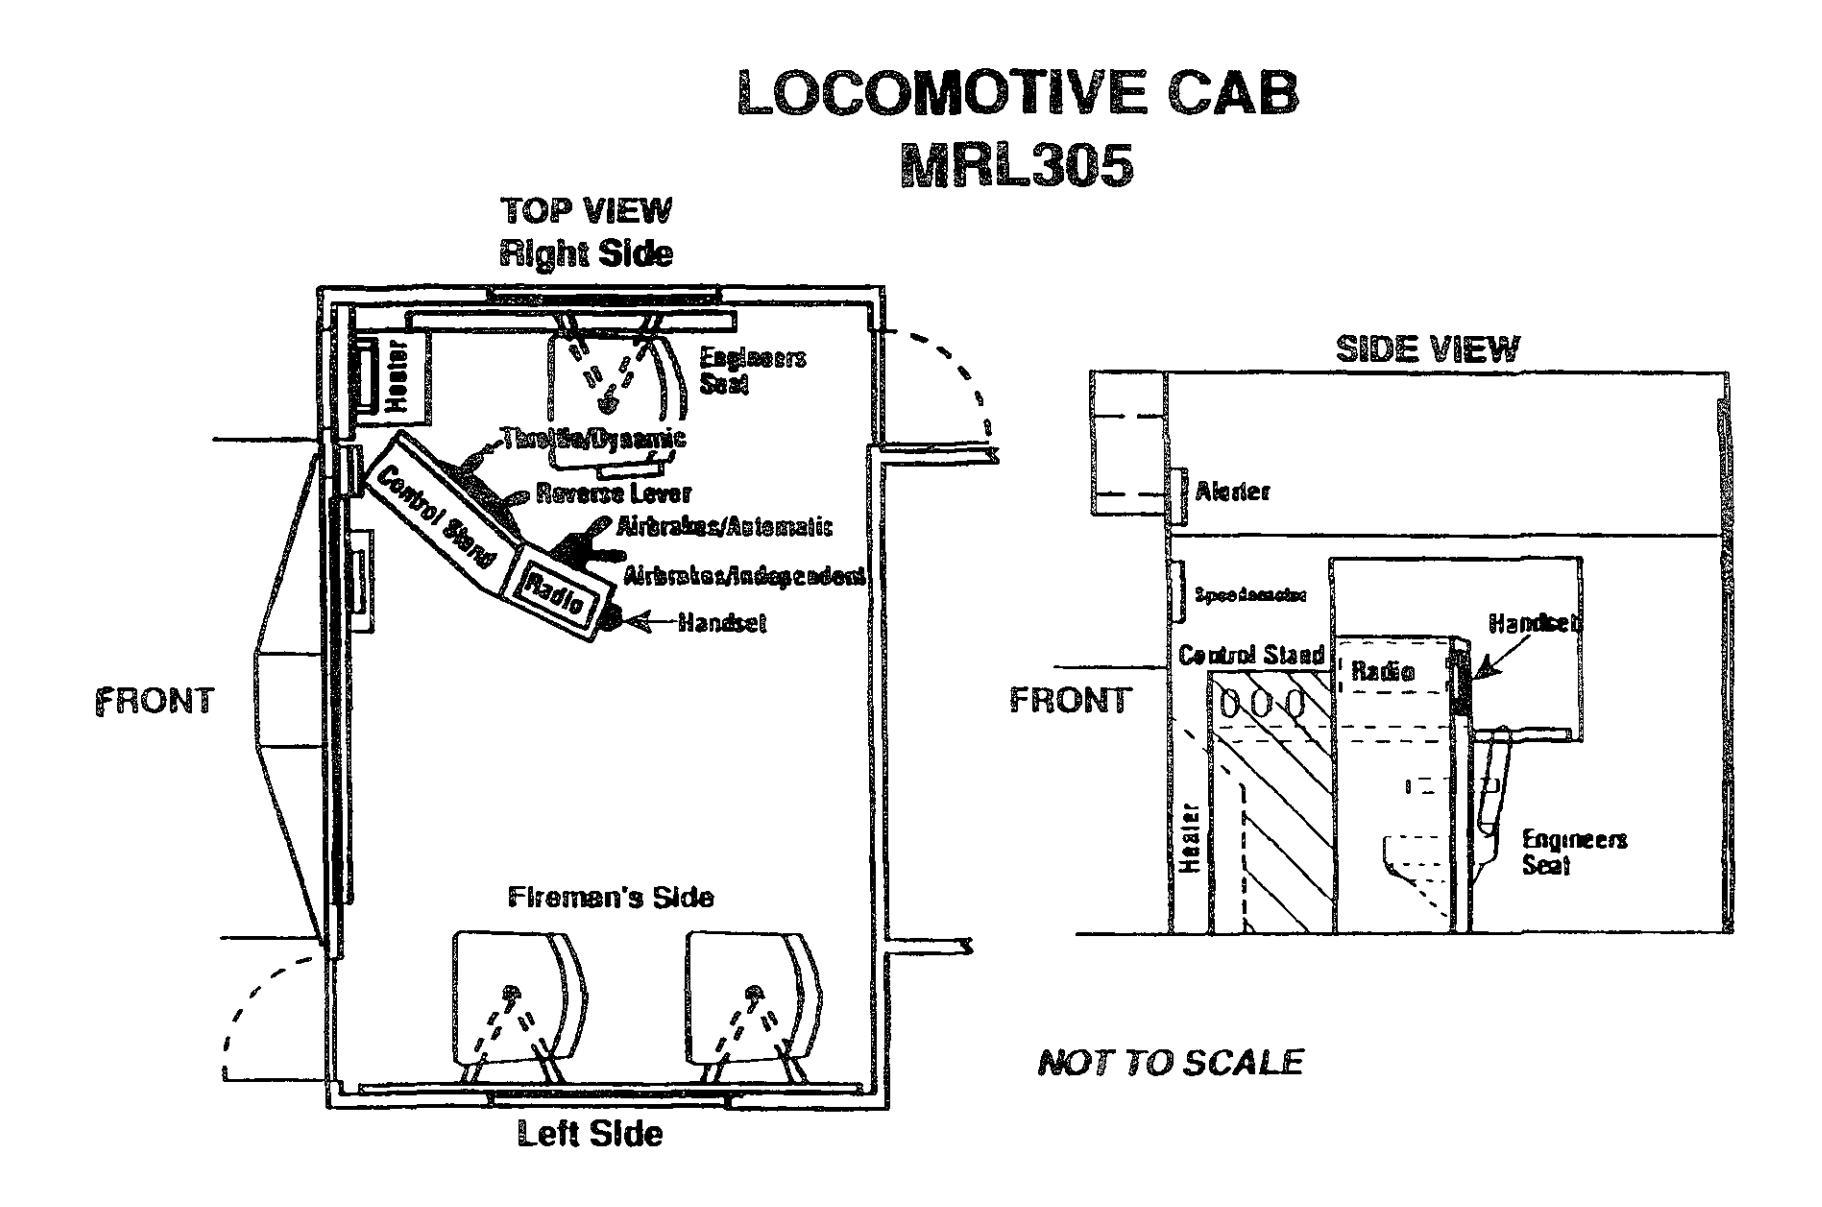
Figure 5 -- Diagram of locomotive.

Since the lead locomotive was destroyed in the collision, the investigators inspected a sister MRL locomotive The engineer's seat was in the traditional position on the right side of the cab, and the seats for the head brakeman and/or conductor were on the left side. The control stand was along the engineer's left, extending from the cab heater to alongside the engineer's seat at about a 30-degree angle. The radio was recessed inside the control stand to the engineer's immediate left, with the hand set located adjacent to the radio in a holder on the end of the control stand. (See figure 5)

The radio conversation may have increased in another way the likelihood of the crew missing the signal The conductor would have had to get out of his seat to pick up the radio handset (see figure 5) Had he remained standing after the conversation, his ability to see signals ahead would have been restricted by the height of the windshield, and his body may have partially obstructed the engineer's view of the left side of the track, where the intermediate signal was

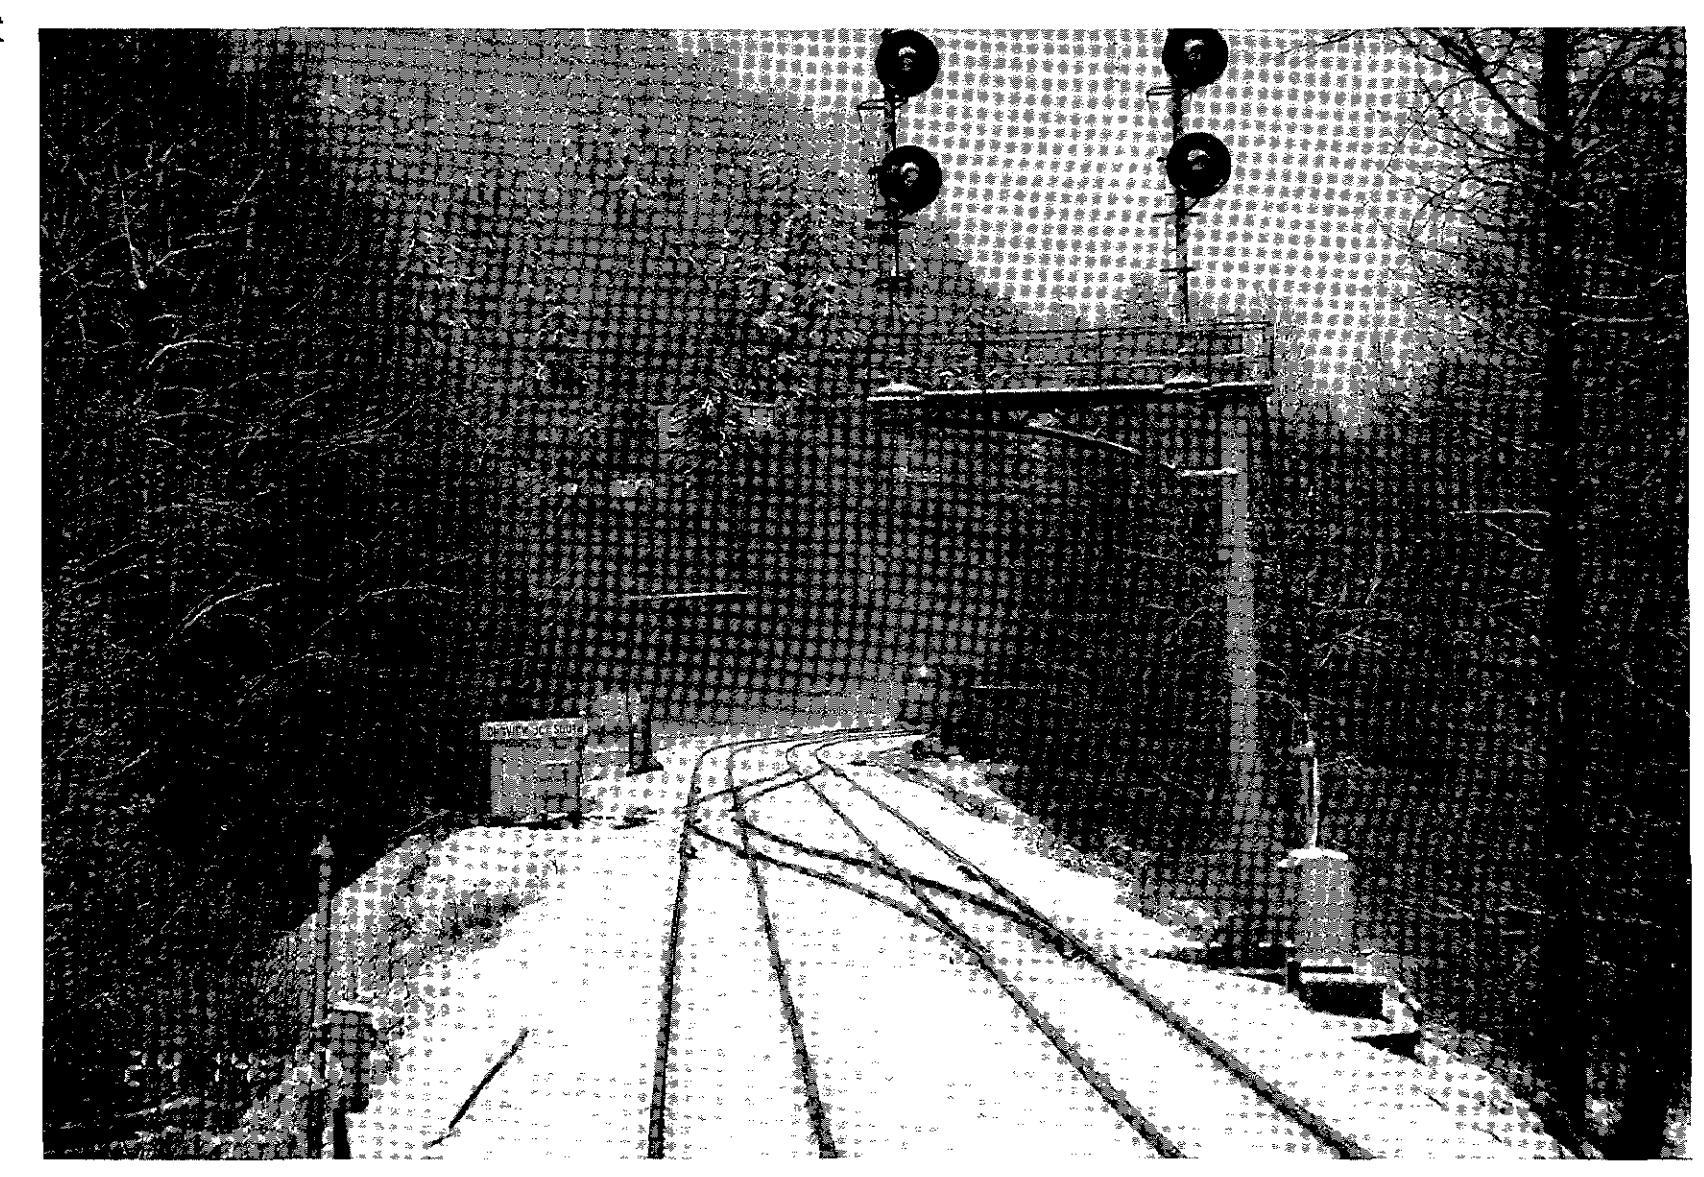
Figure 7.--Longview Junction South interlocking, looking south.

The interlocking at Longview Junction South, MP 102.54, consists of a double crossover The south crossover permits trains to cross from main track 1 to main track 2, and the north crossover permits trains to cross from main track 2 to main track 1. (See figure 7) Each turnout is electrically operated and remotely controlled by the dispatcher in Seattle
