# NATIONAL TRANSPORTATION SAFETY BOARD

## RAILROAD ACCIDENT REPORT

DERAILMENT OF  
BURLINGTON NORTHERN RAILROAD COMPANY  
FREIGHT TRAIN NO. MTC-0718  
NEAR CRYSTAL CITY, MISSOURI  
JULY 18, 1983

NTSB/RAR-84/01

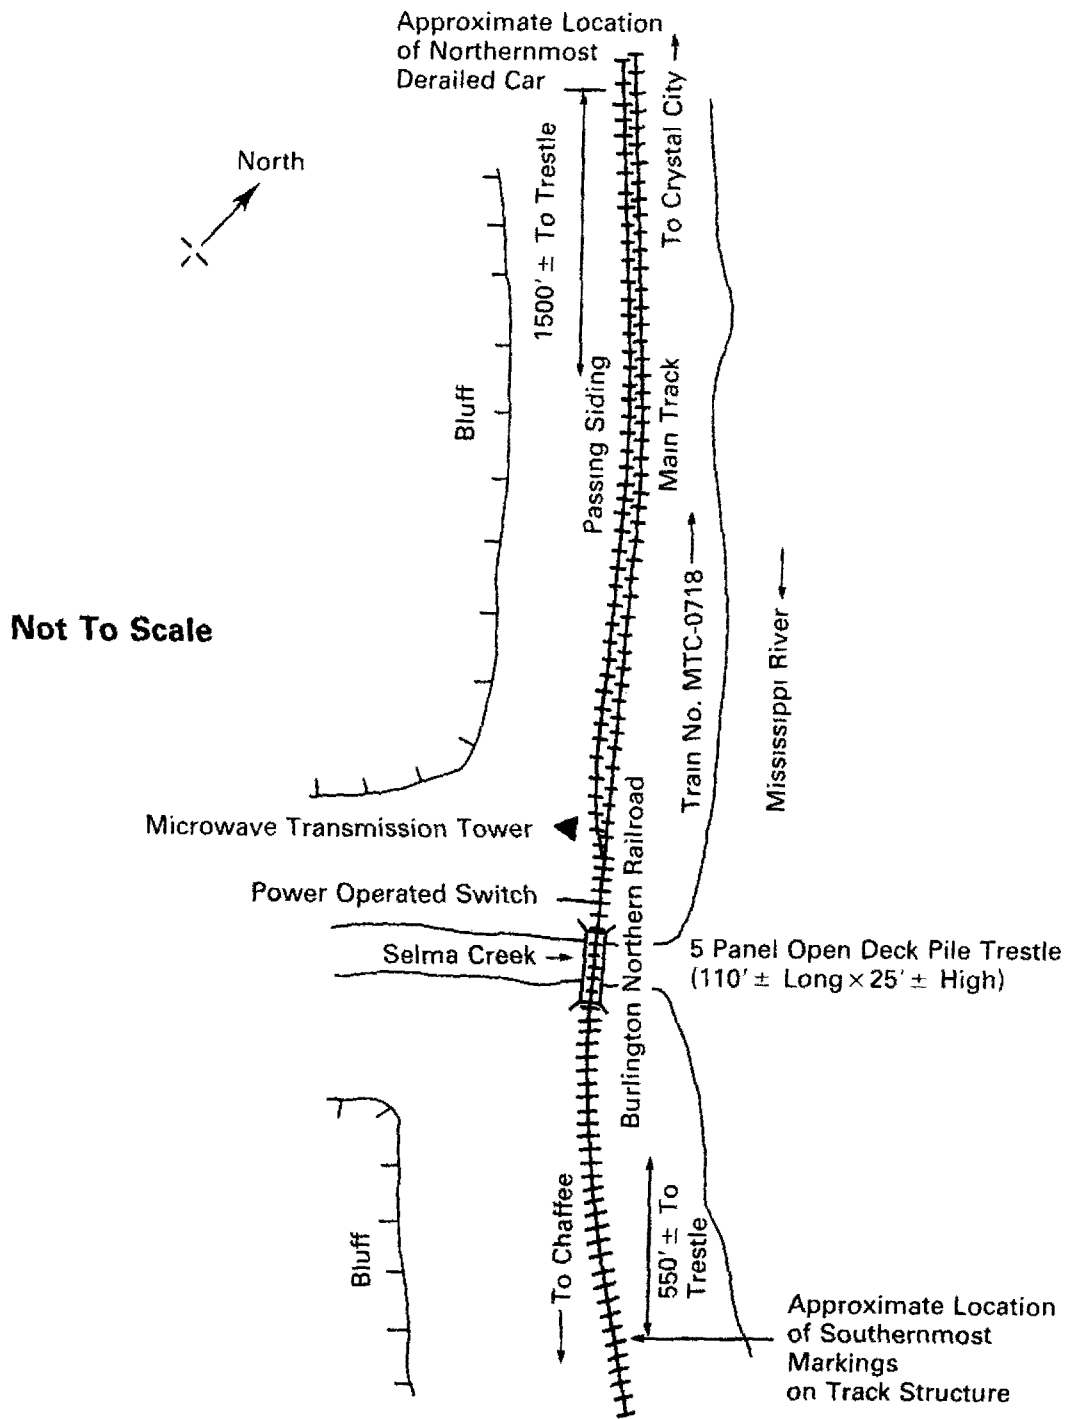
Figure 2.—Plan view of derailment site.

Investigation of the track structure within the derailment site indicated that the first set of derailment markings (southernmost) occurred at about the transition from the tangent track into the 3-degree curve to the right, south of the trestle. (See figure 2.) The mark extended downward from the gage corner of the west rail to the bottom corner of the rail head. (See figure 4.) The west rail is the outside rail in the curve at this location. The cross-ties at this location met FRA track safety standards, but there were wheel flange markings near the east rail. The track spikes had been elevated on the gage side and bent over to the west on the field side of the west rail. From this point northward to the trestle, the east rail was displaced to the east and the west rail was displaced to the west. Examination of the component structural members of the wooden trestle did not disclose any defects that would have contributed to the accident.
