NATIONAL TRANSPORTATION SAFETY BOARD

RAILROAD ACCIDENT REPORT

**DERAILMENT OF AMTRAK TRAIN NO. 5
(THE SAN FRANCISCO ZEPHYR)
ON THE BURLINGTON NORTHERN RAILROAD
EMERSON, IOWA
JUNE 15, 1982**

NTSB/RAR-83/02

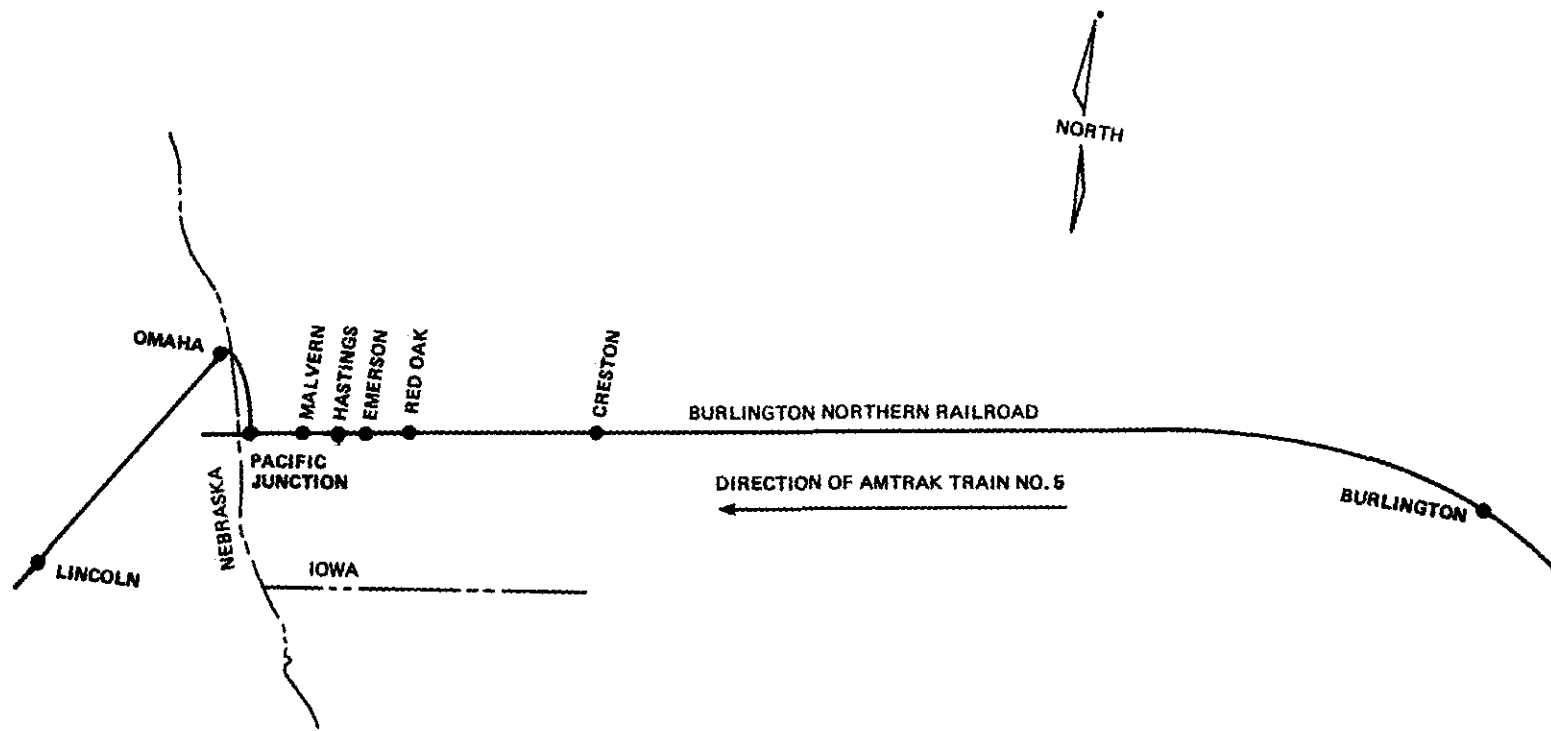
Figure 1.—Location plan.

Shortly after 10 p.m. 1/ on June 14, 1982, police began to evacuate parts of the towns of Malvern, Hastings, and Emerson, in southwest Iowa, because of flooding caused by heavy rainfall earlier in the evening. All of the towns, which are located about 5 miles apart, were stations on the Burlington Northern Railroad (BN). (See figure 1.)

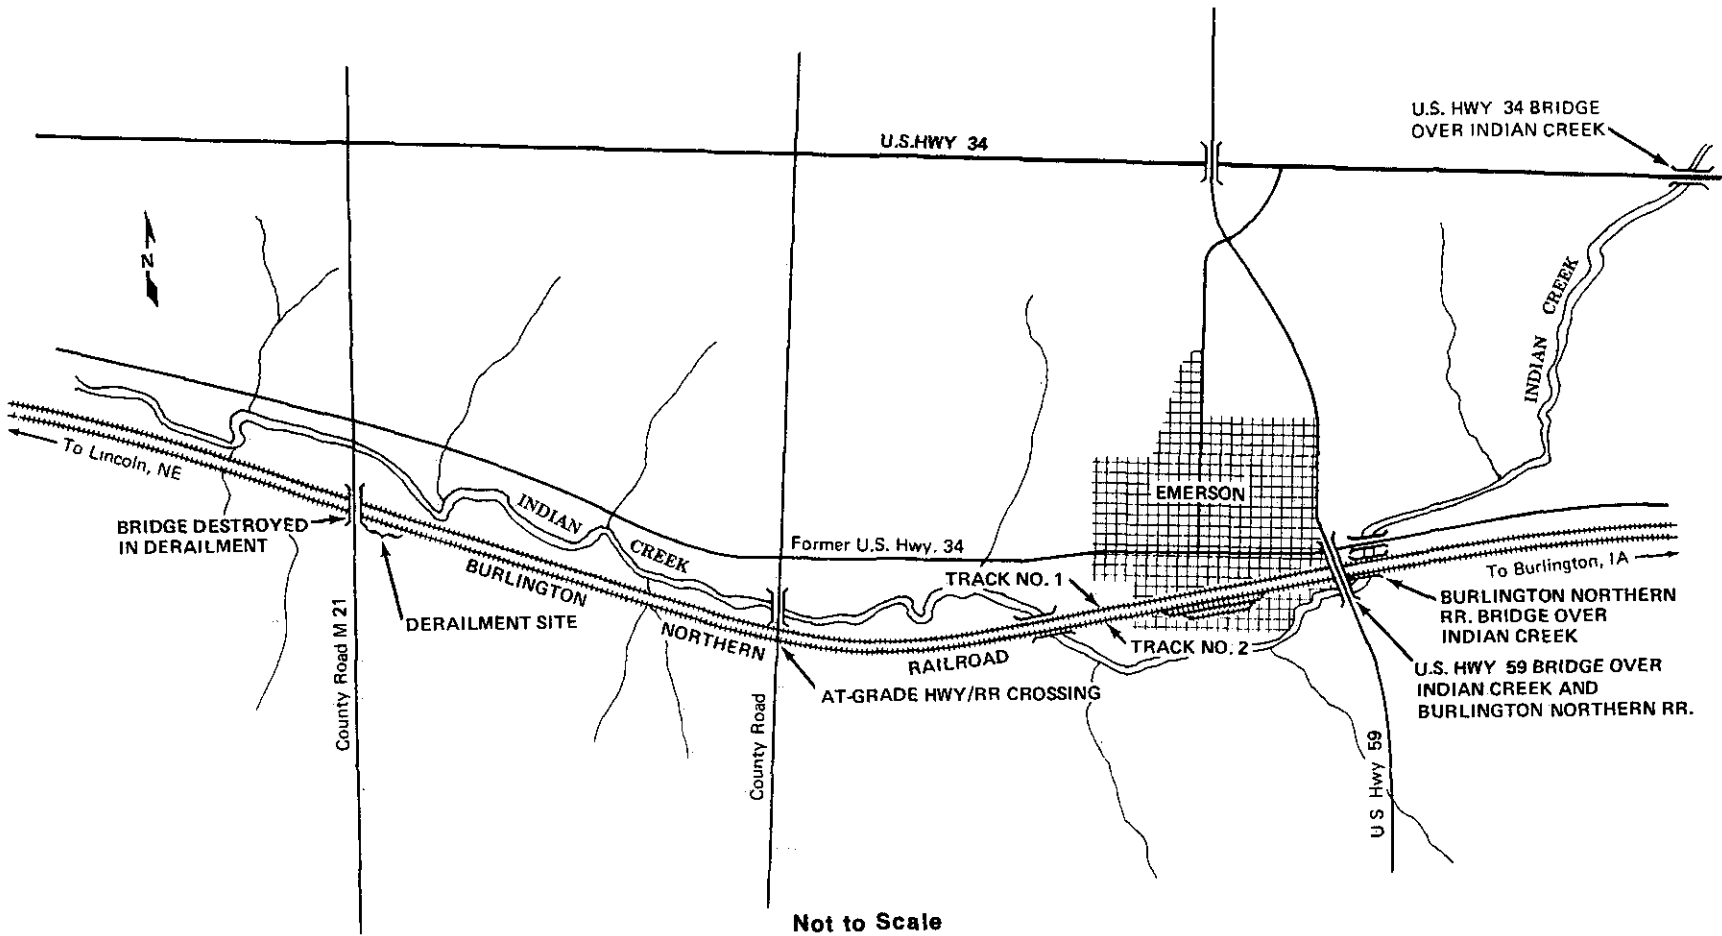
Figure 2.—Site plan.

The operator at Pacific Junction stated that at the end of his tour of duty at midnight, he advised his relief of the extra track patrols on the Lincoln Division. About 12:40 a.m., while en route home eastbound on U.S. Highway No. 34, the operator had to stop at the Indian Creek Bridge near Emerson (see figure 2) because water was covering the bridge. An Iowa Department of Transportation pickup truck and a sheriff's car were being used to block the west approach to the bridge. The operator stated that he sat in his car during a light rain until about 1:30 a.m., and then joined the highway department employee in the pickup truck, where he sat until 3:30 a.m. waiting for the water to recede. He said that he talked with the highway department employee about the water, and that the highway employee was discussing the situation around Emerson with other

persons via a two-way radio in the truck. The operator stated that he did not make any effort to contact the BN concerning the flooding situation at Emerson because "the [railroad] roadbed is several feet higher than the main street." Traffic was allowed to proceed over the Indian Creek Bridge when the water receded about 4:05 a.m.
