# NATIONAL TRANSPORTATION SAFETY BOARD

## ✓ RAILROAD ACCIDENT REPORT

HEAD-ON COLLISION OF  
BURLINGTON NORTHERN RAILROAD  
FREIGHT TRAINS EXTRA 6760 WEST AND  
EXTRA 7907 EAST  
NEAR MOTLEY, MINNESOTA  
JUNE 14, 1984

✓  
NTSB/RAR-85/06,

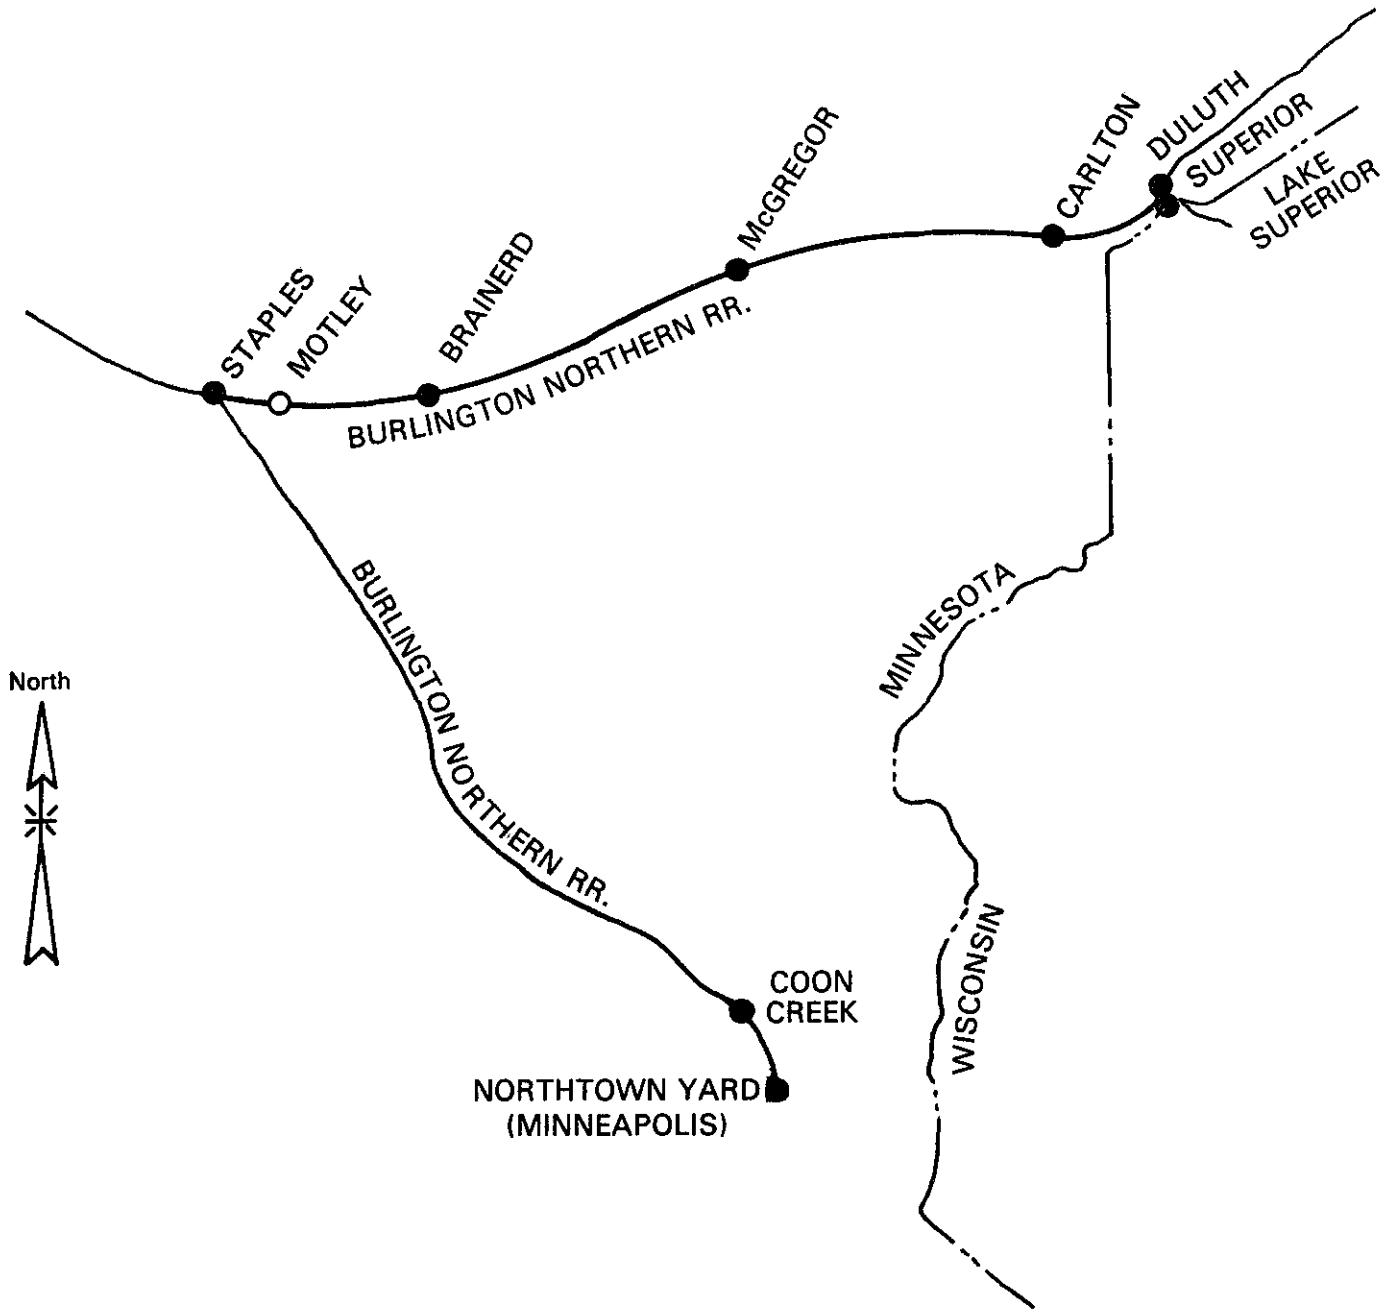
Figure 1.—Location diagram.

About 11:41 p.m. the dispatcher, located at Northtown Yard in Minneapolis, issued Train Order No. 85 (see appendix C), establishing authority for train Extra 7907 East from Staples to Carlton. (See figures 1 and 2.) (The route from Carlton to Superior is on a different subdivision and under the jurisdiction of another dispatcher.) Train Order No. 85 authorized train Extra 7907 East to proceed after train Extra 6730 West had arrived at Staples; however, train Extra 6730 West had already arrived at Staples at 11:35 p.m. The Train Order Crew Board (TOCB) clerk at Staples advised the dispatcher of the train's arrival, but the dispatcher did not cancel Train Order 85 and issue a new order. Rather, he issued Train Order No. 86 as an advisory that train Extra 6730 West had arrived. The dispatcher issued the clearance allowing train Extra 7907 East to proceed about 11:50 p.m. Shortly after the train order and clearance were received at Staples, the engineer and brakemen returned from the restaurant, met with the conductor, read the train orders and clearance, and were transported by a van to train Extra 7907 East.
