NATIONAL TRANSPORTATION SAFETY BOARD

REAR END COLLISION OF TWO
BURLINGTON NORTHERN RAILROAD COMPANY
FREIGHT TRAINS
PACIFIC JUNCTION, IOWA
APRIL 13, 1983

NTSB/RAR-83/09

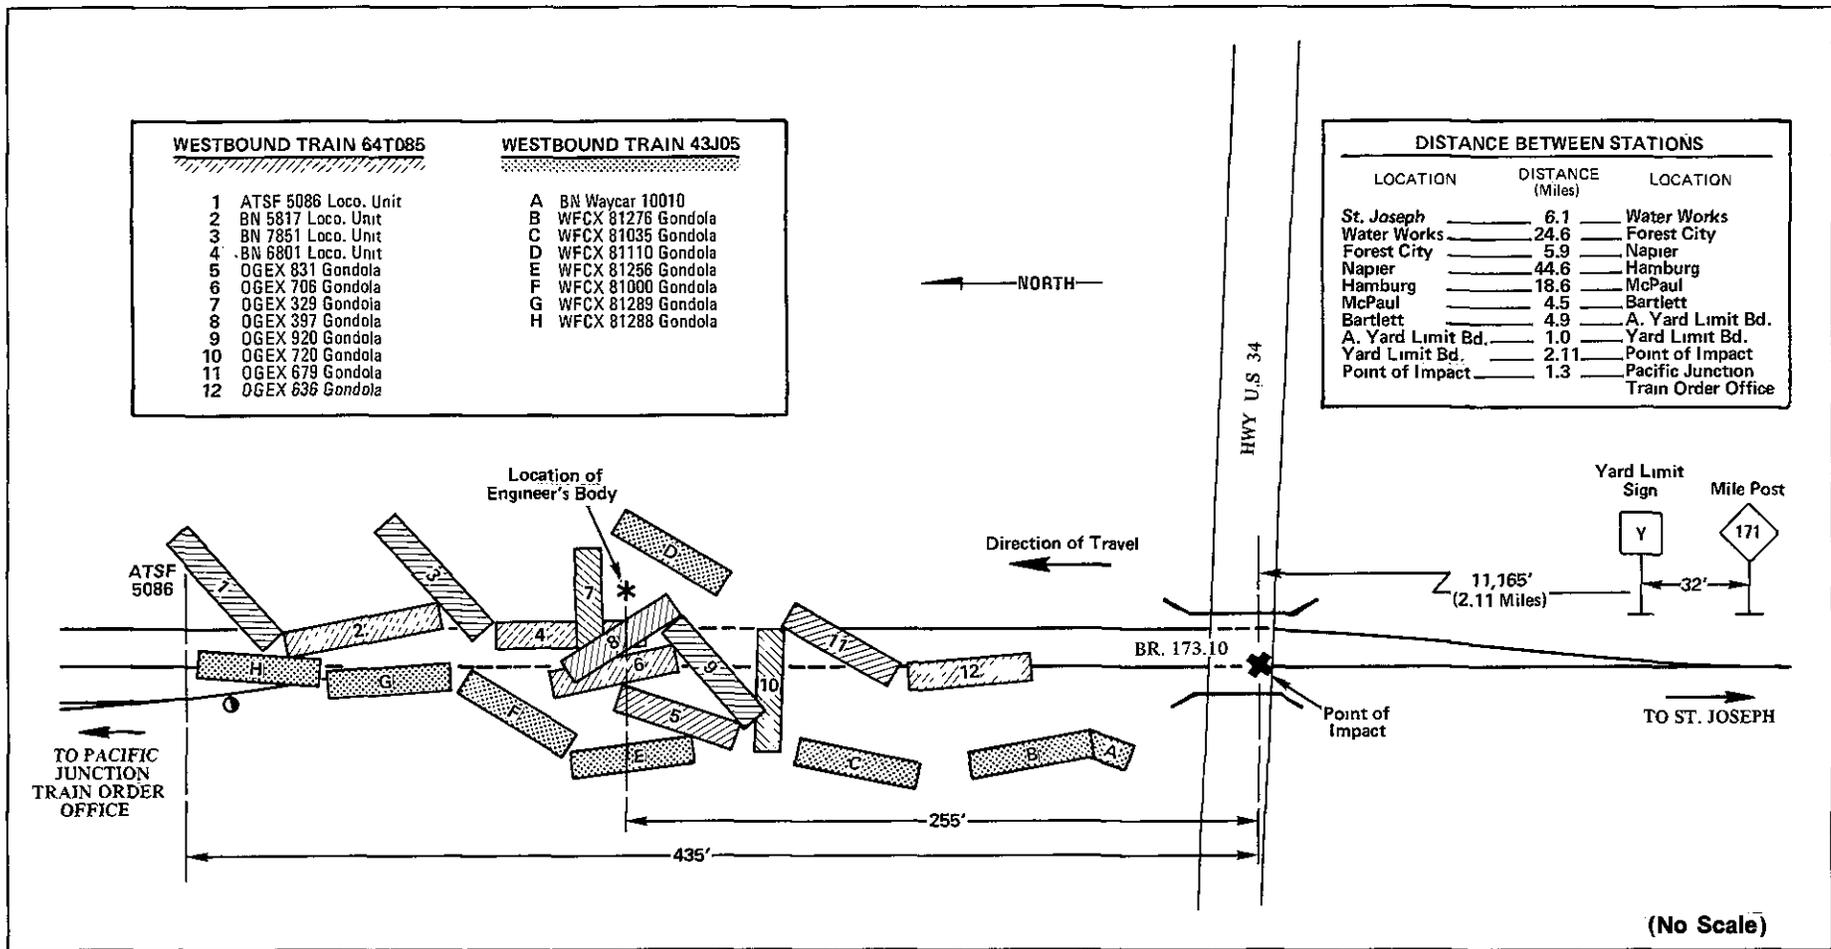
Figure 1.—Plan view of accident site.

Train 43J05 arrived at Pacific Junction at 3:15 a.m. after an uneventful trip between St. Joseph and Pacific Junction. The crewmembers remained aboard the train awaiting the arrival of a relief crew. The rear of the train, with the caboose's red rear marker light illuminated, was located at milepost 173.1, about 2.1 miles north and inside of the posted Pacific Junction yard limit. (See figure 1.) There was no flag protection provided by the standing train, and none was required by BN operating rules for standing trains within yard limits.

About 3:45 a.m., while the conductor was seated facing rearward at his desk in the caboose, he saw the headlight of an approaching train about 2 miles behind train 43J05. When the headlight was not switched from bright to dim intensity, as is required when a train is moving closely behind another train, the conductor became concerned. He said that as he observed the approaching headlight of the train, he believed that the speed of the train was greater than it should have been and that the train did not appear to be slowing. He attempted several times to contact the approaching train by radio, but he did not receive a response. The engineer of train 43J05 reported later that he heard the conductor's radio calls to the approaching train. The rear brakeman descended from the cupola and also tried to contact the approaching train by radio, but he got no response. The conductor and rear brakeman then decided to leave the caboose because they did not believe that the approaching train would be stopped before it struck train 43J05. No attempt was made by the conductor of Train 43J05 to contact his engineer about the pending collision. The conductor and rear brakeman left the caboose from the west side and ran up an embankment.

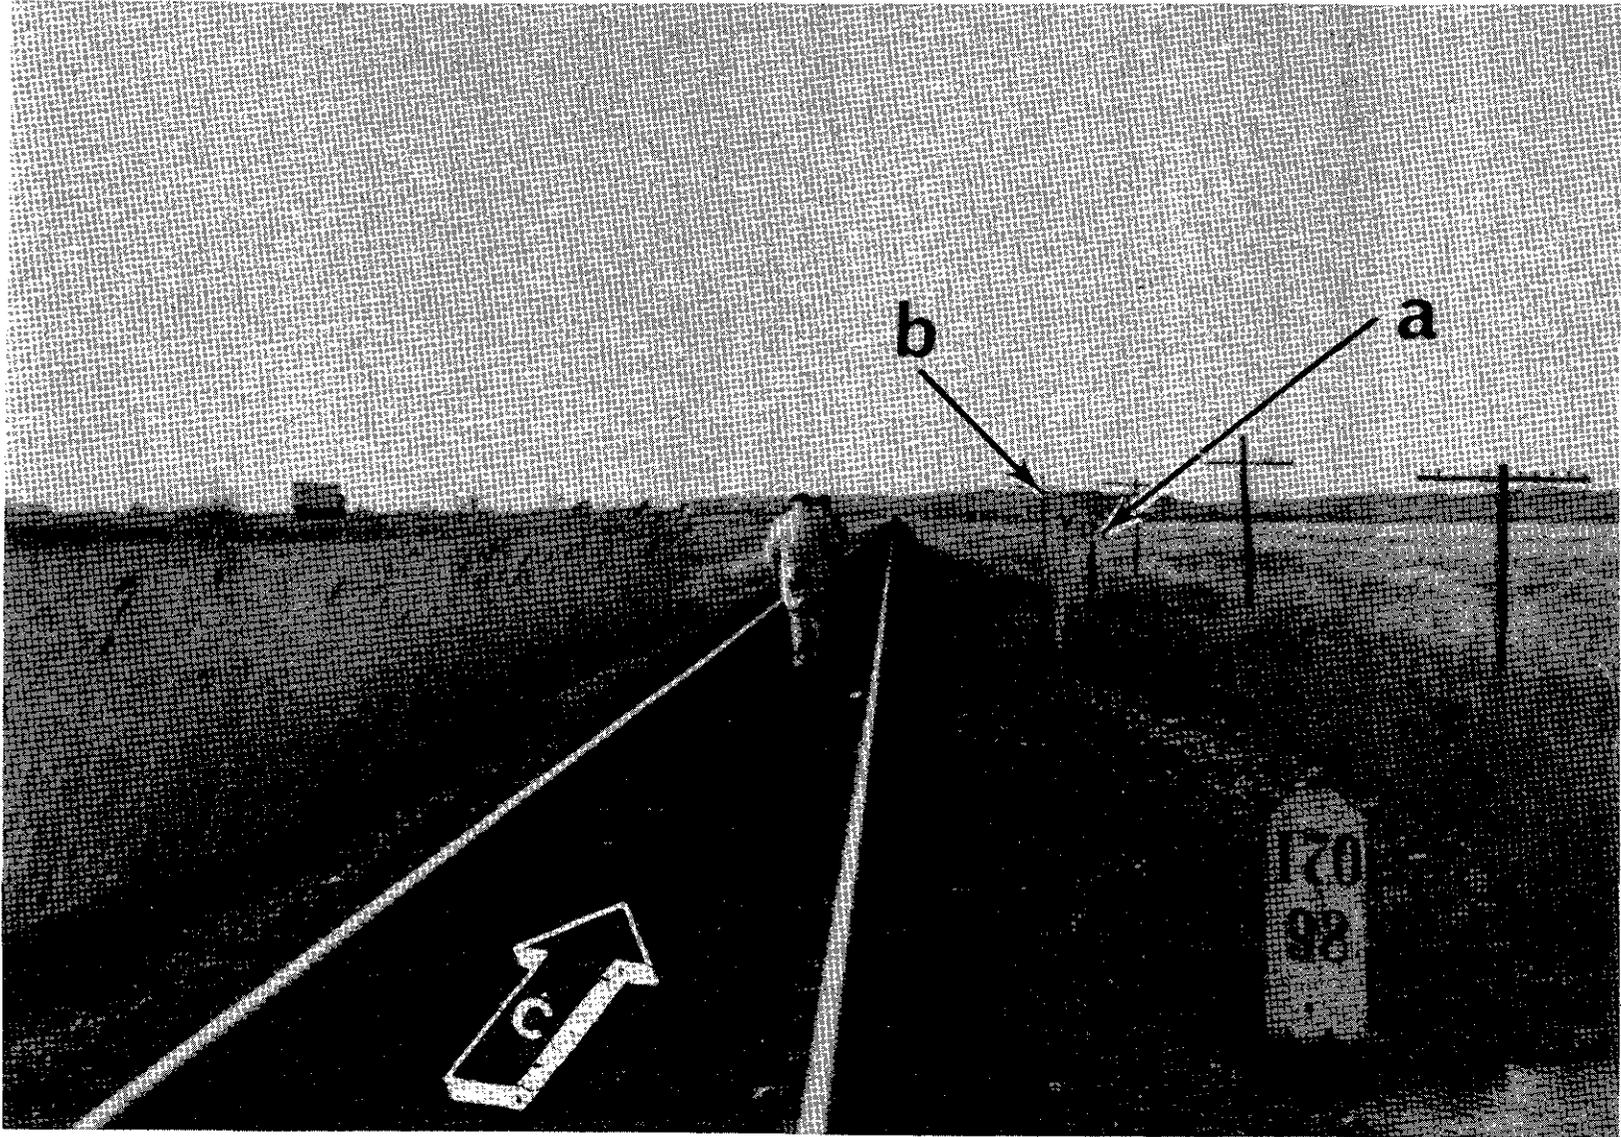
Figure 6.--Pacific Junction yard limit sign at milepost 171.

The south approach to the yard limit at Pacific Junction was marked with a square reflectorized white board located at milepost 171. The letter "Y" is painted in black on the reflectorized background. The yard limit sign was preceded by an advance yard limit sign of similar design located at milepost 170. (See figure 6.) Neither board was lighted, but both were in plain, unobstructed view on the east side of the track. They are defined in the operating rules as fixed signals and as such should be acknowledged by the locomotive crew in accordance with operating rule No. 34. (See appendix E.) BN operating rule No. 93 requires that trains in yard limits move at a speed prepared to stop within one half the range of vision but not to exceed 20 mph. (See appendix E.)
