NATIONAL TRANSPORTATION SAFETY BOARD

RAILROAD ACCIDENT REPORT

HEAD-ON COLLISION OF
BURLINGTON NORTHERN RAILROAD FREIGHT TRAINS
EXTRA 6714 WEST AND EXTRA 7820 EAST
WIGGINS, COLORADO
APRIL 13, 1984

READ-END COLLISION OF
BURLINGTON NORTHERN RAILROAD FREIGHT TRAINS
EXTRA 7843 EAST AND EXTRA ATSF 8112 EAST
NEAR NEWCASTLE, WYOMING
APRIL 22, 1984

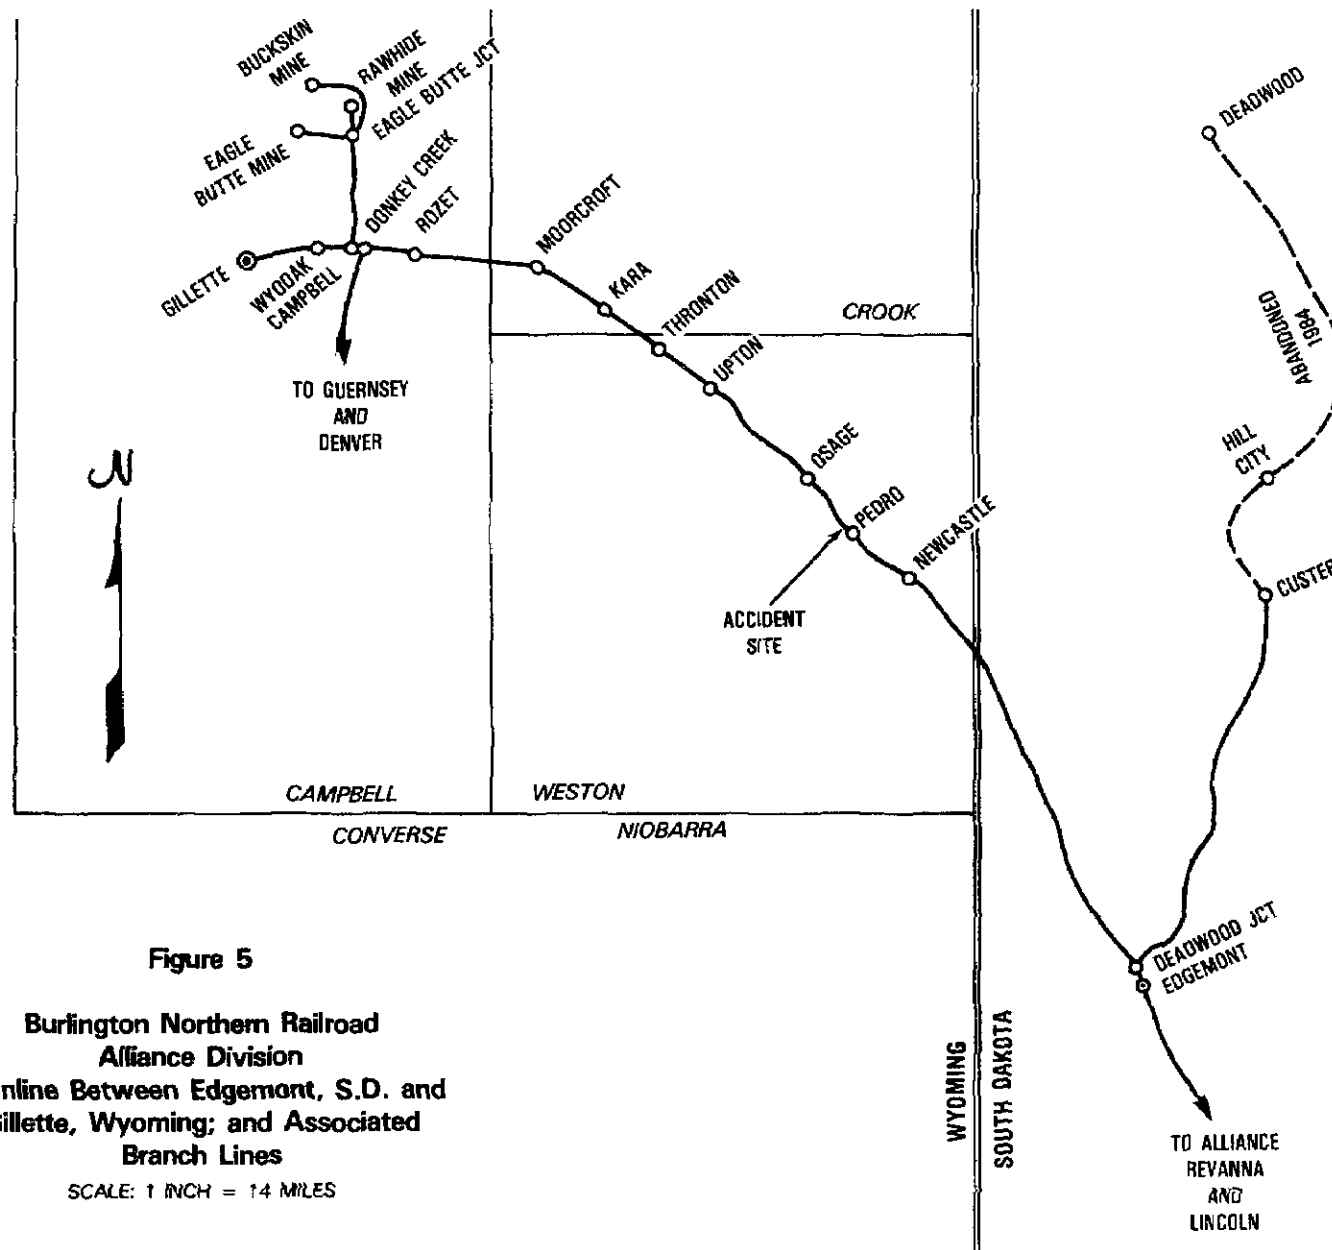
Figure 5
Burlington Northern Railroad
Alliance Division
Mainline Between Edgemont, S.D. and
Gillette, Wyoming; and Associated
Branch Lines
 SCALE: 1 INCH = 14 MILES

Extra 7843 East, consisting of 5 locomotive units, 115 cars, and a caboose, had departed from the Eagle Butte Coal Mine, north of Gillette, about 1:50 a.m. and followed Extras 5533 and ATSF 8112 East. The train had traveled 73.9 miles to Pedro and was moving east on the single main track. (See figure 5.) The engineer was operating the train from the lead locomotive unit. The head brakeman was also on the lead unit, and the conductor and rear brakeman were in the caboose.

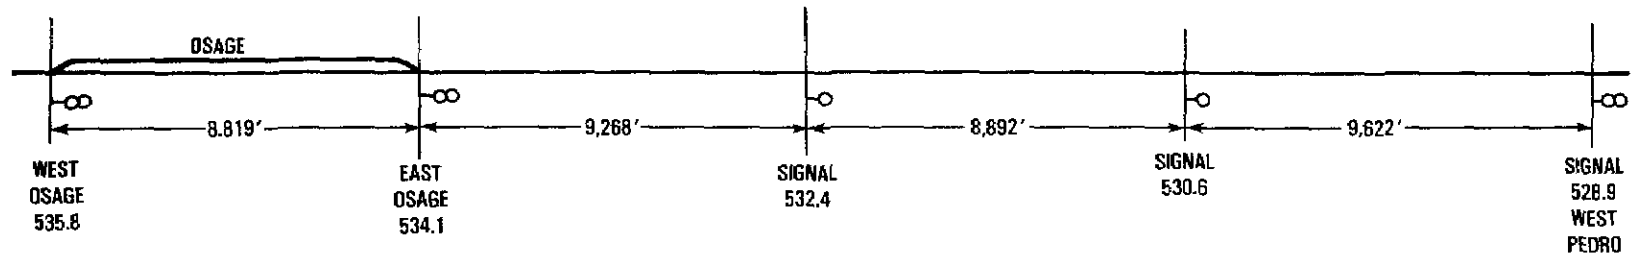
Figure 7

Signals Between Osage and Pedro
SCALE: 1 INCH = 1.5 MILES

Extra 7843 East began accelerating from a speed of about 21 mph in the vicinity of MP 536, approaching West Osage interlocking. The engineer had the locomotive running in full throttle. The train passed through the East Osage interlocking (MP 534.1) at an average speed of 26.4 mph. About 1.3 miles east of East Osage interlocking, the train began to descend Y.T. Hill, and by the time the locomotive had reached the vicinity of MP 530.4, slightly more than 3 1/2 miles east of East Osage, the train was moving at a speed of about 65 mph. (See figure 7.)

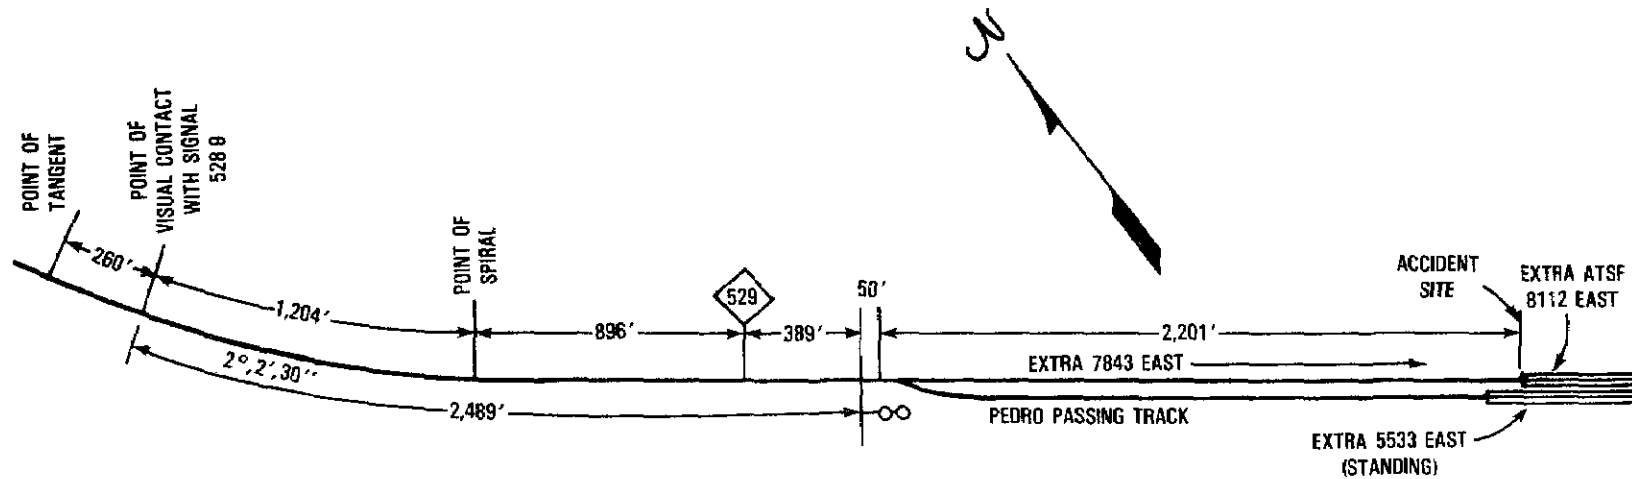
Burlington Northern Railroad
Alliance Division
Approach to Pedro Passing Track and
Accident Site

about 1.2 miles. The curve closest to the accident site was a 1,464-foot, 2-degree, 2-minute, 30-second lefthand curve eastbound. The distance from the exit spiral of this curve to the accident site was about 3,536 feet. (See figure 7.)
