RAILROAD ACCIDENT REPORT

DERAILMENT OF
AMTRAK PASSENGER TRAIN NO. 60,
THE MONTREALER, ON THE
CENTRAL VERMONT RAILWAY
NEAR ESSEX JUNCTION, VERMONT
JULY 7, 1984

NTSB/RAR-85/14

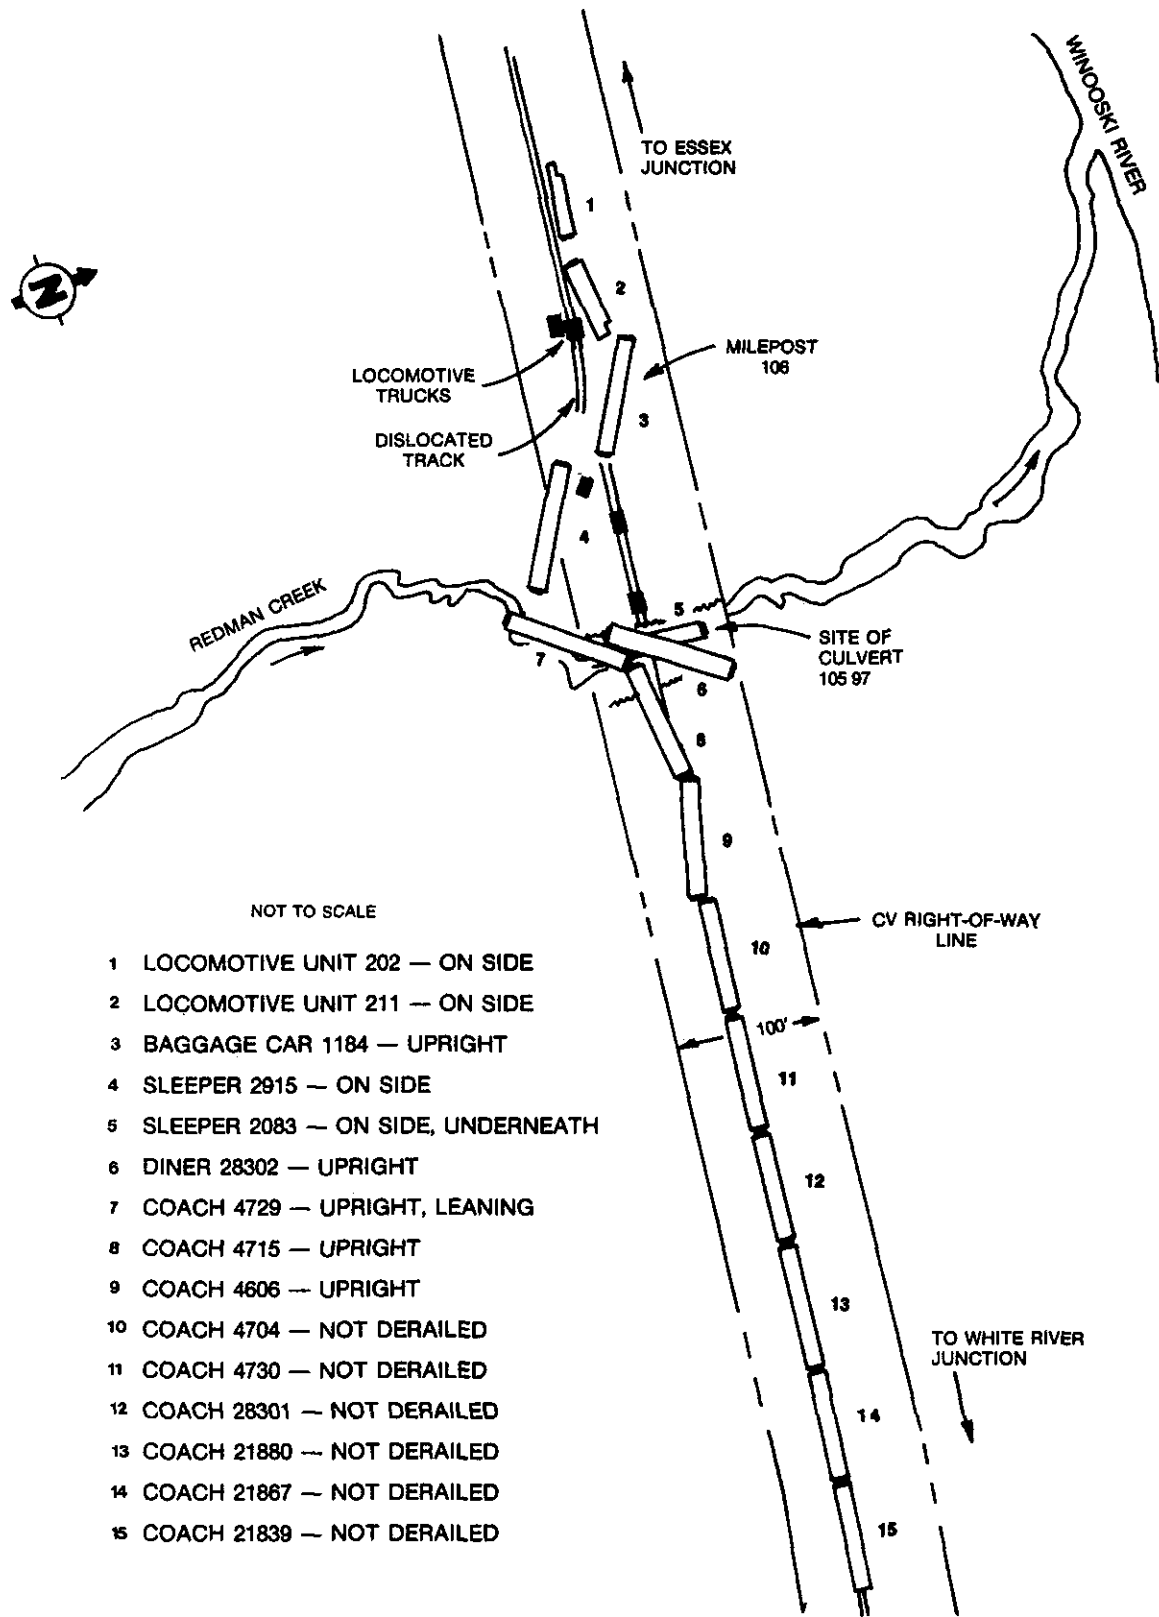
Figure 1.—Plan view of wreckage distribution.

Initial rescue efforts were hampered by a lack of direct access between the landfill road and the accident site. This obstacle was overcome by bulldozing a wide roadway about 450 feet long between the two points. (See figure 1.) All 294 persons aboard the train, were treated at a triage area, which was set up where the new road joined the landfill road; 47 persons received outpatient medical treatment at the IBM plant dispensary. Helicopters used a small open area as a pad and carried the most critically injured to hospitals. The less critically injured were transported in ambulances as they became available. The uninjured were taken to the Williston Armory and from that location they were transported to their destinations in Amtrak-chartered buses. Operations at the triage area continued into the night of July 7-8.

Both locomotive units were heavily damaged as a result of their being separated from their trucks and overturned. The fuel tanks of both units ruptured and lost their contents, but the fuel did not ignite. The battery cases under the decks of the units were crushed and all auxiliary power was lost. Slumbercoach No. 2915 was crushed and destroyed. The baggage car (No. 1184), a standard roomette/bedroom sleeping car (No. 2083), a food service car (No. 28302), and a coach (No. 4715) had extensive exterior damage; and all of these cars, except the food service car, were determined to be damaged beyond economical repair. The remaining cars in the train sustained some damage, mostly to interior fixtures. (See figure 1.) About 80 feet of embankment, the culvert, and about 300 feet of track were destroyed.

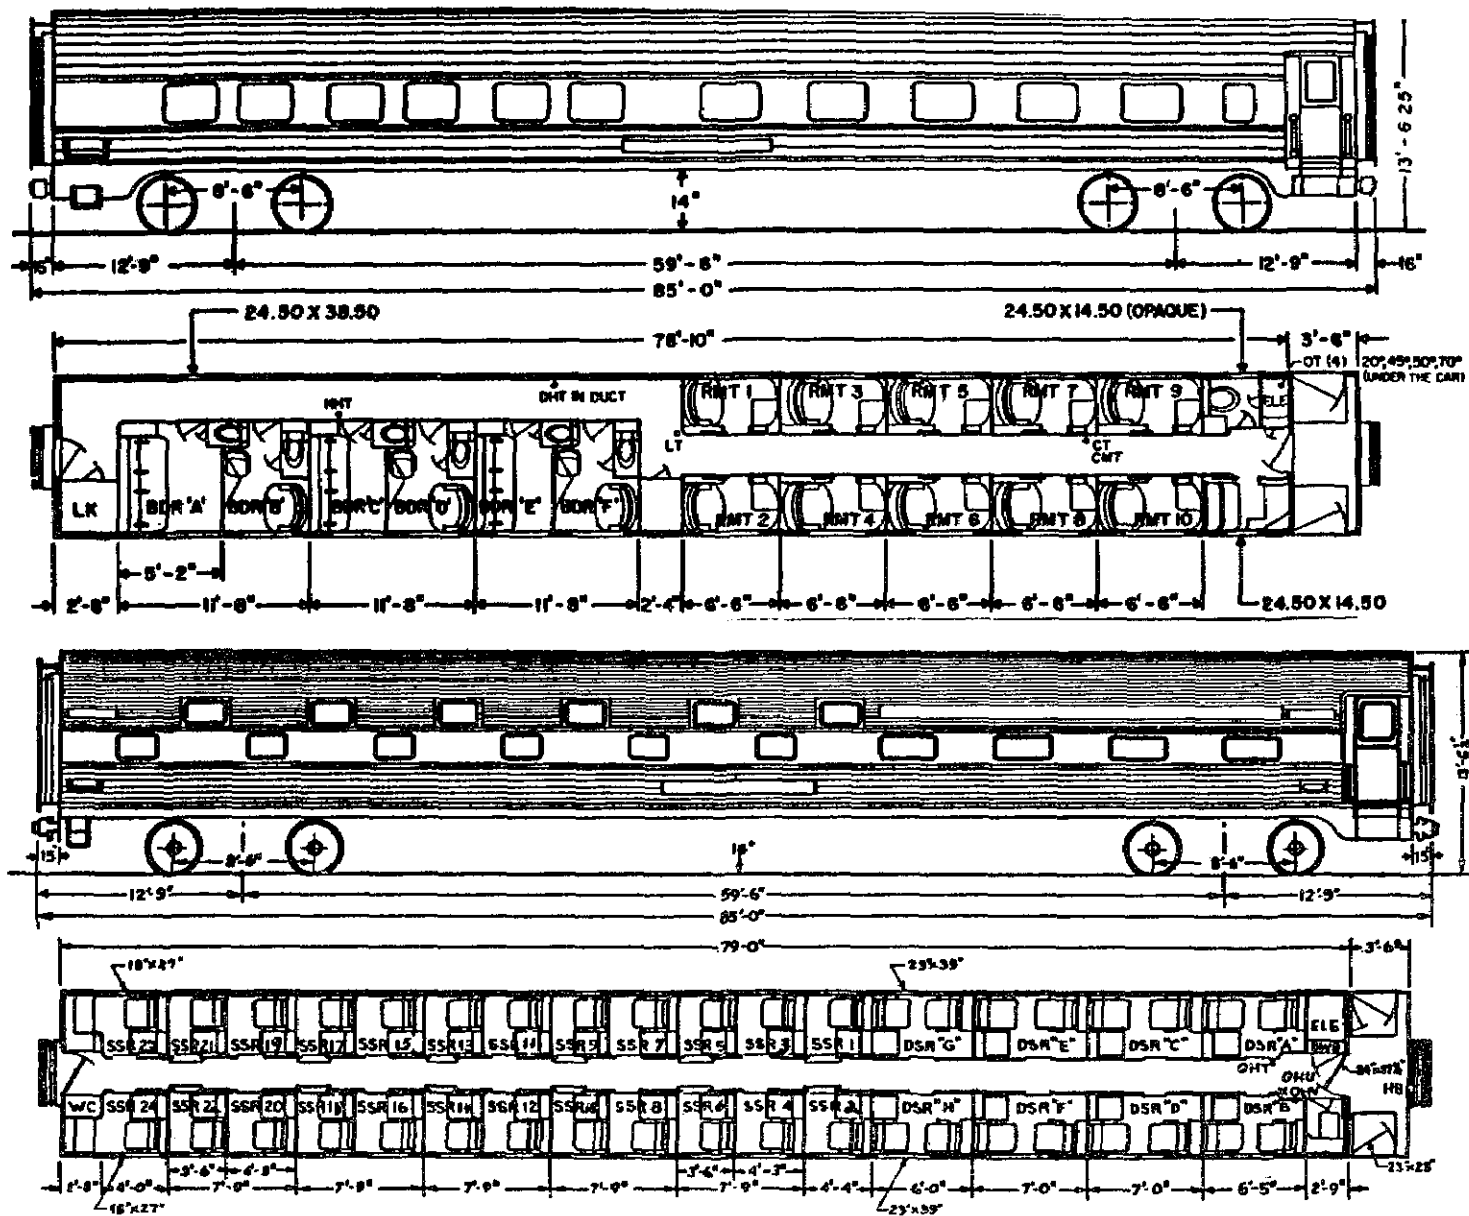
Figure 3.-- Plan view for Amtrak Bedroom/Roomette car No. 2915 (above) and Slumbercoach No. 2083 (below).

Evacuation of bedroom/roomette car No. 2915 proved difficult. The car came to rest on its left side on the south side of the embankment west of the opening. The rear end was at the base of the embankment; the forward end was at the top. The doors of the occupied compartments were closed, and many were jammed making it impossible for the occupants to open them unassisted. The windows of the five roomette compartments on the bottom side were against the embankment, so the occupants of these compartments were trapped and had to be extricated from above. Since the emergency lighting apparatus did not function, these occupants were in total darkness. Most occupants of the topside roomettes were able to evacuate through their window openings after rescuers had removed the windows. Injured occupants of one bedroom had to be rescued through the compartment window; persons in the other bedrooms had to crawl down the narrow corridor to the rear vestibule. Head room was greatly reduced because the car was on its side. (See figure 3.) The baggagemaster and passengers in the bottom side roomettes were evacuated through topside window openings after rescuers forced open their compartment doors and helped them climb out. The baggagemaster stated that upwards of an hour passed before he was evacuated.
