BUREAU OF SAFETY

REPORT NO. 1986

REPORT OF THE DIRECTOR OF THE BUREAU OF SAFETY CONCERNING AN  
ACCIDENT ON THE CHESAPEAKE & OHIO RAILWAY NEAR SOUTH  
FAYETTE, W. VA., ON MAY 21, 1935.

Inv. No. 1986  
Chesapeake & Ohio Ry.  
South Fayette, W. Va.  
May 21, 1935

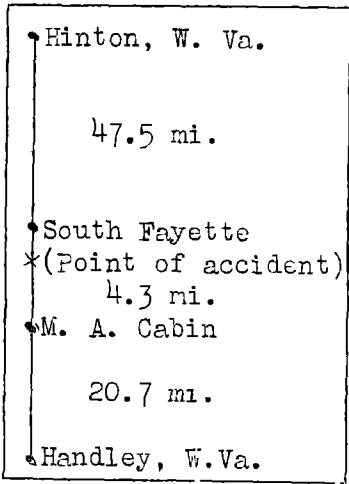
Point of accident →

This accident was caused by a large rock falling against the road bed and knocking the track out of alinement.
