RAILROAD ACCIDENT INVESTIGATION

REPORT NO 4093

CHICAGO & EASTERN ILLINOIS RAILROAD COMPANY

HOOPESTON, ILL

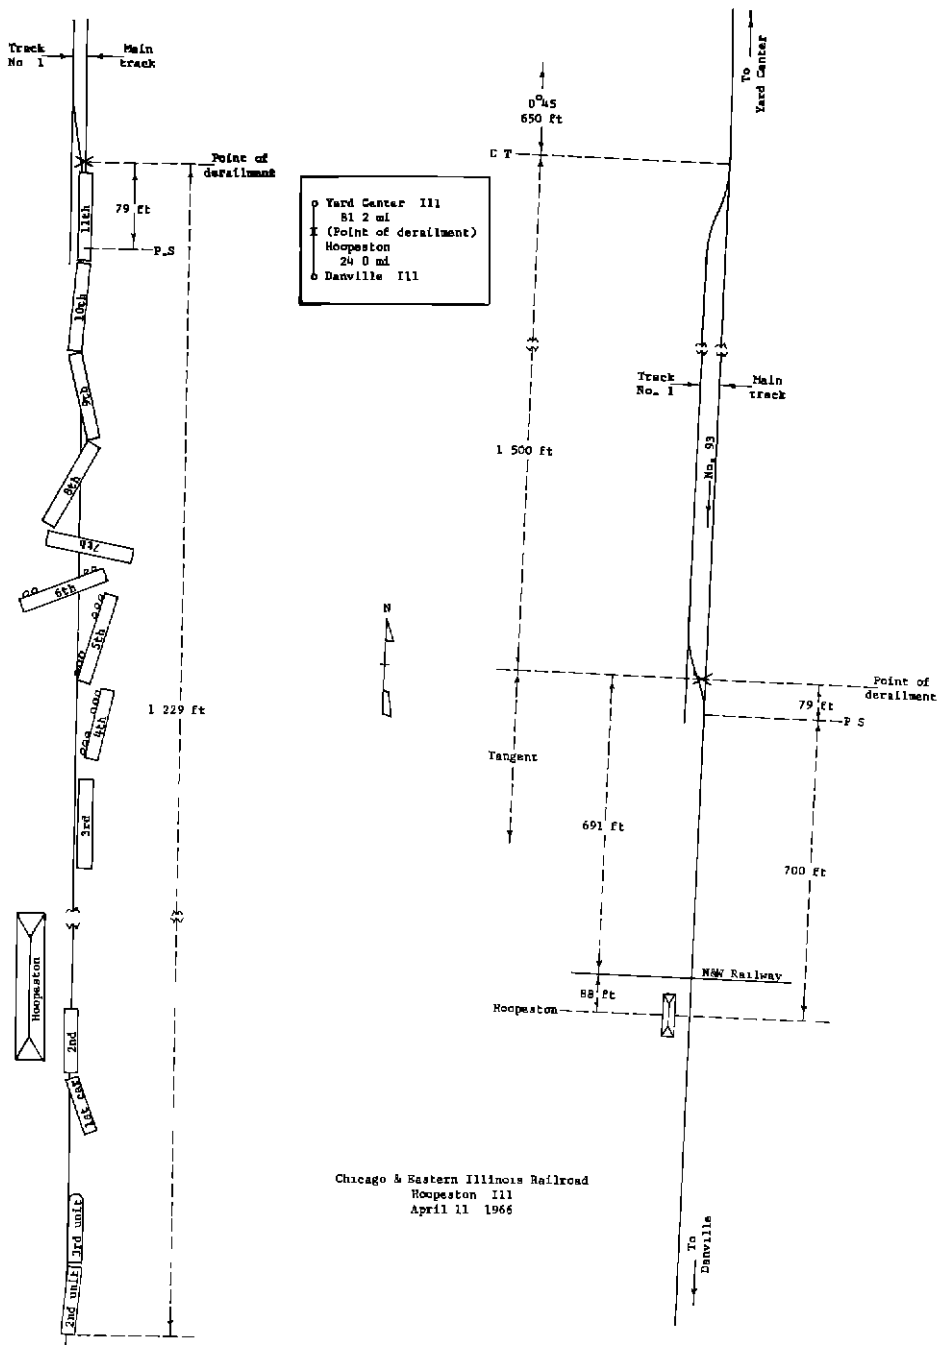
The frog was provided with hold down horns and housings 4 inches and 40 inches north of the frog point. The welds securing the hold down housings to the frog base plate were broken. The spikes supplementing the welds were loose. These defective conditions permitted vertical movements in excess of the allowable one-eighth inch of the spring wing rail above the level of the frog and of the frog below the level of the spring wing rail. Examination of the fractures of the welds disclosed worn and rusty surface conditions indicating a 75 percent old fracture at the south hold down housing and a 95 percent old fracture at the north housing. The spike holes in the ties for the hold down housings were worn to the extent that the spikes could be inserted full length by hand. The south hold down housing was found 108 feet south of the frog on the west side of the track. The north housing was found along the west side of the frog base plate.

The worn and rusty condition of the fractures of the welds and the loose condition of the spikes clearly indicates that the hold down housings of the spring rail frog were inadequately maintained.

Apparently, as the first locomotive unit moved over the frog, the complete fracture occurred in the 95 percent defective weld of the north hold down housing. This immediately put additional strain on the south hold down housing, resulting in the complete fracture of its 75 percent defective weld. As the first wheel of the second locomotive unit moved onto the frog, which then had no

Sketch of frog showing position of wheel where a dangerous condition existed, due to defective hold downs, as shown in Section A-A.

Section A-A
Defective hold down

Section B-B
Wheel derailed after passing over point of frog.

It is recommended that the Chicago & Eastern Illinois Railroad Company immediately take such action as is necessary to insure the adequate maintenance of spring rail frog assemblies.
